Narrowgate House, Coach-house and Stables

**REPORT ON: HISTORIC WALLPAPER RECORDING AND CONDITION SURVEY
WITH NOTES ON ASSOCIATED HISTORIC FINISHES SURVIVING IN-SITU
AT NARROWGATE HOUSE, ALNWICK**

The Front Façade of Narrowgate House, Alnwick, (Formerly General Lambert's House) 31 & 33 Narrowgate.

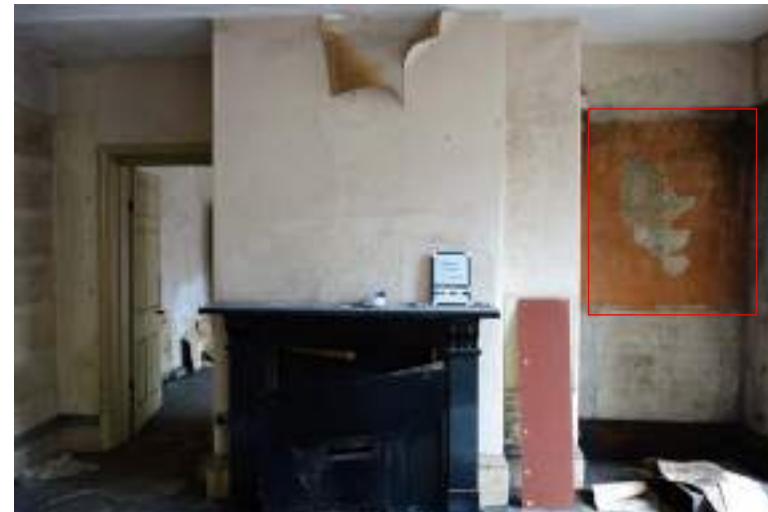
INTERIOR NO. 3

Surface print -	clear, some abrasion
Substrate -	damp, poor air circulation
Staining -	some mould stains and sooty deposits
Infestation/damp -	mould and some damp
Risk H&S -	mould
Testing -	none required
Friability -	embrittled
Approx. date -	c.1860

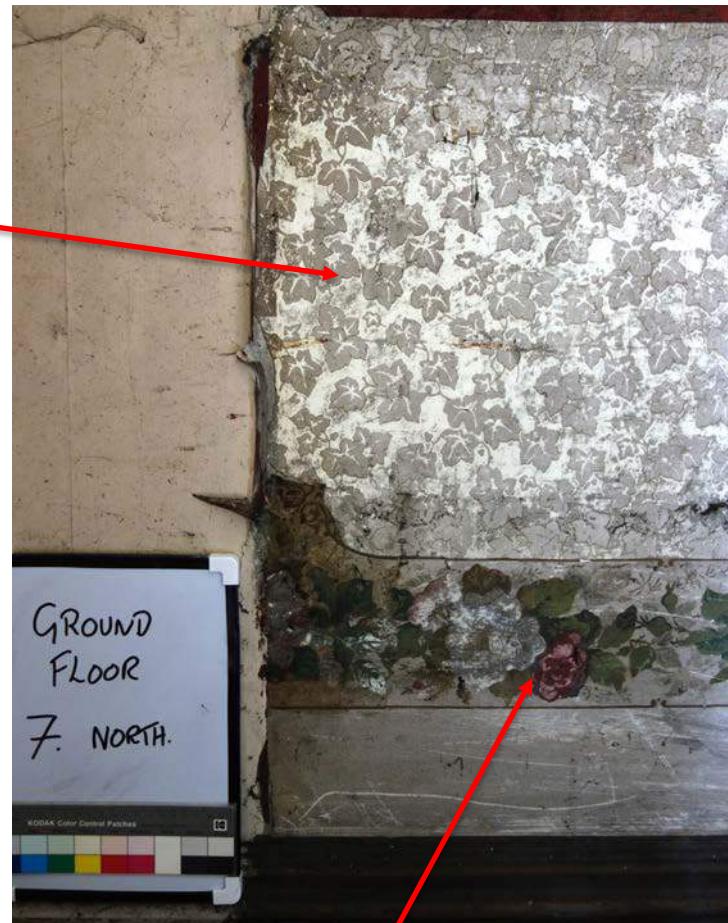
Friability - where exposed, surface dirt with tears and buckling,
with mechanical abrasion and moisture damage.

Requires conservation cleaning detailed recording and removal of a section by conservator, followed by cleaning and archival storage together with its rose border.

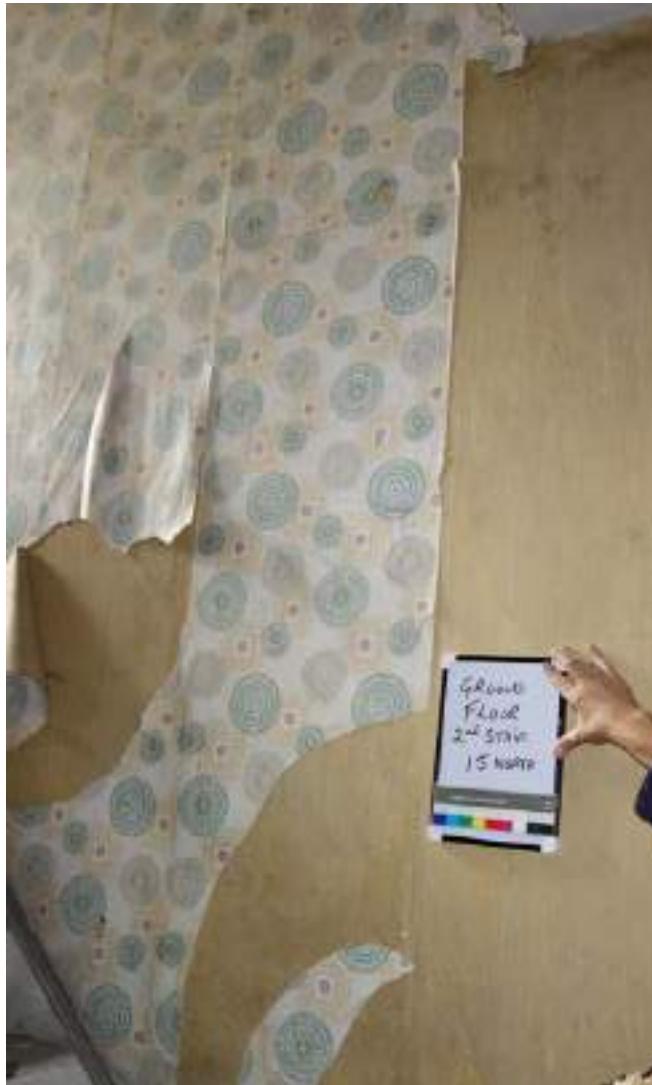
The image below shows the later twentieth century wallpapers, these are post 1950 and of very thin, poor quality. As such they are not considered to be significant.

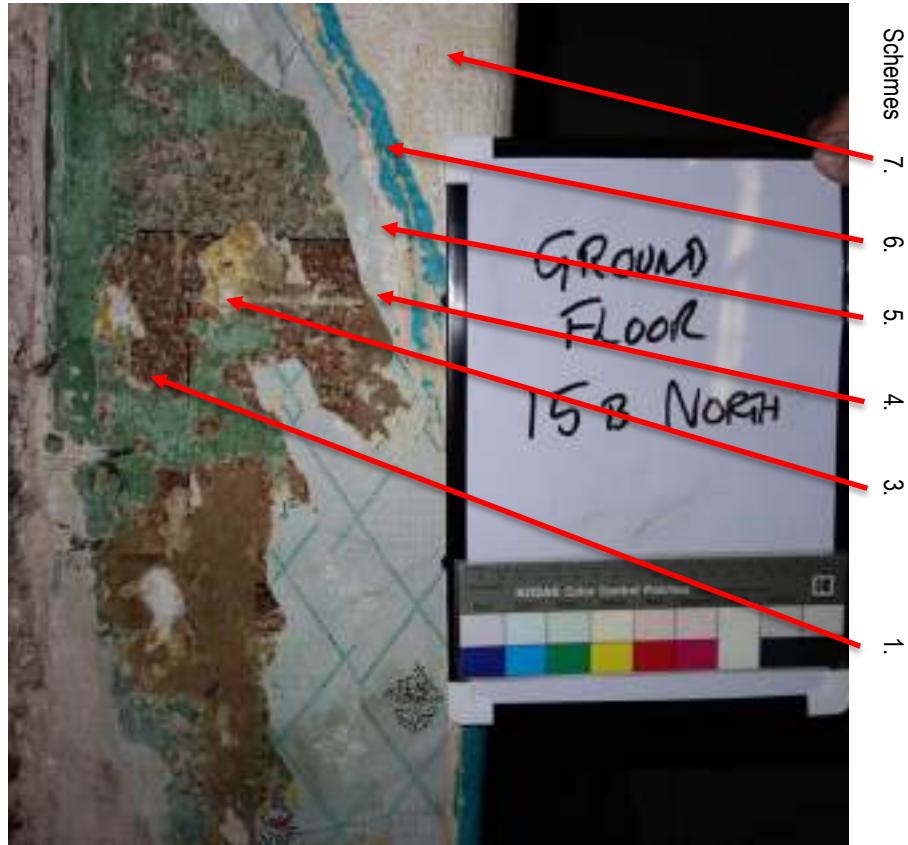
INTERIOR NO. 15b

Surface print - where exposed, surface dirt with some buckling, mechanical abrasion and moisture damage

Requires conservation cleaning, detailed recording and removal by conservator, followed by separation of layers, cleaning and appropriate archive storage.

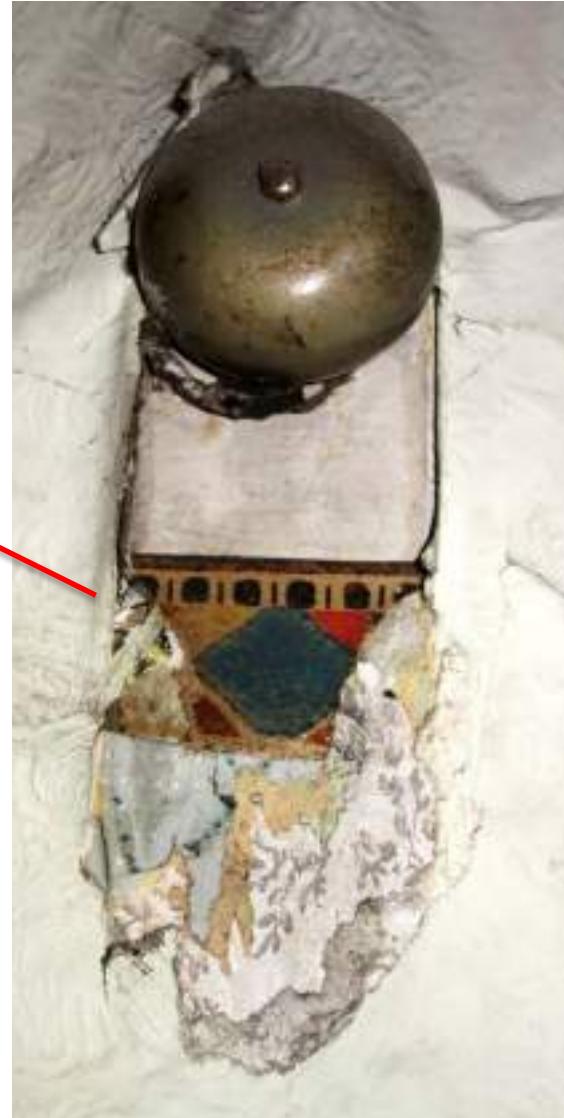
Detail of the high level geometric frieze paper

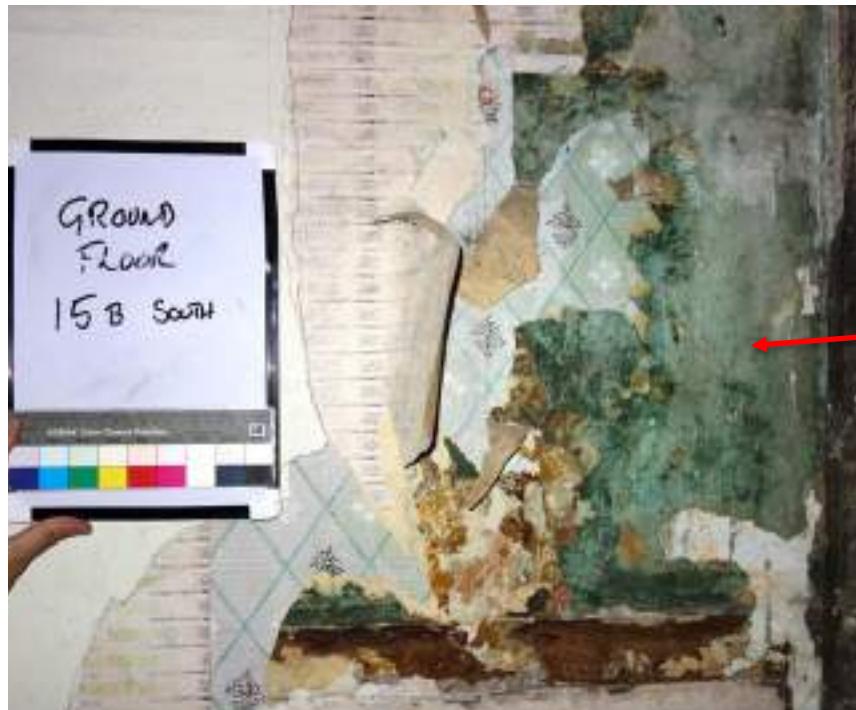
The complex chronology of wallpaper schemes is the same here on the South wall face. The area of wall is extremely damp resulting in the degradation of the wall papers. It is therefore not possible to identify each clearly here. The chronology is the same as the remainder of the interior and as detailed below.

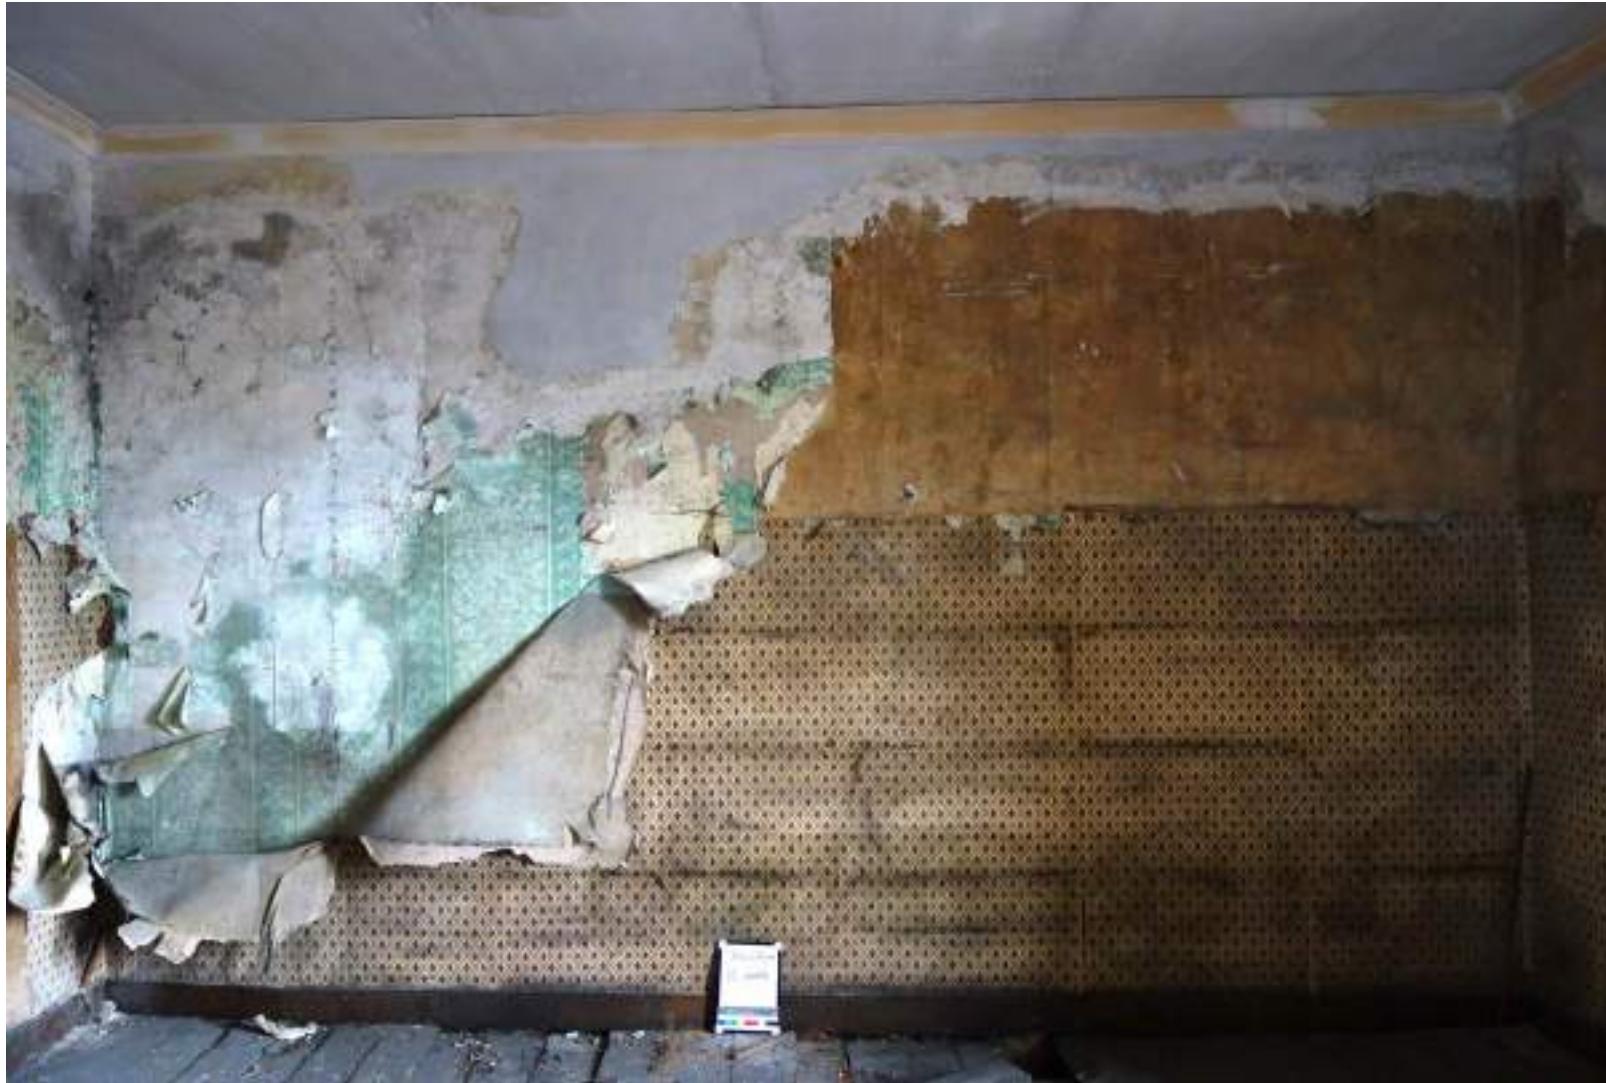
North wall face displaying the significant sequencing. Samples of the green Regency striped wallpaper were removed for arsenic testing

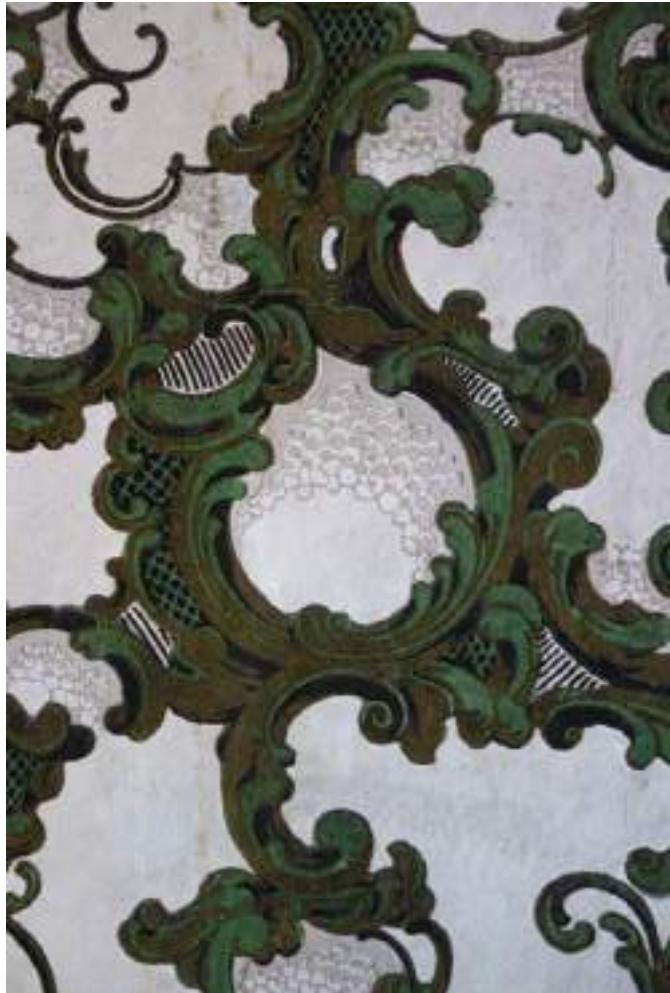
The green scheme seen here identified positive for arsenic at 1.0 ppm

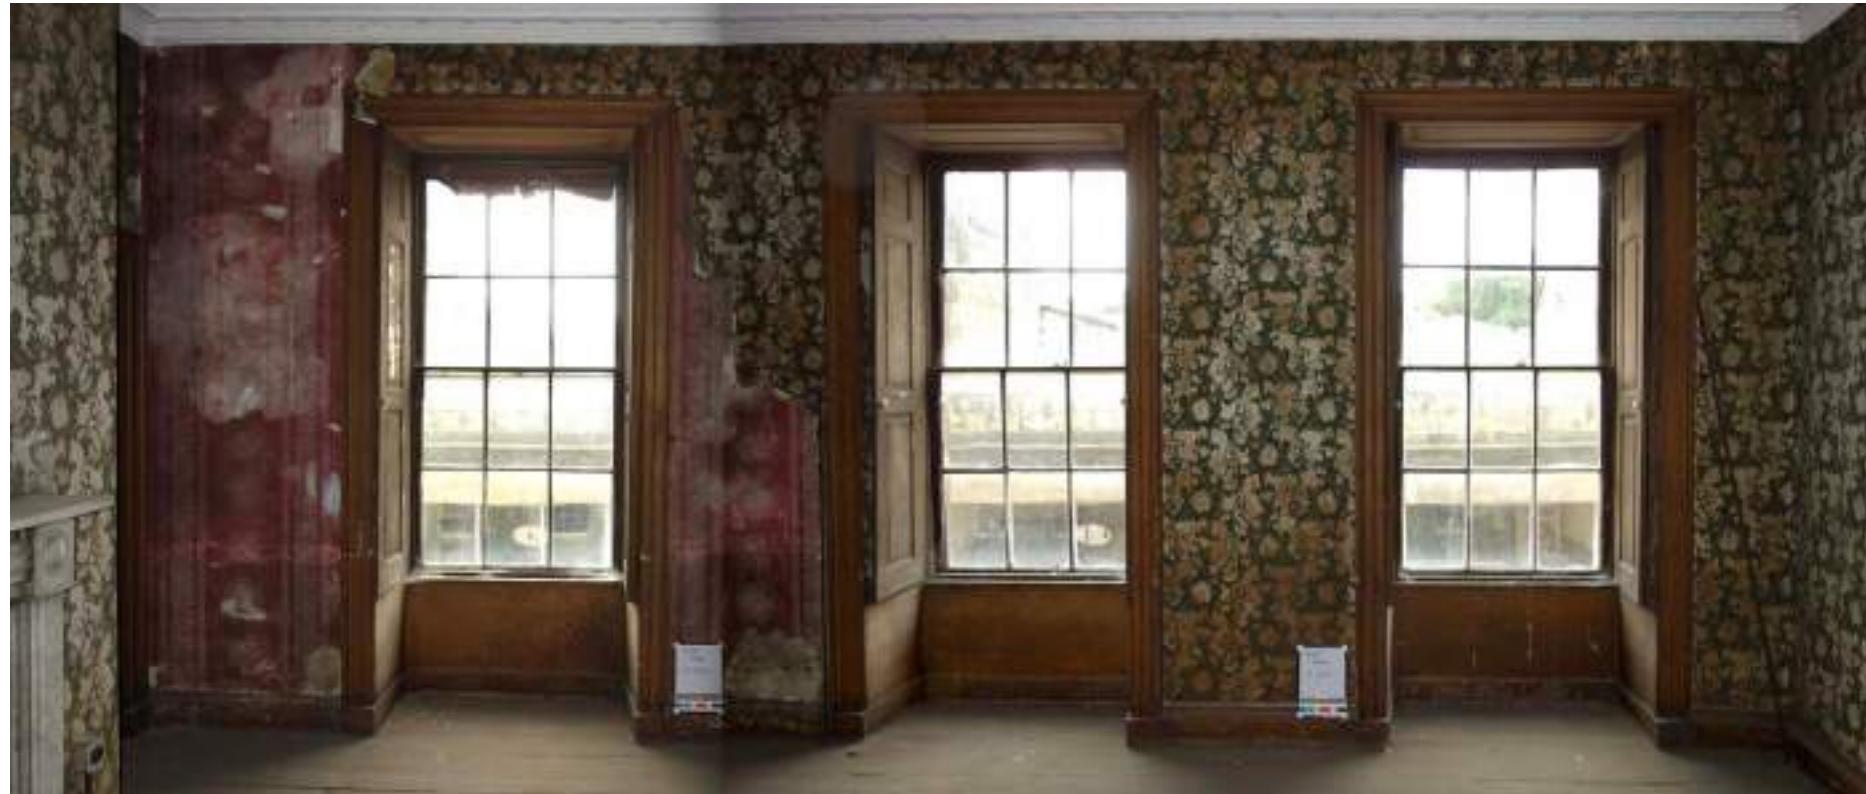
East wall in its entirety, showing the earliest scheme revealed on the left hand (North) side

Arsenic testing proved positive for scheme 2 at 0.05 parts per million and high for scheme 3 at 1.0 parts per million.

The removal of the main wallpapers within this interior must be undertaken by a suitable specialist company due to the high arsenic levels.

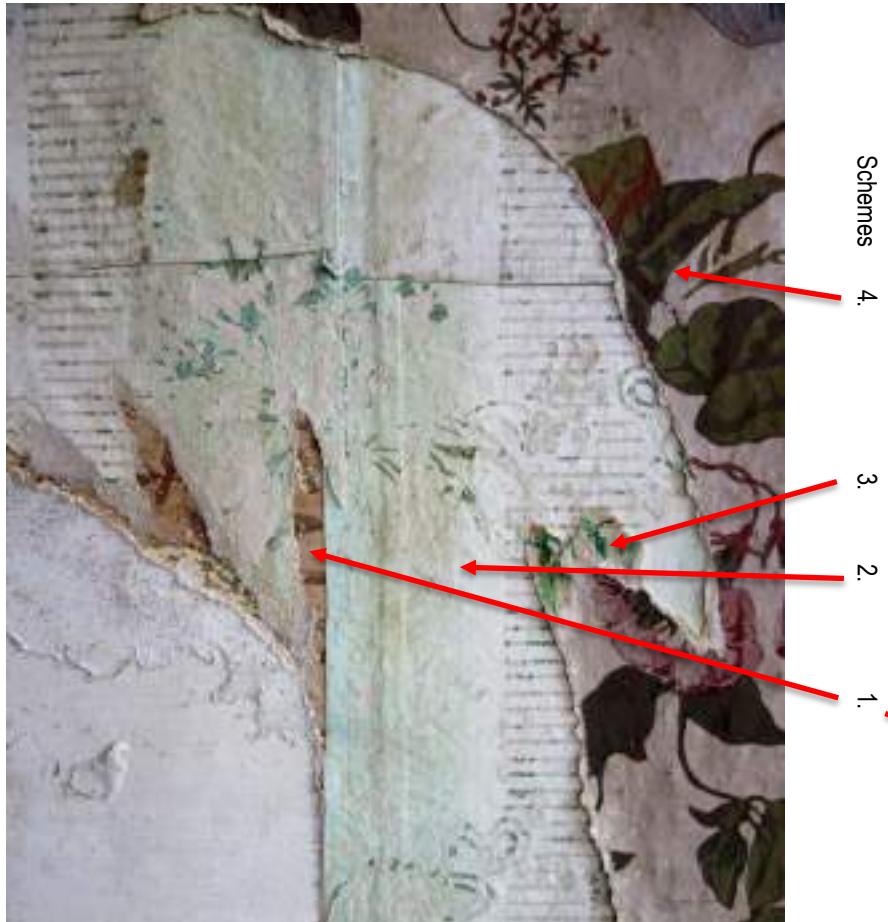
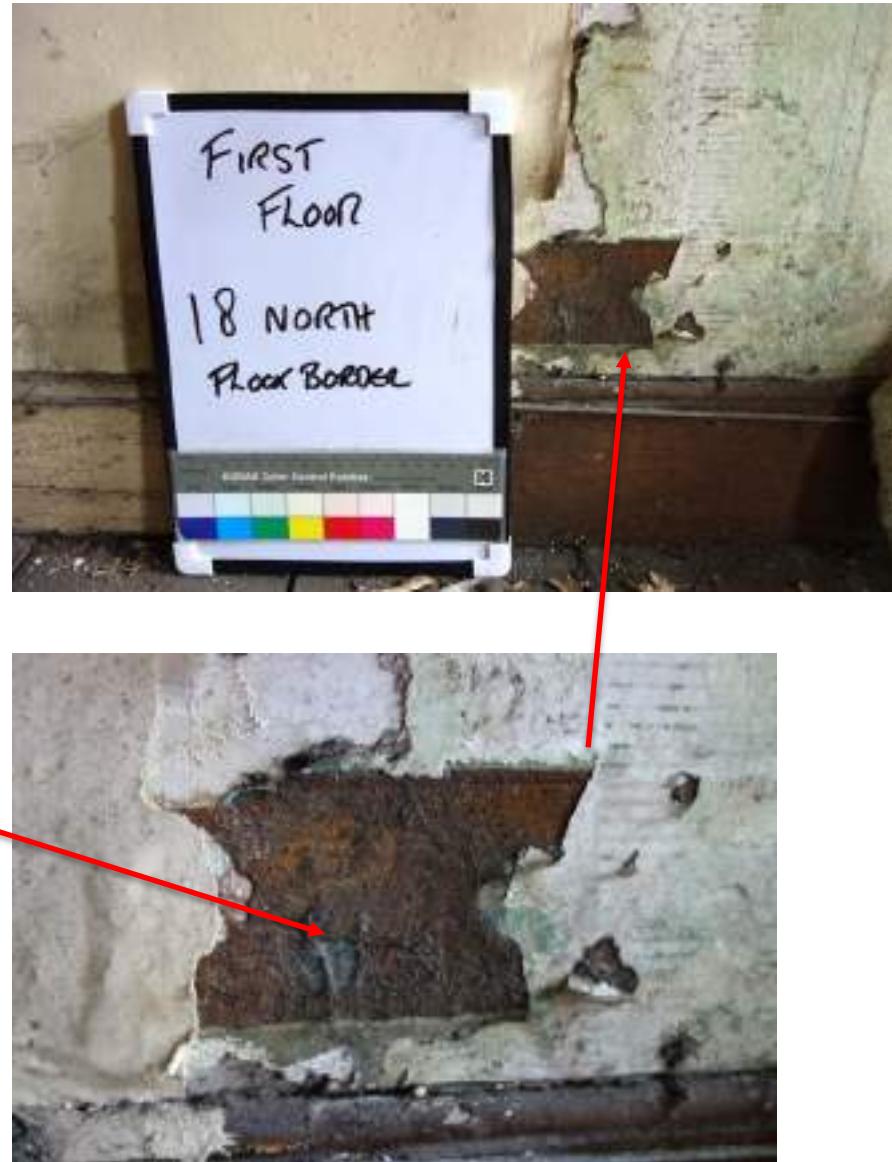
Detail of schemes 1 to 4 showing the vivid green of scheme 2 which tested positive for arsenic

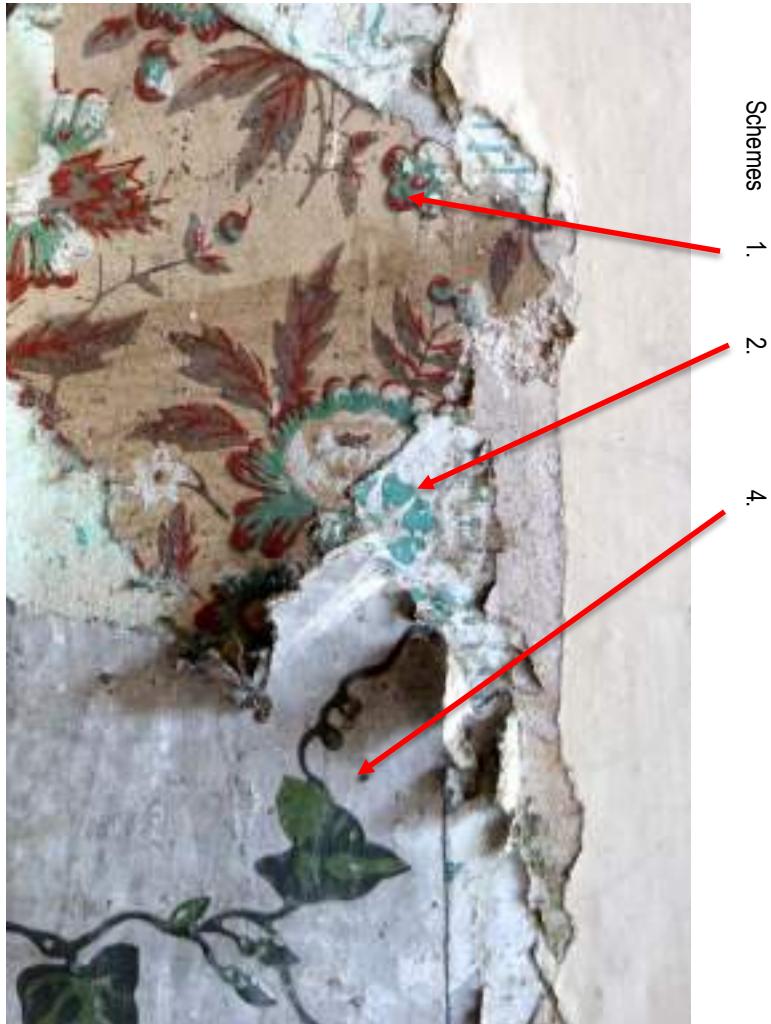
Detail of schemes 1, 2 & 4 showing the vivid green of scheme 2 which tested positive for arsenic

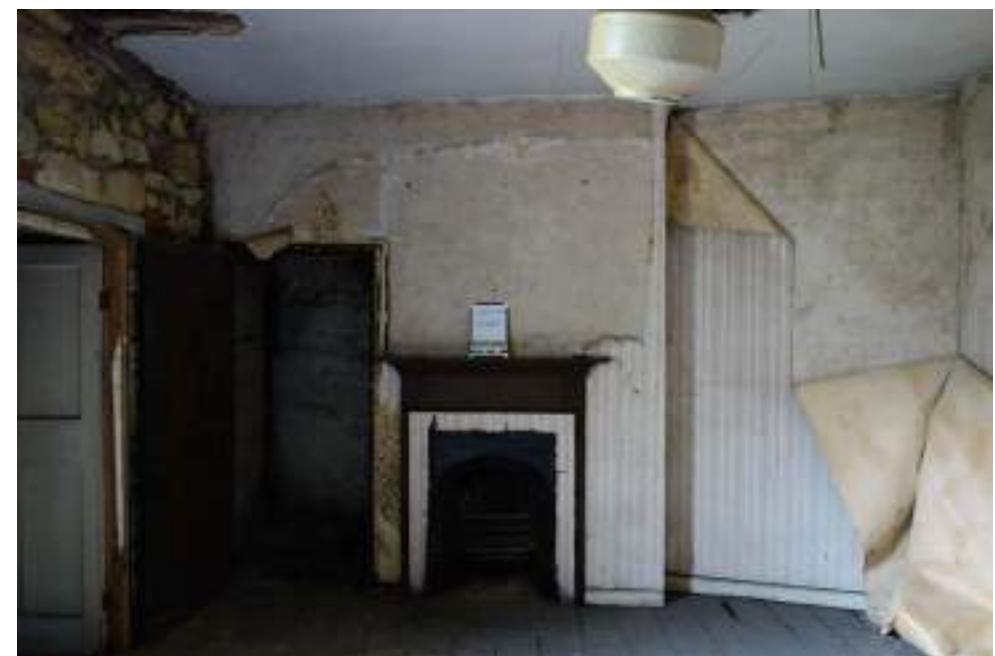
ROOM 19, North wall showing stripped and falling wall paper with plaster removed to the West wall

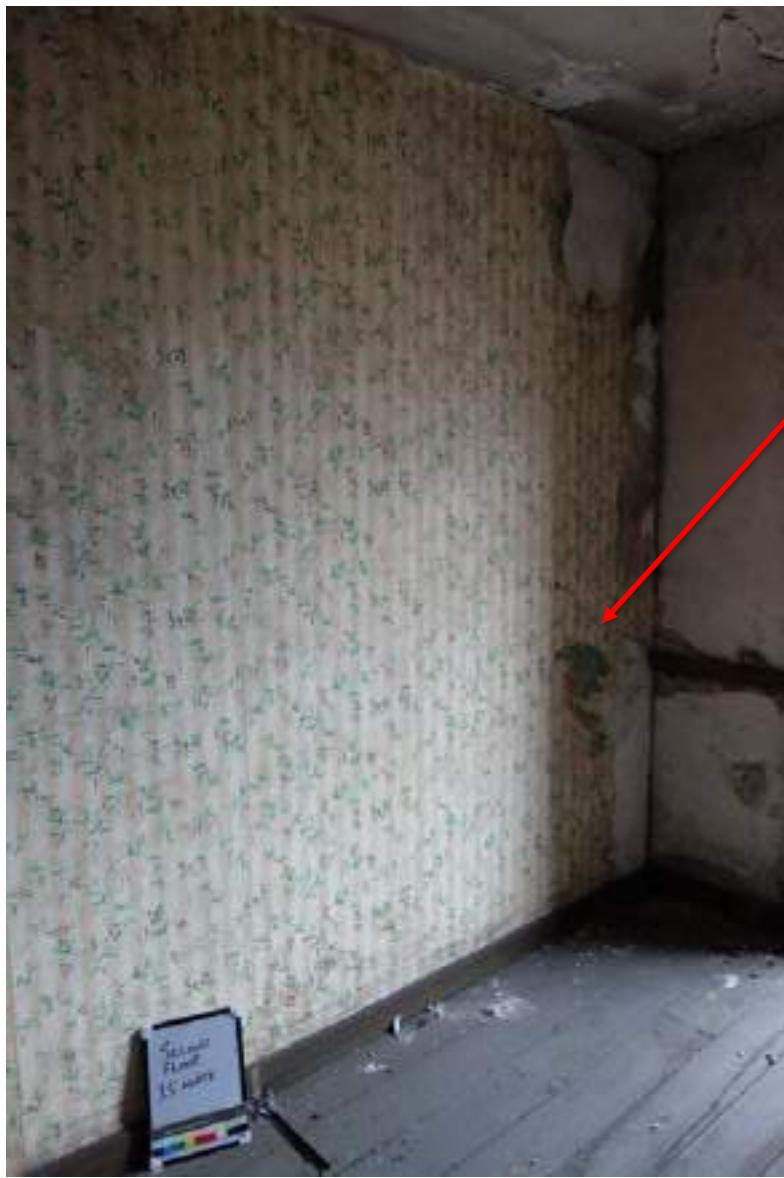
Room 35 North wall, full height survival
