STRUCTURAL INSPECTION

THE DIRTY BOTTLES
28 NARROWGATE
ALNWICK
NORTHUMBERLAND
NE66 1JG

S4510-R02

GREENE KING BREWING & RETAILING LTD

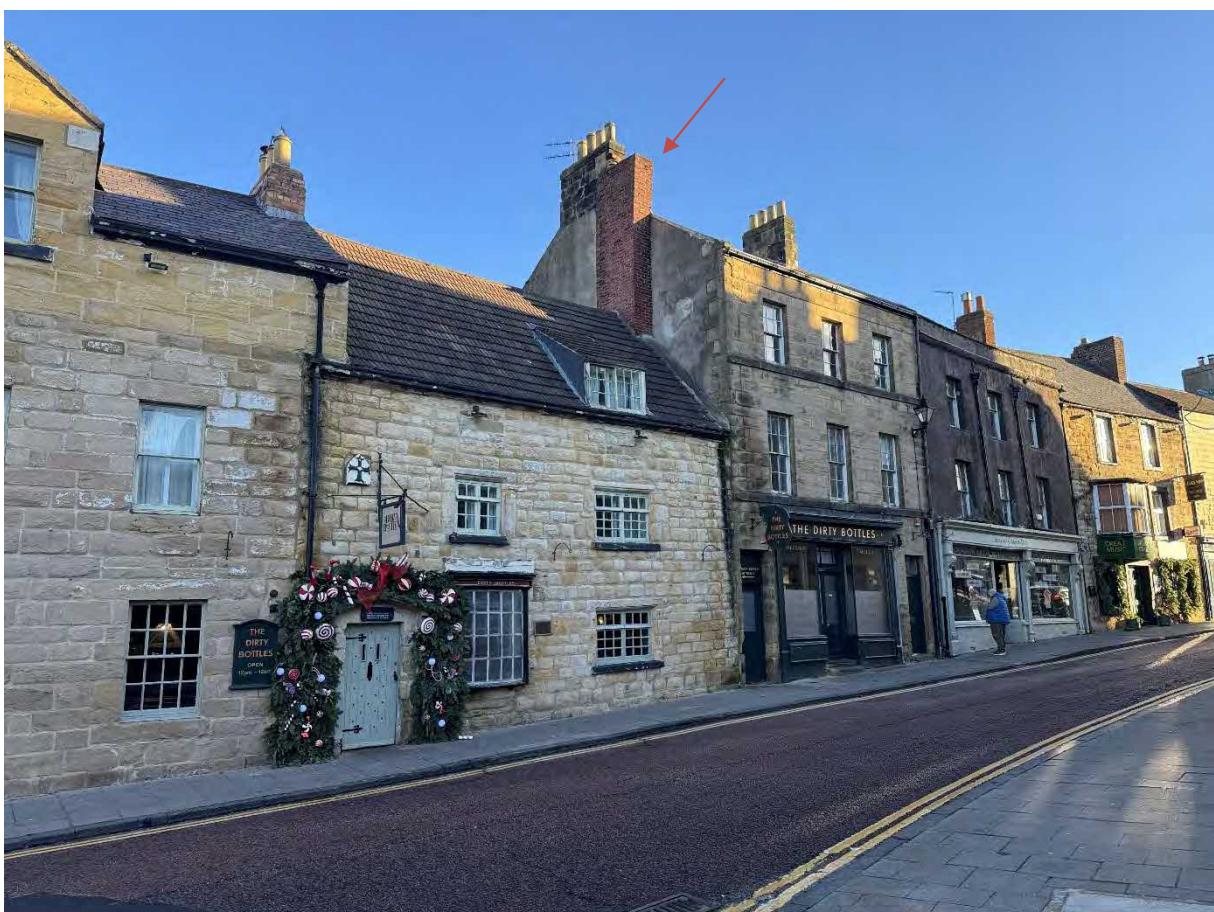
P4 – The Dirty Bottles – No. 28 - 32 Narrowgate - Alnwick - Front, southwest elevation.
Red arrow highlighting chimney stack with poor vertical alignment.

The external chimney stack has poor vertical alignment at high level. We recommend that the upper section of the chimney stack, above the higher roof level (approx 1.0-1.5m), be taken down and rebuilt to a sympathetic and satisfactory vertical alignment. The chimney stack should be rebuilt using existing brickwork where possible with damaged and defective bricks being replaced with matching, reclaimed bricks.

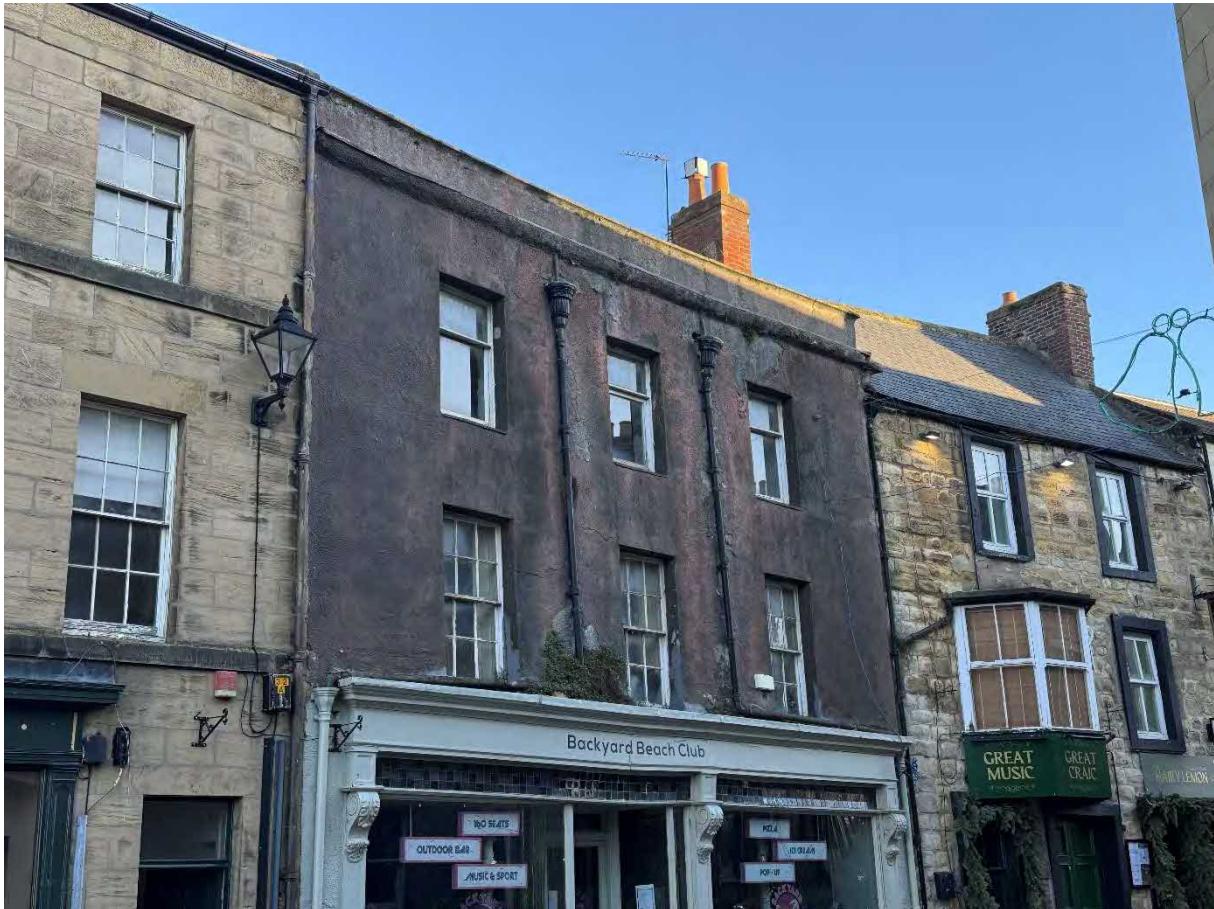
Viewed externally, the wall was noted to have poor vertical alignment at first and second floor levels, the head of the wall leaning (and bowing) inwards towards the north. Refer photograph P7, Appendix A.

The external roof rainwater drainage appears to be defective and water damage and vegetation growth were evident within the wall and above the shopfront fascia. Refer photographs P7 to P9, Appendix A.

P7 – No. 28 Narrowgate - Alnwick - Front, southwest elevation.

Poor vertical alignment within front elevation wall, leaning and bowing inwards at 1st and 2nd floor

During the extensive structural remedial works required within the building, we also recommend that additional lateral restraint be provided to the external wall, this may include strapping to internal buttressing walls, installation of internal structural timber frames and tying walls to new floor and roof structures.

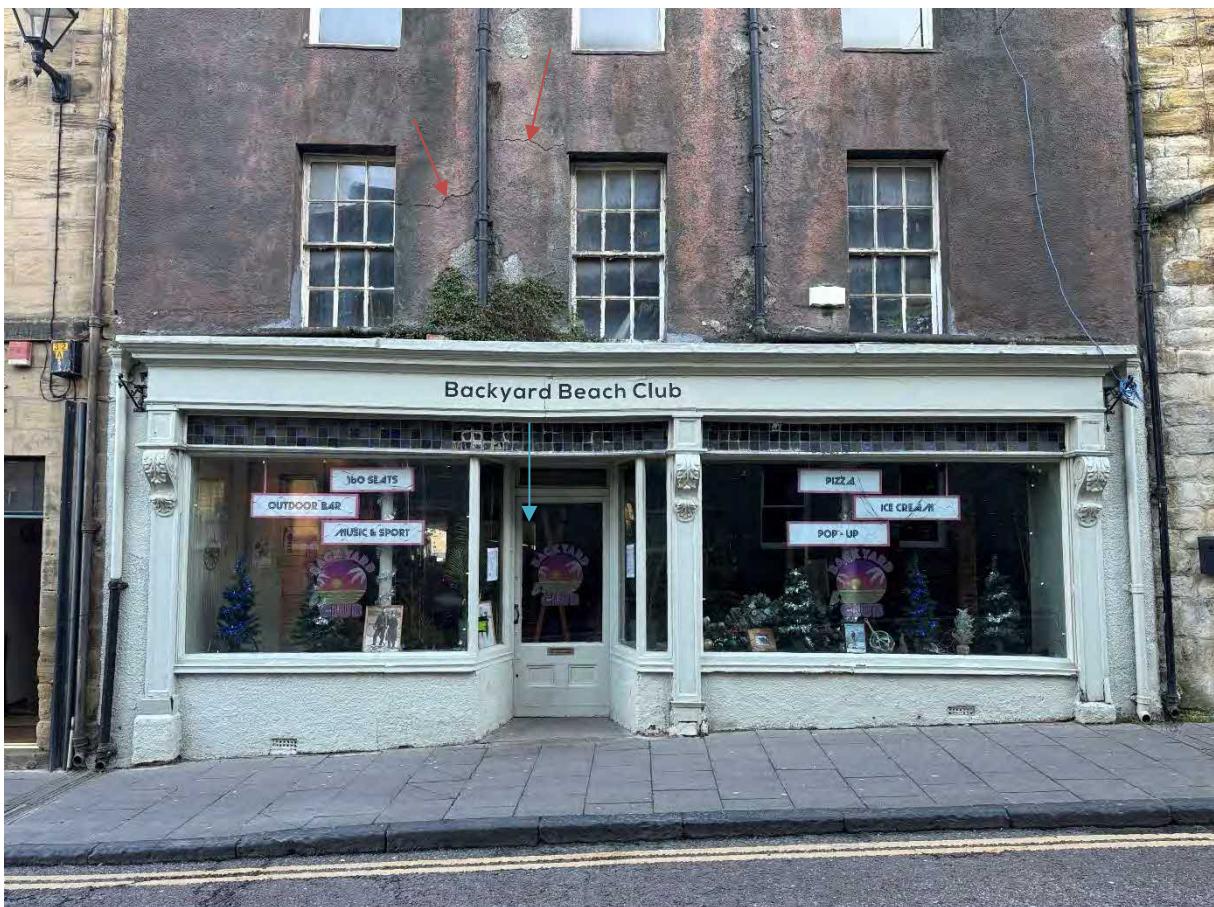
The beams supporting the front elevation wall, above the shopfront, appear to have failed locally, this is evident in the misalignment observed within the shopfront fascia signage and the cracking within the first-floor masonry wall above. Refer photographs P8 to P12, Appendix A. The shopfront beams were not visible for inspection during our visit.

The cracking and movement observed within the front (south) elevation wall would appear to be the result of the partial failure of the shopfront beams, at first floor level. The existing shopfront beams are currently concealed behind plaster and timber cladding and the details and condition of the beams could not be confirmed. Based on our observations, the existing front elevation wall will require temporary propping to allow the existing beams to be repaired, treated or more likely replaced with new. The front elevation wall, timber upper floors and roof structure will require temporary propping to allow the shopfront supports to be reinstated, repaired or replaced.

P8 – Cracking within first floor wall (red arrows) above deflected shopfront beam (blue arrow)

The front elevation wall will require structural repair to cracks, repair to rainwater drainage and all timber lintels above external openings are likely to require replacement.

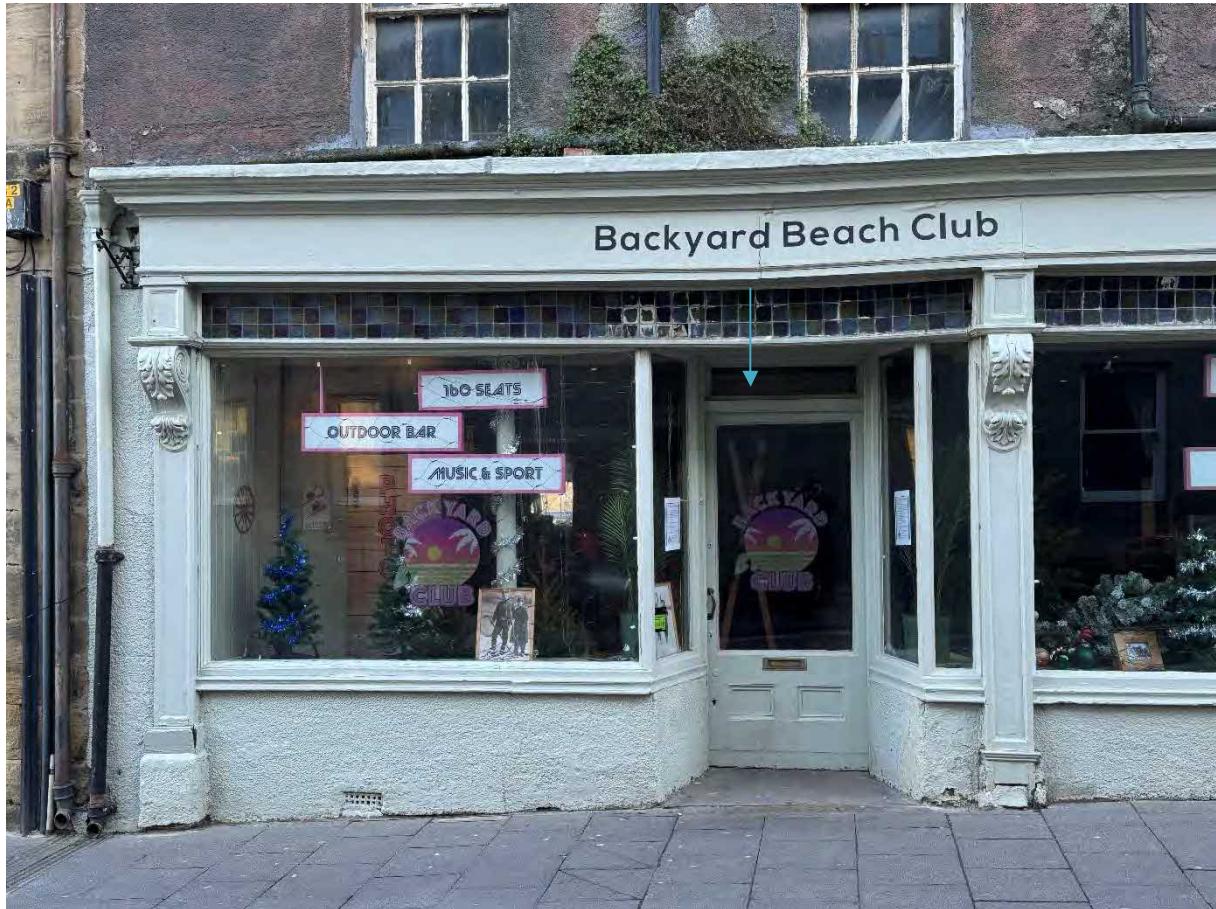
P9 – Deflection within shopfront beam above ground floor entrance with cracking to first floor wall and distortion and damage to shopfront fascia.

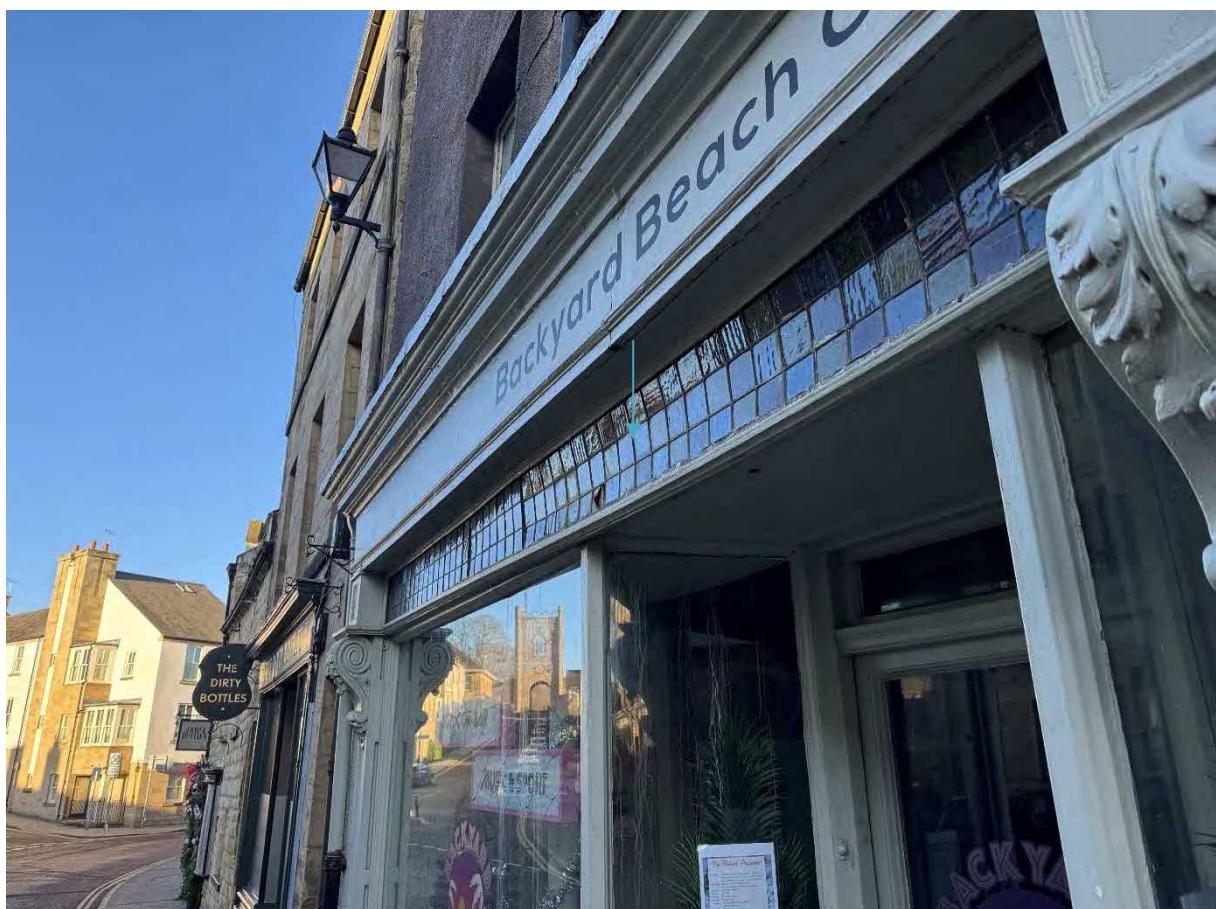
P10 – Deflection within shopfront beam above ground floor entrance with cracking to first floor wall and distortion and damage to shopfront fascia.

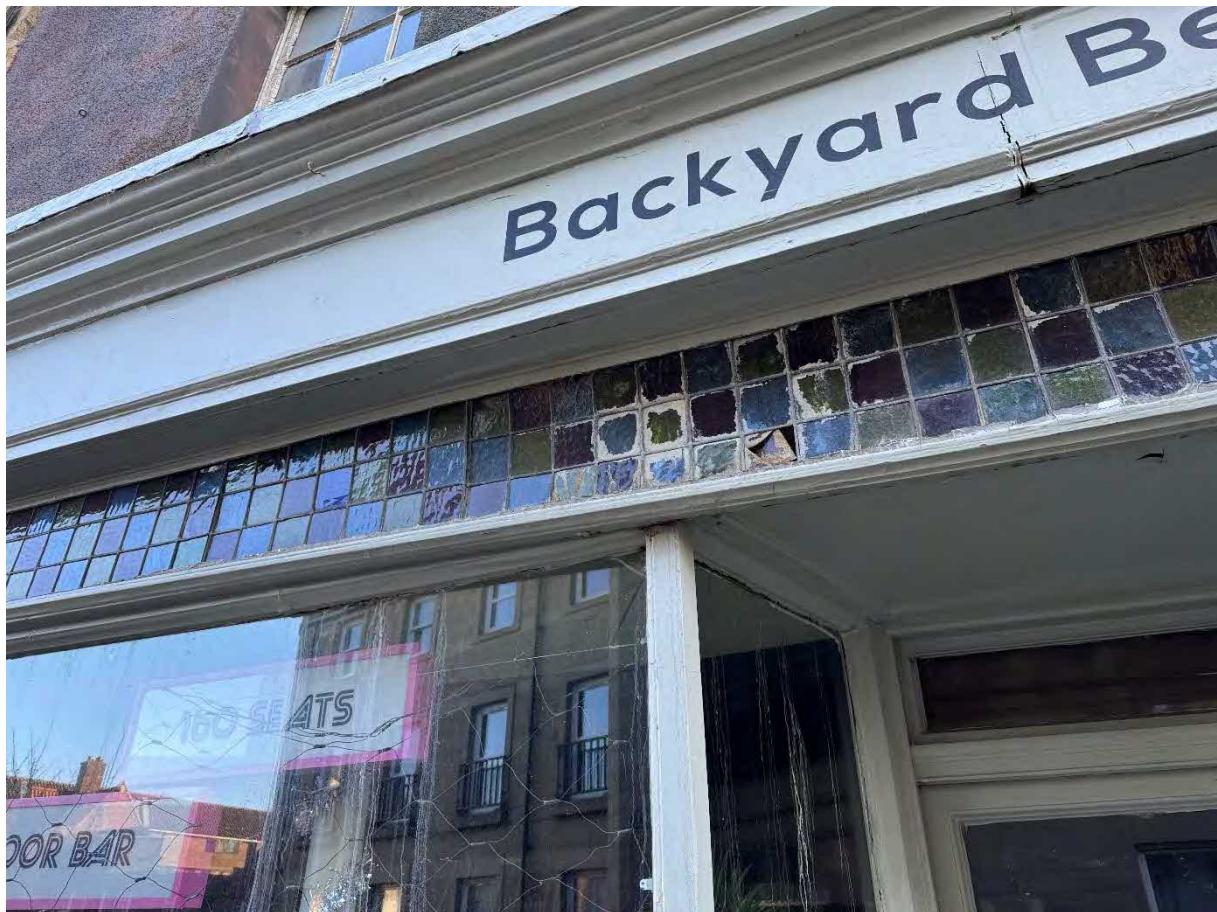
P11 – Deflection within shopfront beam above ground floor entrance with cracking to first floor wall and distortion and damage to shopfront fascia.

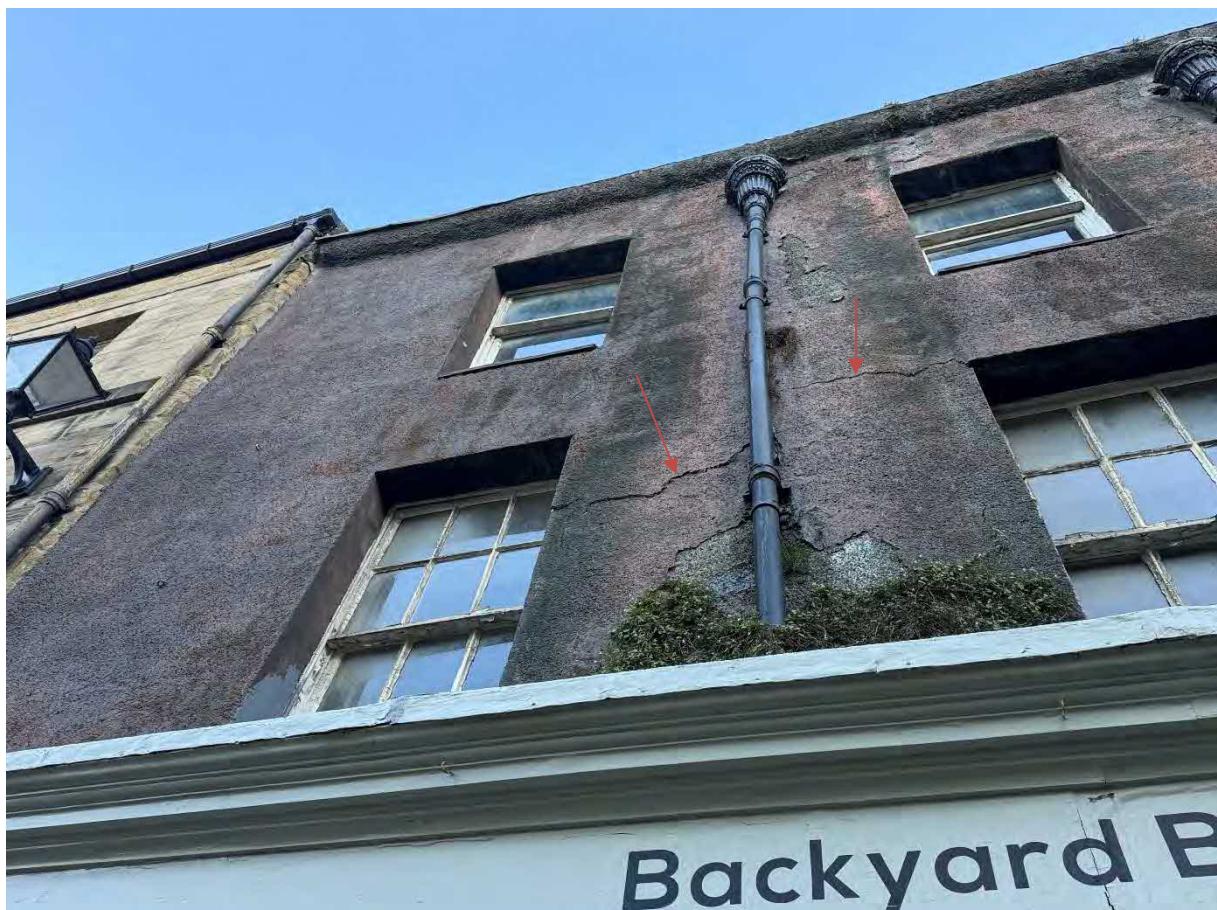
P12 – Cracking within first floor wall above defective shopfront beam.
Defective roof rainwater drainage.

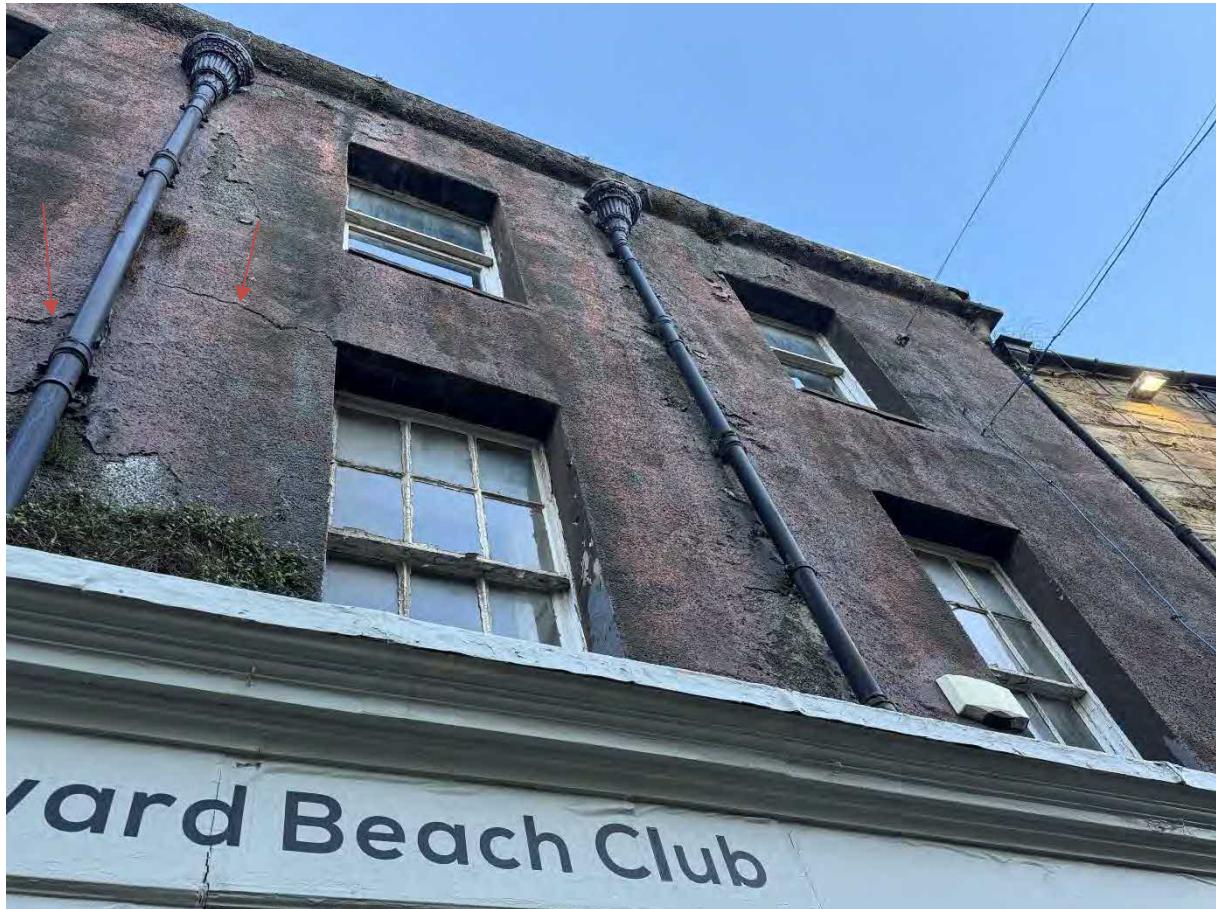
P13 – Cracking within first floor wall above defective shopfront beam.
Defective roof rainwater drainage.

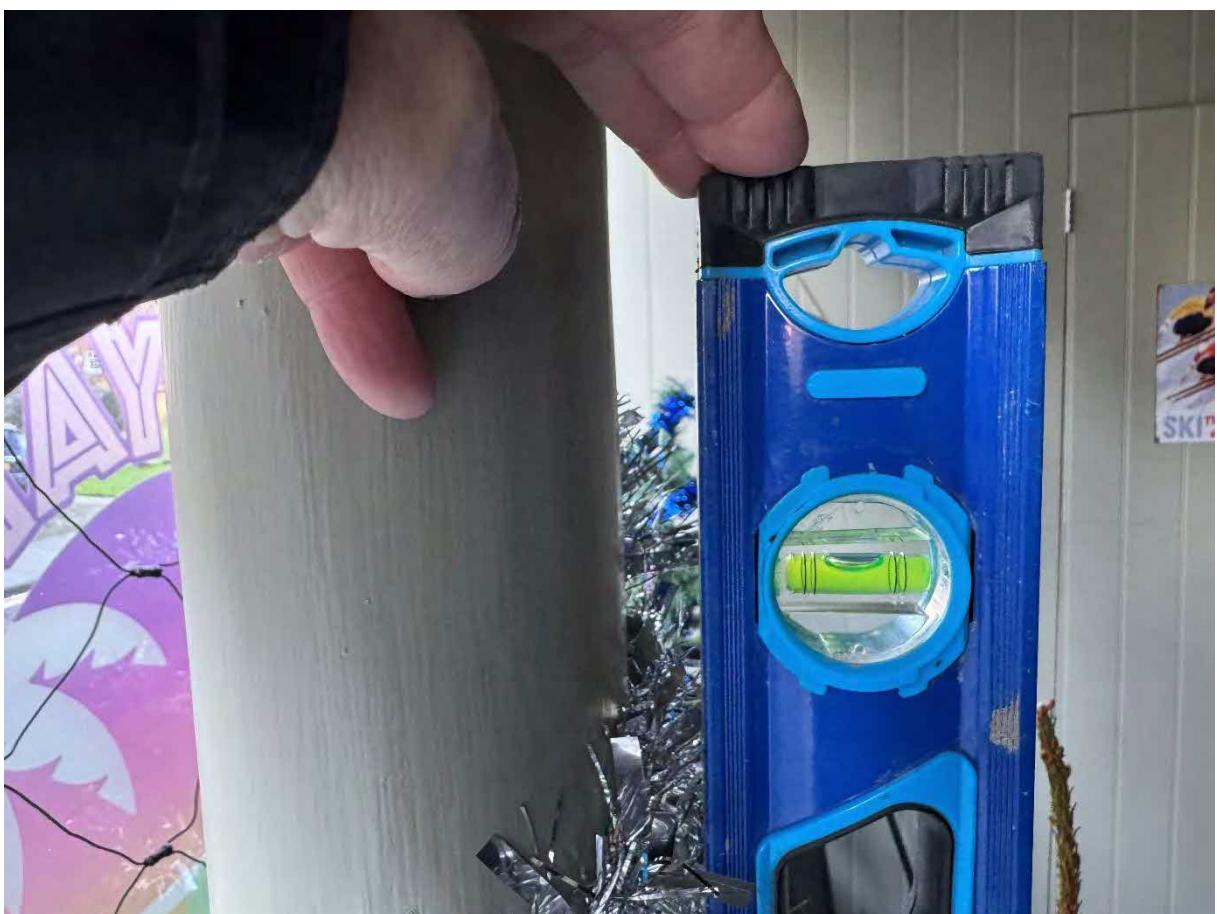
The two outer cast iron columns, supporting the shopfront beams at ground floor level, were noted to lean outwards approx. 20mm over 1.0m level length, towards the road (south). Refer photographs P20 + P21, Appendix A.

P20 – Head of outer (two) cast iron columns lean out to south by approx 20mm over 1.0m level length.

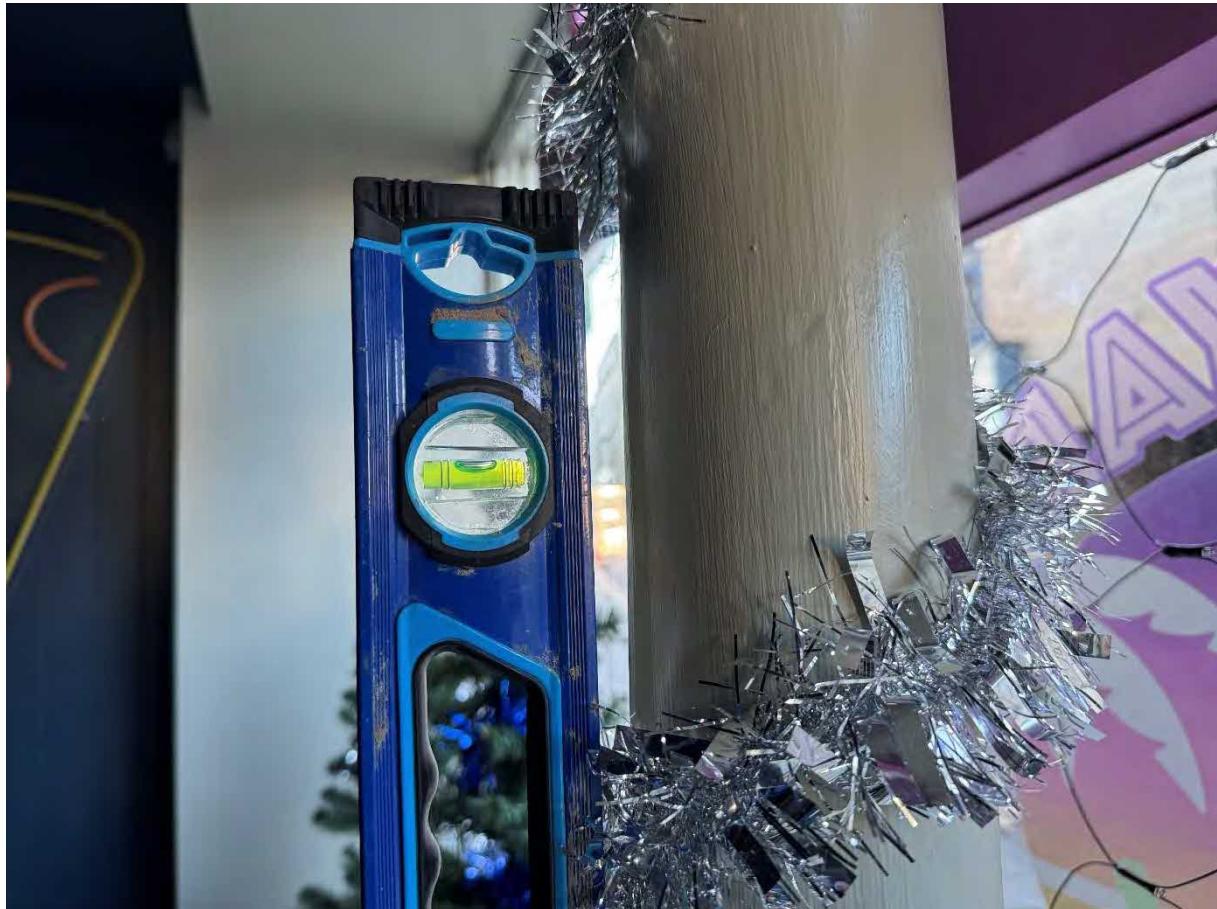
P21 – Head of outer (two) cast iron columns lean out to south by approx 20mm over 1.0m level length.

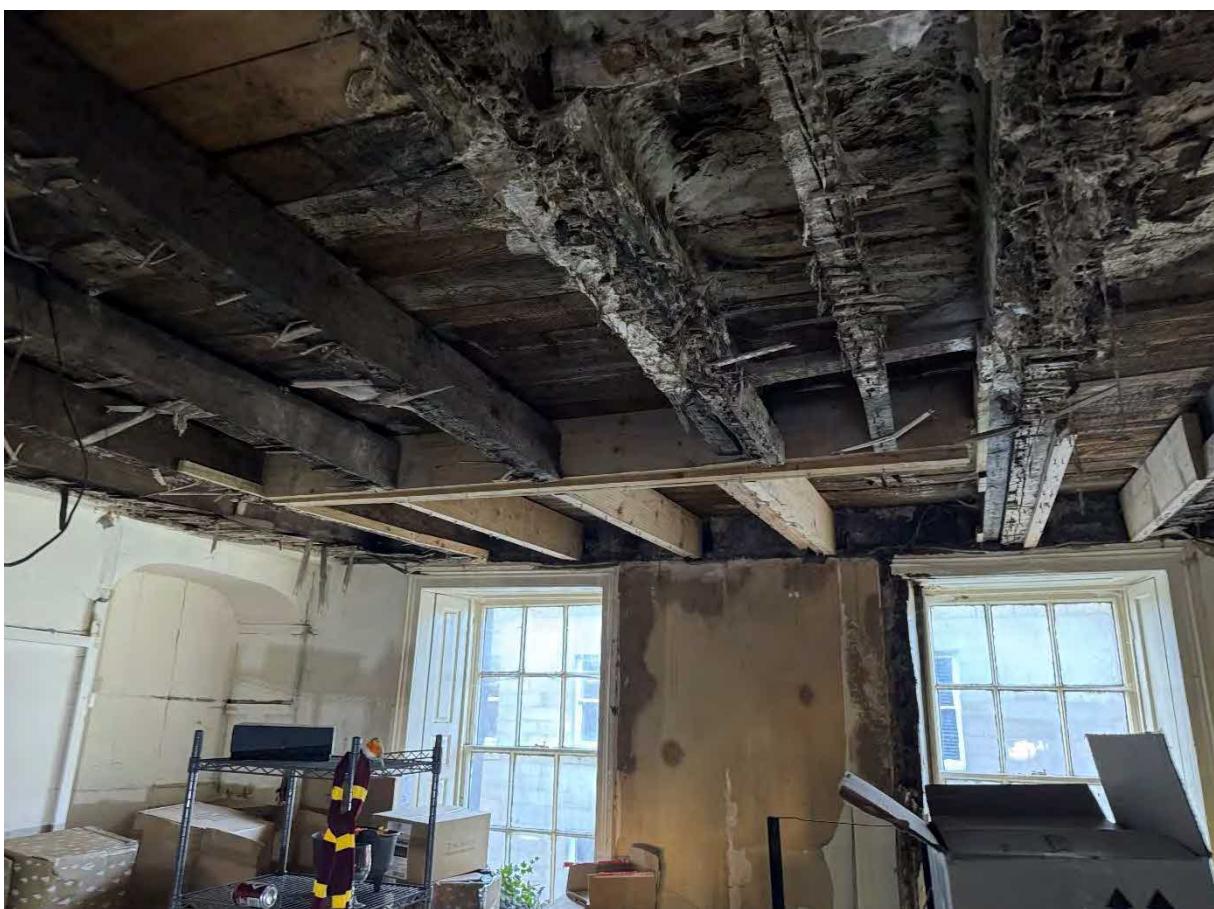
The timber second floors (all rooms) have suffered severe decay with evidence of extensive wet and dry rot throughout the timber floor deck, joists, trimmers and floor beams.

Past modifications and repairs to the timber floor within the front section of the building (room 6) have been poorly implemented and the floor has suffered significant deflection and misalignment.

P24 – First floor level – front room (3). Severe decay (wet and dry rot) within timber second floor structure. Past modifications and repairs to second floor structure appear to have been poorly implemented and the floor is potentially unsafe.

The timber staircases and second floors within the building are in very poor, potentially unstable and dangerous condition. We recommend that the second floors should not be accessed until temporary support has been provided at the lower levels.

The timber staircases and second floor structures will require removal and replacement with new. Temporary lateral restraint will be required to the front elevation wall to allow the floor to be removed and replaced. Temporary support (propping through to basement level) will also be required to allow safe access to the upper floors and roof structures.

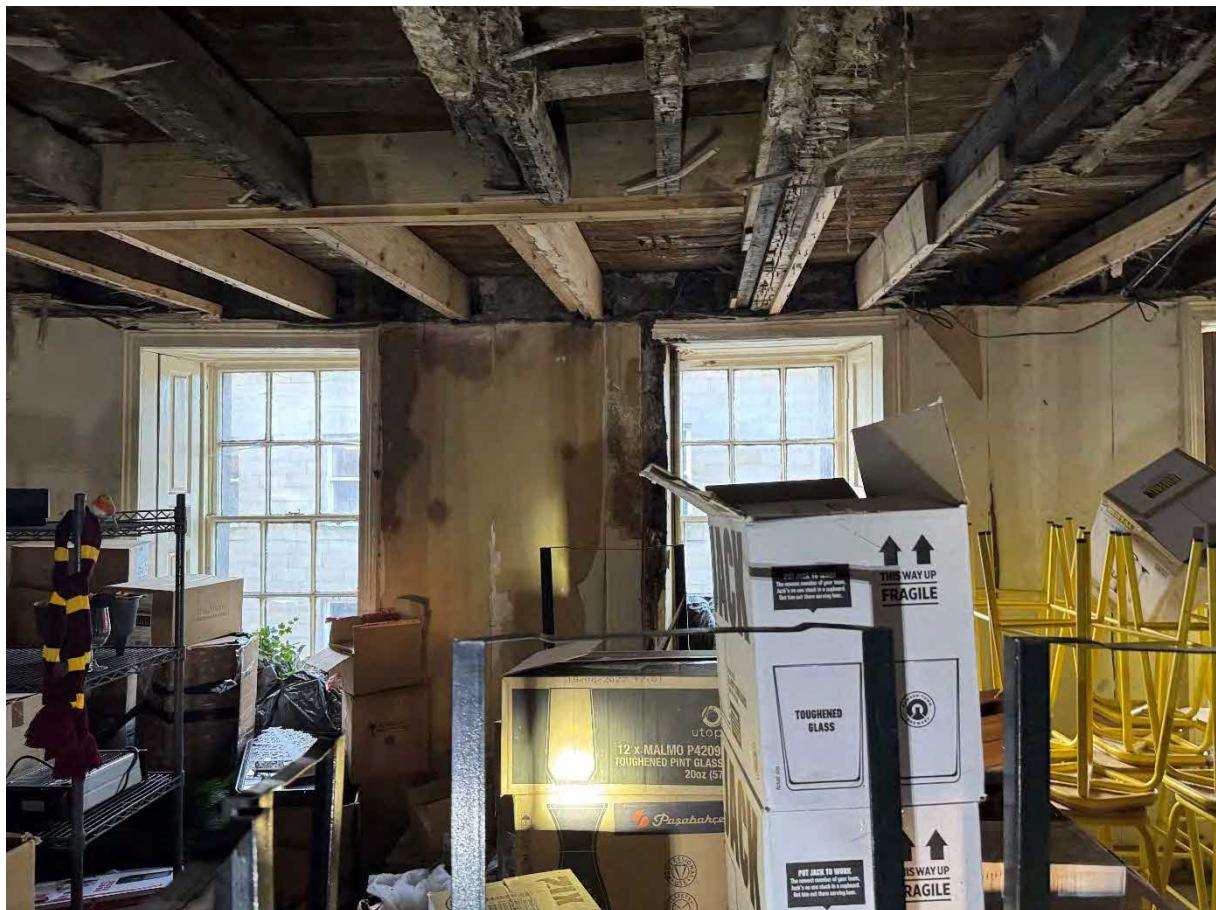
P25 – First floor level – front room (3). Severe decay (wet and dry rot) within timber second floor structure. Past modifications and repairs to second floor structure appear to have been poorly implemented and the floor is potentially unsafe.

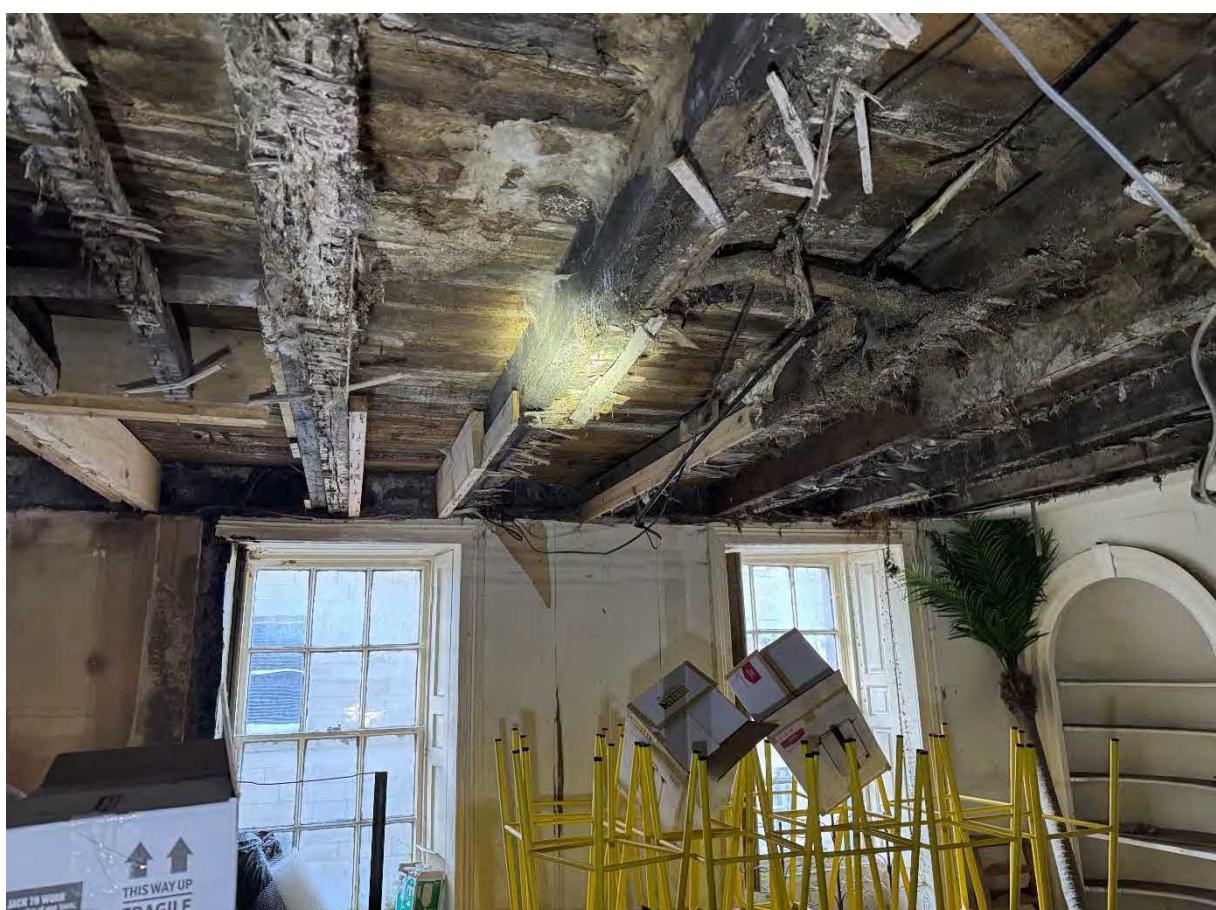
P26 – First floor level – front room (3). Severe decay (wet and dry rot) within timber second floor structure. Past modifications and repairs to second floor structure appear to have been poorly implemented and the floor is potentially unsafe.

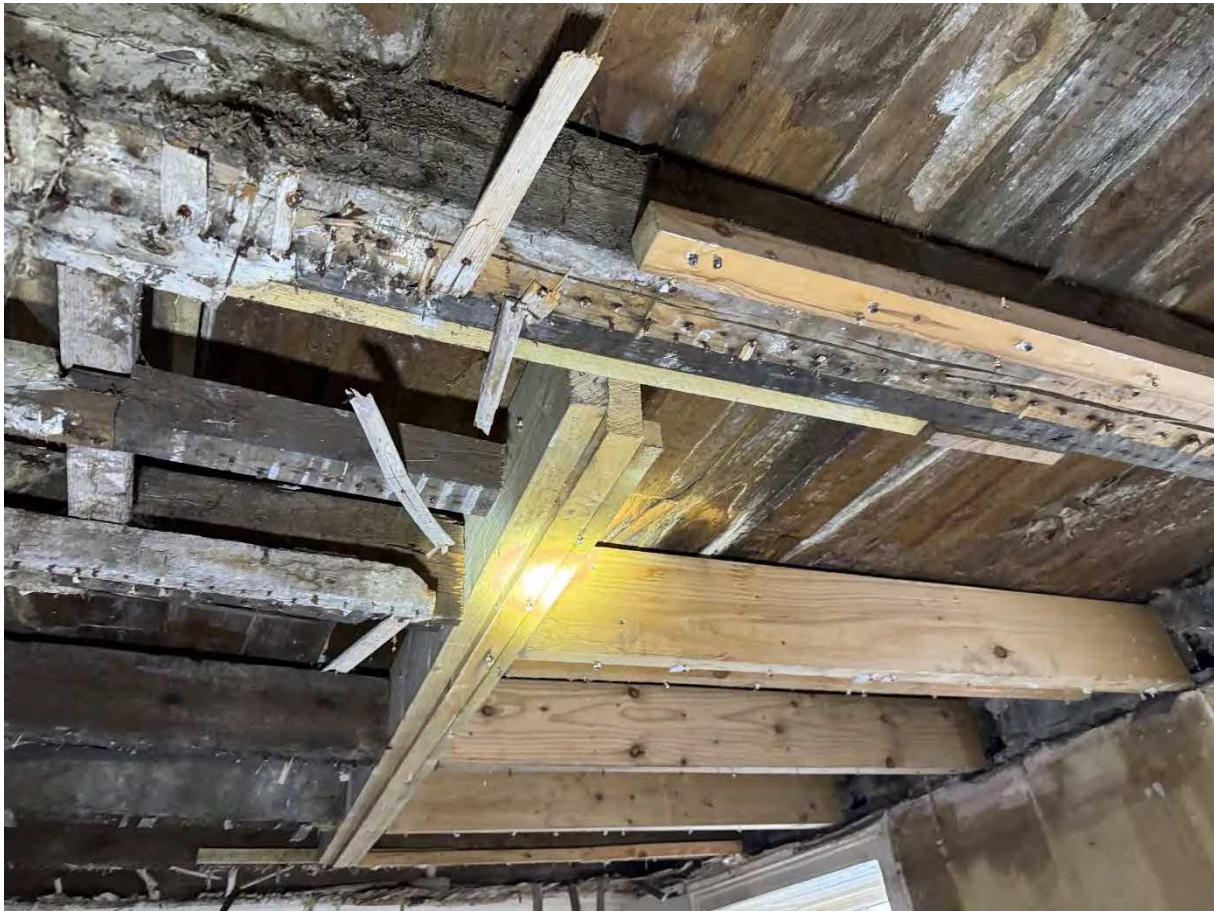
P27 – First floor level – front room (3). Severe decay (wet and dry rot) within timber second floor structure. Past modifications and repairs to second floor structure appear to have been poorly implemented and the floor is potentially unsafe.

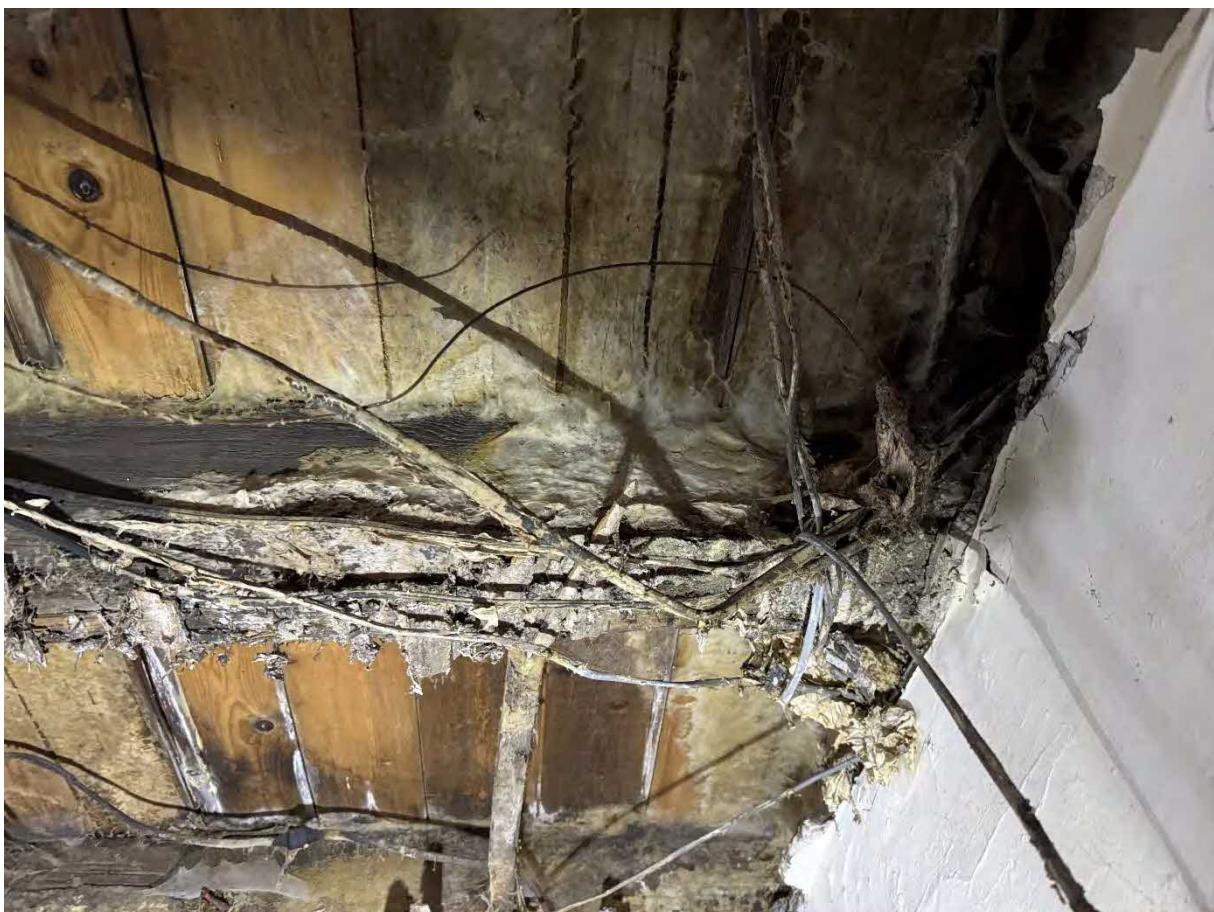
P28 – First floor level – front room (3).
Severe decay (dry rot) within timber second floor structure.

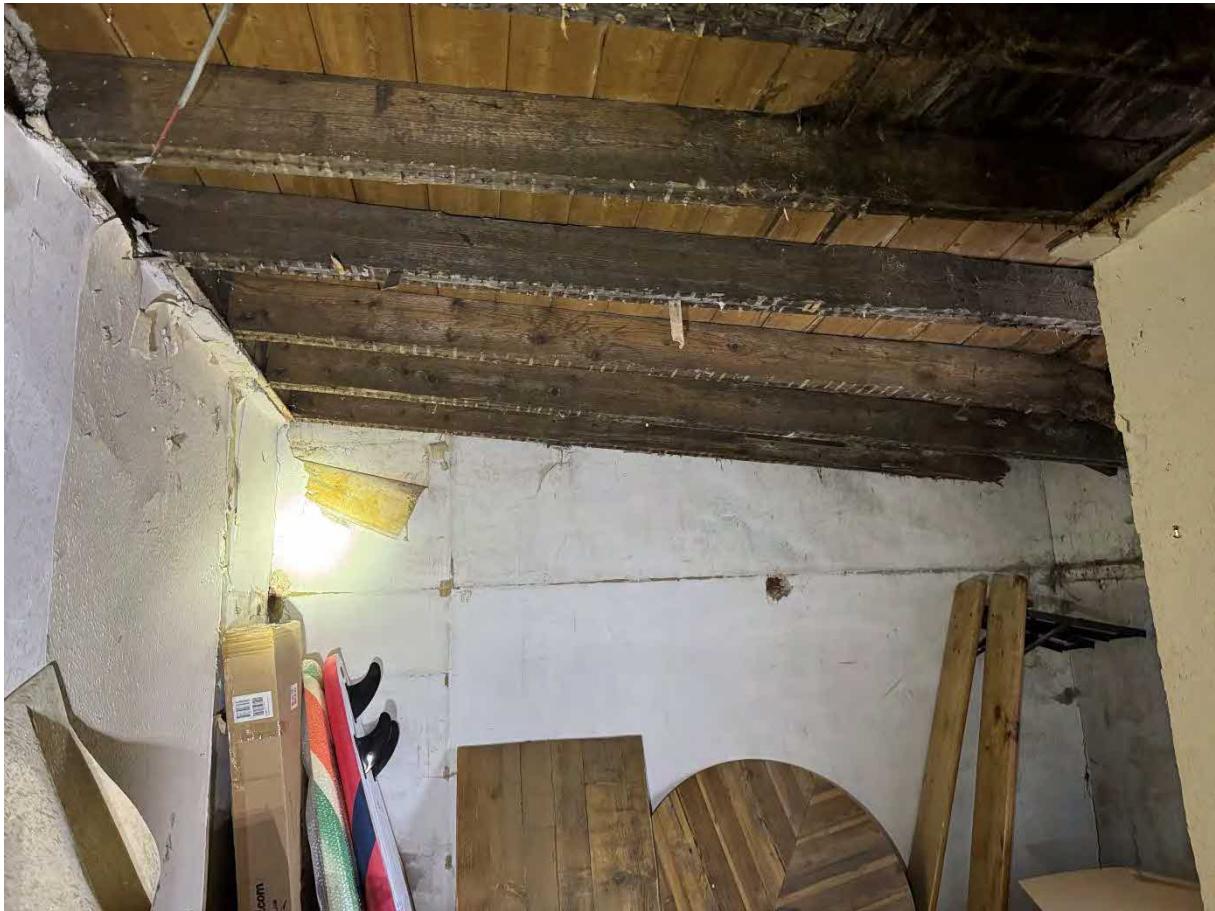
The second floor joists within room (4), at the northwestern corner of the building, have failed at their junction with the rear elevation wall. The northern edge of the floor appears unsupported and has dropped in level. Refer photographs P29, P30 + P35, Appendix A.

P29 – First floor level – front room (1). Second floor structure (over) has failed at bearing onto rear elevation wall. Second floor over has poor horizontal alignment and is unstable.

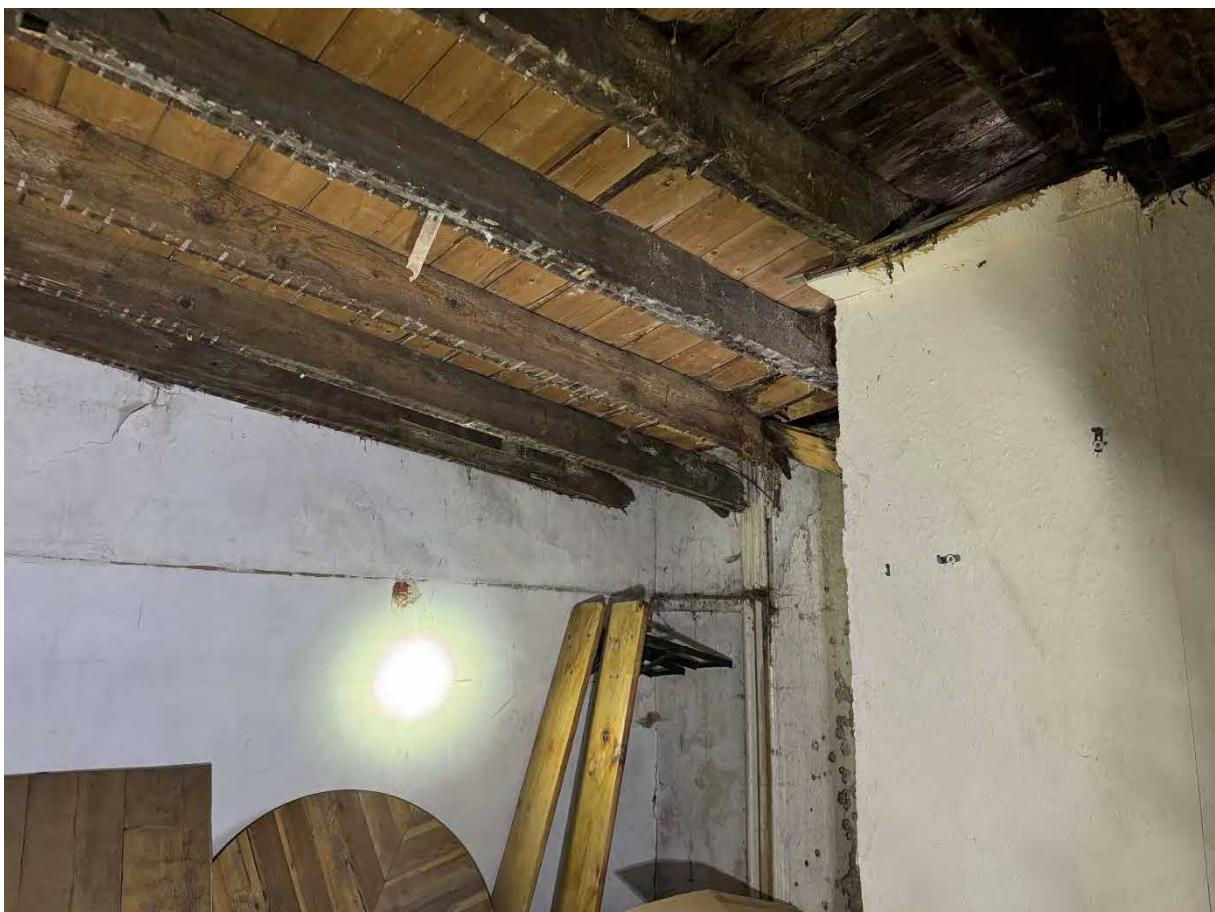
P30 – First floor level – front room (1). Second floor structure (over) has failed at bearing onto rear elevation wall. Second floor over has poor horizontal alignment and is unsafe.

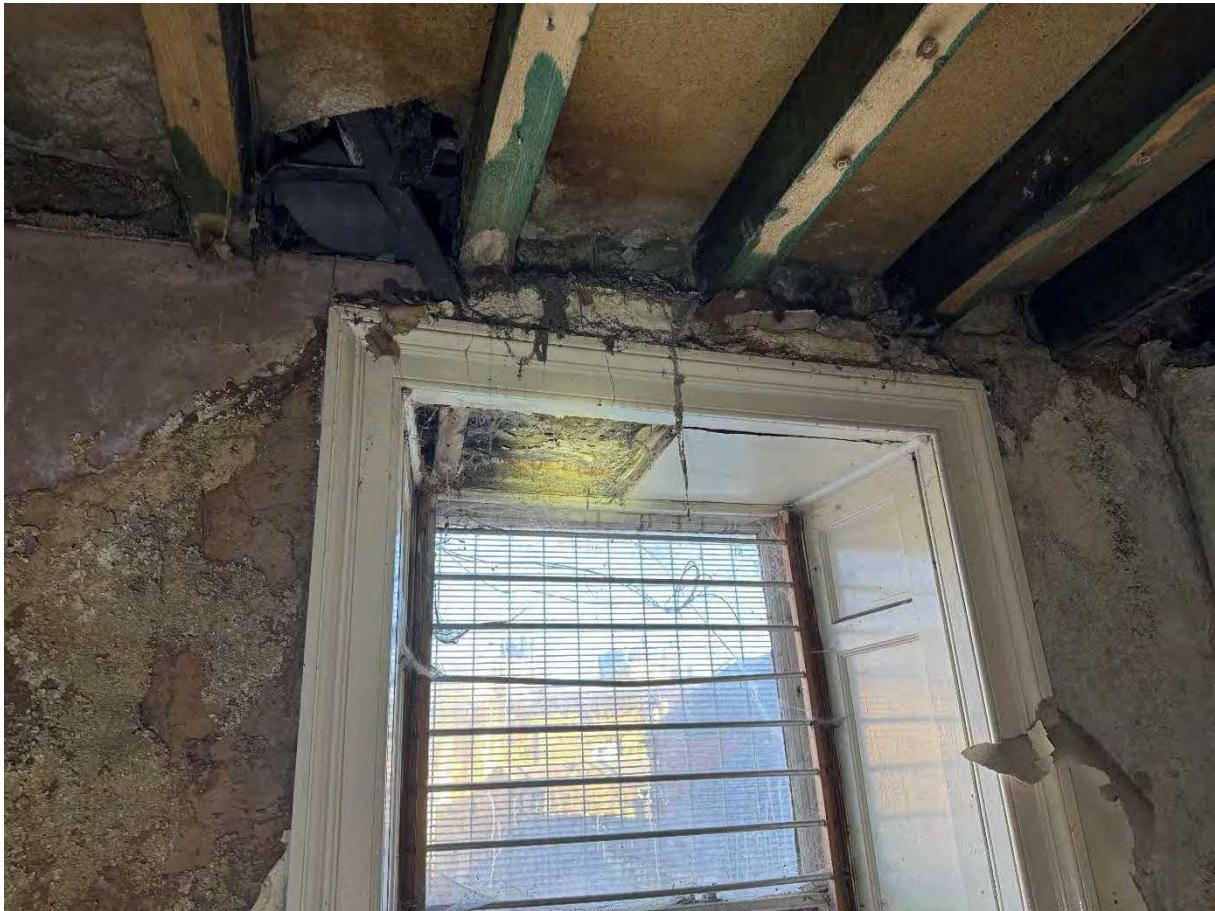
Where visible internally, timber lintels above external window openings were noted to have suffered timber decay. Refer photographs P31 and P47, Appendix A.

The second floor timber joists within room (5) at the northeastern corner of the building have been replaced at some time in the past (not recent), the joists have suffered subsequent timber decay at the bearing onto the rear elevation wall of the building with significant loss of cross section in some cases. Refer photograph P31, Appendix A.

P31 – First floor level – front room (2). Second floor structure (over) has been replaced in the past (not original). Timber joists have suffered severe decay at bearing onto rear elevation wall. The second floor (over) is potentially unsafe.

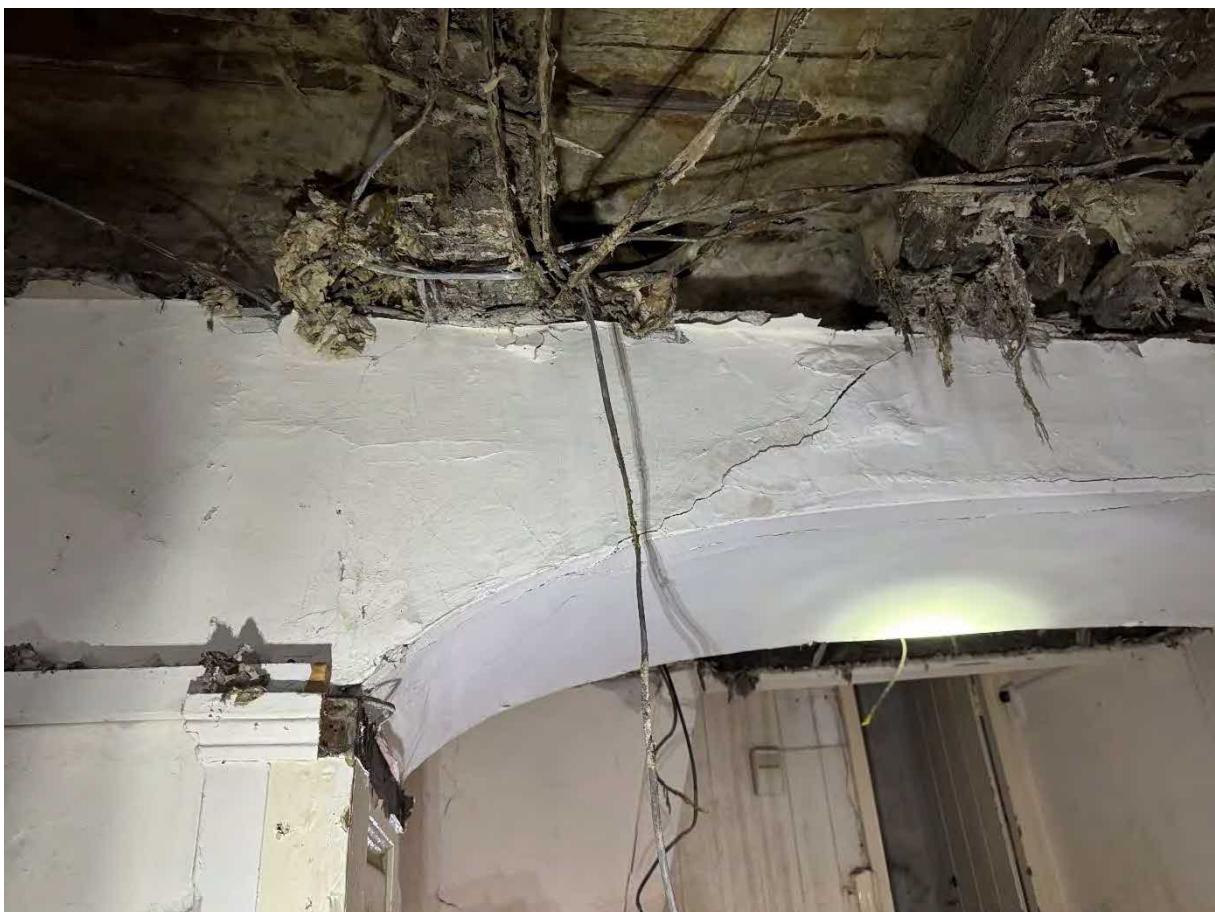
P32 – First floor level – cracking within plaster arched opening between front room (3) and landing.
