STRUCTURAL INSPECTION

THE DIRTY BOTTLES
28 NARROWGATE
ALNWICK
NORTHUMBERLAND
NE66 1JG

S4510-R02

GREENE KING BREWING & RETAILING LTD

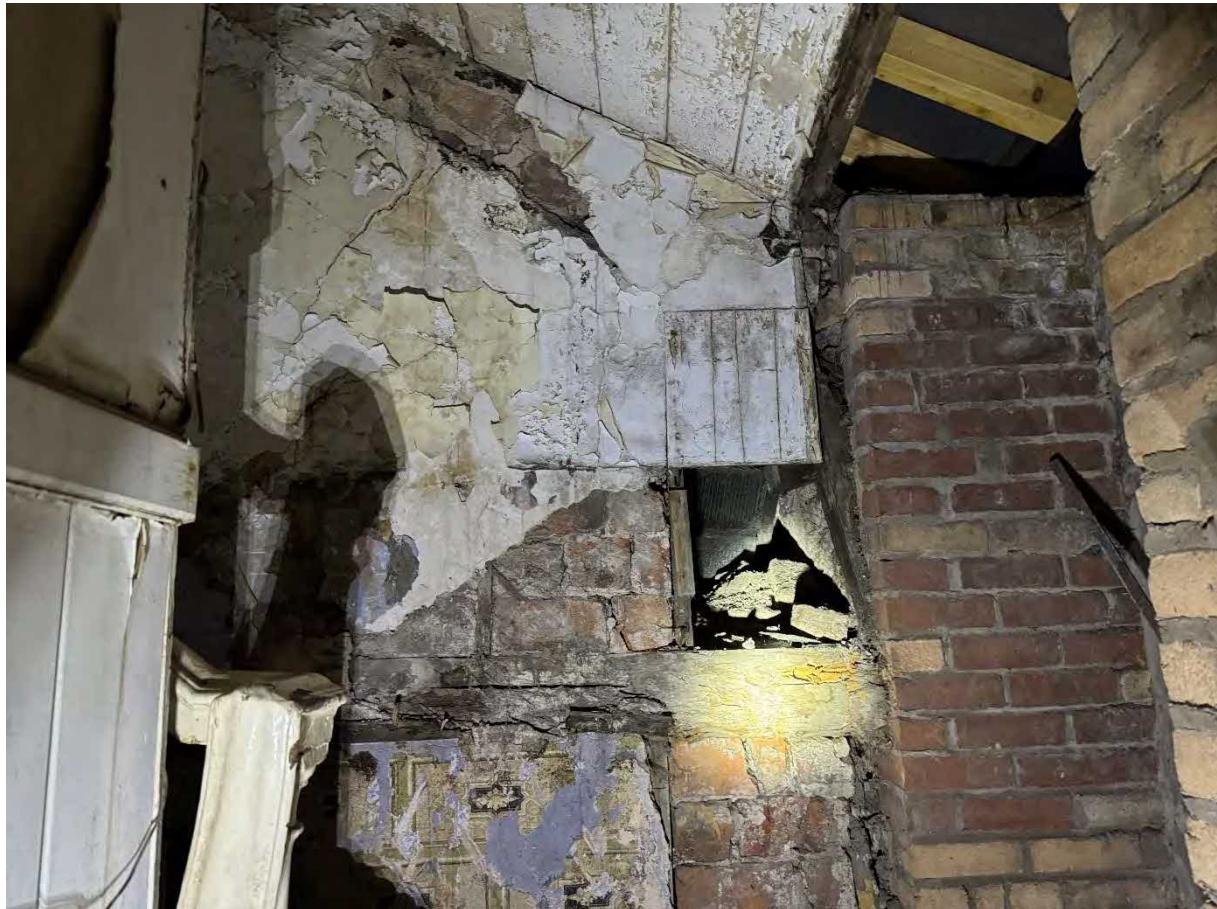
P33 – Loose masonry and decayed timber within wall at second floor landing.

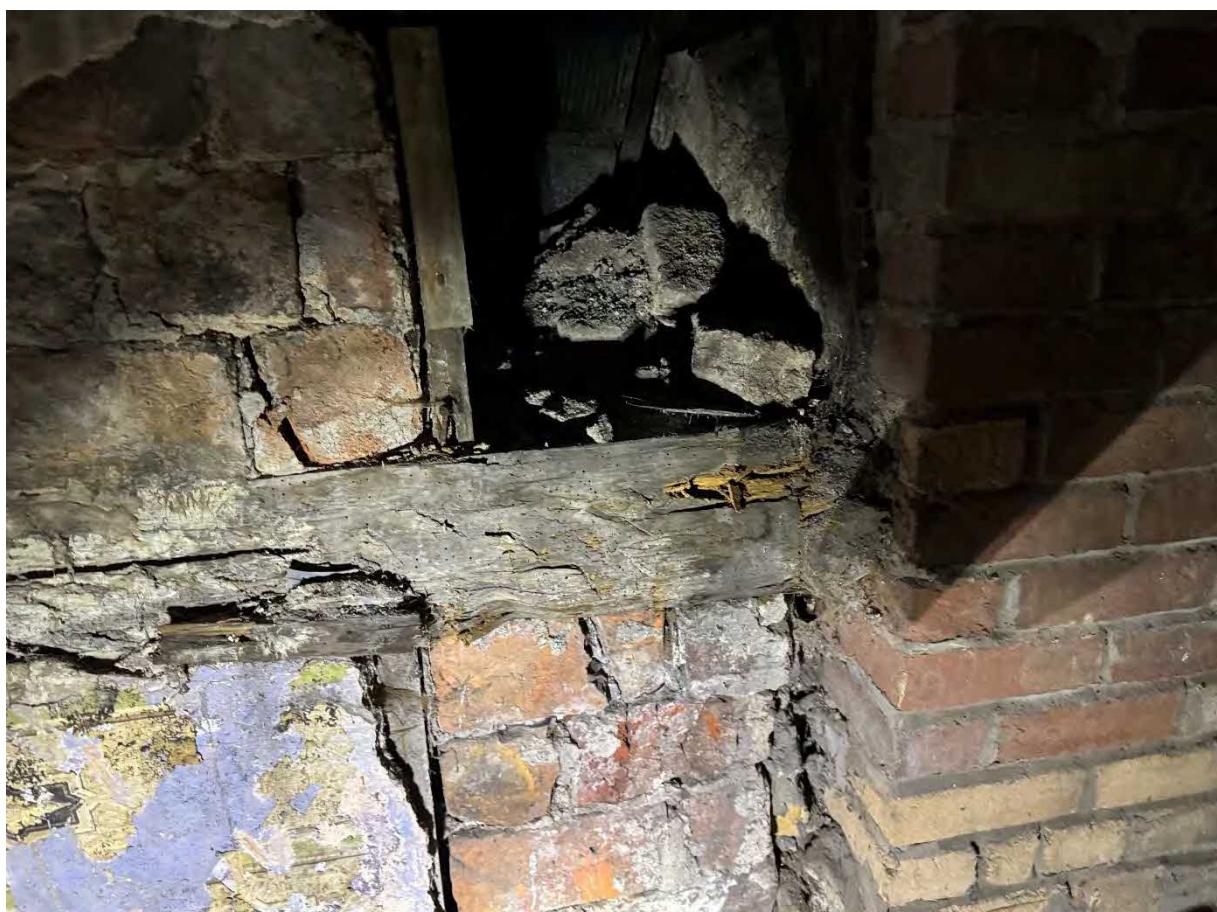
P34 – Loose masonry and decayed timber within wall at second floor landing.

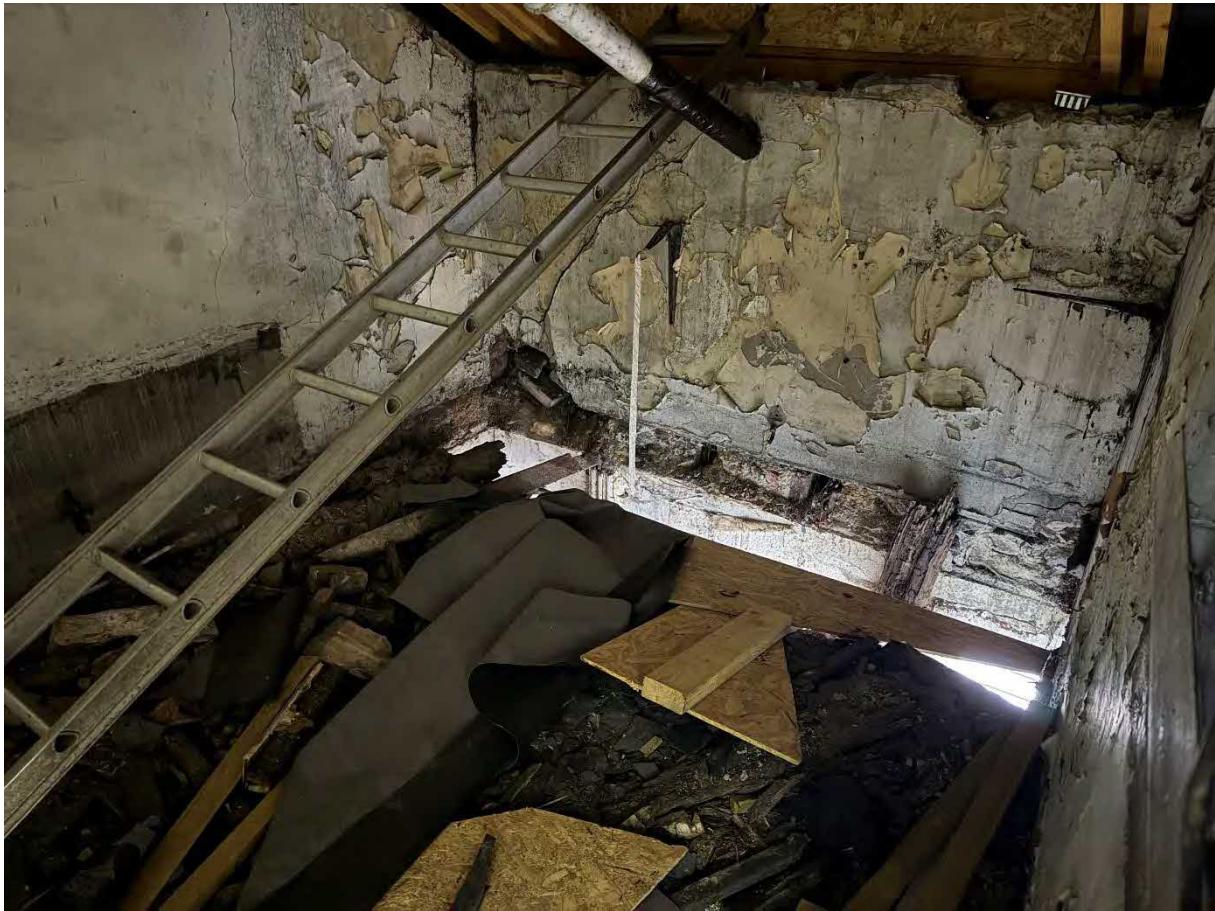
P35 – Second floor level – rear room (4). Second floor structure has failed at bearing onto rear elevation wall. Timber floor structure has poor horizontal alignment and is unstable.

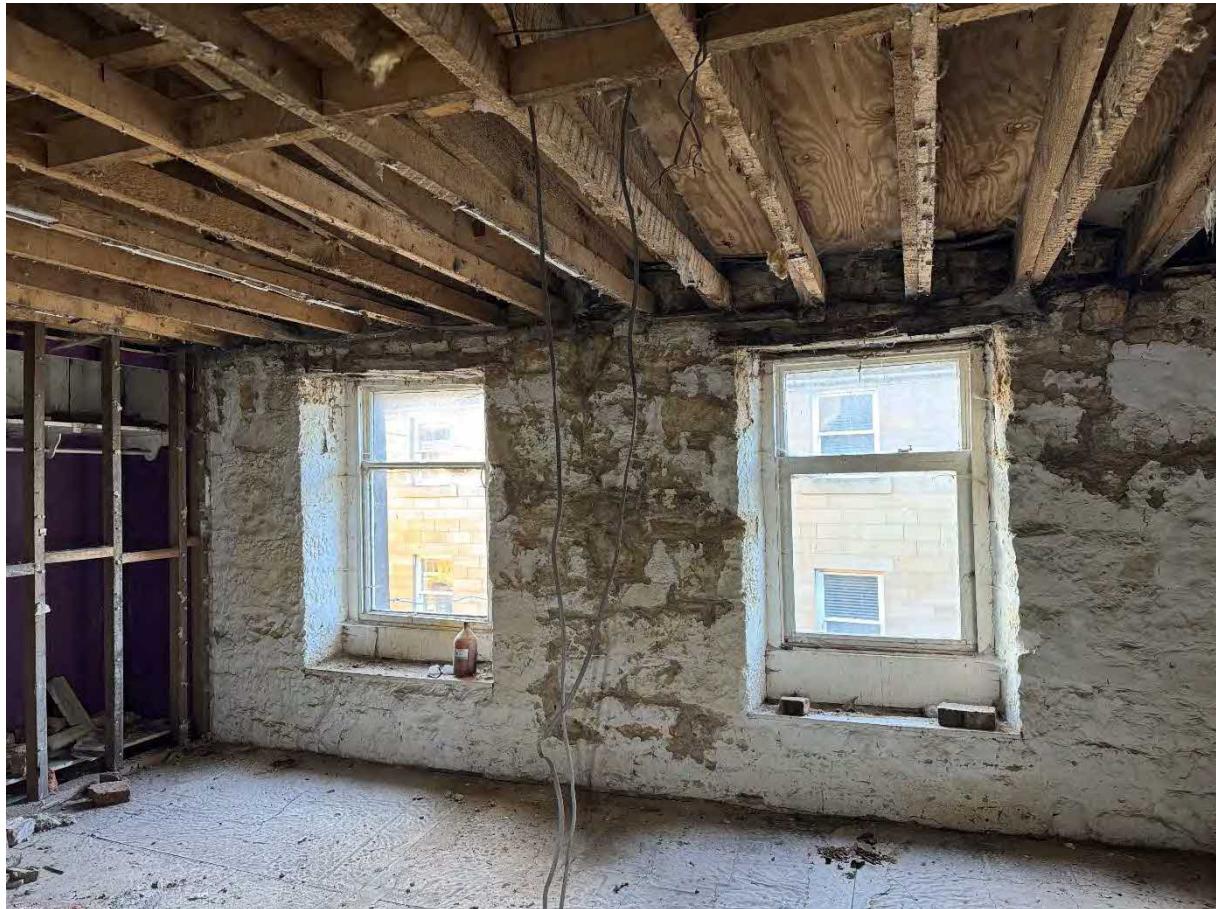
Where visible internally, the timber lintels above first and second floor window openings were noted to have suffered timber decay. Refer photographs P37 to P40, Appendix A.

P37 – Internal view – front elevation wall, second floor level – room (6)

Severe decay within timber lintels above window openings (viewed from distance).

The front elevation wall will require structural repair to cracks, repair to rainwater drainage and all timber lintels above external openings are likely to require replacement.

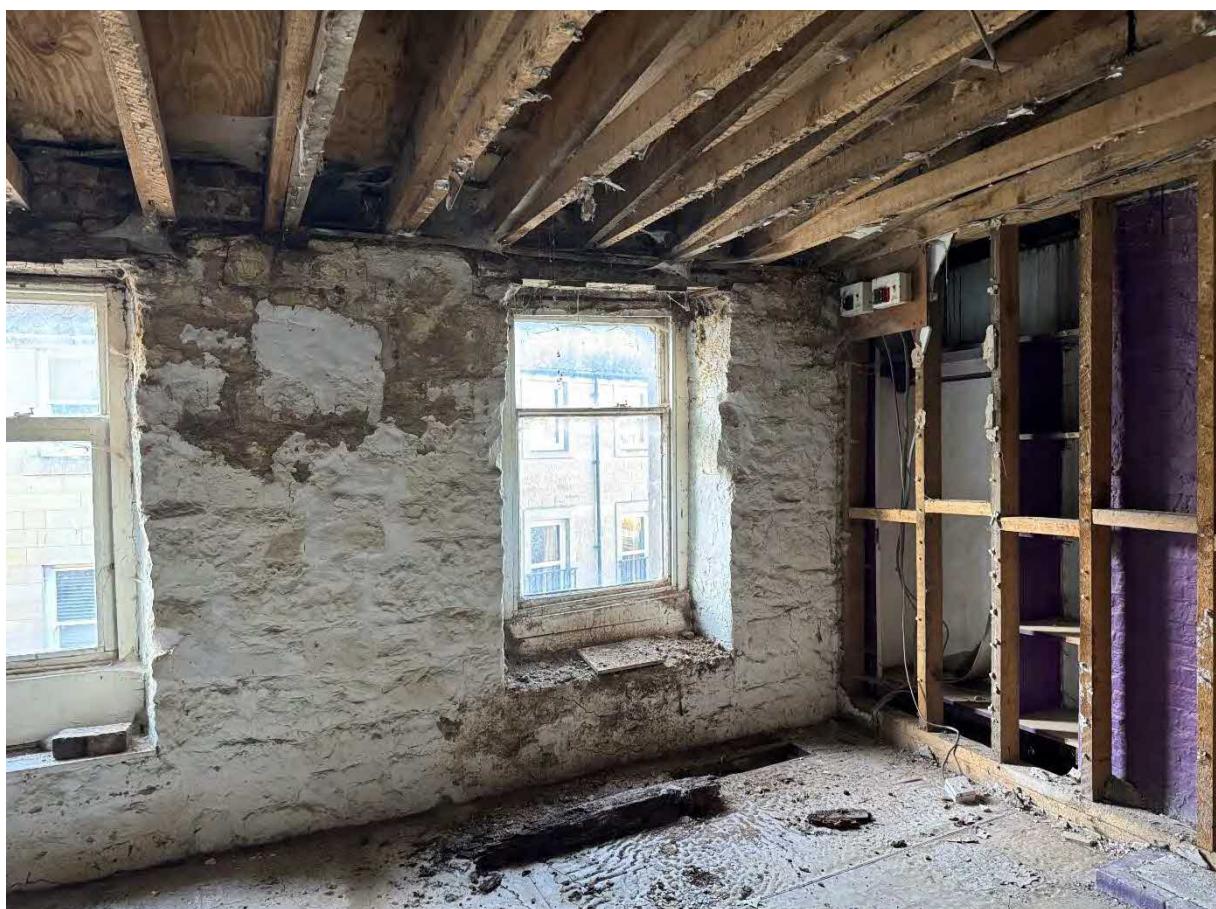
P38 – Internal view – front elevation wall, second floor level – room (6)

Severe decay within timber lintels above window openings (viewed from distance).

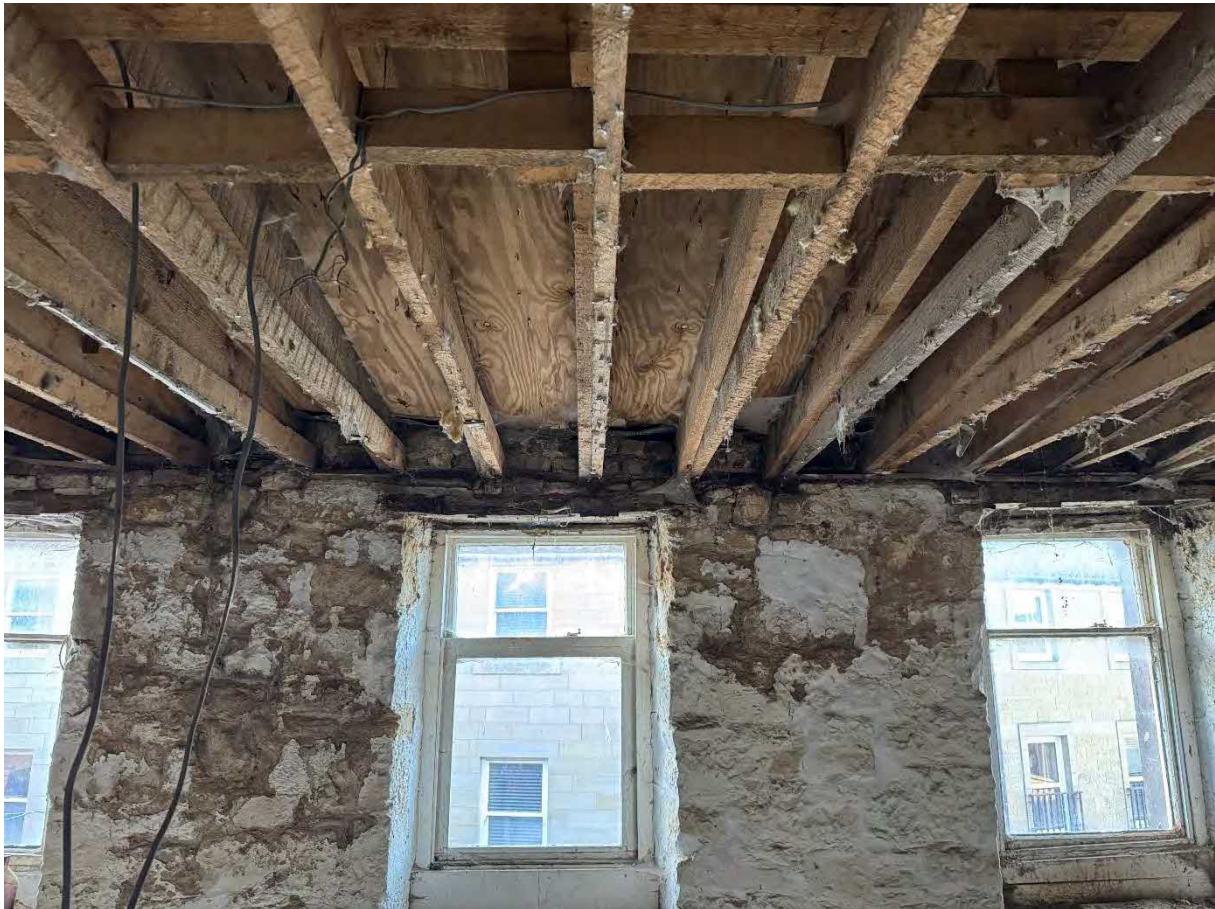
P39 – Internal view – front elevation wall, second floor level – room (6)

Severe decay within timber lintels above window openings (viewed from distance).

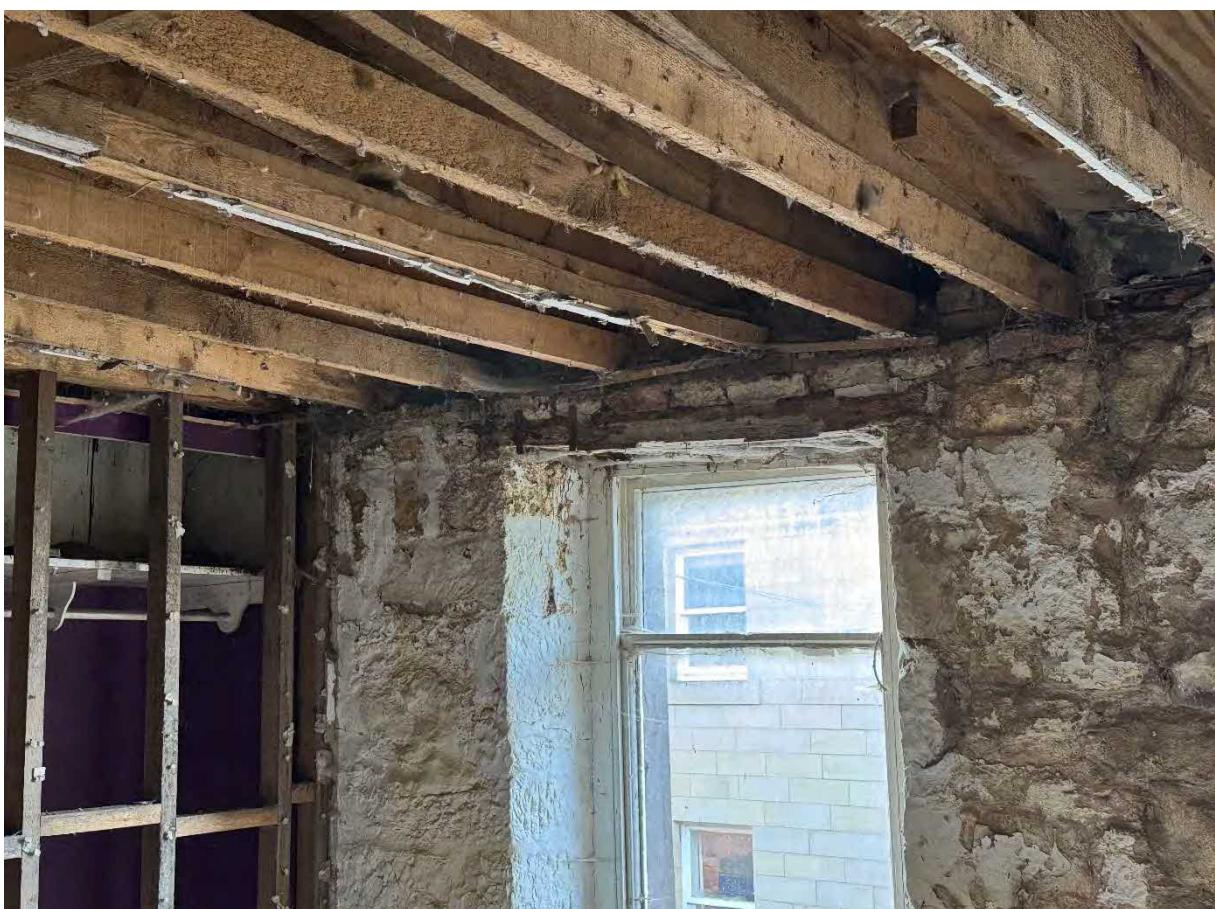
The roof to the front (south) section of the building was only visible internally and appears to be of a low-pitched construction, with bitumen felt, on plywood deck, on timber roof joists which span between the front elevation wall and internal load bearing wall of the building. Past water ingress was noted adjacent to the front elevation wall (gutter line) with evidence of timber decay within the timber joists at their bearings onto the wall. Refer photographs P39 + P40, Appendix A.

P40 – Internal view – front elevation wall, second floor level – room (6)

Evidence of water ingress and timber decay at junction of timber rafters into wall - (viewed from distance).

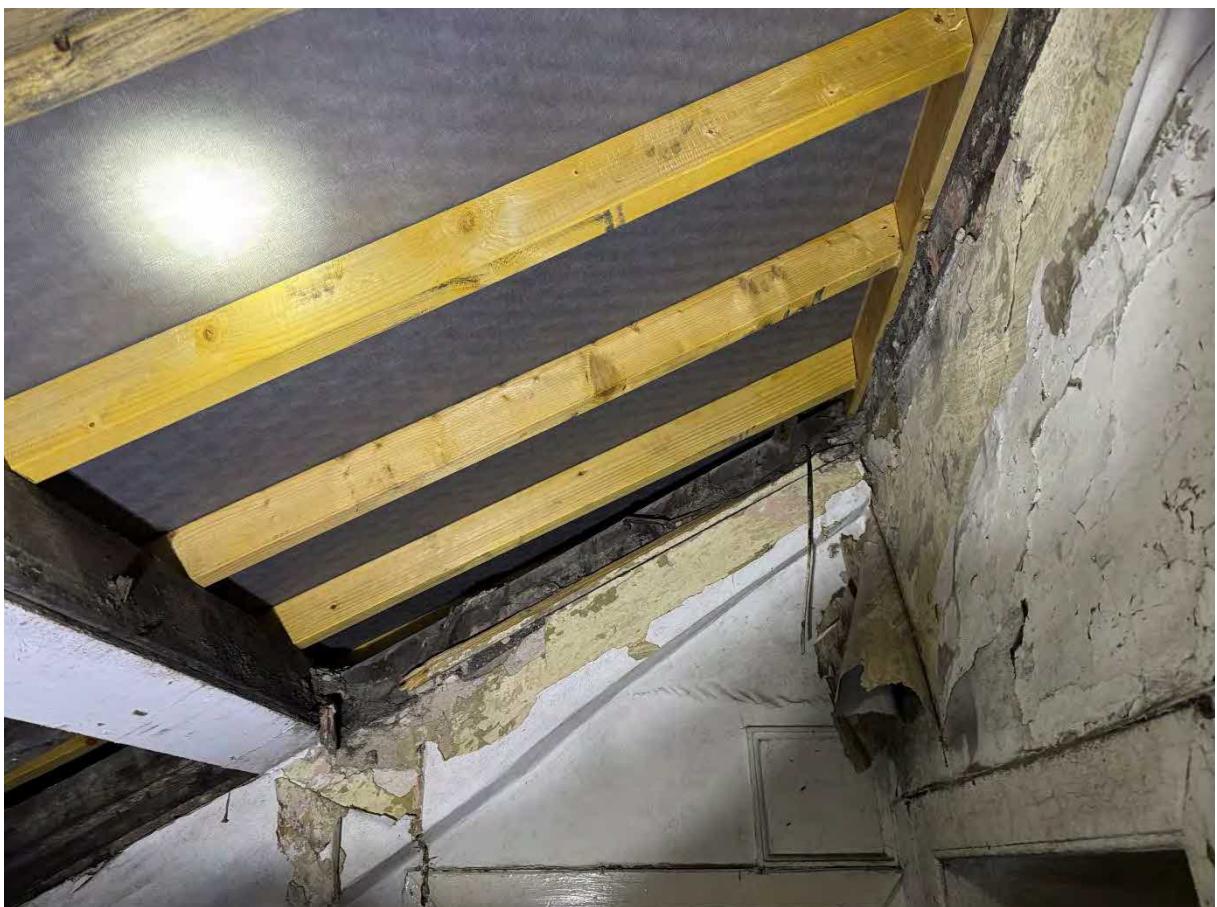
The timber roof structure to the rear (north) of the property appears to have been recently reconstructed. New timber rafters and dormers have been constructed off existing timber rafters and purlins (some decay was evident within the original timber elements). Refer photographs P42 to P45, Appendix A.

P42 – Recently installed timber rafters and roof membrane – supported on original timber roof structure.

Areas of rot and decay were identified within the timber roof structures (note:- only limited access was possible within the second floor), new timber roof structures also appear to have been constructed off existing decayed timber elements. Extensive repair and reinstatement of the roof structures will be required and in the worst case the roofs may require removal and replacing with new (to be confirmed). Gutters, flashings and rainwater drainage will require repair and/or replacement.

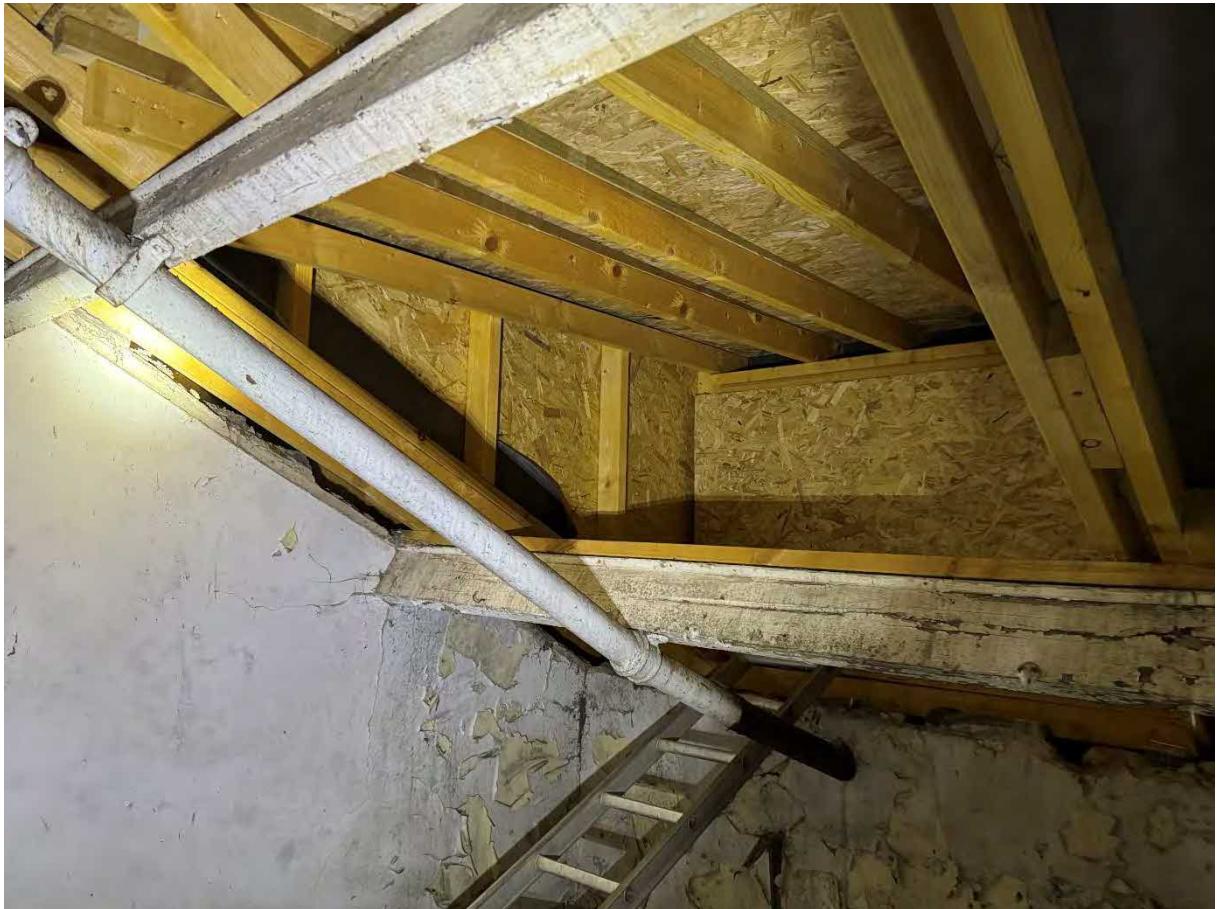
P43 – Recently constructed timber dormer to rear of property.
Dormer constructed off original timber roof structure.

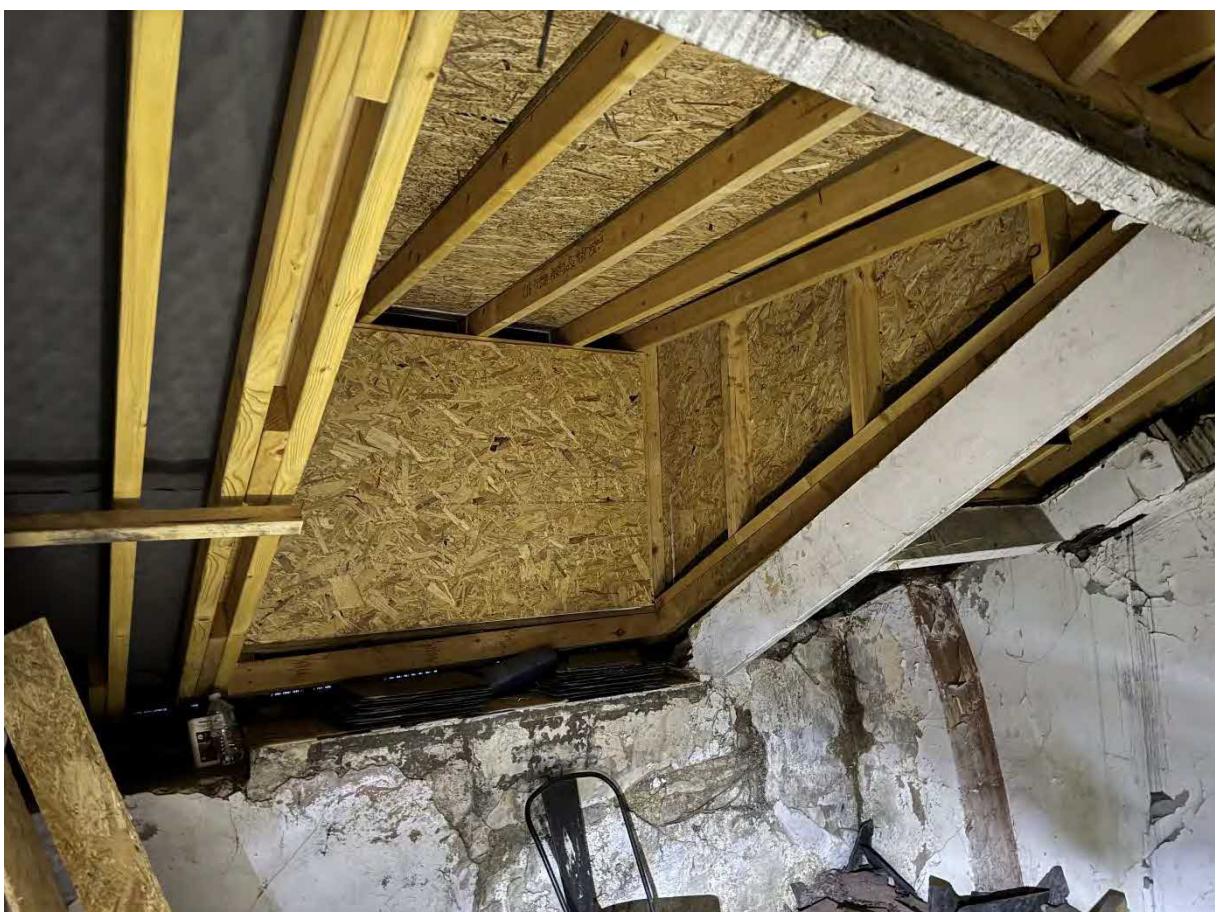
P44 – Recently constructed timber dormer to rear of property.
Dormer constructed off original timber roof structure.

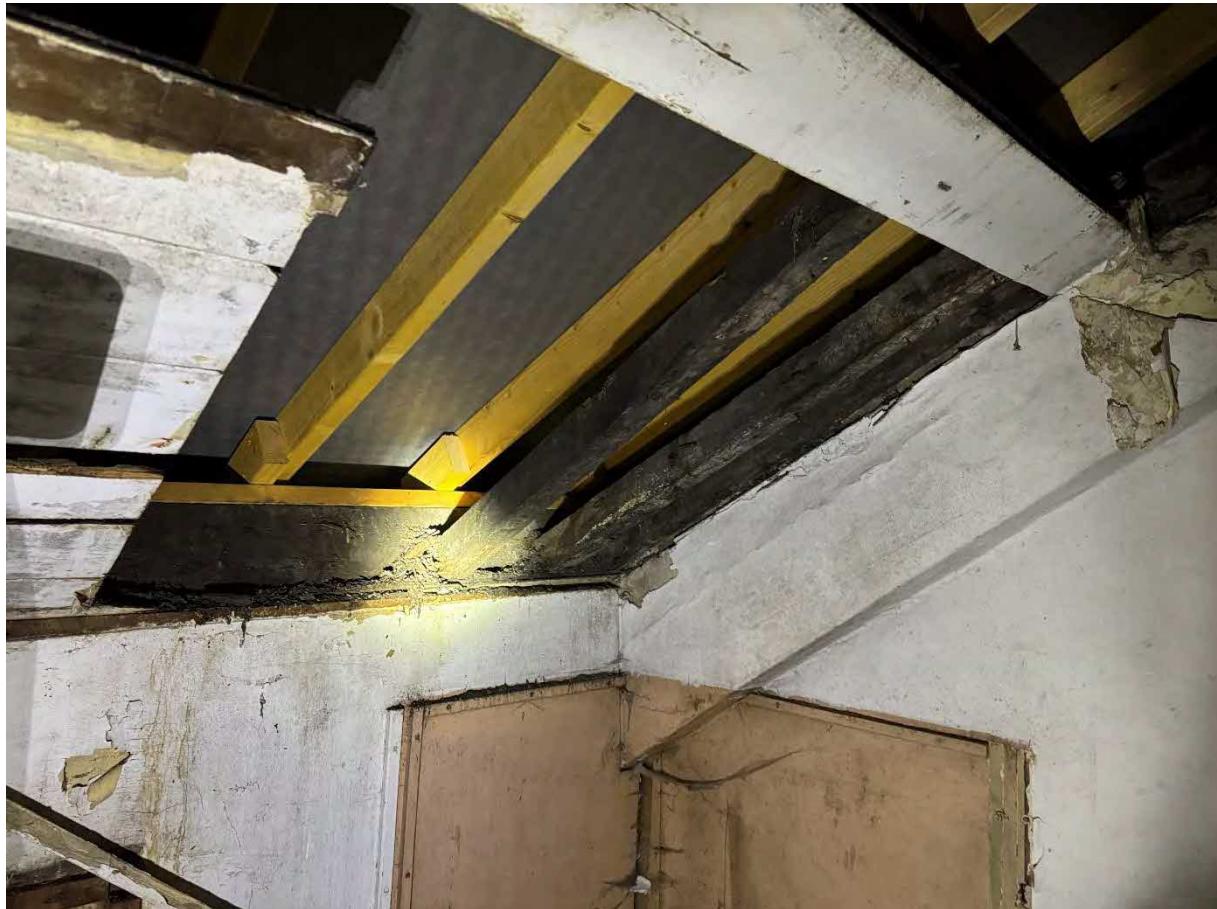
P45 – Recently installed timber rafters and roof membrane – supported on original timber roof structure.
Rear roof slope.

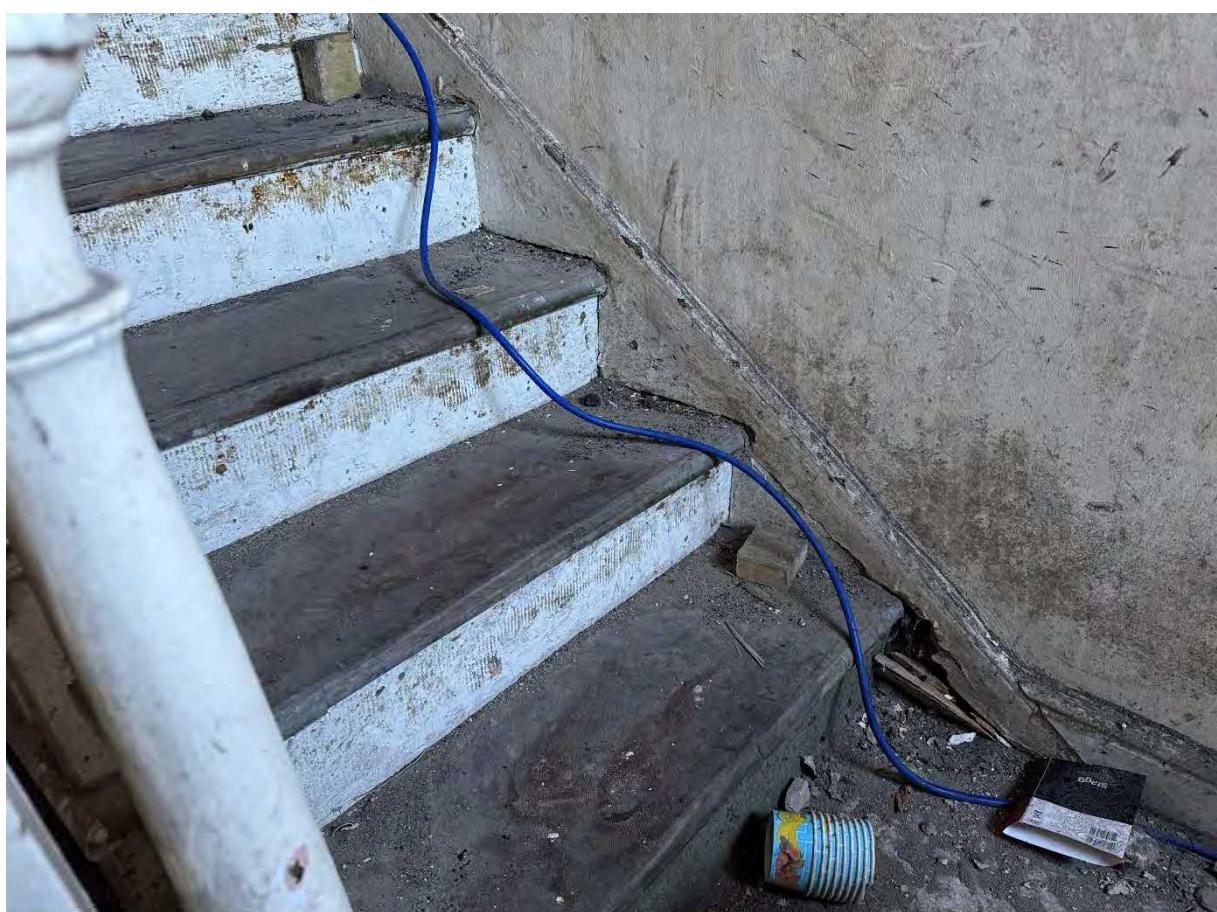
Internal timber staircases provide access from ground to first and second floor levels. The staircases have poor alignment throughout and appear to have suffered severe timber decay (dry rot) in many locations. Refer to photographs P46 to p51, Appendix A.

P46 – Internal timber staircase – ground to first floor level.
Staircase has poor alignment.

The timber staircases and second floor structures will require removal and replacement with new. Temporary lateral restraint will be required to the front elevation wall to allow the floor to be removed and replaced. Temporary support (propping through to basement level) will also be required to allow safe access to the upper floors and roof structures.

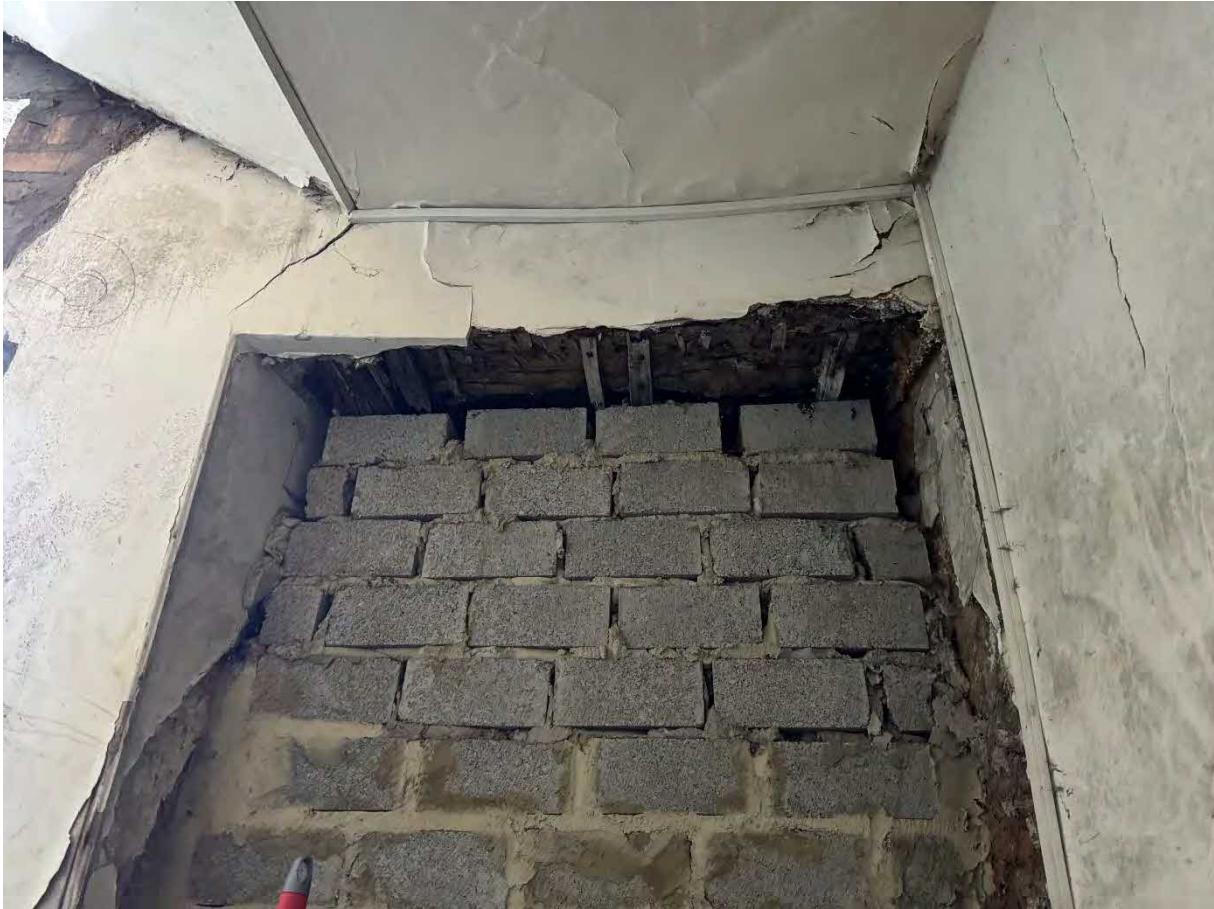
P47 – Poorly infilled window opening within rear elevation wall – staircase.

Built in timber lintels appear decayed.

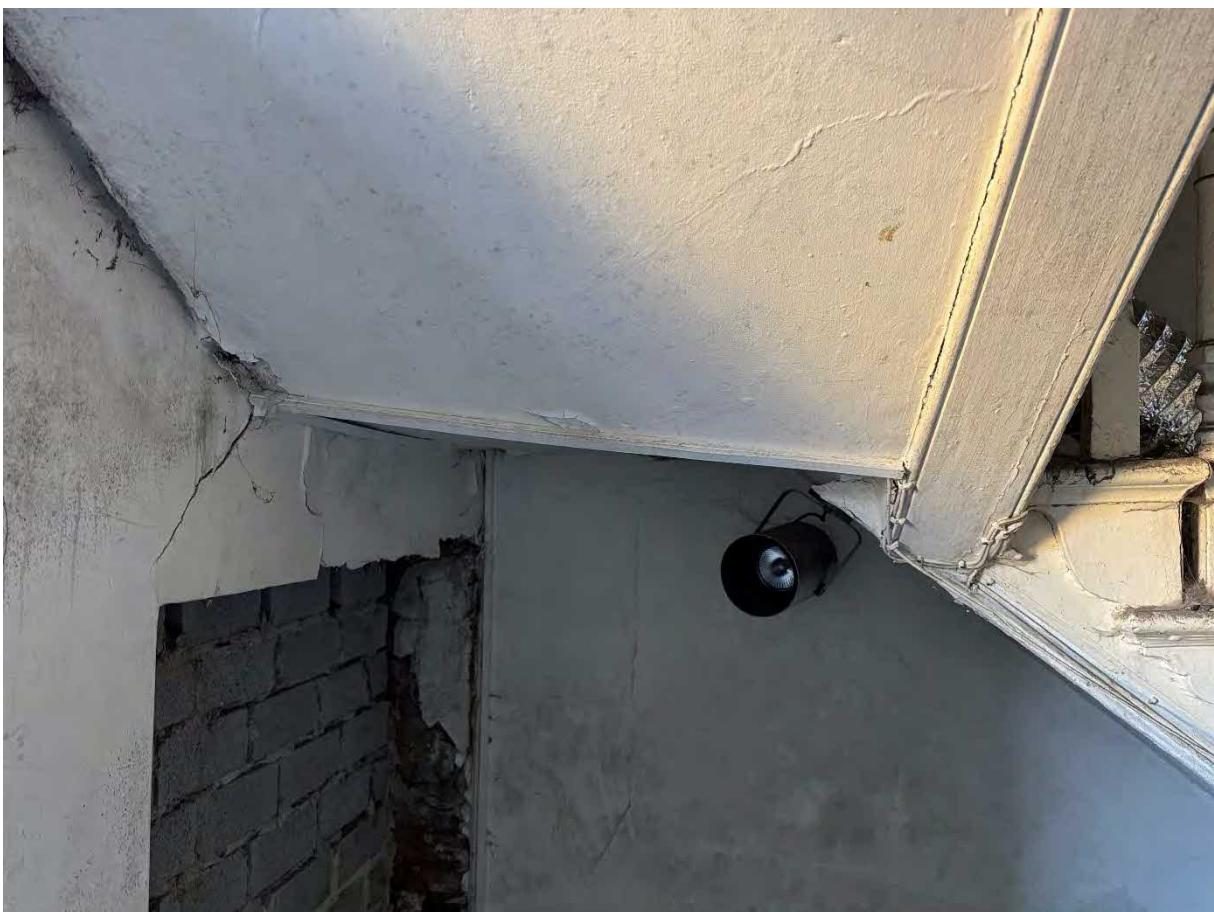
P48 – Internal timber staircase – ground to first floor level.

Staircase has poor alignment.

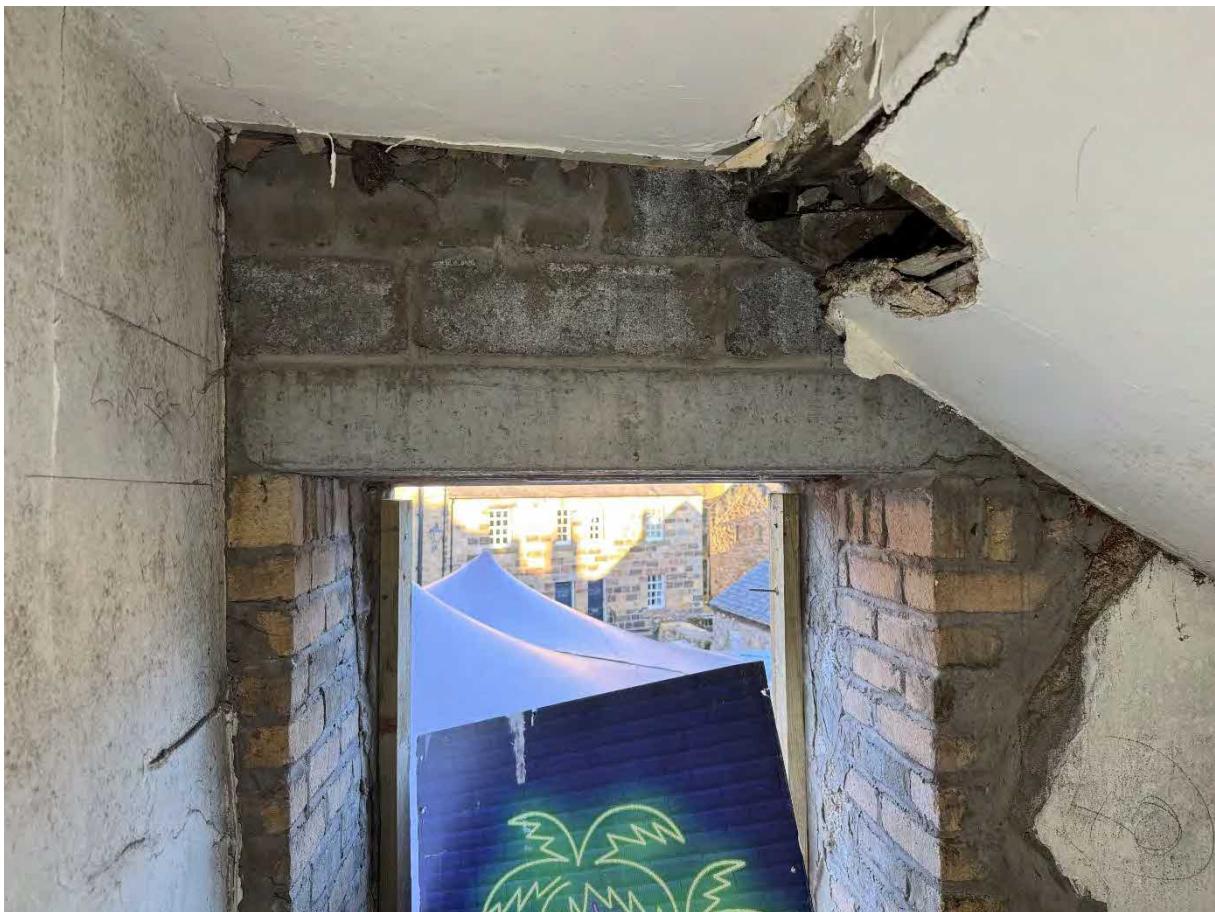
P49 – Recently replaced lintels forming opening within rear elevation wall.

Internal timber staircase – first to second floor level (RHS) has poor alignment with evidence of timber decay.

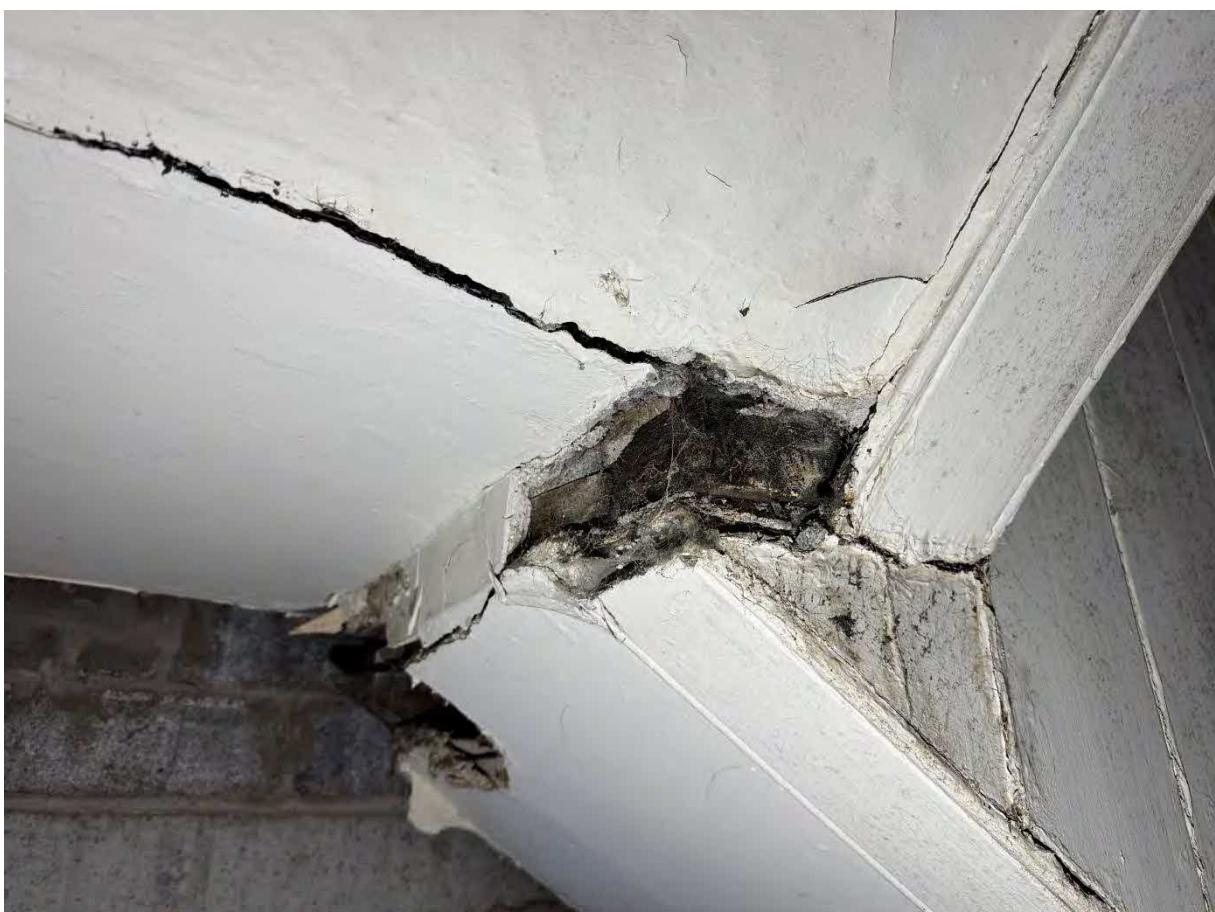
P50 – Underside of internal timber staircase – first to second floor level - has poor alignment with evidence of timber decay. Staircase is potentially unsafe.

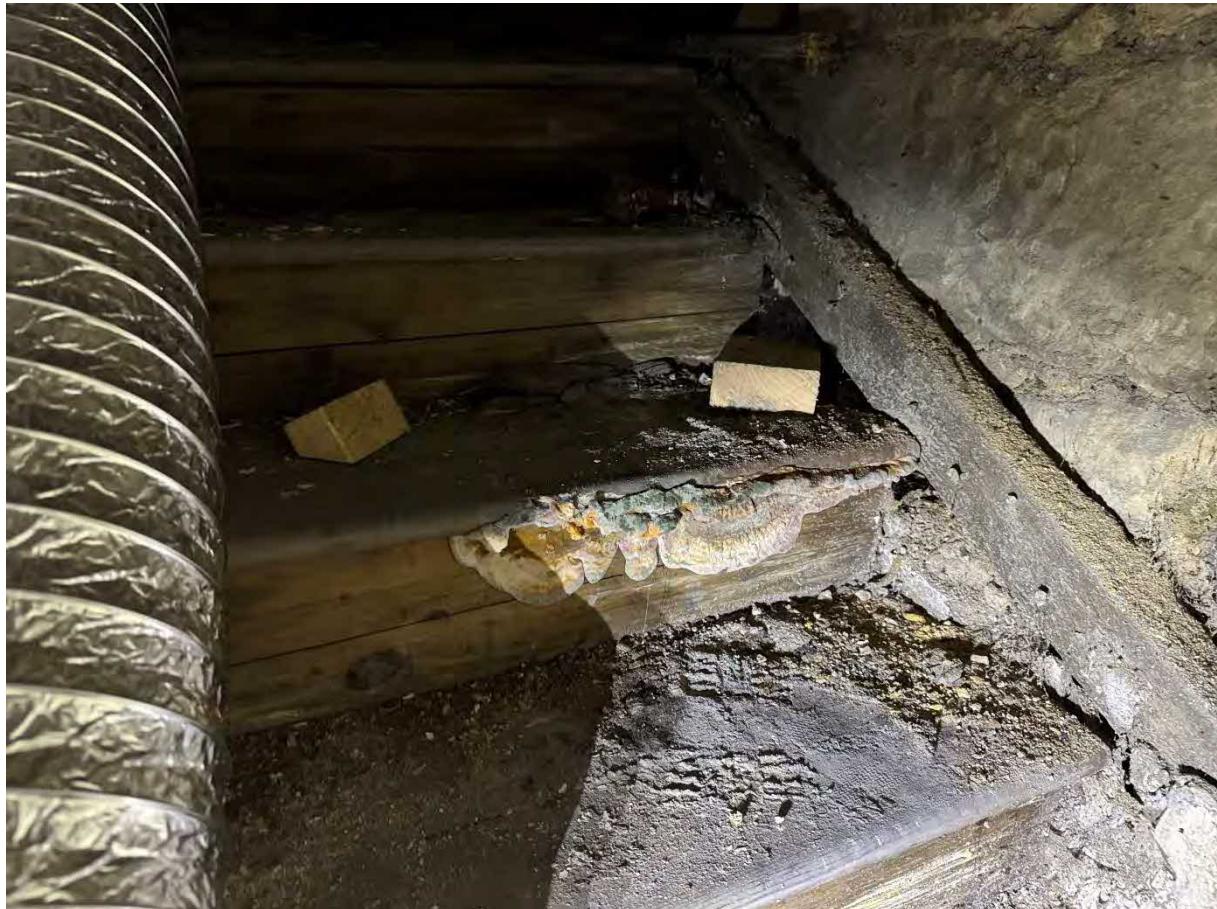
P51 – Dry rot (fruiting body) – timber staircase, first to second floor level.

Where dry rot is identified within timber elements and masonry walls, specialist treatments will be required to retained elements – to both timber and masonry elements.

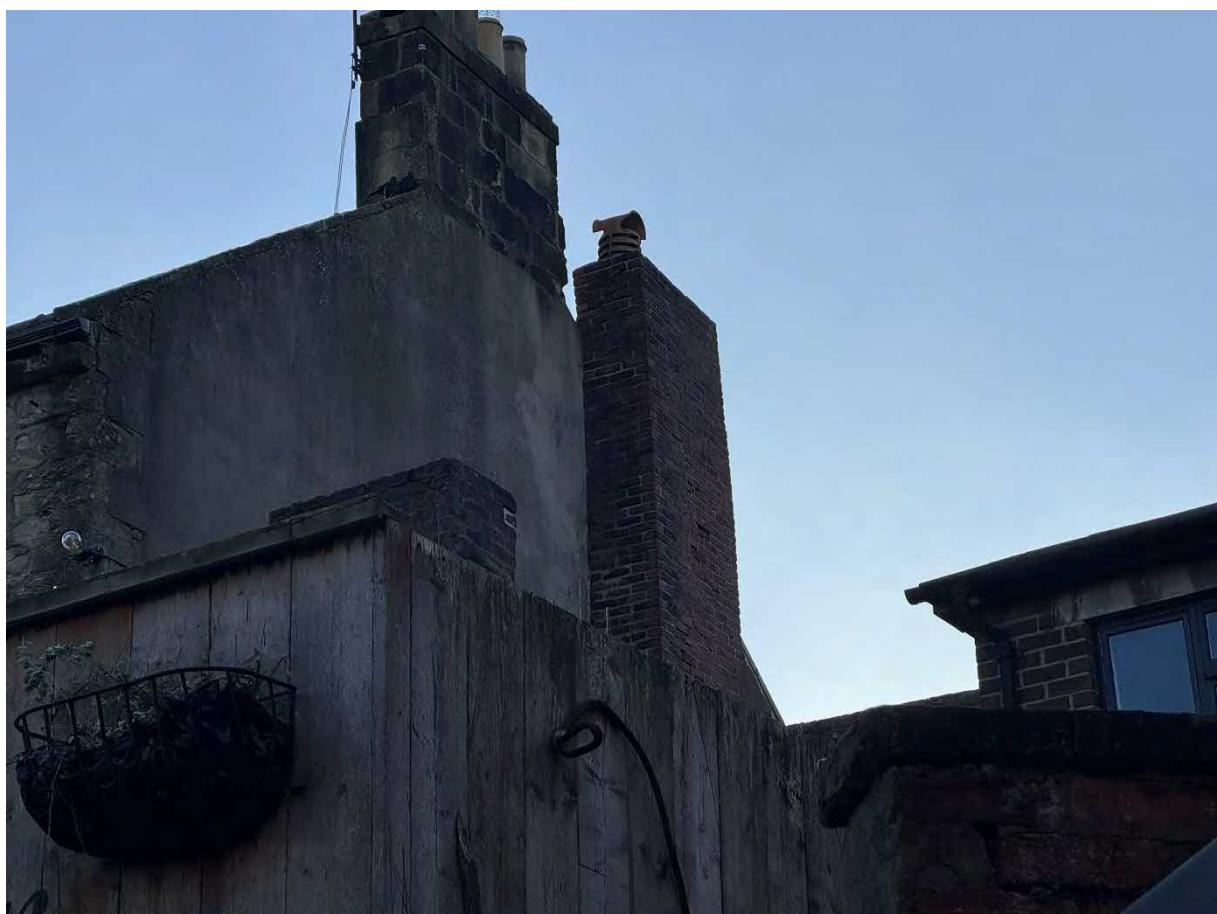
P52 – Chimney stack to party wall of 30-32 Narrowgate – viewed from rear.

Chimney stack has poor vertical alignment, leaning out to east (estimate approx 100mm).

The external chimney stack has poor vertical alignment at high level. We recommend that the upper section of the chimney stack, above the higher roof level (approx 1.0-1.5m), be taken down and rebuilt to a sympathetic and satisfactory vertical alignment. The chimney stack should be rebuilt using existing brickwork where possible with damaged and defective bricks being replaced with matching, reclaimed bricks.

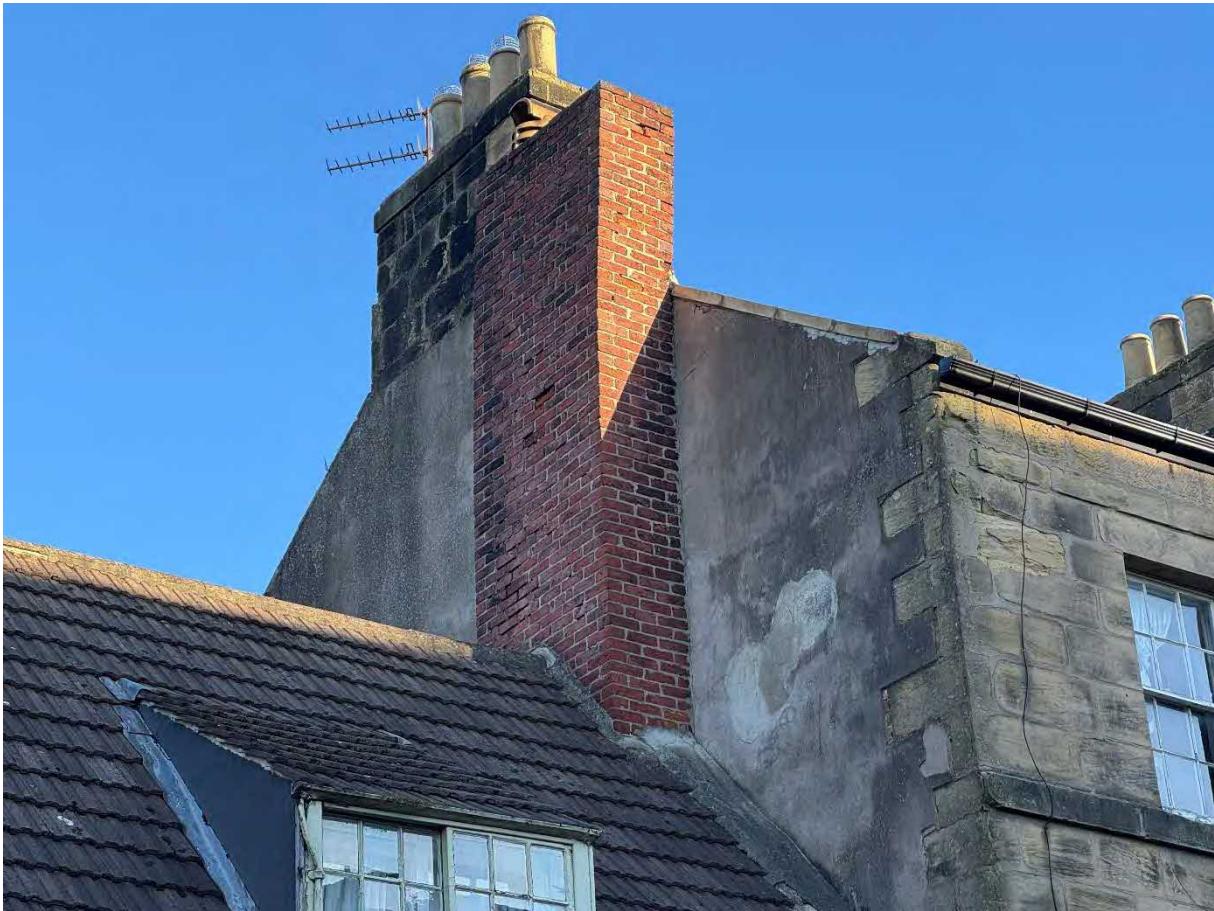
P53 – Chimney stack to party wall of 30-32 Narrowgate – viewed from rear.

Chimney stack has poor vertical alignment, leaning out to east (estimate approx 100mm).
