STRUCTURAL INSPECTION

THE DIRTY BOTTLES
28 NARROWGATE
ALNWICK
NORTHUMBERLAND
NE66 1JG

S4510-R02

GREENE KING BREWING & RETAILING LTD

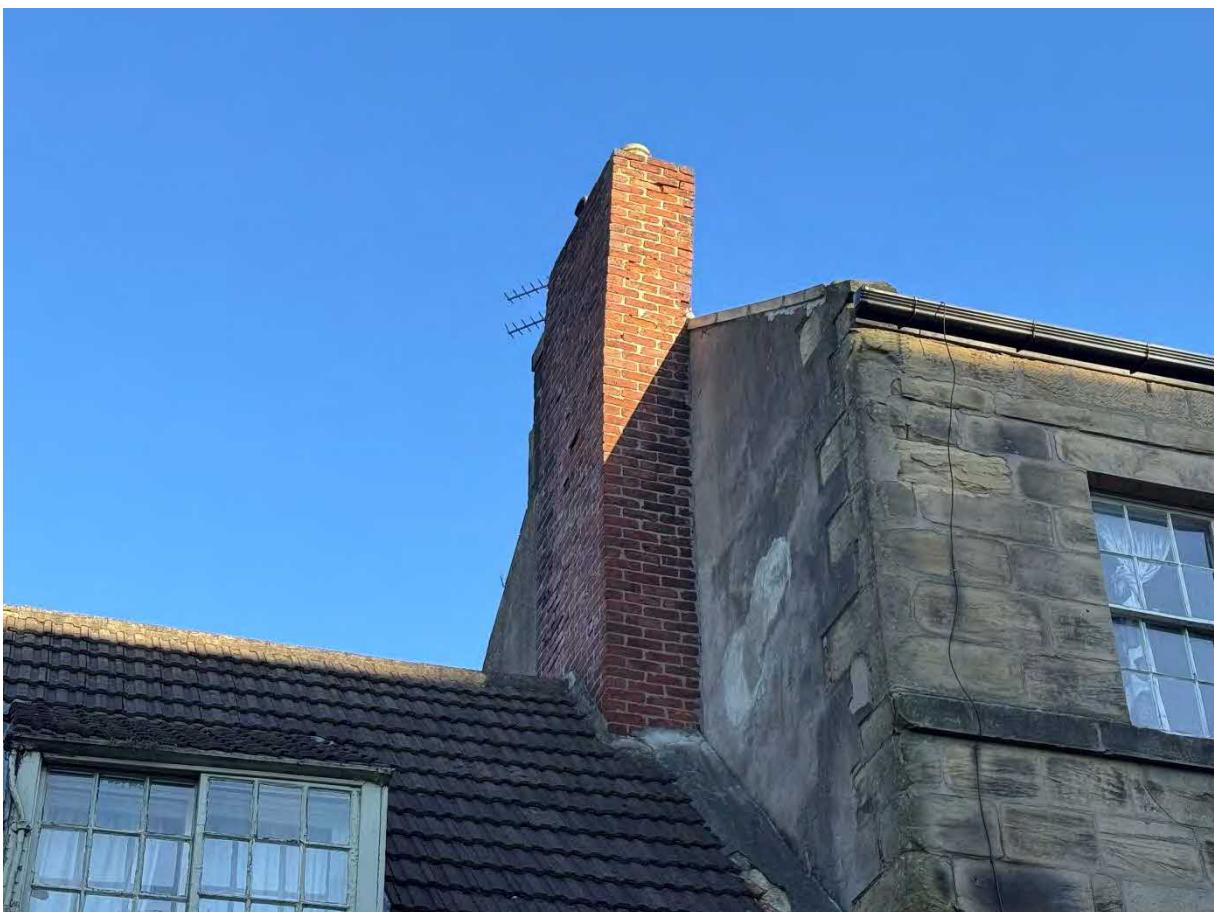
P54 – Chimney stack to party wall of 30-32 Narrowgate – viewed from front (south).

Chimney stack has poor vertical alignment, leaning out to east (estimate approx 100mm).

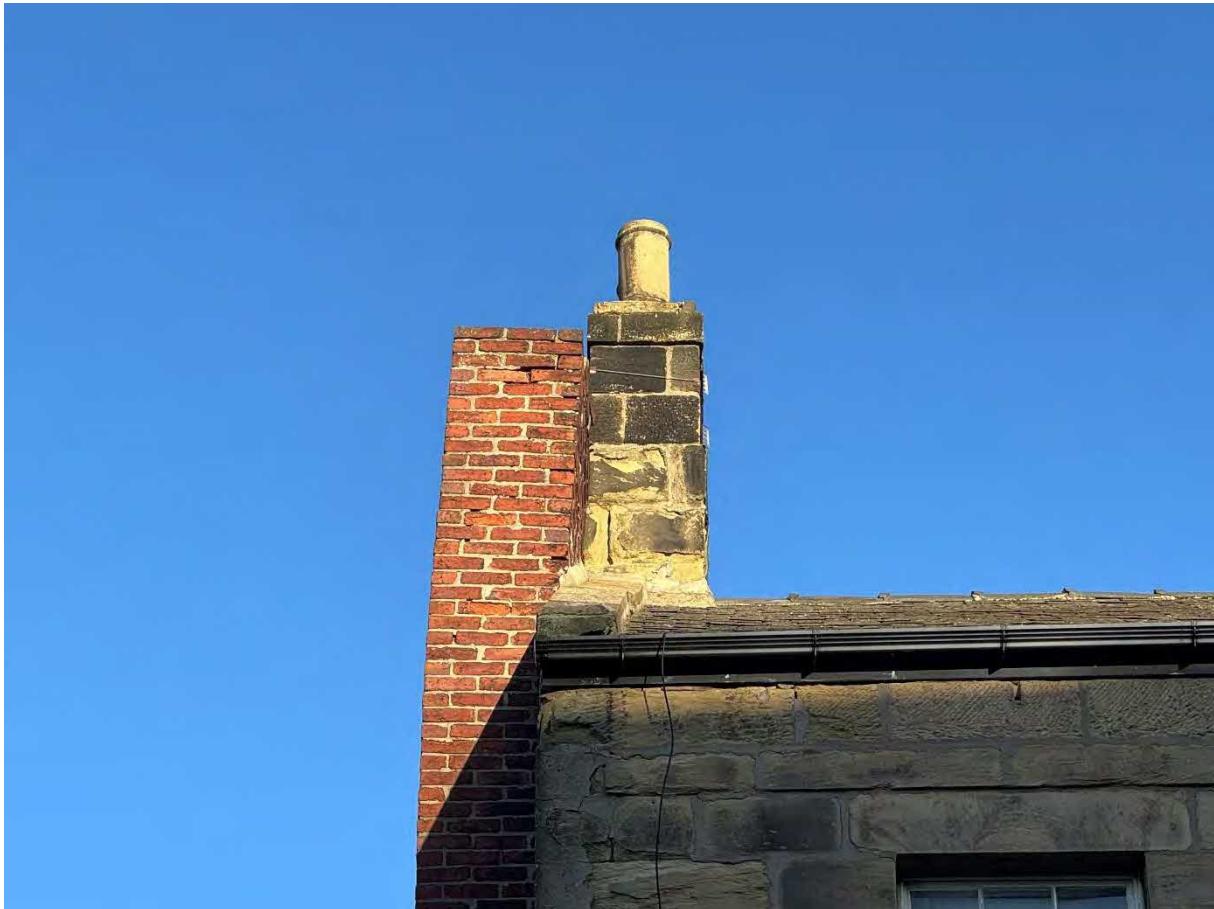
P55 – Chimney stack to party wall of 30-32 Narrowgate – viewed from front (south).

Chimney stack has poor vertical alignment, leaning out to east (estimate approx 100mm).

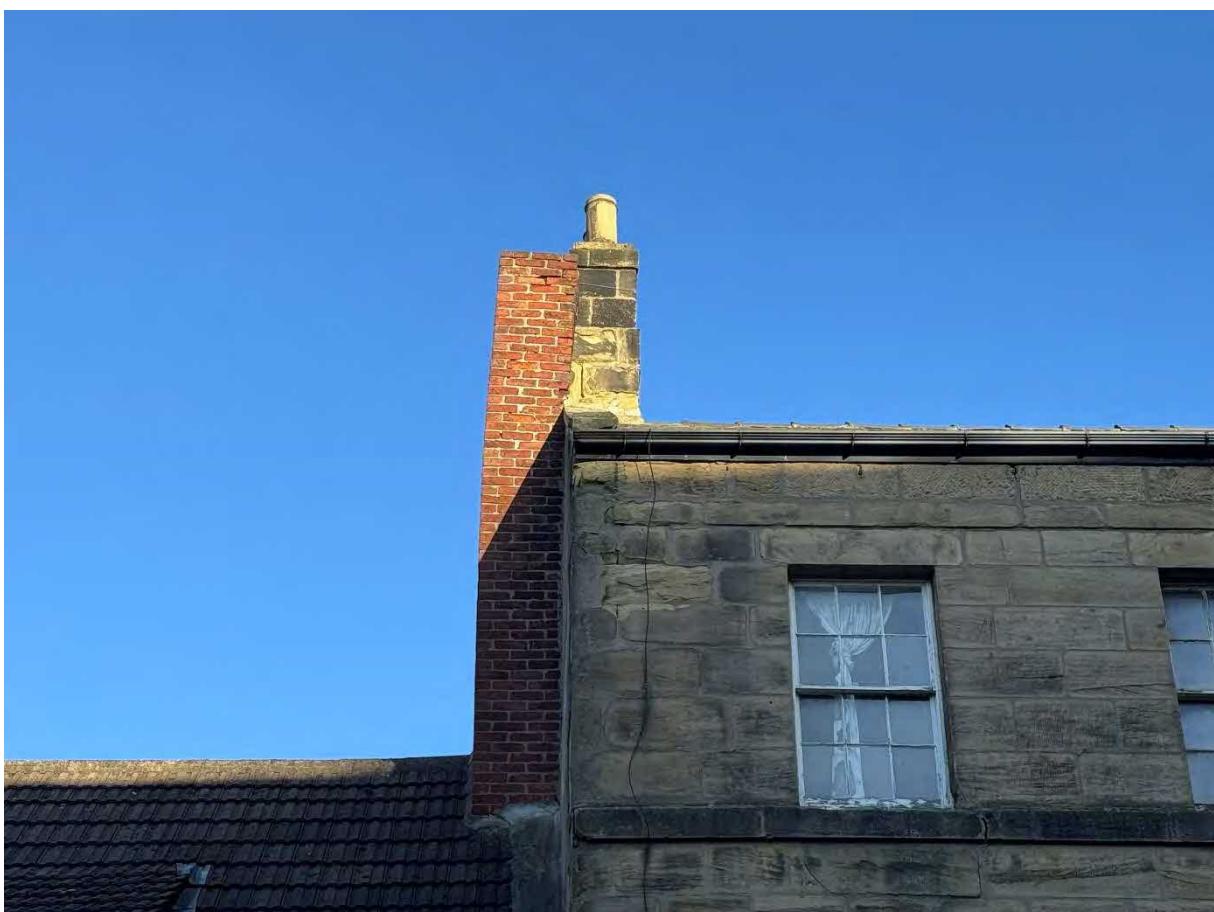
P56 – Chimney stack to party wall of 30-32 Narrowgate – viewed from front (south).

Chimney stack has poor vertical alignment, leaning out to east (estimate approx 100mm).

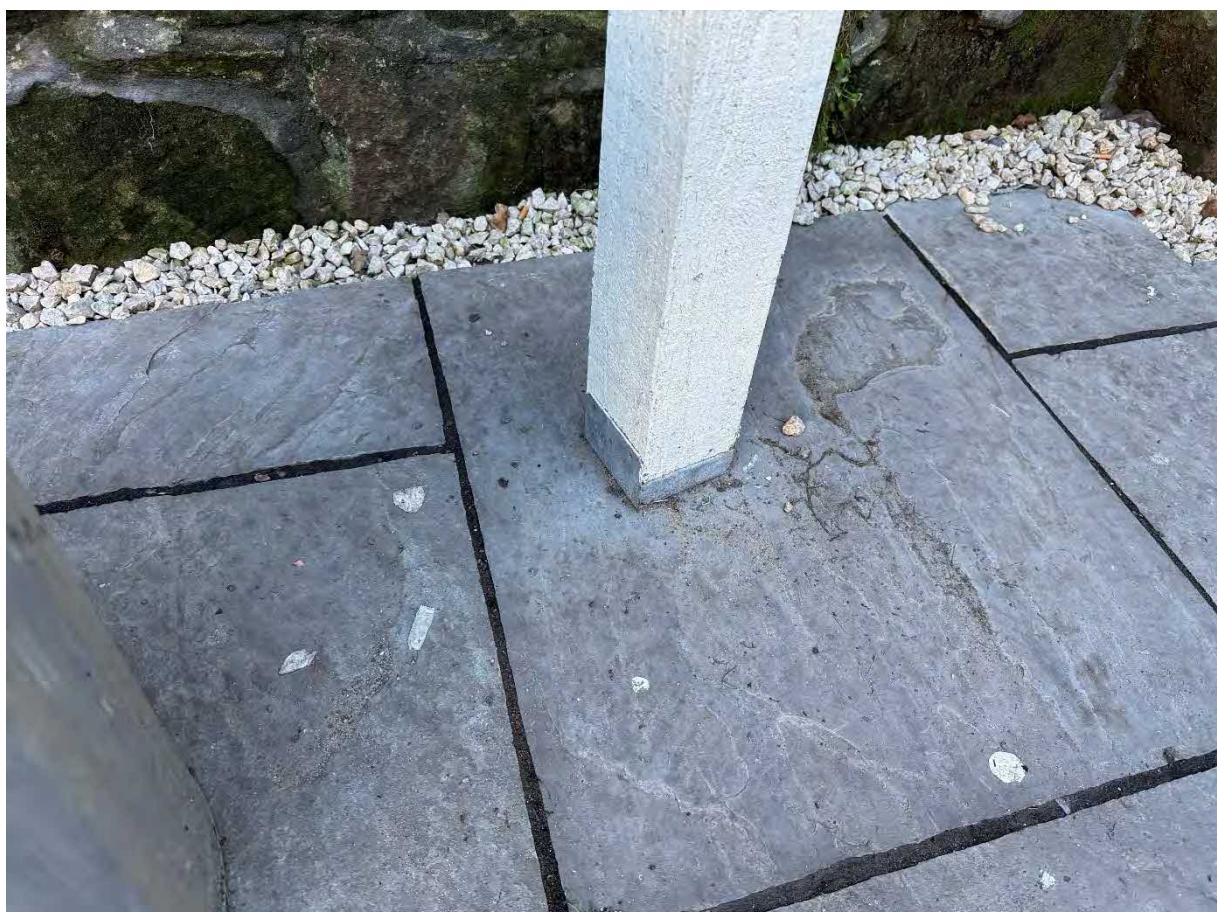
The base support of the posts could not be confirmed. The posts appear to be supported in galvanised steel shoes which bear directly onto the concrete / stone paving. The timber posts appear slender in cross section and some were noted to have twisted (on plan) over their 3m height, refer photographs P62, Appendix A.

The base support of the timber posts is of concern, as the structure is very lightweight and resistance to wind uplift must be achieved by the connection of the posts to a suitable foundation.

P62 – 100x100mm softwood timber post supported in galvanised steel base shoe.

Posts are twisted and base anchorage / support is unknown.

As the post base support and connection details are currently unknown, we recommend that additional anchoring be provided to posts which are isolated or free standing (i.e. may not be required to posts which are bolted to walls, connected to heavy steel containers, etc).

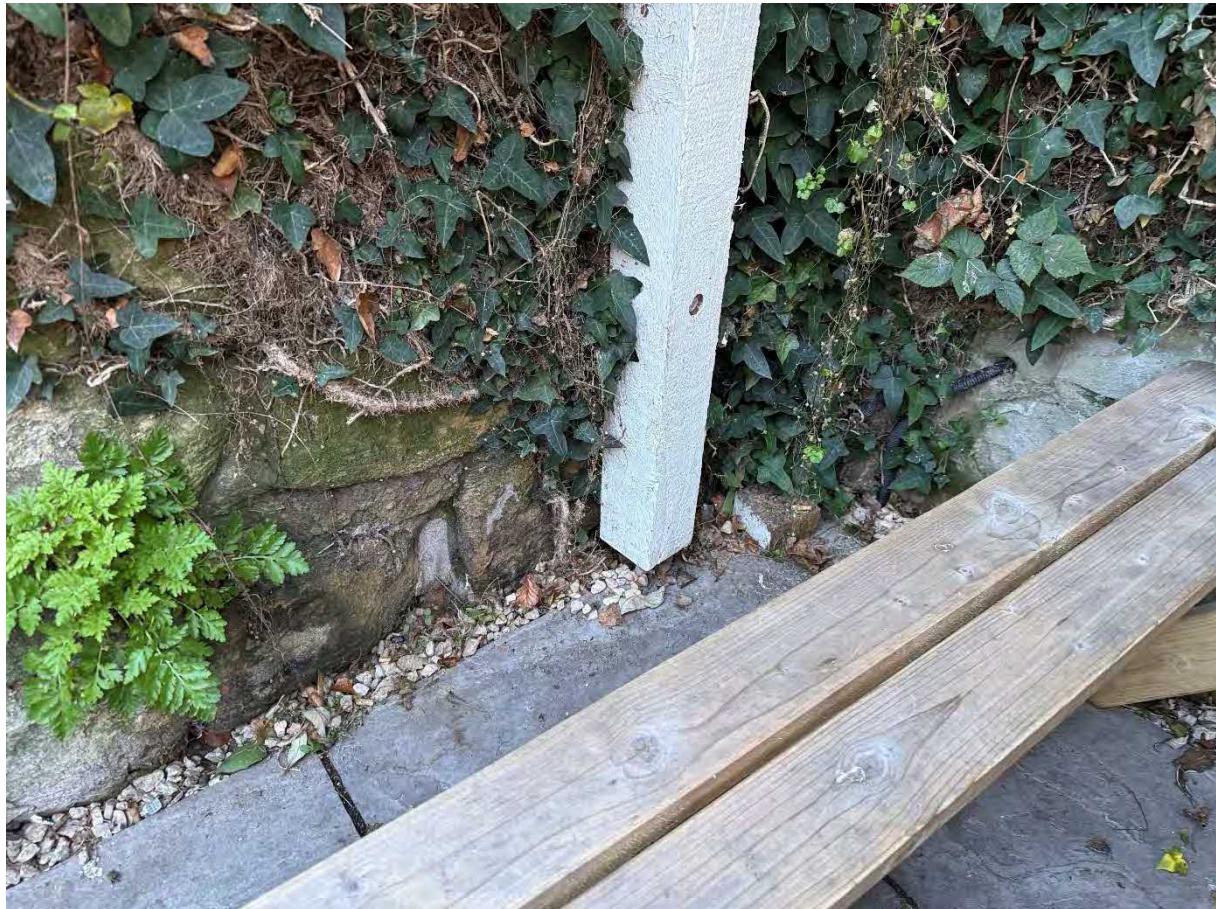
P65 – Timber framed pergola to rear beer garden.

Rear posts bolted to rear stone boundary wall – posts do not extend to ground and are not supported at base

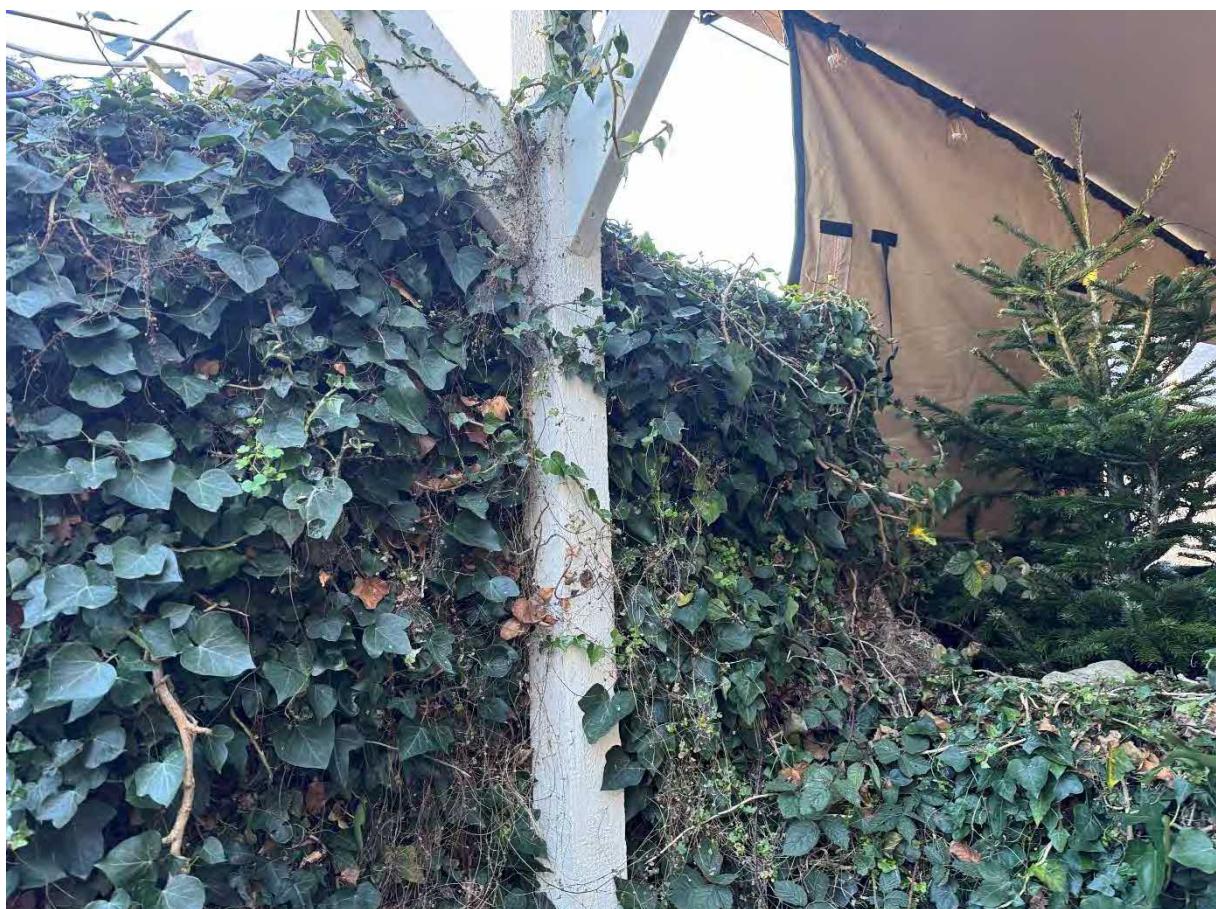
P66 – Timber framed pergola to rear beer garden.

Rear posts bolted to rear stone boundary wall – posts do not extend to ground and are not supported at base

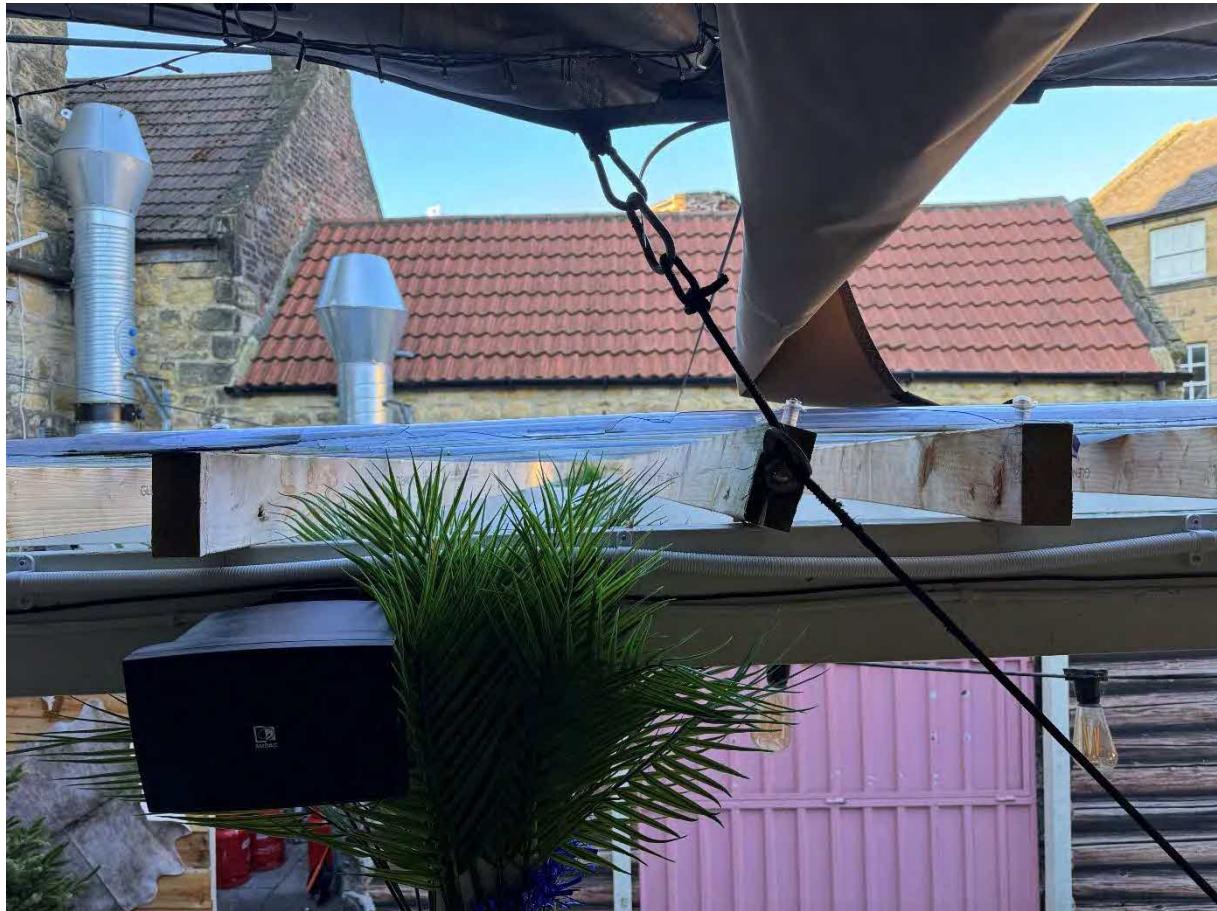
Local damage to one of the roof purlins was noted to have been caused by a tensioning cable from the adjacent tented structure. Refer photograph P67, Appendix A.

P67 – Timber framed pergola to rear beer garden.

Local damage to timber purlin and roof sheet from cable braced structure.

We recommend that the damaged timber purlin (refer photographs P67, Appendix A) be repaired and reconnected to the main roof beam.
