# **Heifer Law Auxiliary Unit Hide**

## **Survey Report**

On 29<sup>th</sup> May 2010, Colin Anderson and Ian Hall carried out a survey of the Auxiliary Unit (Special Duties) Zero Station at Heifer Law, near Alnwick.

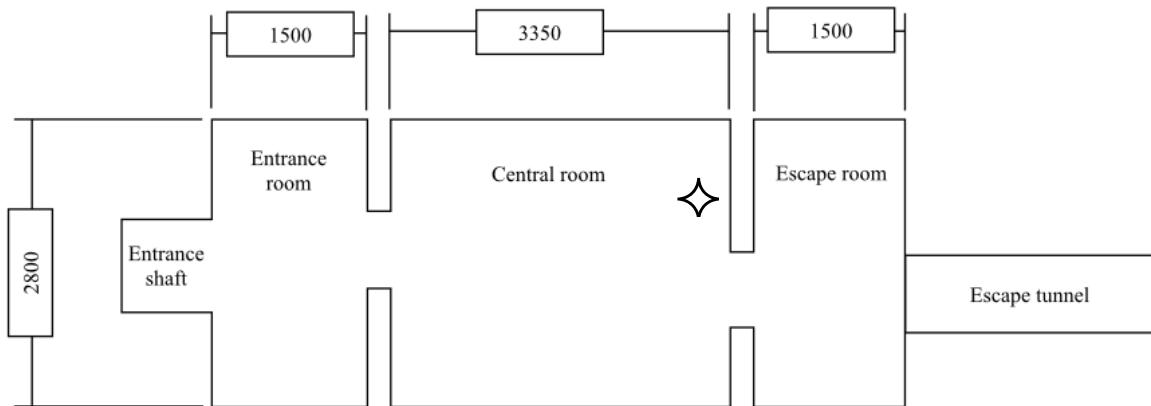
**Figure 1: Plan of hide with dimensions (mm)**

The hide is located within a circular earthwork in Heifer Law wood, to the north of Alnwick [map reference NU180177]. It consists of an underground building with three rooms [figure 1]. At one end there is a vertical access shaft [figure 3]. At the opposite end there is a 14 metre escape tunnel which exits into another vertical shaft [figure 4].

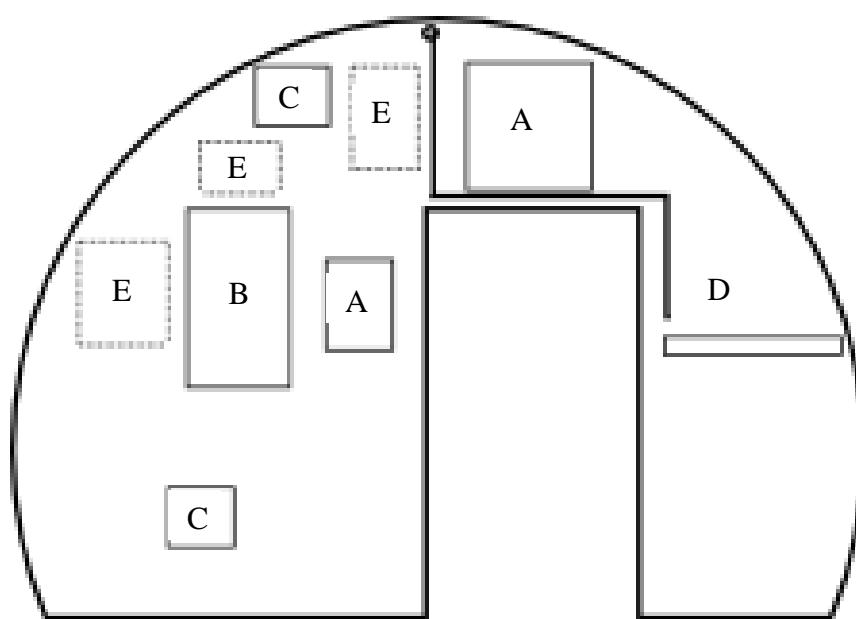
**Figure 2: Layout of end wall in central room (marked ✱ above)**

A small opening leads into the main room. This would originally have had a door, remains of which were found during the survey. This room has a high and low ventilation holes which are connected via two large concrete type tubes in the escape room to an unknown point outside the hide. There are also signs of a lot of equipment being mounted on the wall next to the escape room [figures 2 and 6].

- A Patches on wall where items would have been mounted
- B Recess with wooden shelf (approx 175mm deep)
- C Ventilation openings
- D Shelf
- E Markings – possible posters

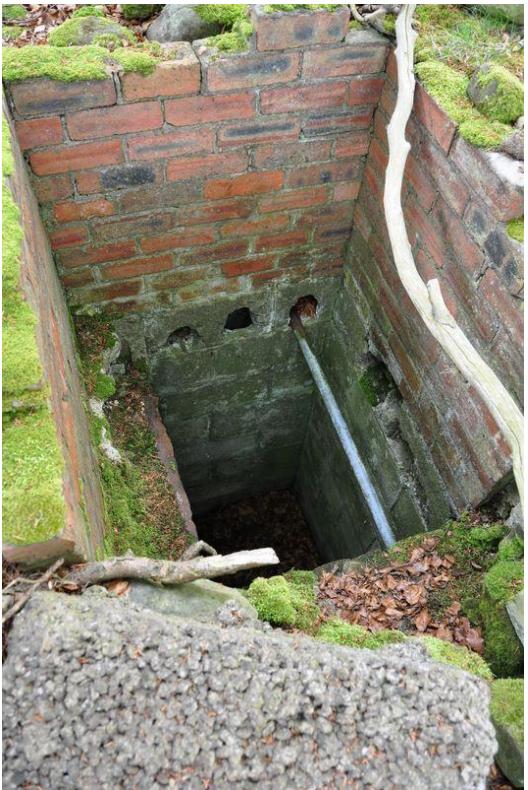
**Figure 3: Entrance shaft**

3. The entrance shaft is not protected, and while the exit shaft is covered by a piece of cast iron, both pose some safety risk. Improvements to the protection of these shafts should be considered, such as fencing.

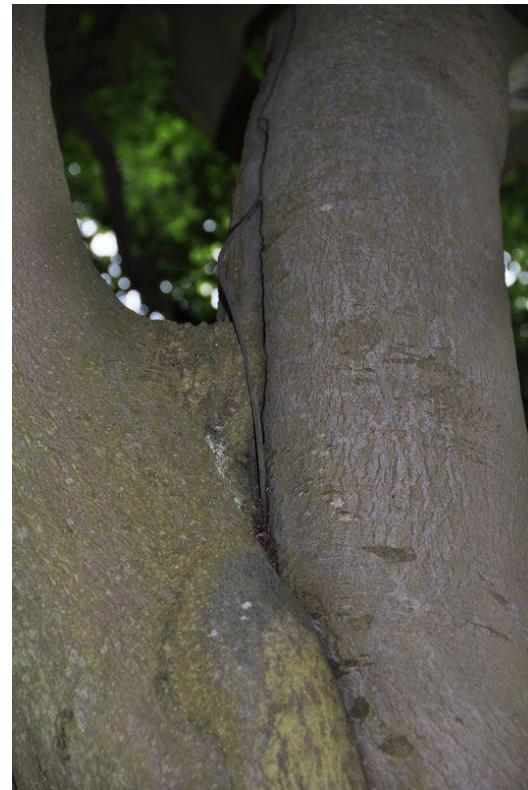
**Figure 5: Aerial in adjacent tree**

A nearby tree has an aerial cable concealed within the bark [figure 5].

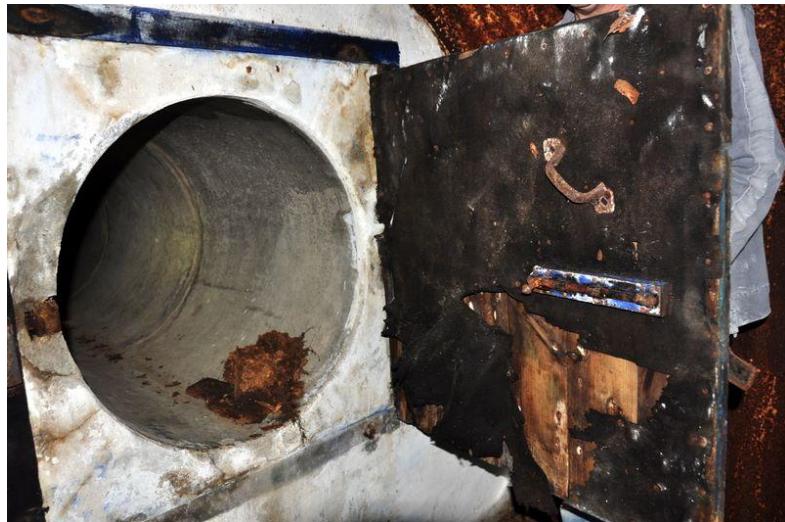
Figure 7: Escape tunnel door held in position

Some parts of the wooden remnants could be identified, though all are in a poor state [figures 7 and 8]. Most of the wood seemed to have been painted blue at some time. Three doors remain as well as a small door which would have blocked off one of the ventilation ducts. These all seem to have had bolts on both sides. The doors were covered with a type of oiled felt. The remnants of what might have been one of the shaft hatch covers were also found.

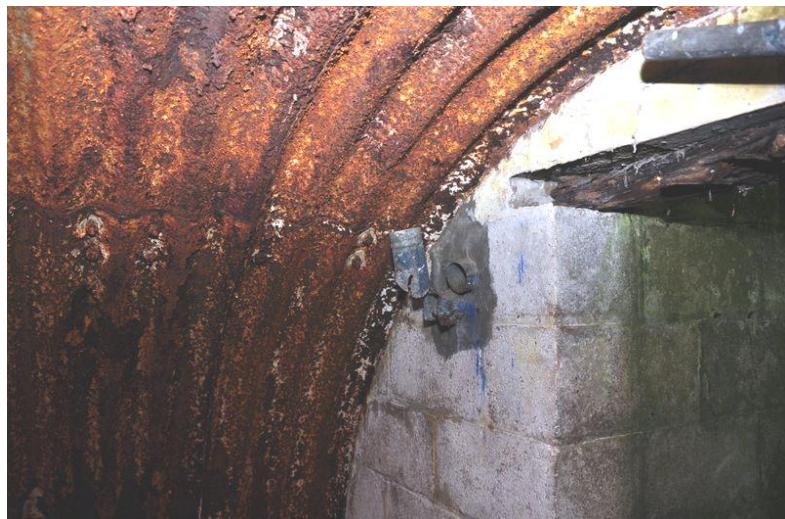
Figure 9: Pipes emerging into entrance room

The entrance shaft is linked directly to the entrance room. Within this room there are two metal tubes, which are connected to a larger underground glazed pipe system [figure 9]. These may have been a means of getting messages into the underground hide. There is also an unidentified 50mm diameter metal tube.

4. There are a number of pipes and tubes which lead from the hide to points outside. These were partially blocked. It might be useful at some time to try and identify where these pipes lead to, which might help confirm what they were used for.
