# Land at Narrowgate House, Alnwick, Northumberland

## archaeological evaluation

**Report 1984**

September 2008

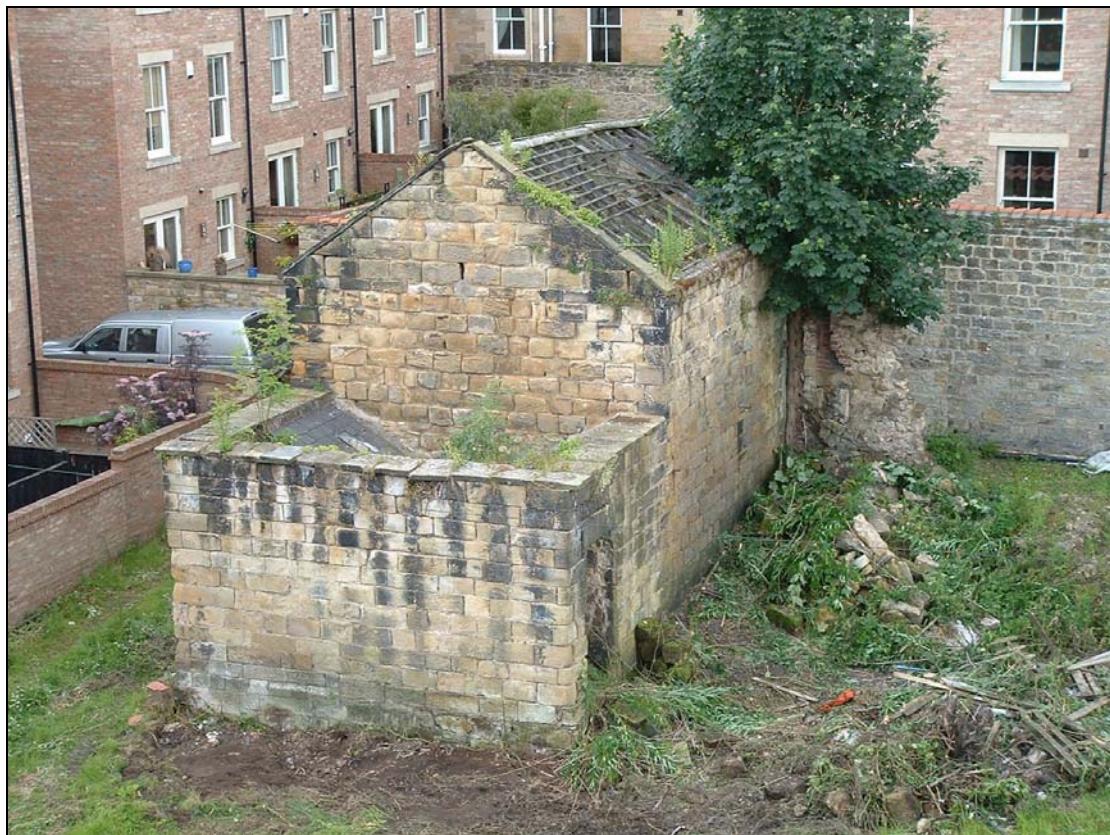
**Figure 7**  
The stable from the house roof

8.3 In the south part of the garden is a three-bay stable with a carriage house at its west end and a walled yard at its east (Figures 5, 6 and 7). The building is made of dressed sandstone with a projecting eaves course and a stone water table at the east gable. The foundations are shallow and of the same nature as the walls. The south face is the principal elevation; the carriage house has a high door with a basket arch of reeded masonry, and the stable has a central

11.2 No further archaeological work on the stable / carriage house is recommended. Some remedial work is required as a matter of urgency if the building is not to suffer further decay.

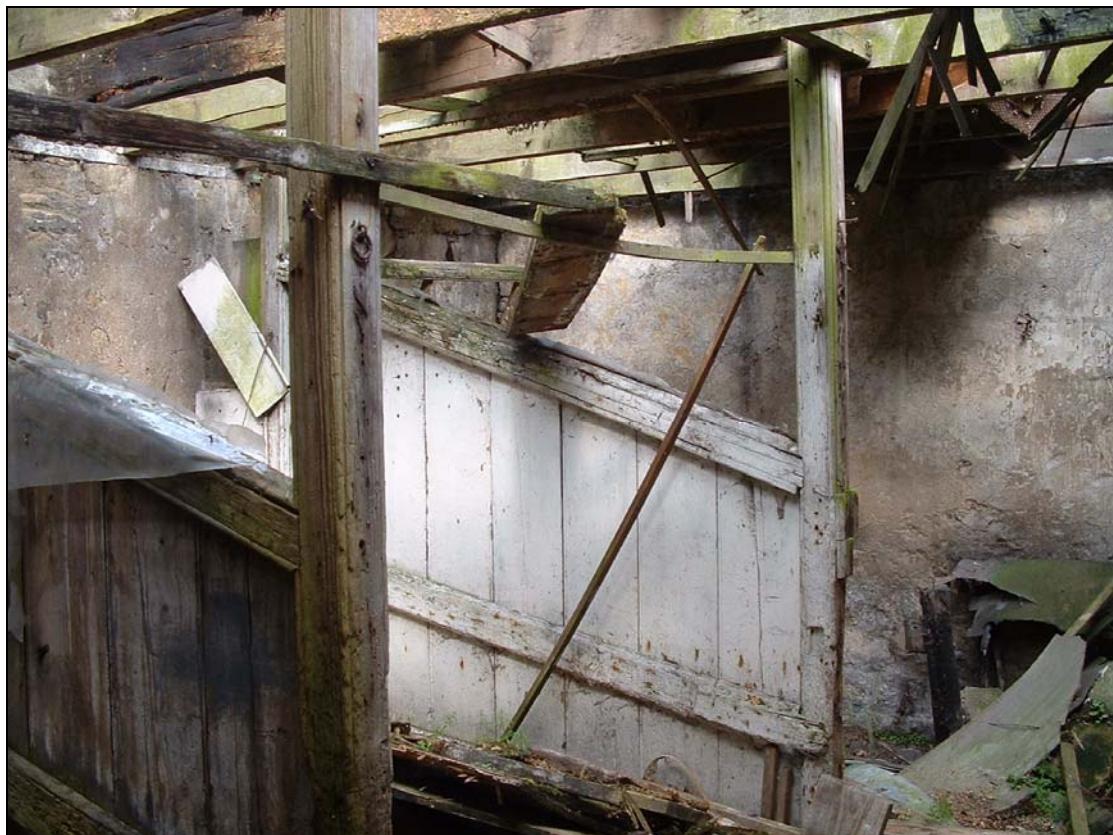
**Figure 9**  
The stable, internal view

8.4 Inside, the walls are plastered. Two timber stall partitions survive, together with the floor and the east end of the manger, but most of the woodwork is in very poor condition (Figure 9). The posts at the end of the stalls have quirked angles and there are the remains of a number of hooks and other fittings; there is no sign of the wooden racks for saddles or tack that are often found in stables. The ceiling retains traces of a hatch to the loft at the south-west corner, and chutes for filling the mangers. There are small vents in the north wall at the head of each stall. The floor is stone.

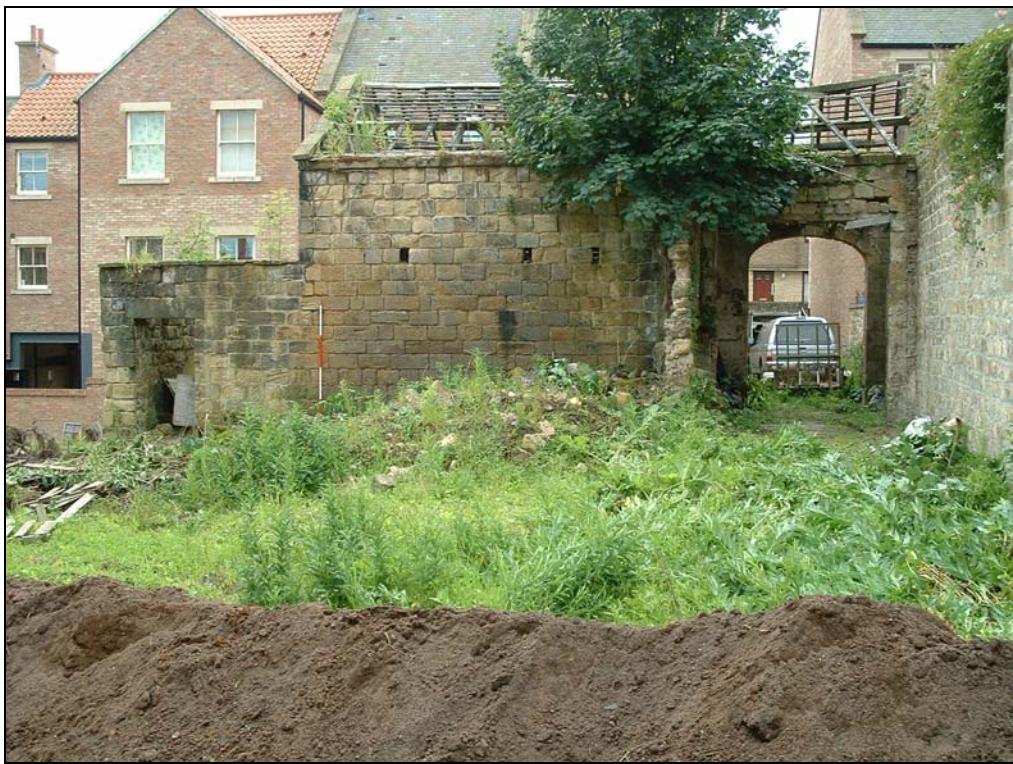
**Figure 11**

The carriage house, view of north wall

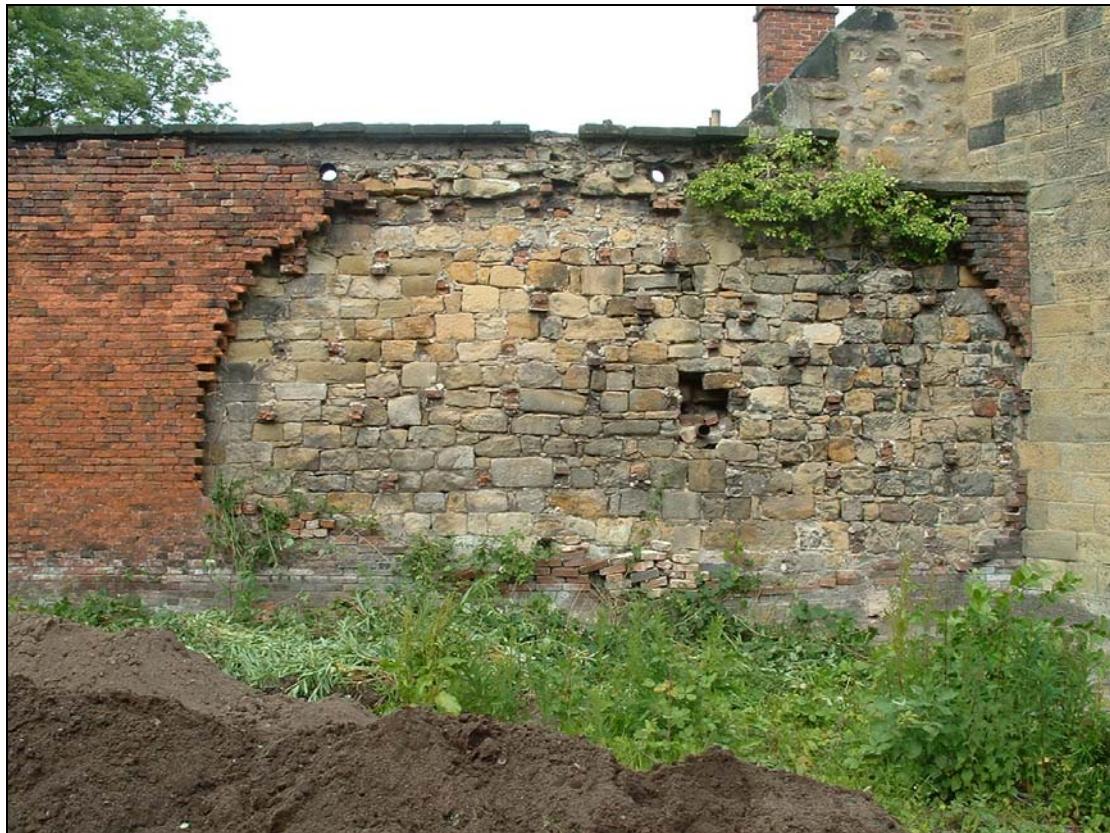
**Figure 13**  
The garden wall

8.10 It possible that this wall was deliberately designed to encourage the growth of vines or cordoned fruit trees. Brick walls were preferred, as they have good thermal properties and provide plenty of scope for nailing on supports for wall-trained plants. The space behind the brick leaf might provide passive insulation as an air space, as was recommended by a contributor to the *Mechanic's Magazine* in 1825:

1.12 Repair and restoration work on the garden wall will be necessary. It is recommended that the wall should be examined carefully when this work is carried out, so that the possibility of active heating can be investigated, and

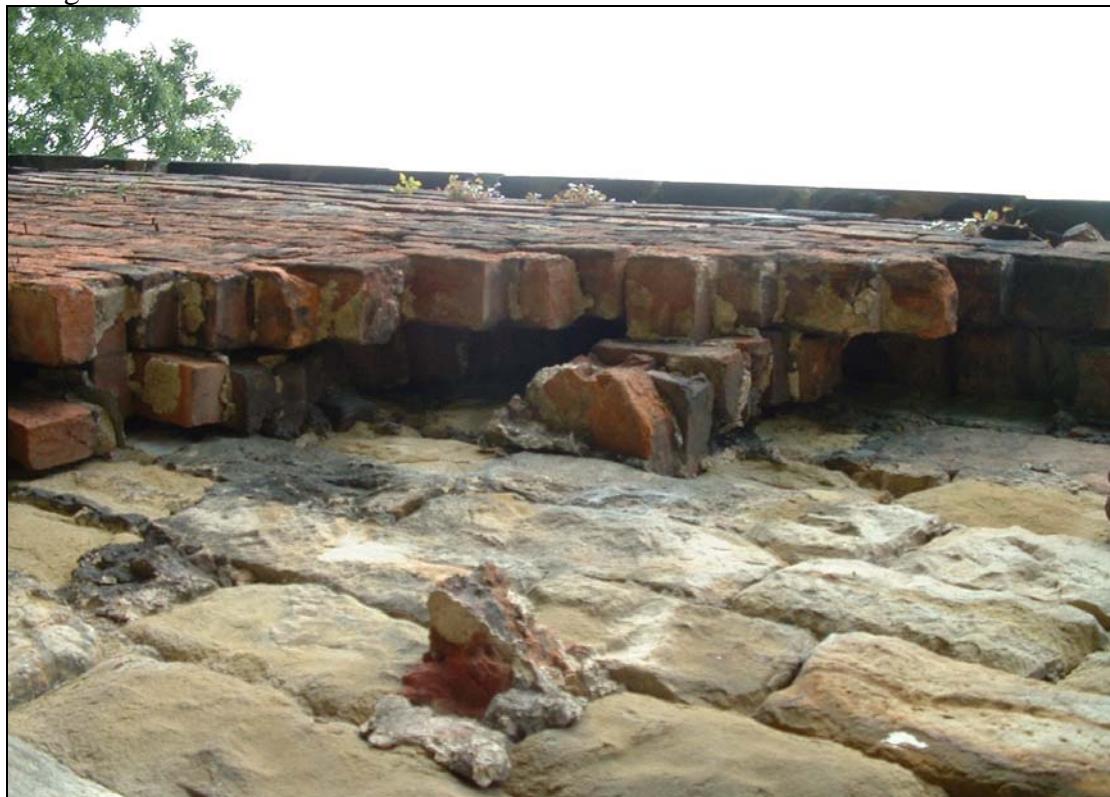
**Figure 14**  
The garden wall, looking up at possible flues

Alternatively, the wall could have been directly heated by flue gases from a stove or furnace. Such a stove could heat a length of wall enough to provide frost protection at critical times of the growing season, even where there was no attached lean-to glasshouse. In the large walled gardens of country houses, where heated walls are generally found (such as Belsay Hall, Northumberland, Croxdale Hall, County Durham, and Clumber Park, Nottinghamshire), heat sources are set against the opposite side of the wall. This would clearly not be practicable here. However, the map evidence shows a small structure against the inside face of the wall before and after the time when the narrow glasshouse was in use; it is possible that this housed a stove. If the wall and glasshouse were heated, the lower iron pipes might represent a later system using hot water. Further investigation of the wall would be required to confirm this hypothesis.
