**Narrowgate House ('General Lambert's House' – HER 4522)
31 and 33 Narrowgate, Alnwick, Northumberland NE66 1 JN
(House centred on NGR 4186299 6134983)**

**Historic Building Recording
by
Northern Counties Archaeological Services
on behalf of
Stablewood Leisure Ltd.**

Historic Building Recording

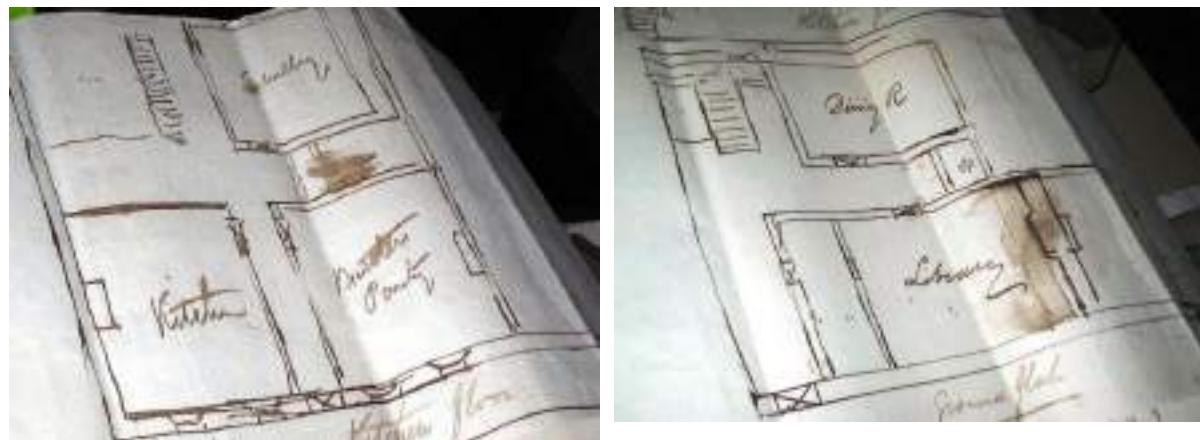
Figure 2. Undated sketch floor plans of what is now 31 Narrowgate, photographed as found in the house in 2002, now at Northumberland Archives (NRO 6393/9-12). Image 9 is the basement (top left), image 10 is the ground floor (top right), image 11 is the first floor (lower left), and image 12 is the second floor (lower right). Images supplied by Spence & Dower LLP.

2.23 Four undated ink sketch plans showing the southern part of house (31 Narrowgate) were found in the house in 2002. The originals are now untraceable, but photographs (NRO 6393/9-12) show they were drawn on back of printed papers, the typeface suggesting an early 19C date, possibly 1830s-40s. The functions of the rooms are given. There are some differences between the sketches and the existing floor layouts which may be no more than a result of rough drawing, but raises doubt as to whether they show 'as existing' floor plans or were outline drafts for a remodelling.

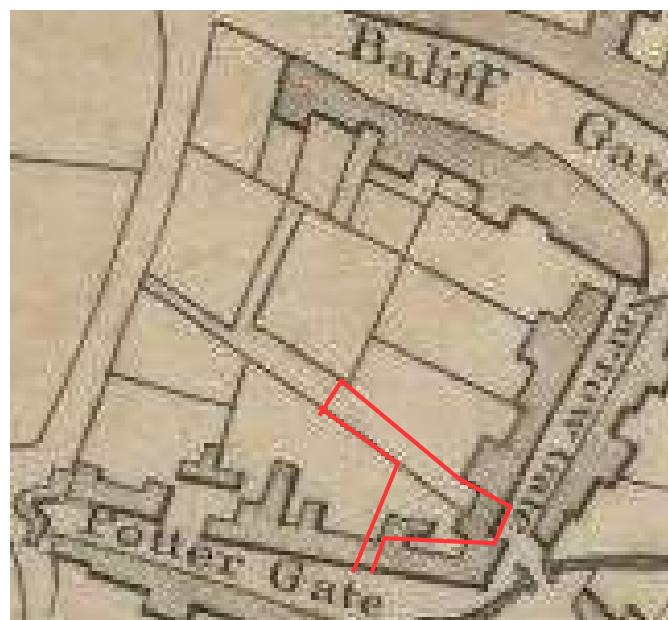
Figure 4. Lt. Andrew Armstrong and Son, 1769. Alnwick, from their map of Northumberland. The representation of the house is schematic but suggests a western outshot. The northern boundary may be misplaced (communities.northumberland.gov.uk).

2.16 The first known 18th century town plan is that of 1769 by Armstrong (Figure 4) which shows a building occupying the site of Narrowgate House. More accurate is Thomas Wilkin's 1774 plan (AC O.I.9b, Figure 5). This shows that the building then on the site of 31-33 Narrowgate was a single-pile construction with no indication of sub-division. It also shows there was a south-western rear range overlying basement Rooms 26-30, and that the east façade had a 'forecourt' with what appear to be steps roughly in the centre. A linear feature appears west of the house, perhaps a terrace, with a small square structure at the centre, and a range of outbuildings against the south burgage plot boundary.

3.23 The west wall and west gable forms part of property division recorded as early as Armstrong 1769 (Figure 4). It is built of sandstone rubble in which an area of rubble and brick patching [212] may represent a blocked flue belonging to a building on the west side of the boundary wall (P17). The absence of render over most of this wall-face suggests it has been stripped for re-pointing or consolidation.

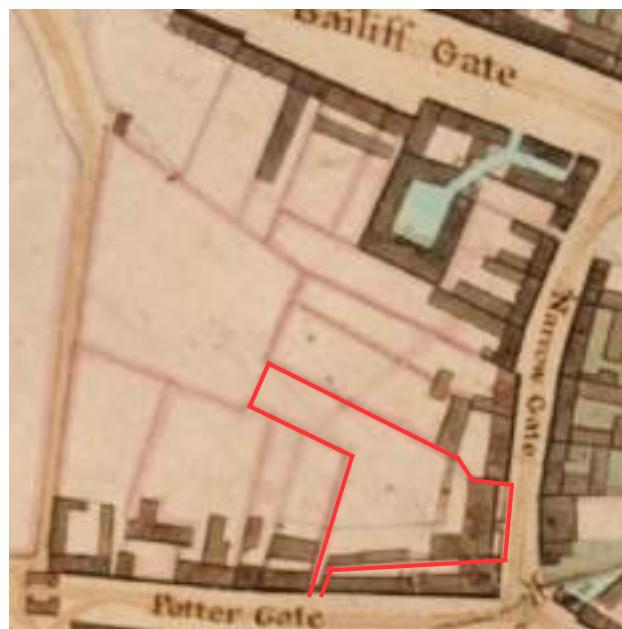
Figure 5. Thomas Wilkin, 1774. Extract from his plan of Alnwick. The single-pile house with its western outshot and backland is clearly identifiable though the north and south boundaries are too far apart. The forecourt appears to be crossed by a flight of steps to an entrance just south of centre in the east facade (Collection of the Duke of Northumberland, Alnwick Castle, O.I.9b)

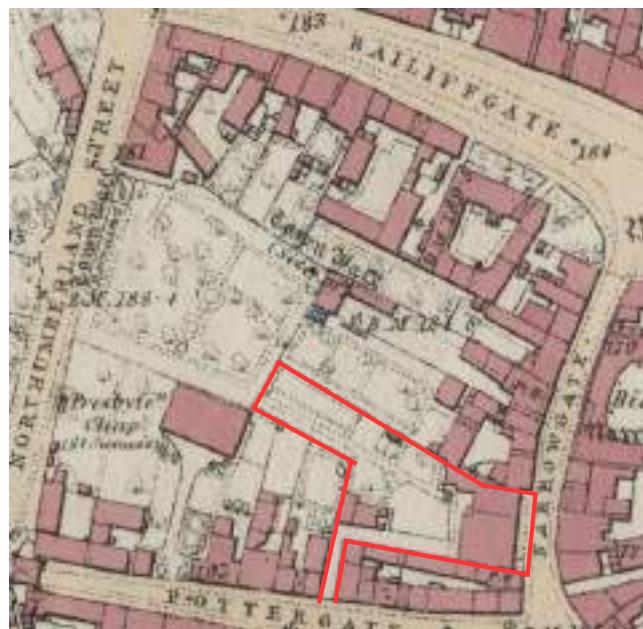
Figure 8. First edition Ordnance Survey 25" (1:2500) map sheet XXXII.9, c.1861. Narrowgate House appears in its fully developed form, with garden walks, beds, and a building against the north boundary wall which may have been a kennels. The division of the house into the later 31 and 33 Narrowgate is shown (Northumberland Archives, Woodhorn).

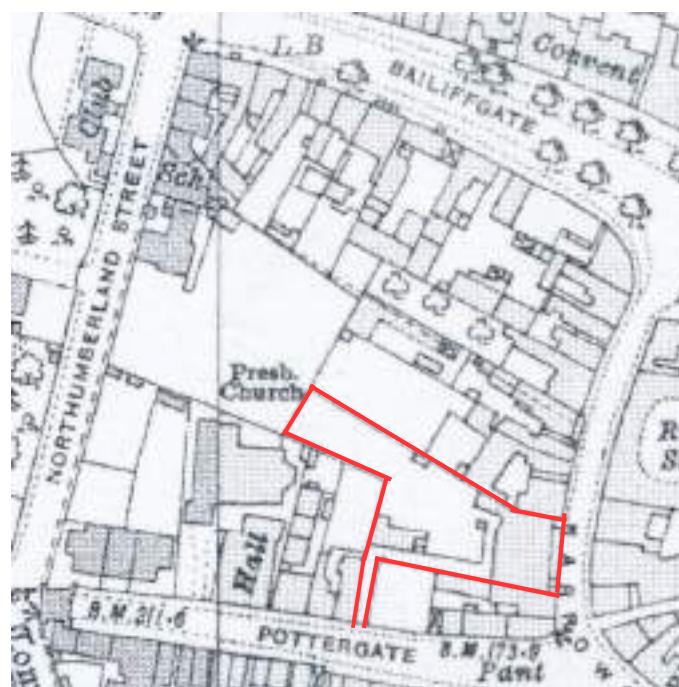
Figure 10. Third edition Ordnance Survey 25" (1:2500) (New Series) XXXV.1 and 2. Revised 1921-22. Published 1923. The house footprint is unchanged. A smaller glass-house has appeared against the northern boundary wall. (National Libraries of Scotland).

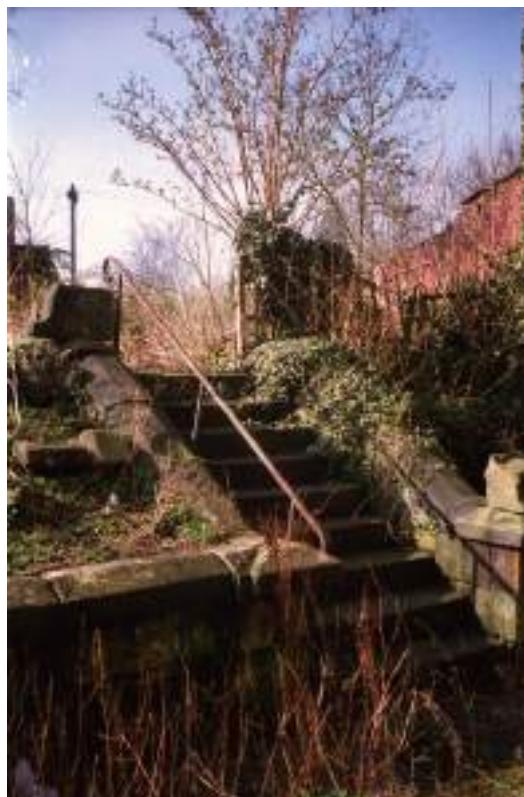
Figure 11. The dwarf wall (left) and garden steps c.2002. A cap-stone similar to that in the foreground is now in the coach-house. To the right is one of the pieces of architectural masonry described in paragraph 3.8 below. (Courtesy of Spence & Dower/Woodhorn)

- 3.8 At its northern end the dwarf wall runs to the foot of a truncated flight of stone steps, then takes a dog-leg west before returning north to butt the north-western corner of the No.33 outshots (Figure 14, Build G). This latter section at least must post-date construction of the westernmost outshot. The steps are shown on a photograph of c. 2002 (Figure 10) with a capstone to the north-west angle apparently that which is now in the coach-house (see paragraph 3.20). The surviving dwarf wall and steps will be retained within the proposed development (Approved drawing M561/06D).

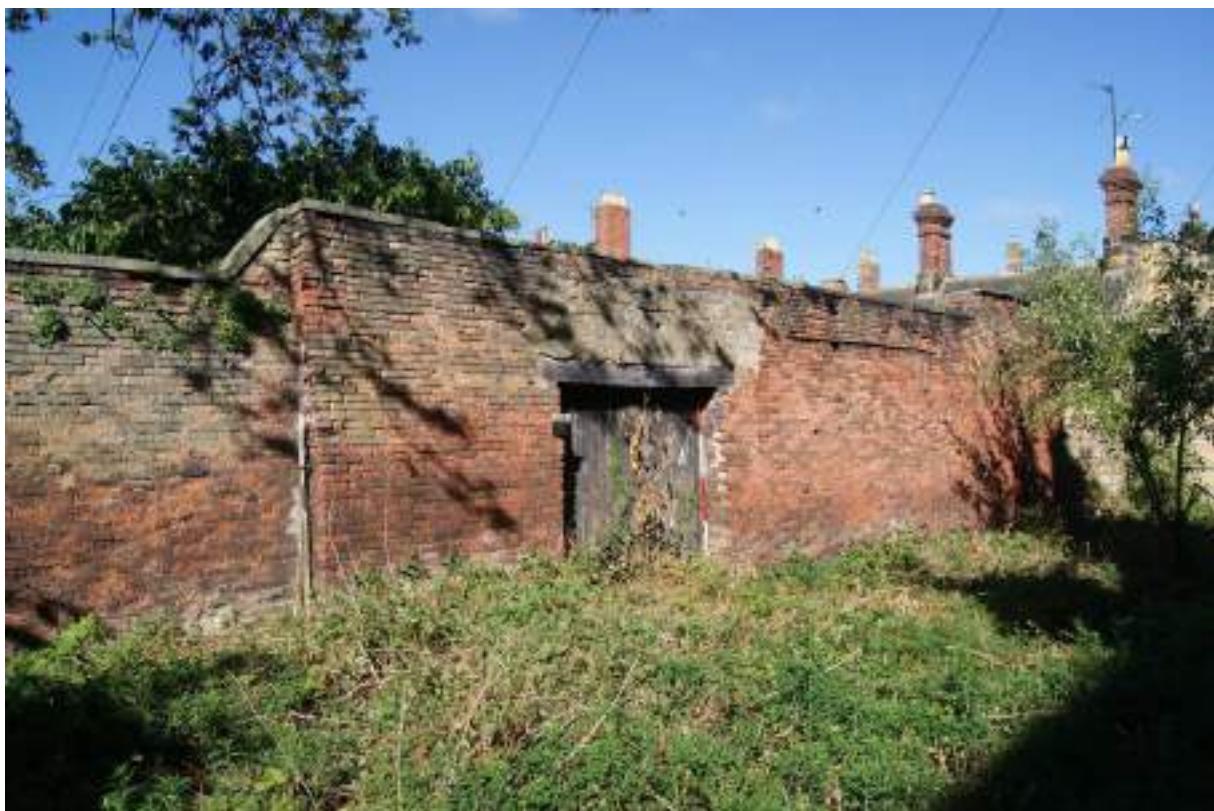
P1 (top). The north burgage boundary wall looking north-east showing the start of the 'hot wall', pierced by a later double-door vehicle access. Scale 2m. NGA5/060

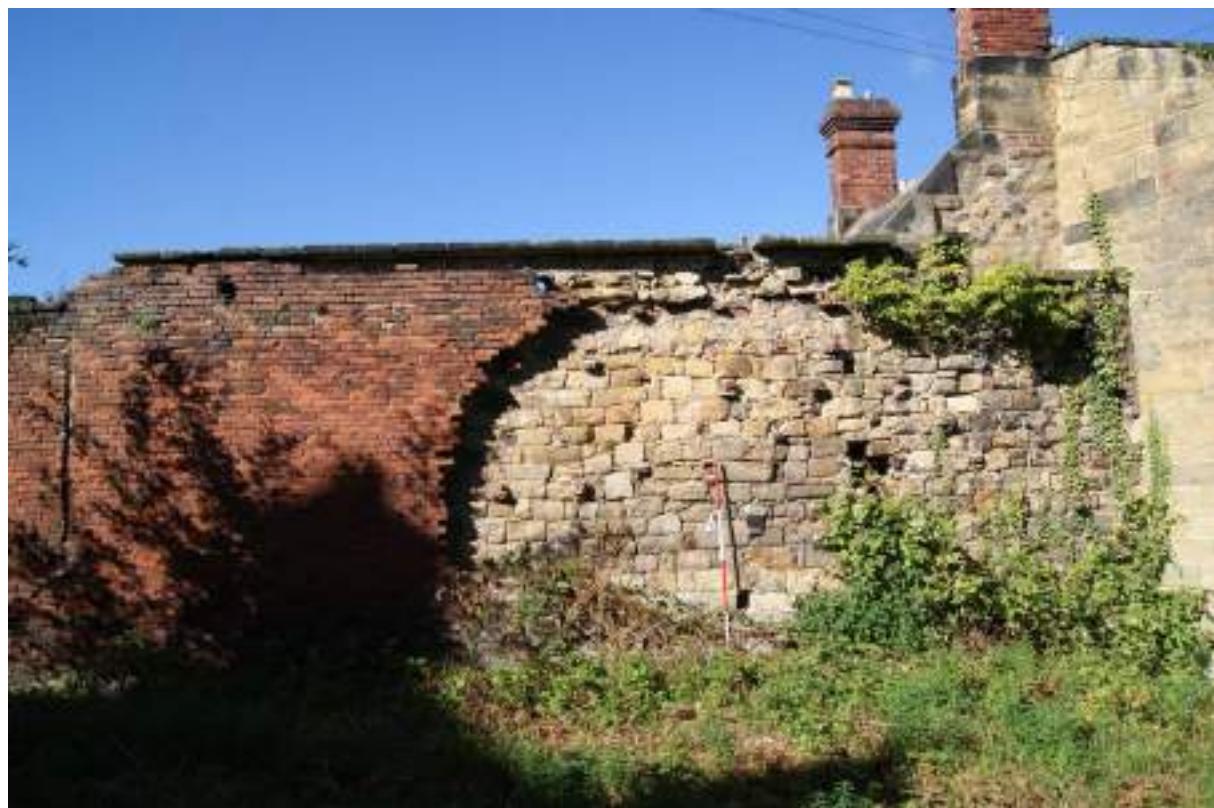
P2 (below). Collapsed section of the 'hot wall' showing keying-in bricks and the exposed stone wall behind, with coping slabs and vents. Scale 2m. NGA6/059

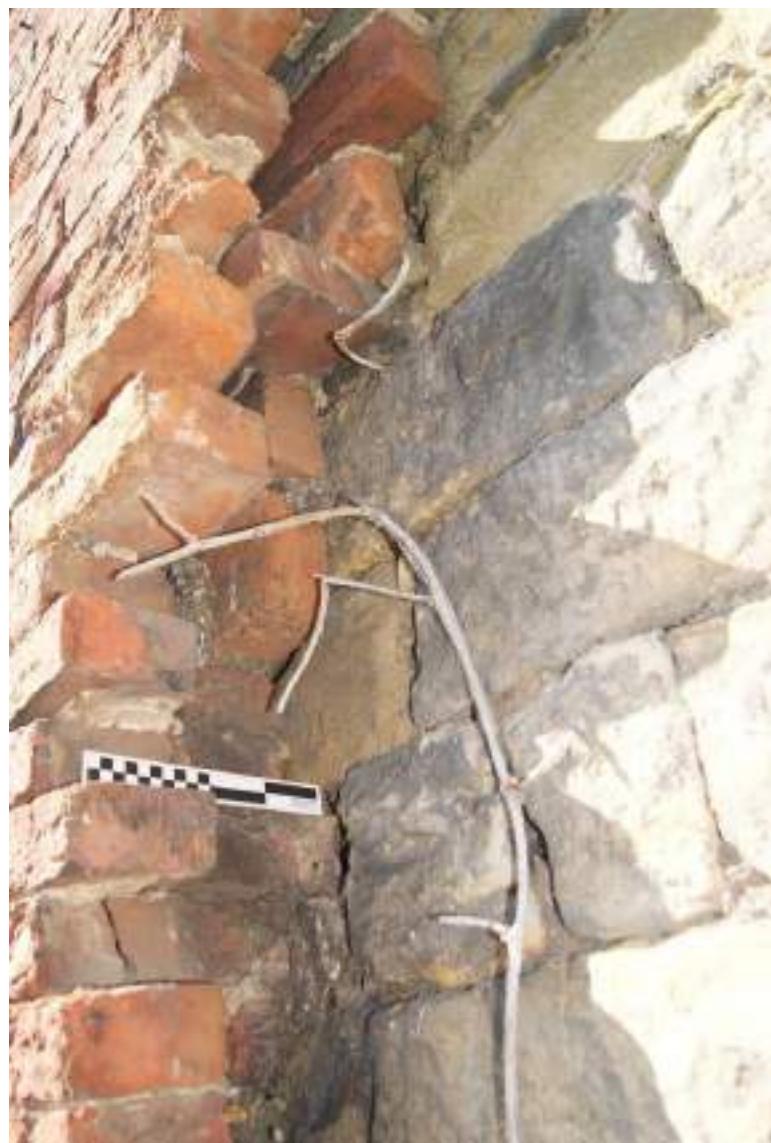
P3 (top). Detail of the 'hot wall' structure showing keying-in bricks, flues, and soot on the earlier masonry boundary wall. Scale 20cm. NGA6/058

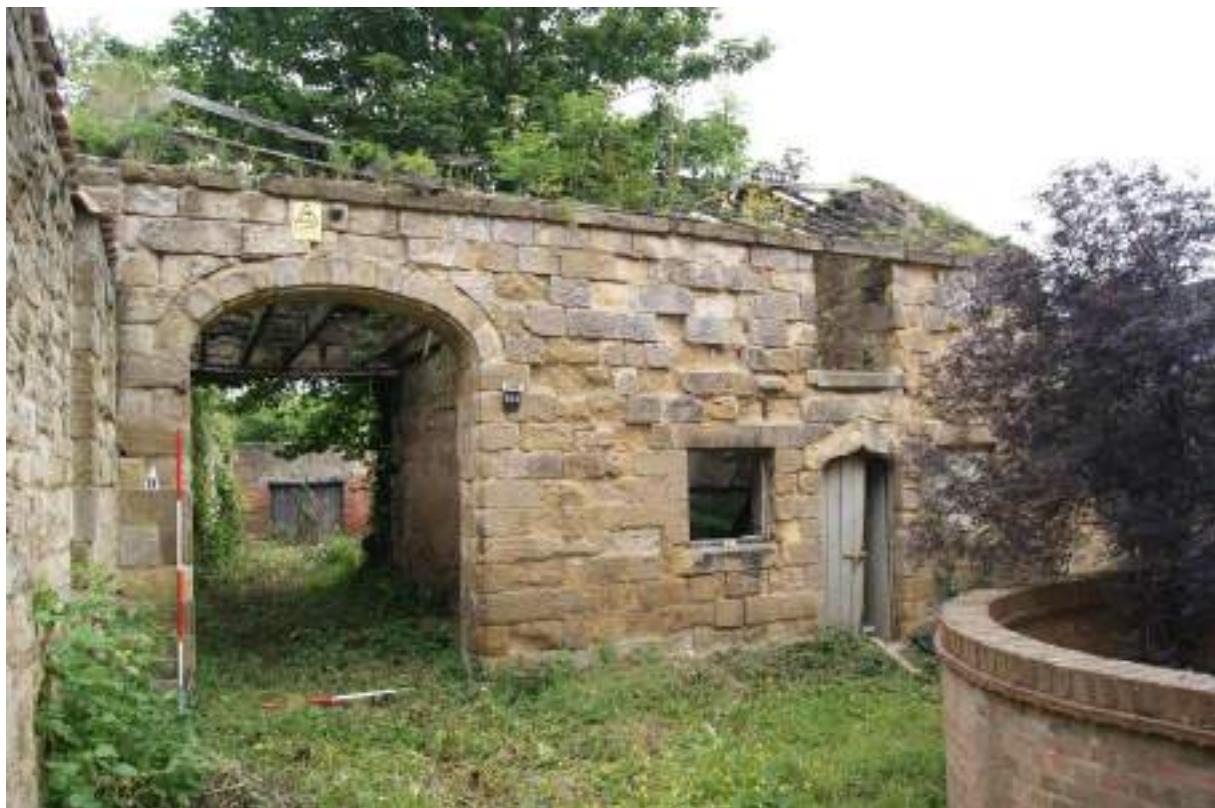
P4 (top). The coach-house and stables, south elevation, looking north-east. The carriage entrance 201] is on the left, window [202] and stable entrance [203] with pitching-eye [205] above is on the right. Scales 1m and 2m. NGA2/001

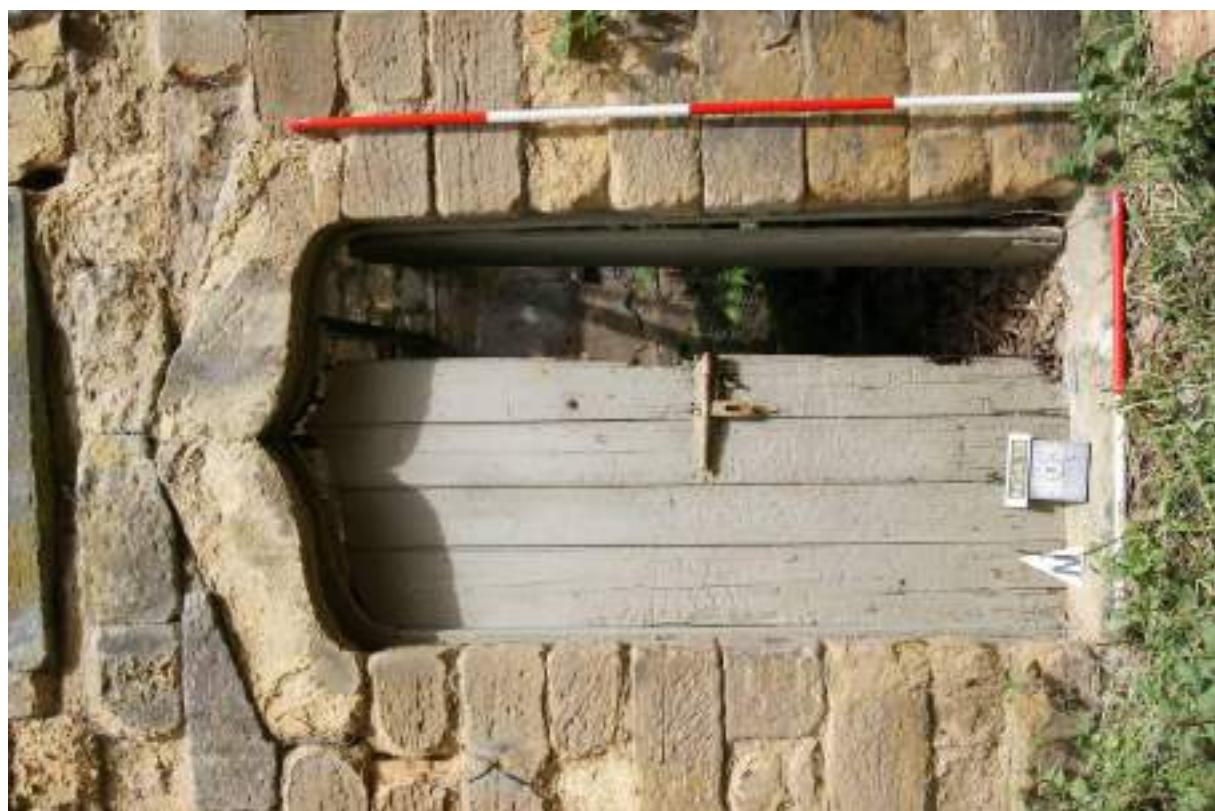
P6 (top). Stables: interior looking south-west to the inner face of the stable door [203] showing two-section door leaf with hinges and bolts and inner face of ogee lintel. Scales 1m and 2m. NGA2/010

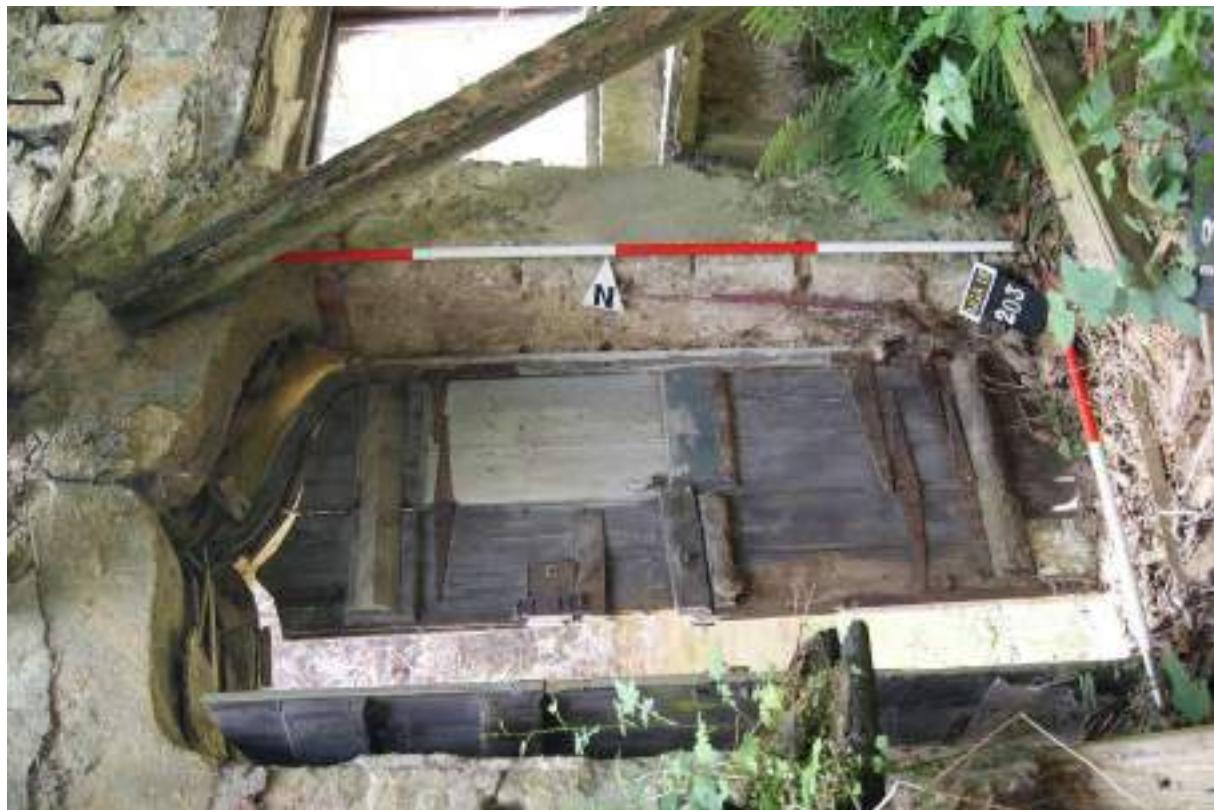
P7 (below). Stables: interior looking west, showing window [202], butt-joint between the west partition wall and the external south wall, and fallen/collapsing timberwork. Scale 2m. NGA2/008

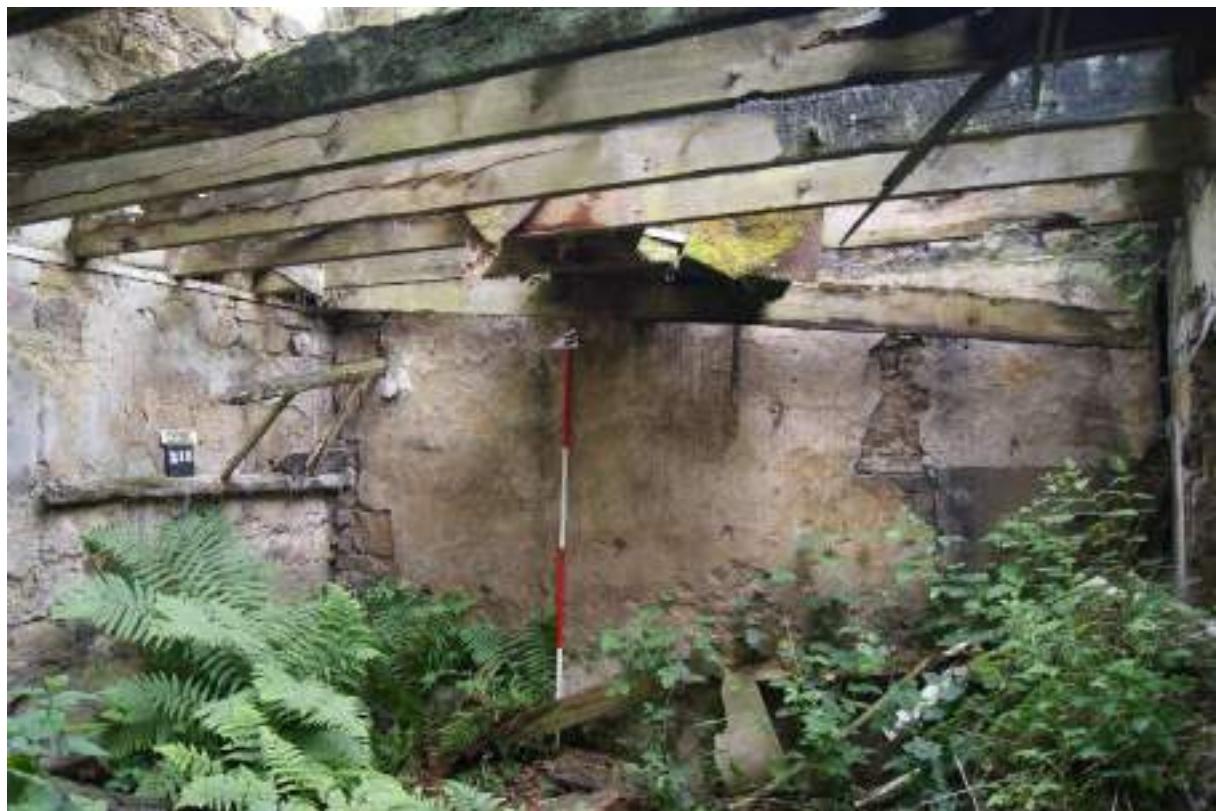
P8 (top). Stables interior looking north-east, showing east partition and butt joints with outer walls, remains of manger (left) and fallen/collapsing joists. Scale 2m. NGA2/011

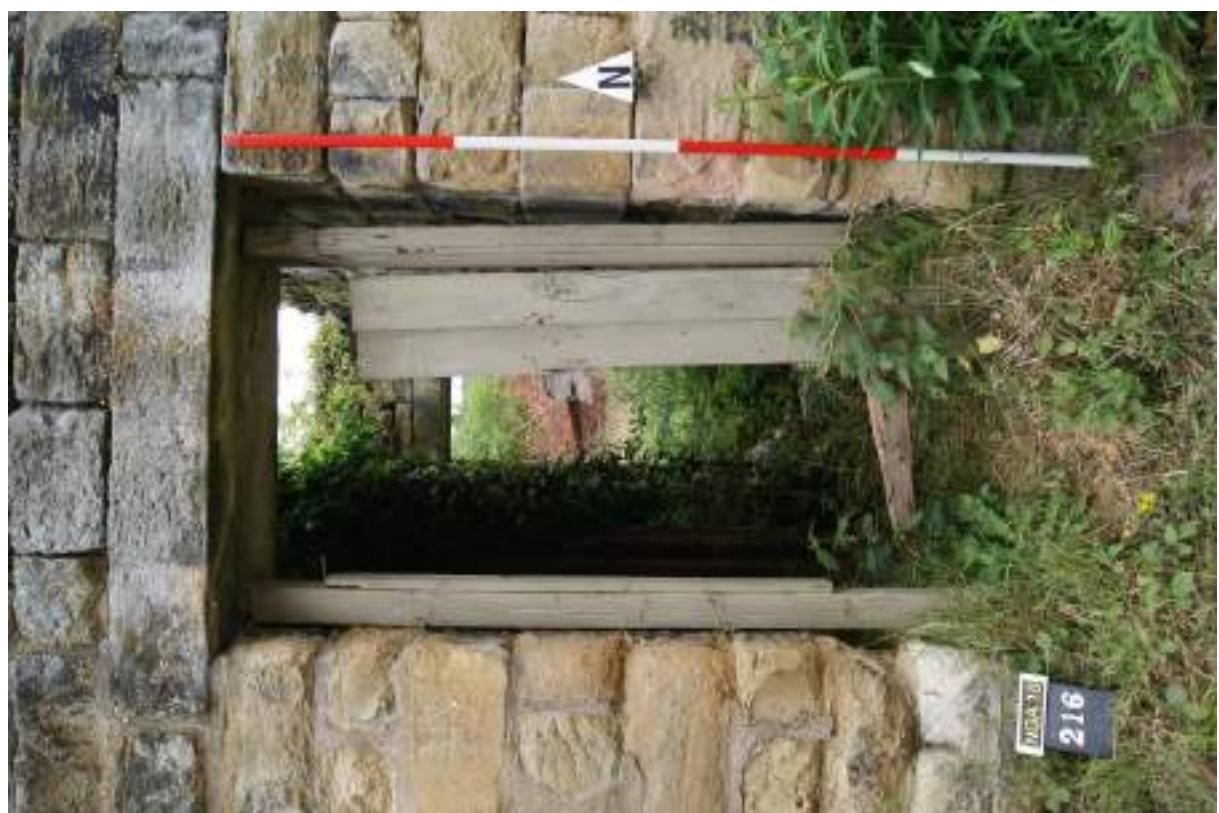
P9 (below). Southern yard door [206] looking north, showing modern planked door. Scale 2m. NGA2/024

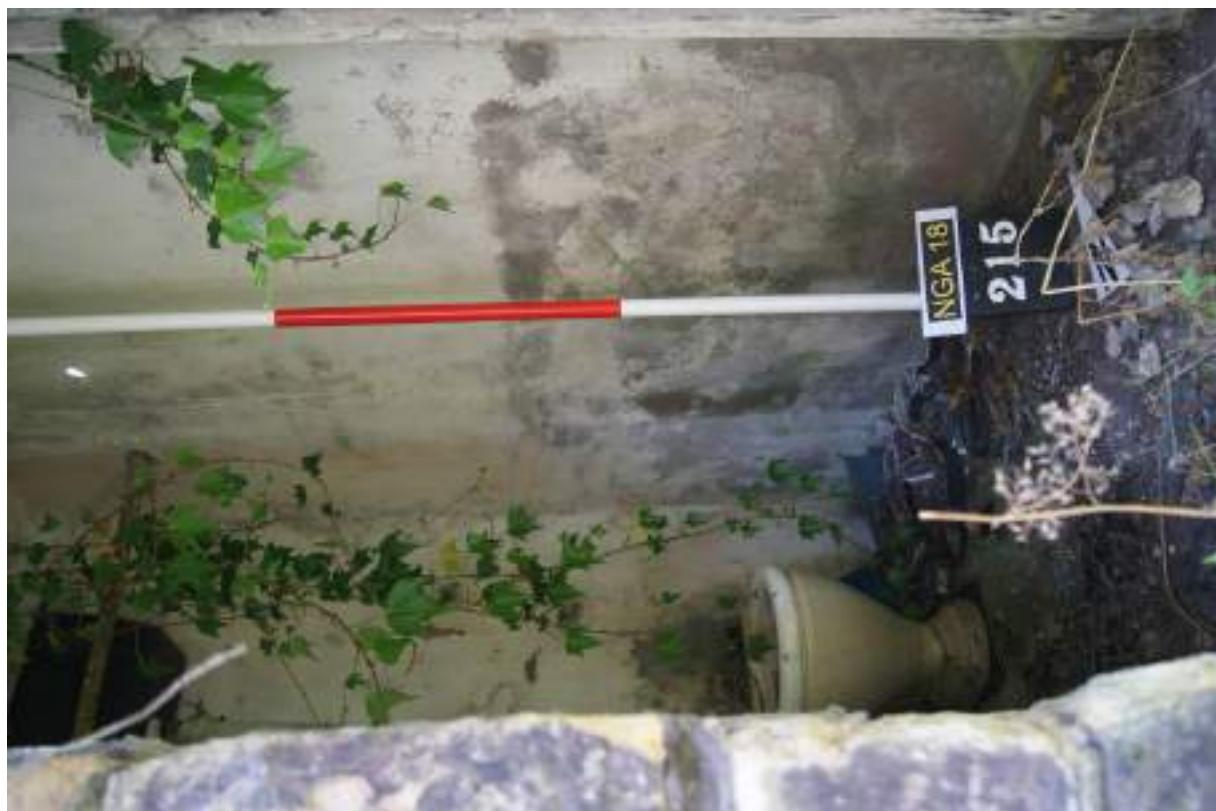
P10 (top). Yard: looking through the doorway of the southern outshot, showing 20th century toilet bowl and illustrating the restricted space for photography within this area Scale 2m.
NGA2/025

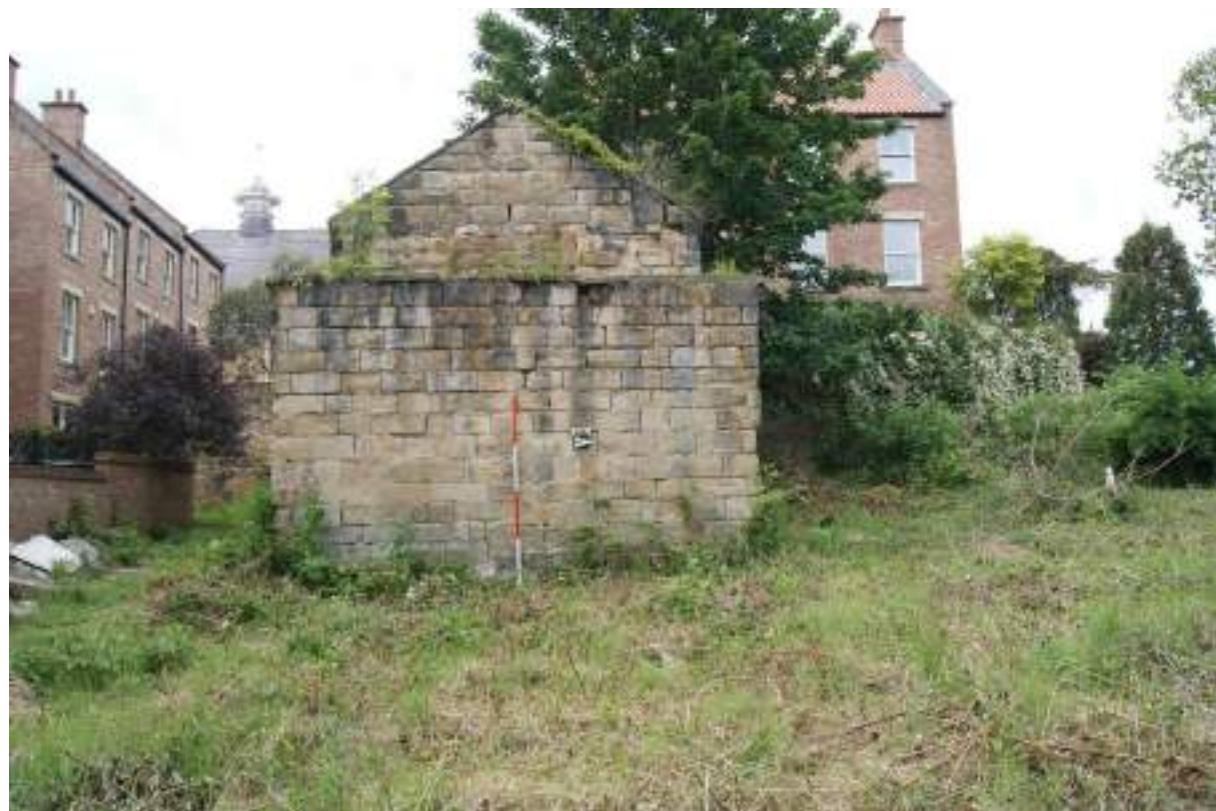
P11 (below). The coach-house/stables looking west, showing the yard wall with the east gable of the stables beyond. A narrow possible ventilation slot [217] in the east gable is just visible. Scale 2m. NGA2/015

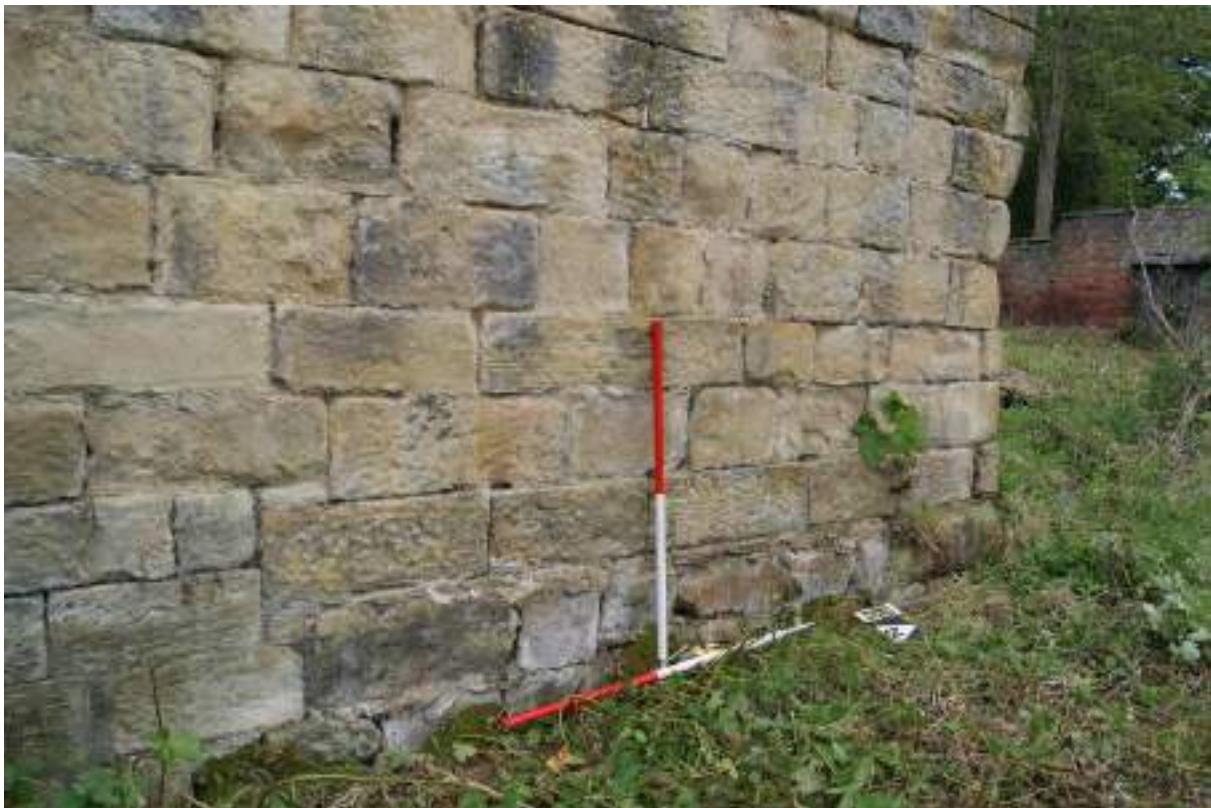
P12 (top). Detail of the east wall of the yard, showing construction joint and differences in the the build to the south and north. Scales 1m and 2m. NGA2/026

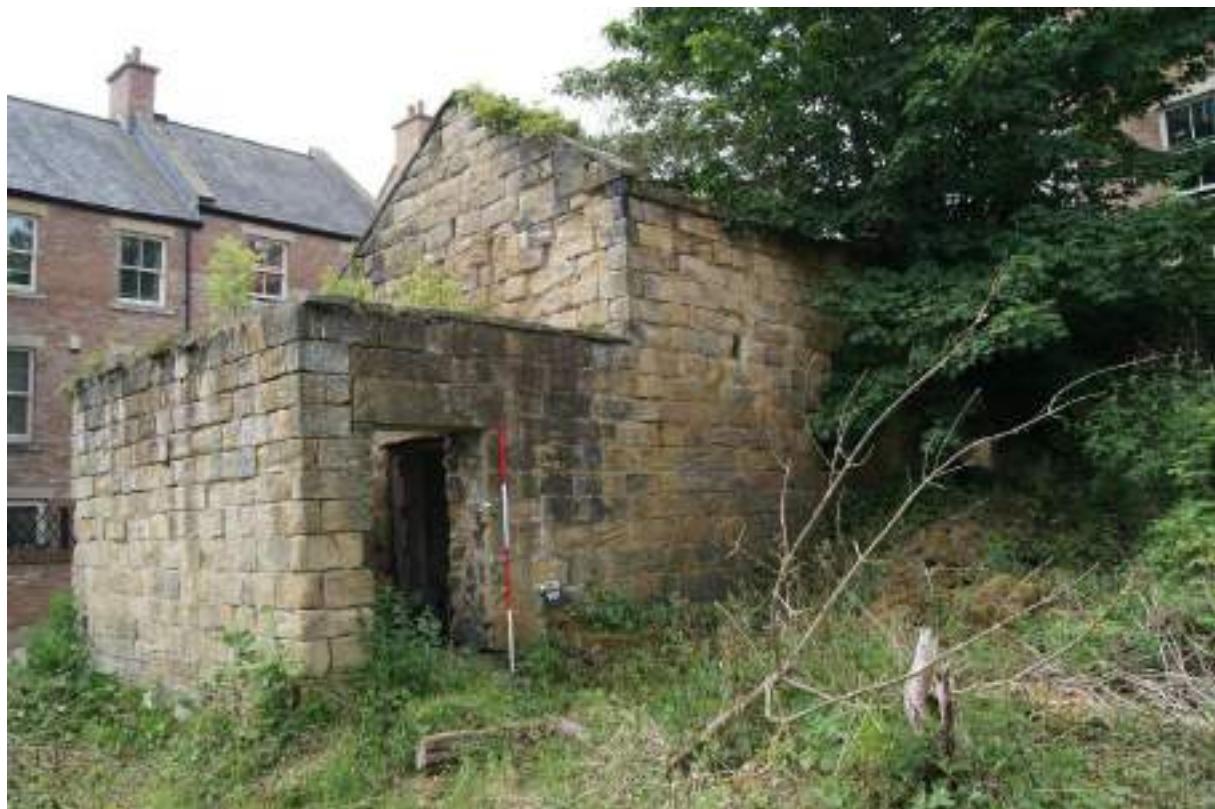
P13 (below). The stables and yard looking south-west, showing the north doorway [207] to the yard and one of the beam-slots [208] in the north wall of the stables. Scale 2m. NGA2/016

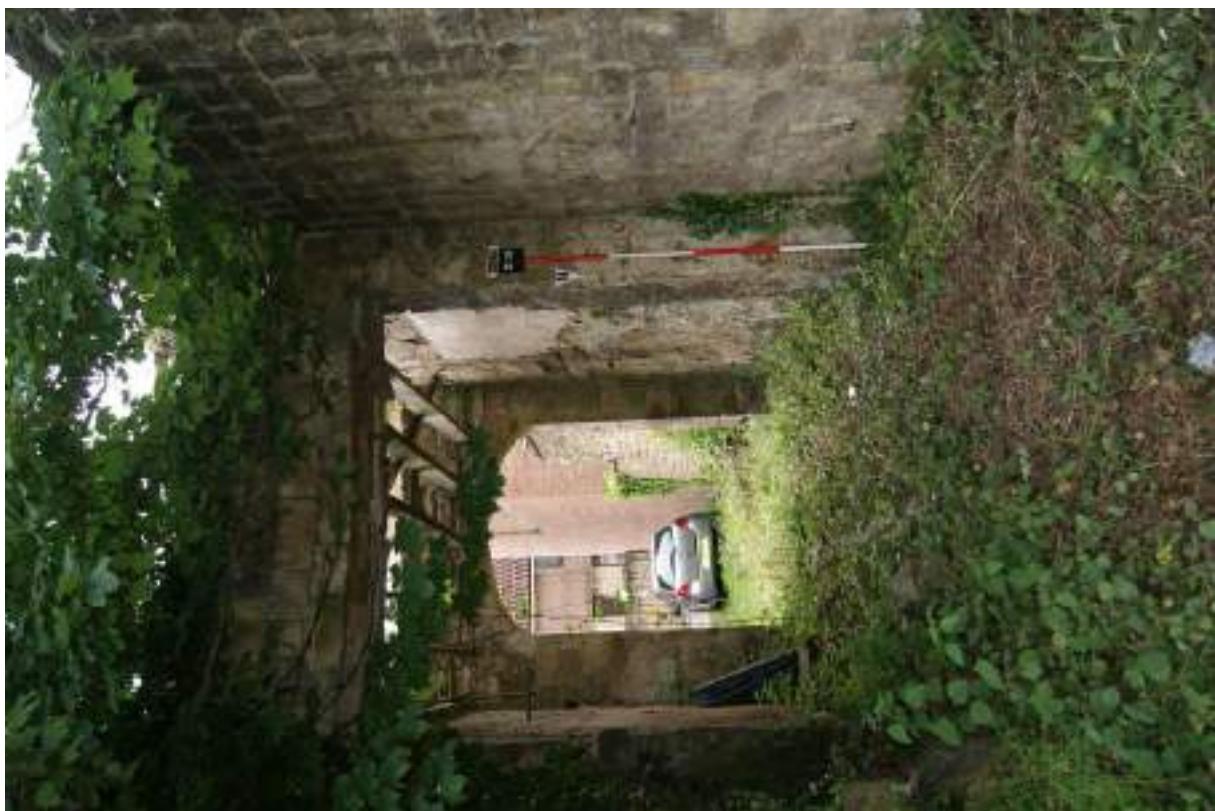
P14 (top). Looking south into the coach-house through the inserted double-doorway [209], showing timber lintel and joists to first floor. Scale 2m. NGA2/019

- 3.38 The north wall of the carriage house has been breached to form a high, full-width, opening allowing vehicle access over the garden and presumably to the double-doors in the northern boundary wall. The appearance of the timber lintel and patching of the breached wall ends suggests this was formed in the mid 20th century.

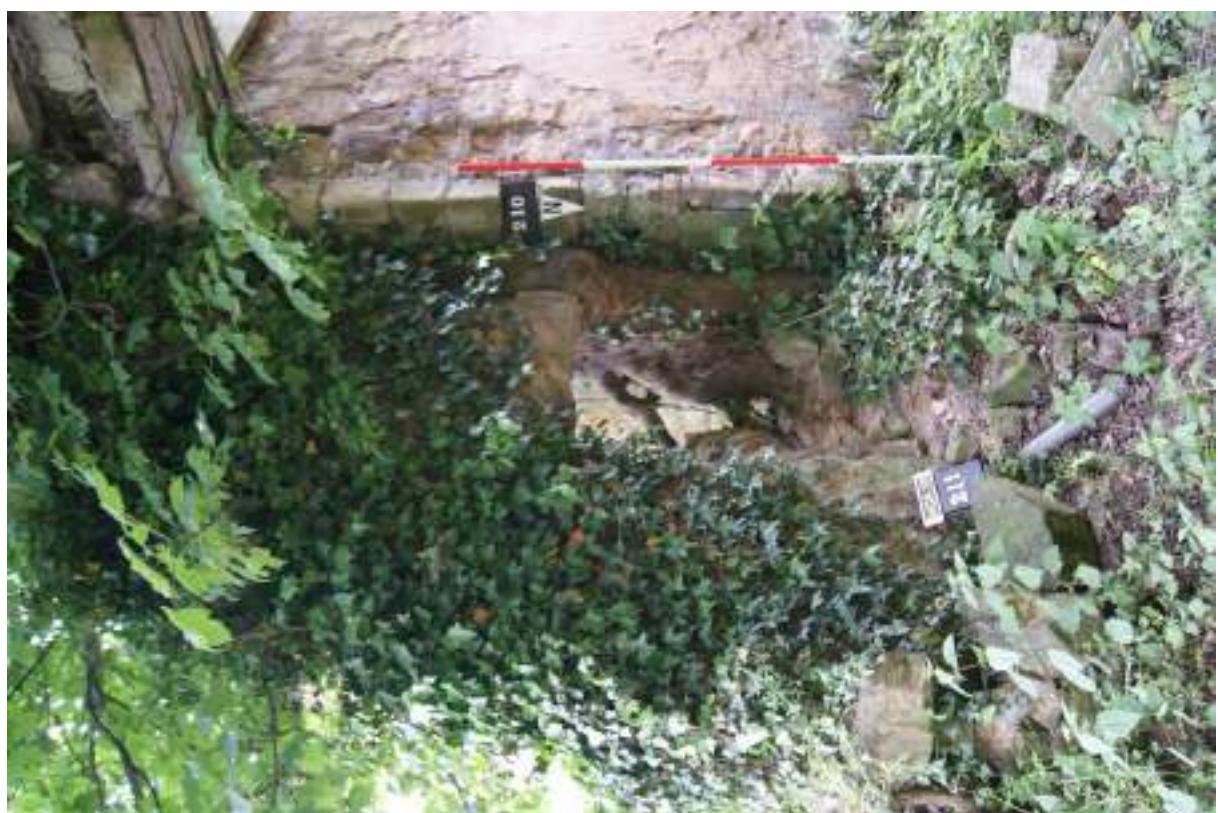
P15 (below). The possible forge [211], completely covered by creeper and vegetation, looking east. The jamb of a former opening [210] in the north wall of the coach house can be seen above the photoboard. Scale 2m. NGA2/021

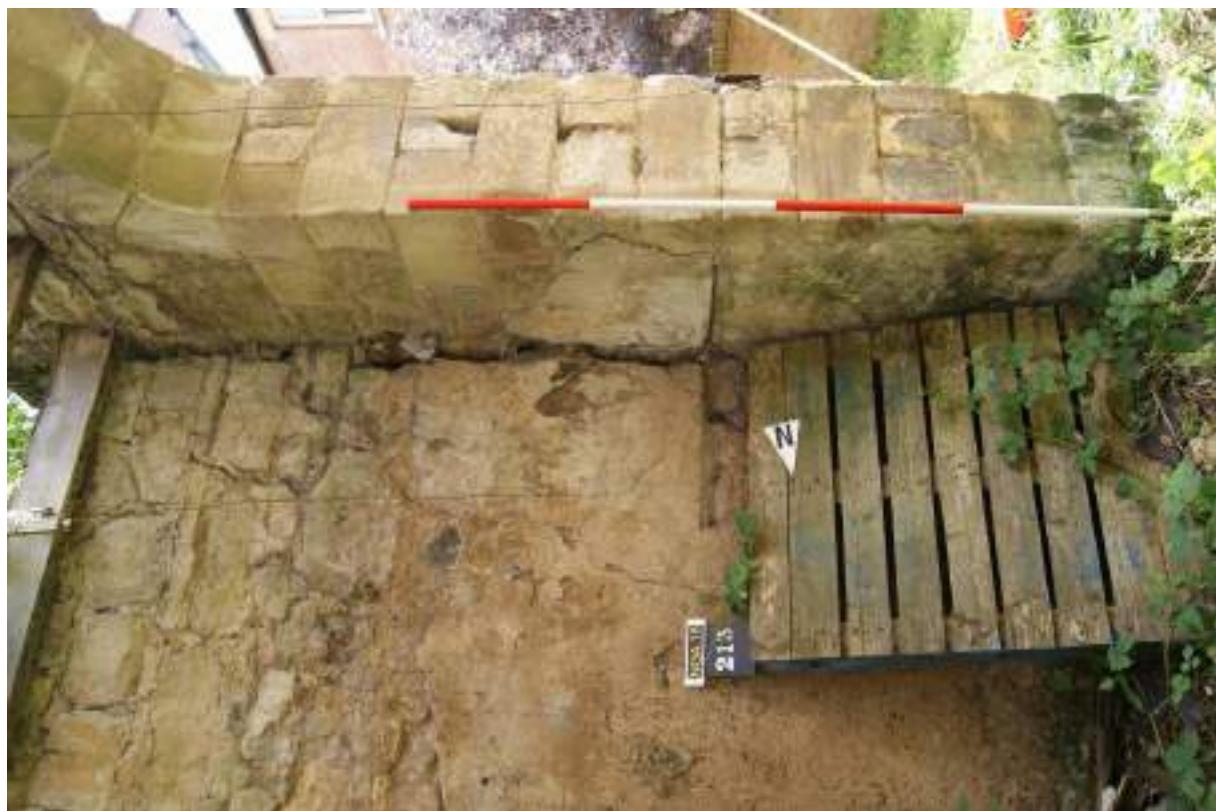
P16 (top). Interior of the coach-house, looking south-east, showing the east jamb of the entrance [201], the butt-joint between the internal and external walls, and the scar of missing shelf [213]. Scale 2m. NGA2/022

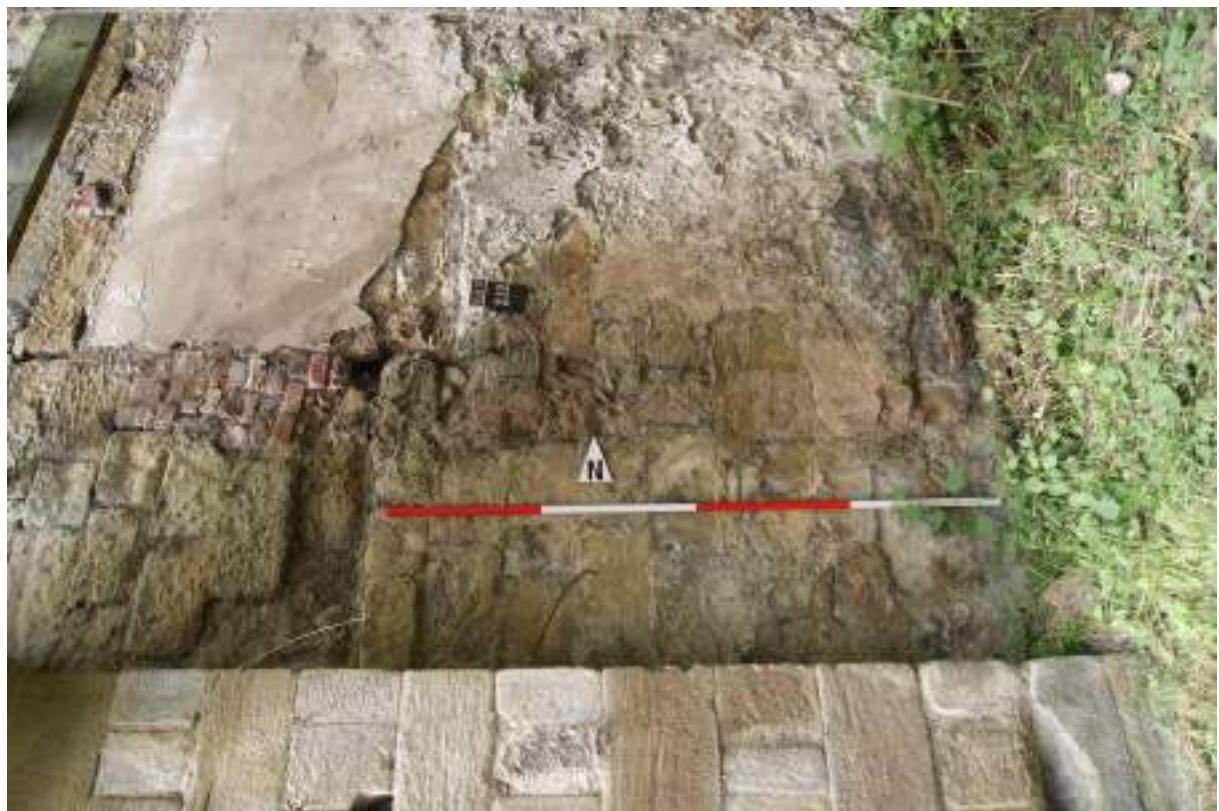
P17 (below). Interior of the coach-house looking west, with west jamb of the entrance (left), showing brick patching [212] in the west wall, and remains of plaster render. Scale 2m. NGA2/023

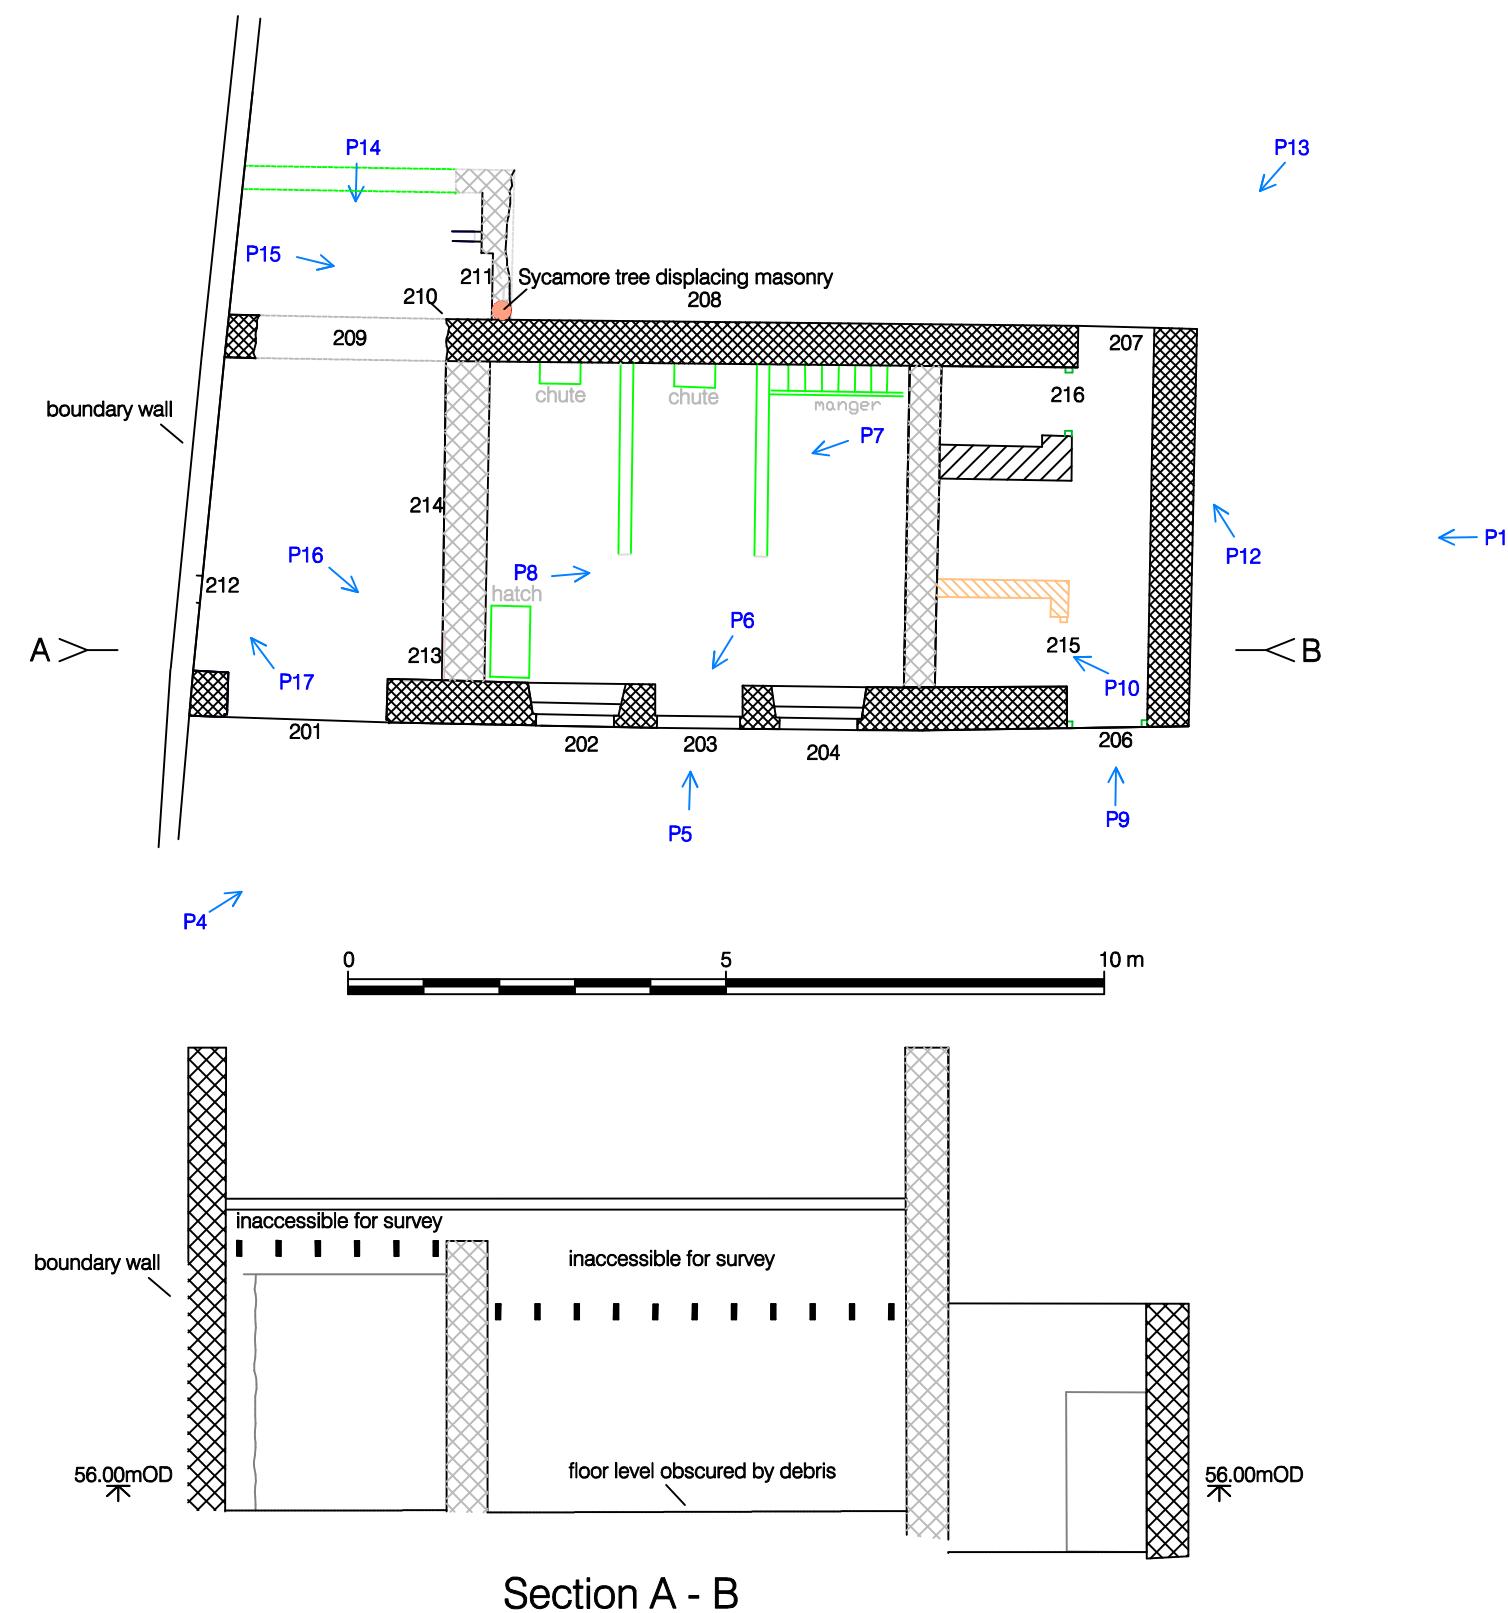
Figure 12

Ground plan and east-west section

3.11 The site conditions inevitably limited the scope of the recording. The drawn record in this report (Figures 12 -13) is based on the 2008 survey, digitally traced, and checked and corrected on-site (where conditions permitted) through additional survey and levelling. The photographic record clearly shows the extent of dilapidation since 2008.
