**Narrowgate House ('General Lambert's House' – HER 4522)
31 and 33 Narrowgate, Alnwick, Northumberland NE66 1 JN
(House centred on NGR 4186299 6134983)**

**Historic Building Recording
by
Northern Counties Archaeological Services
on behalf of
Stablewood Leisure Ltd.**

Historic Building Recording

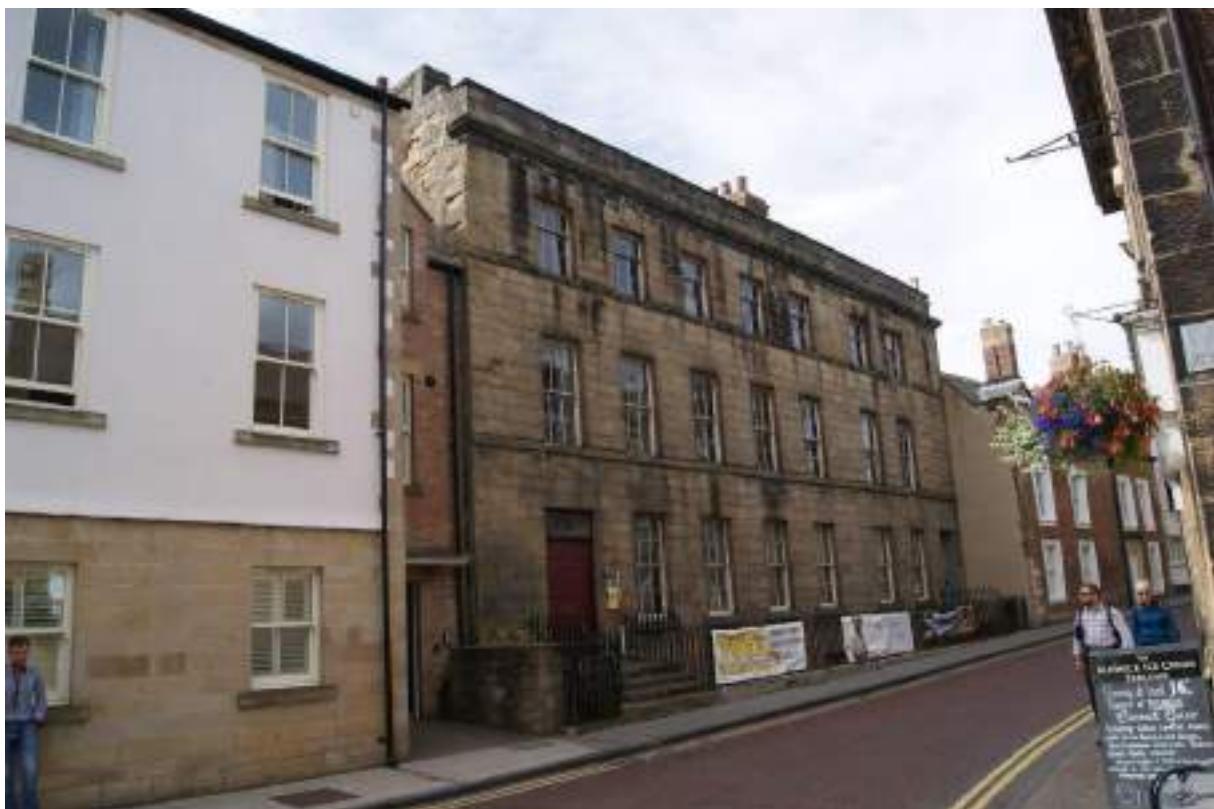
P18 (top). Narrowgate House, east facade, looking north-west. The new build on Pottergate is on the left, Dorothy Forster's House in the distance.

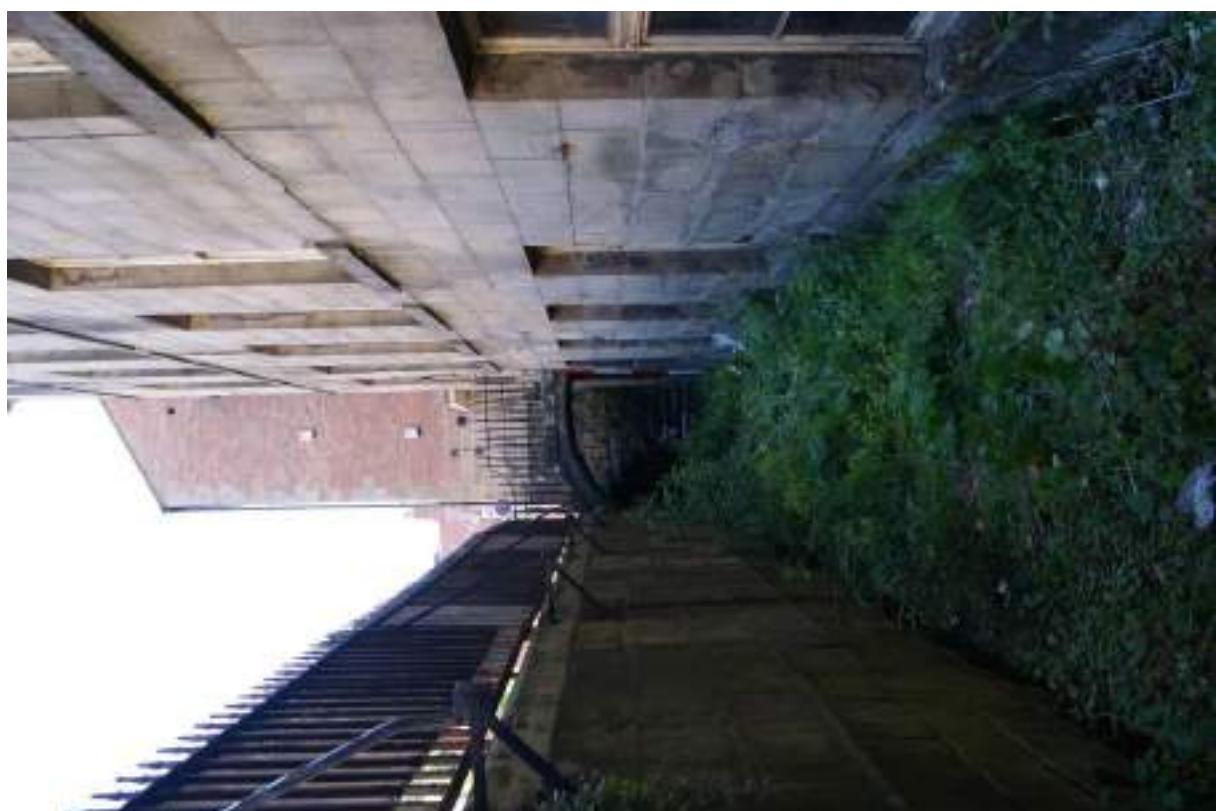
P21 (below). Basement forecourt looking south, with the railed 'flying' stairs leading to the door [41] of No.31 Narrowgate in the background. Scale 2m.

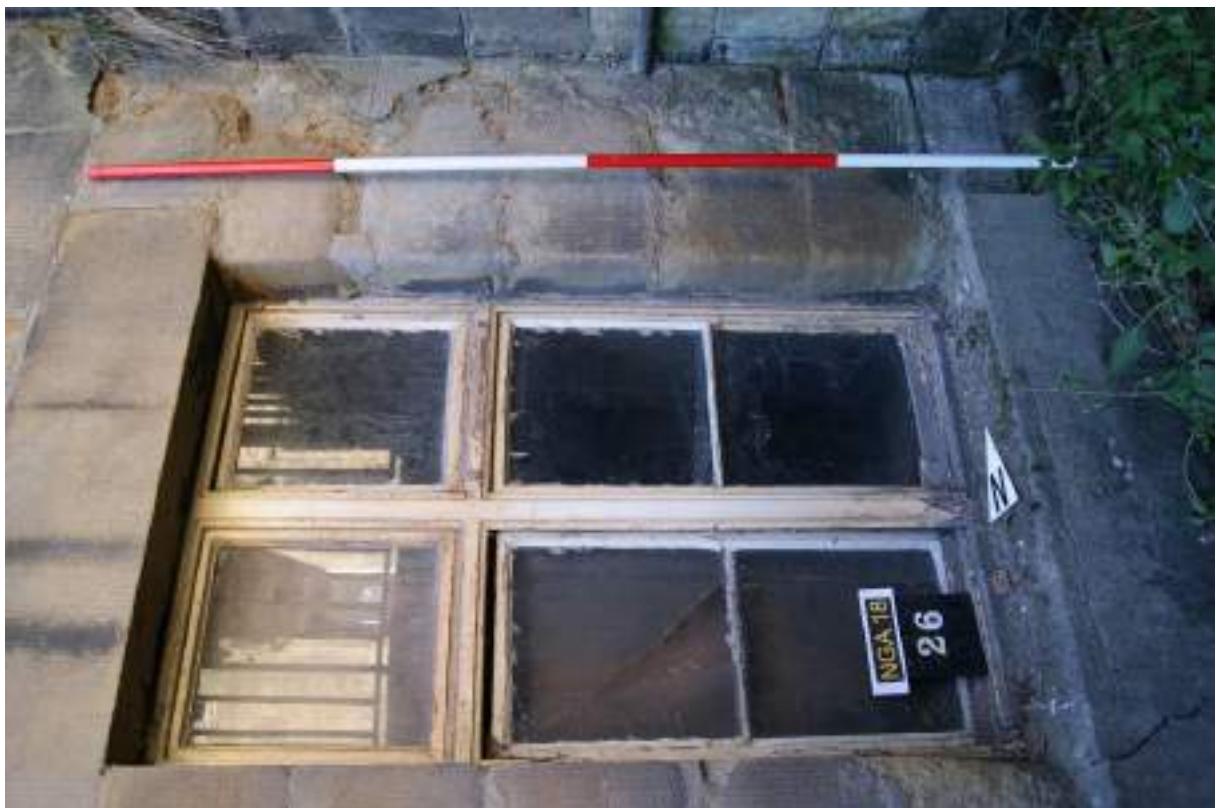
P22 (top). Basement window[26] showing casements, and the butt joint between the ashlar facing of Narrowgate House and the earlier masonry carrying the steps up to the door of No.33. Scale 2m.

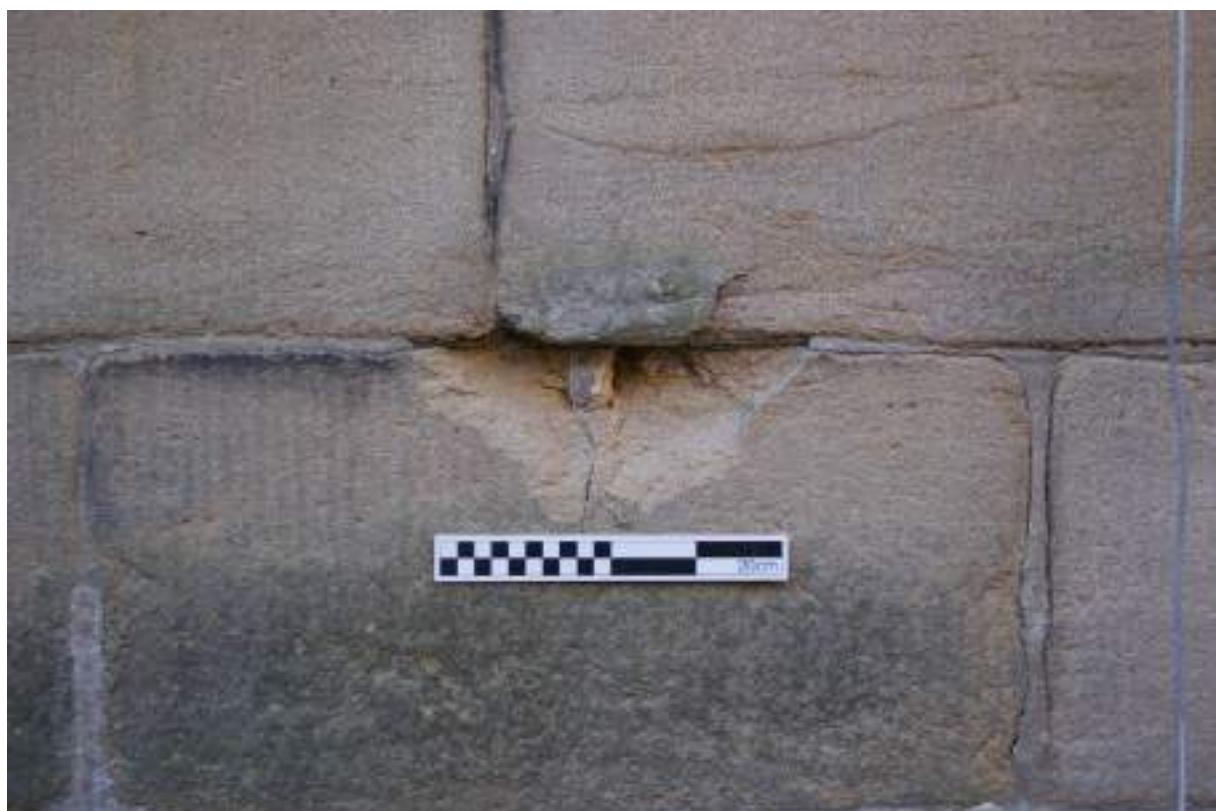
P23 (below). Detail of the ashlar facing to Narrowgate House at basement level, showing an example of the spalling around a leaded-in iron fixing. Scale 20cm.

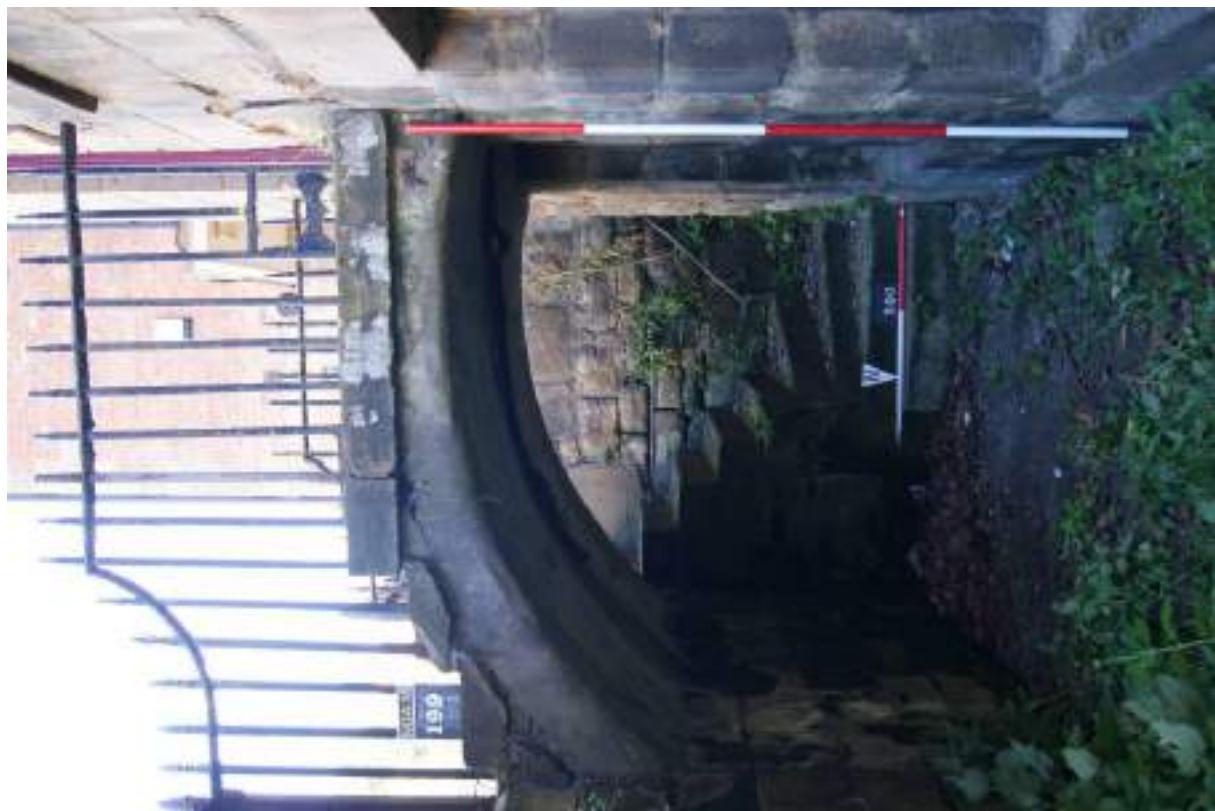
P24 (top). The 'flying' stairs to the front door of No.31 showing railings an boot-scraper, with steps from basement forecourt to street behind. Scales 1m and 2m.

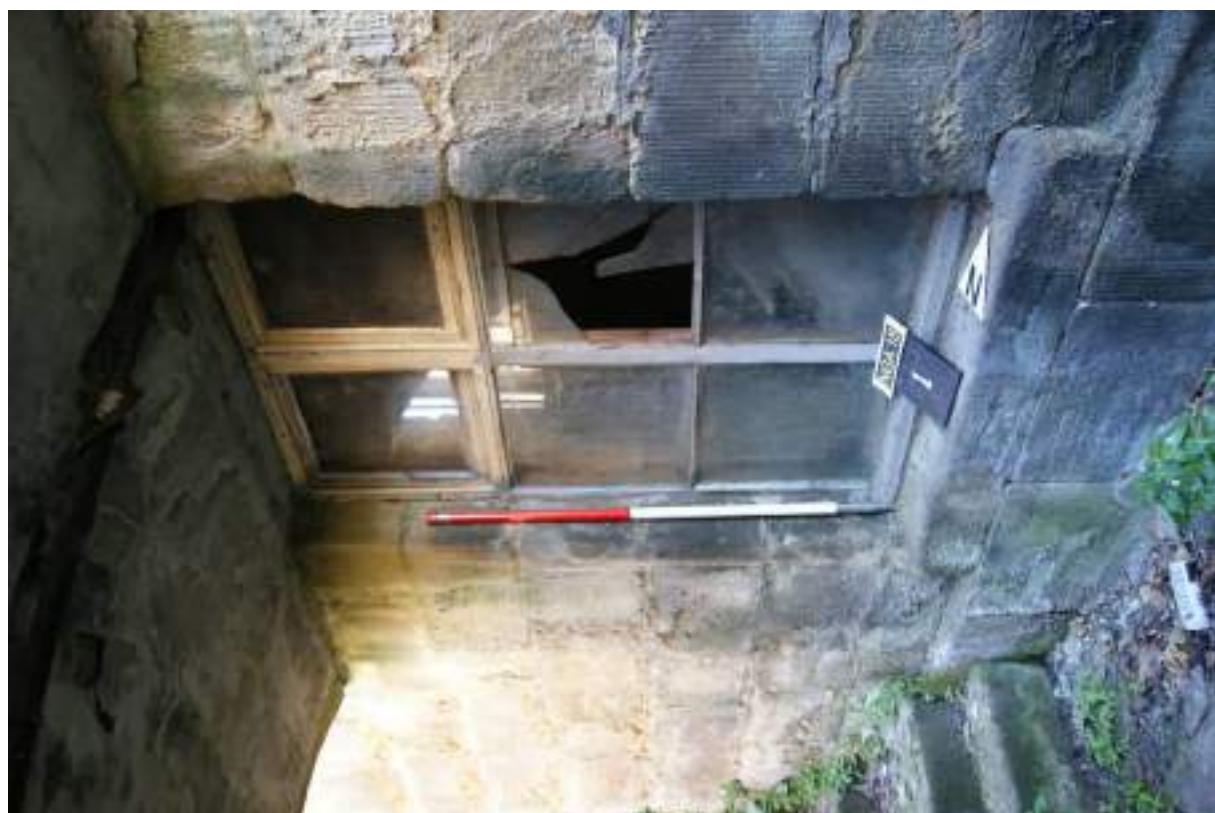
P25 (below). Basement window [1] showing renewed casements and offset plinth course, butted by the steps [200] to Narrowgate. Scale 1m.

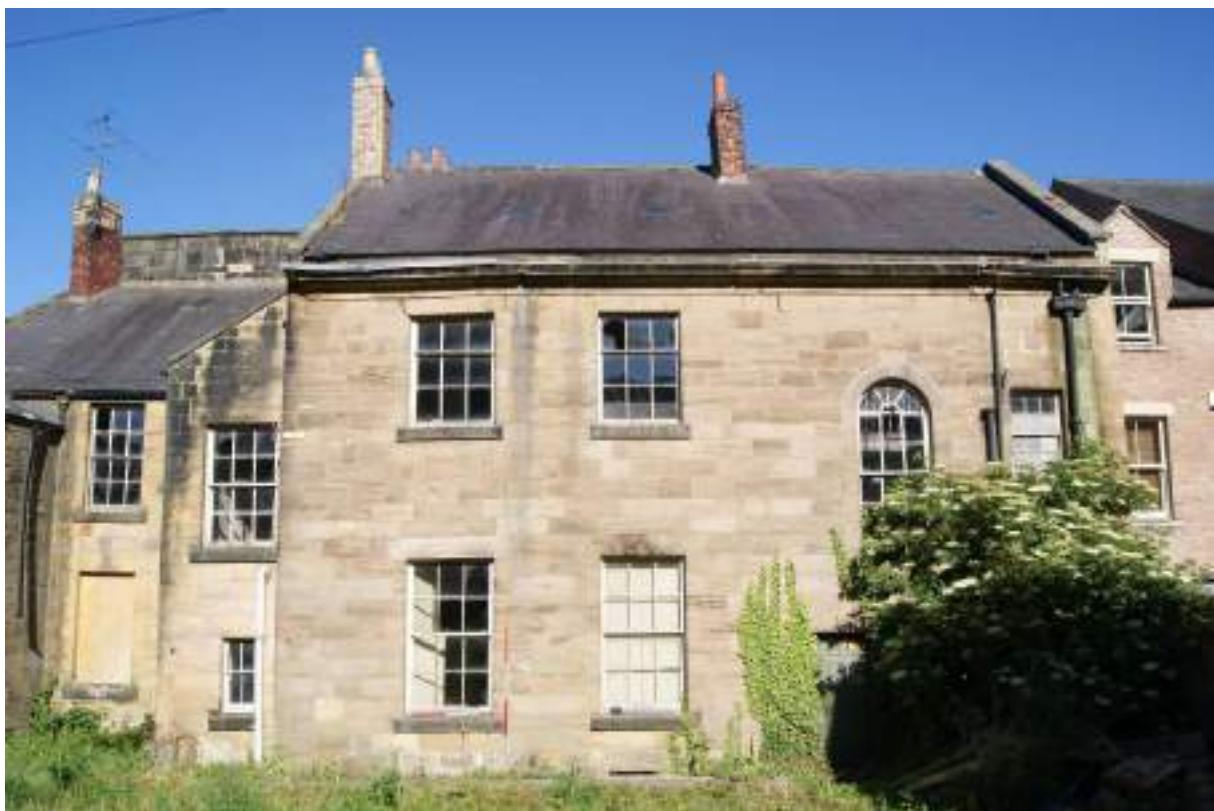
P26 (top). The west facade of the principal western extension showing chimneys [190] (centre) and [191], windows [83], [84], [92], [136] and [140]. Rear door [49] partly concealed by creeper and overgrowth. Scales 1m and 2m.

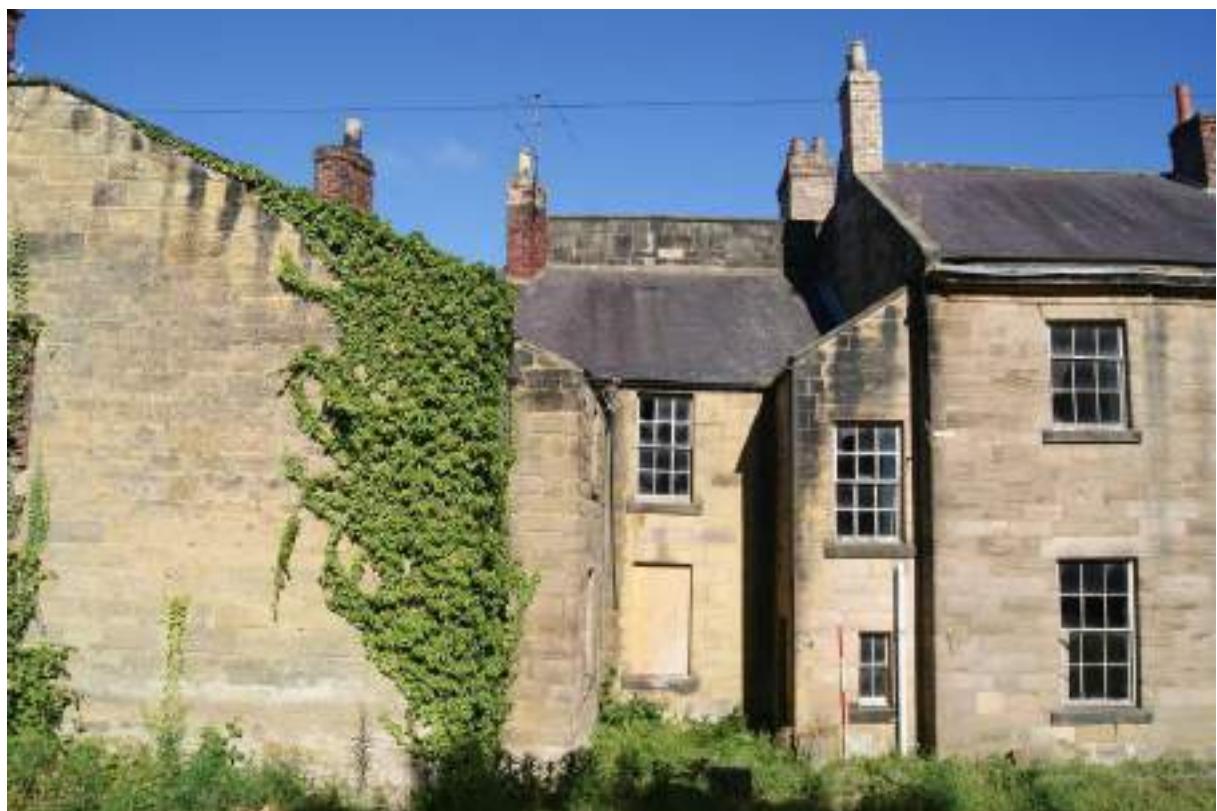
P27 (below). West facades of extension to No.33 showing chimneys [193] (centre) and [195] (left), windows [73],[79] (boarded), [121] and [128]. Scales 1m and 2m.

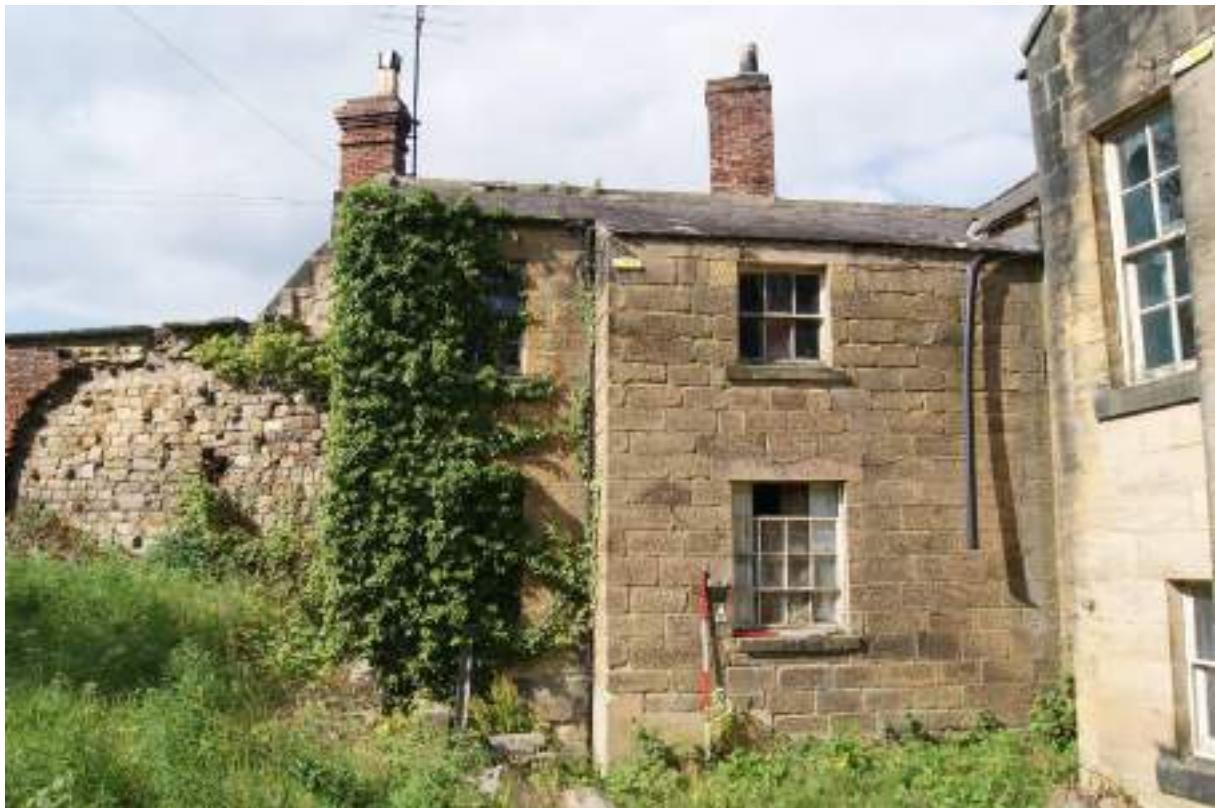
P28 (top). South facing facades of the western out-shots to No.33 showing chimney [195], windows [80], [82] (concealed by creeper), [123] and [127] (concealed by creeper). The brick "hot wall" is to the left. Scales 1m and 2m.

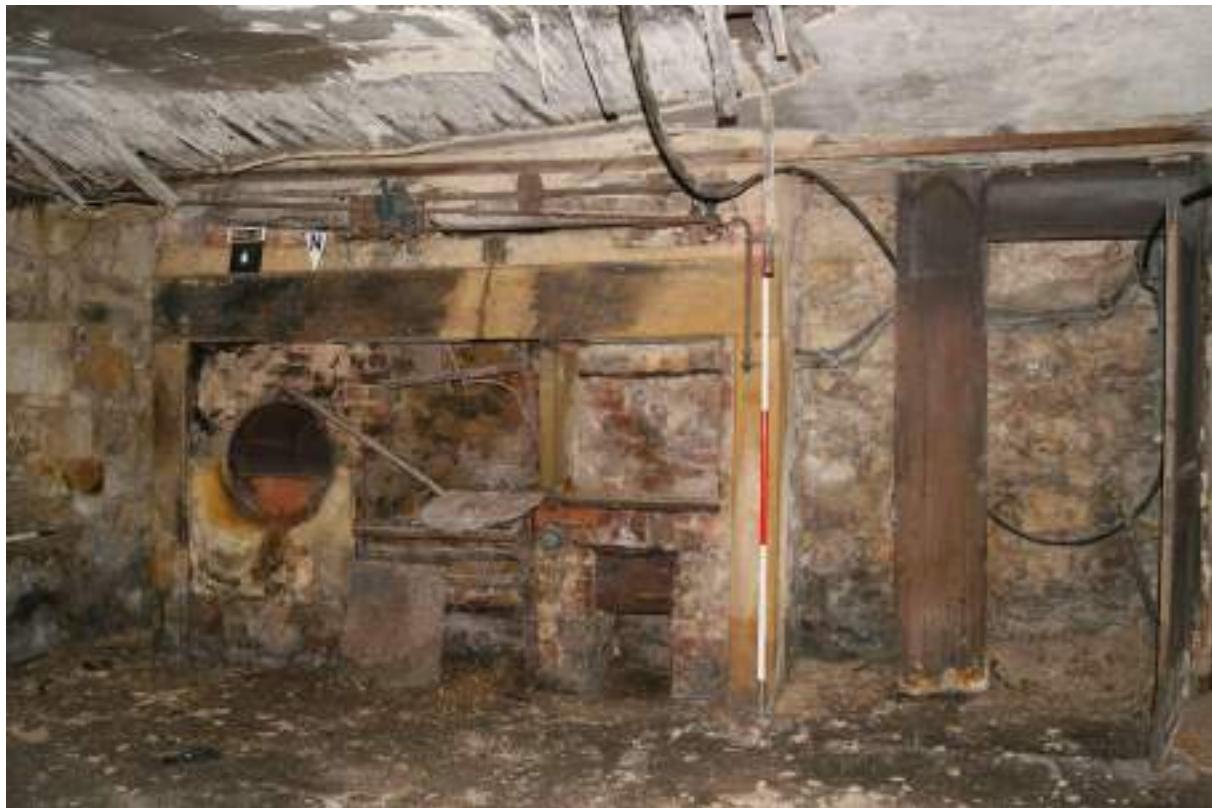
P29. Room 22 looking south-east, showing range [4] with oven, pot-crane, and boiler, and cupboard [5] on the right. Lath and plaster ceiling collapsing. Scale 2m.

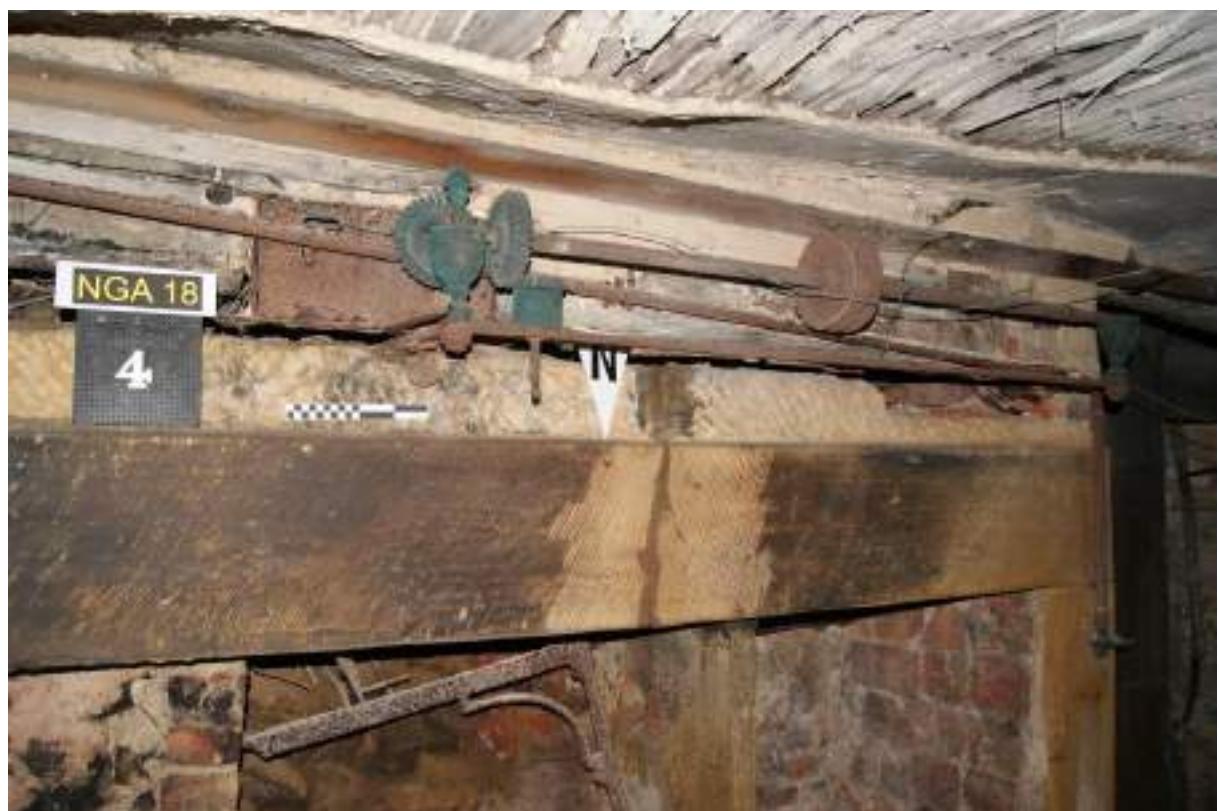
P30. Room 22. Detail of range [4] showing opposed gearing for a roasting spit driven by a fan in the flue, and the pot-crane. Scale 20cm.

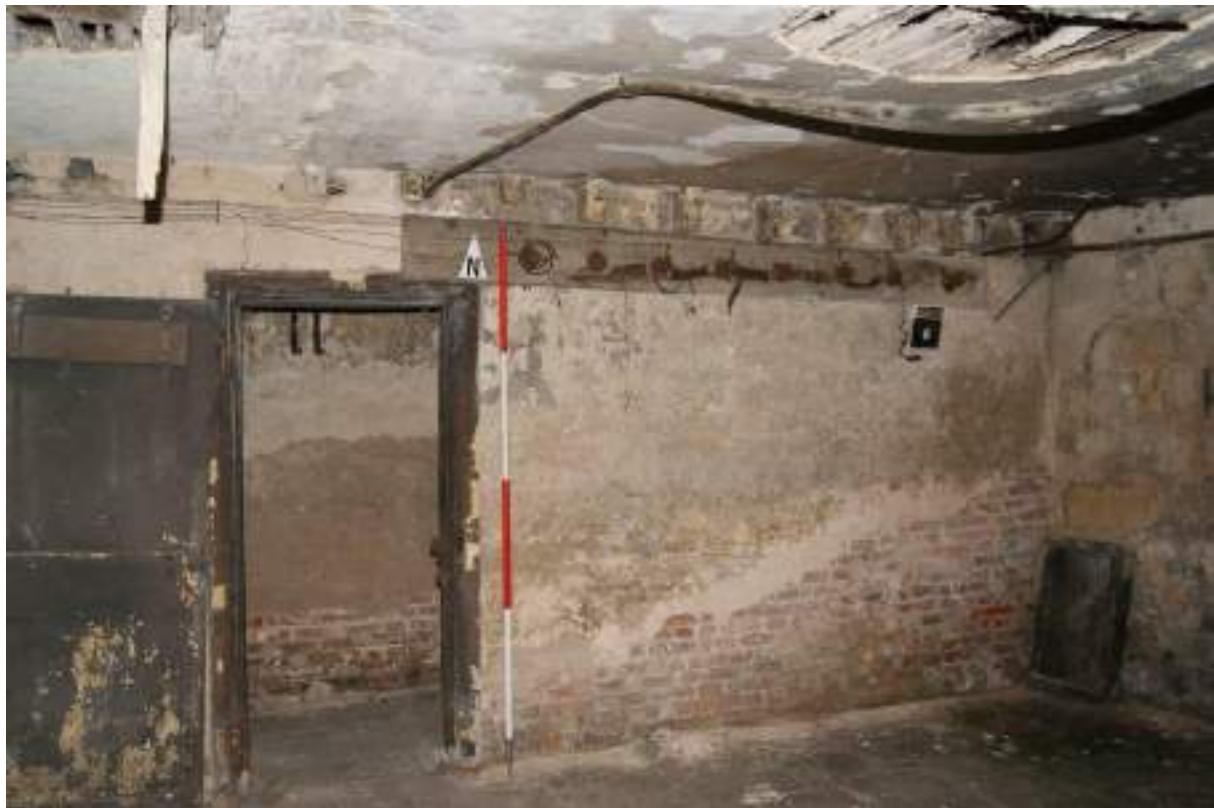
P31. Room 22 looking north-east showing door [7], servant's bells [6], and truncated north-south joists to 1st floor. A detached stone sink leans against the east wall. Scale 2m.

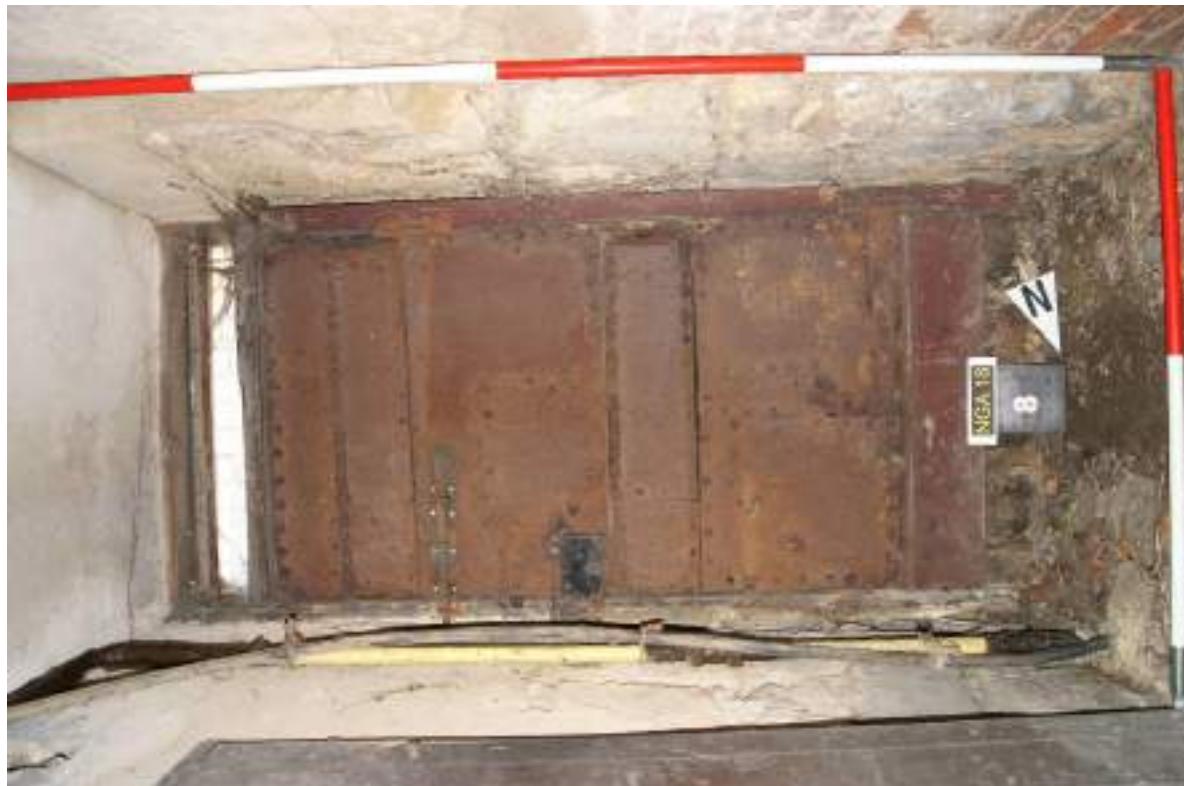
P33. Room 25. Detail of door [8] showing a spring catch of a form known from the 1820s. Later iron-cased lock below. Scale 20cm.

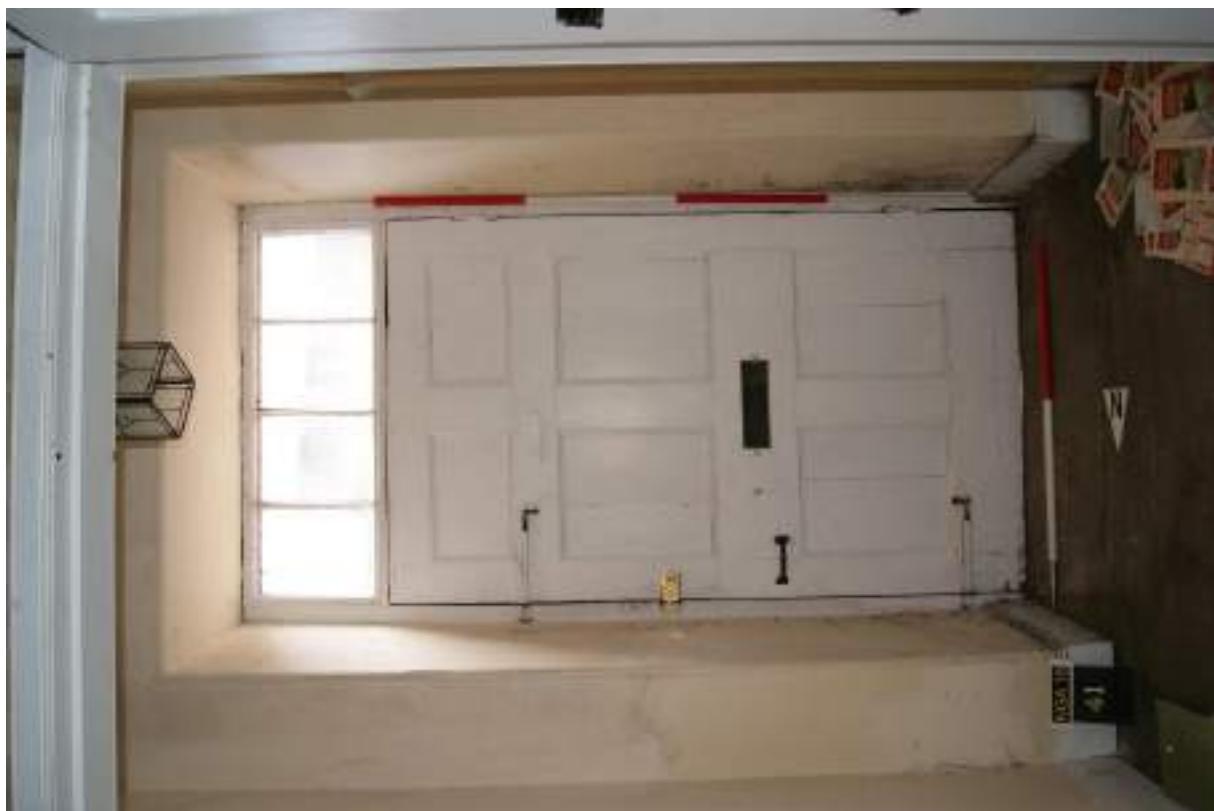
P45 (top). Room 2 looking east to the front door [41] to No. 31 Narrowgate. Scales 1m and 2m.

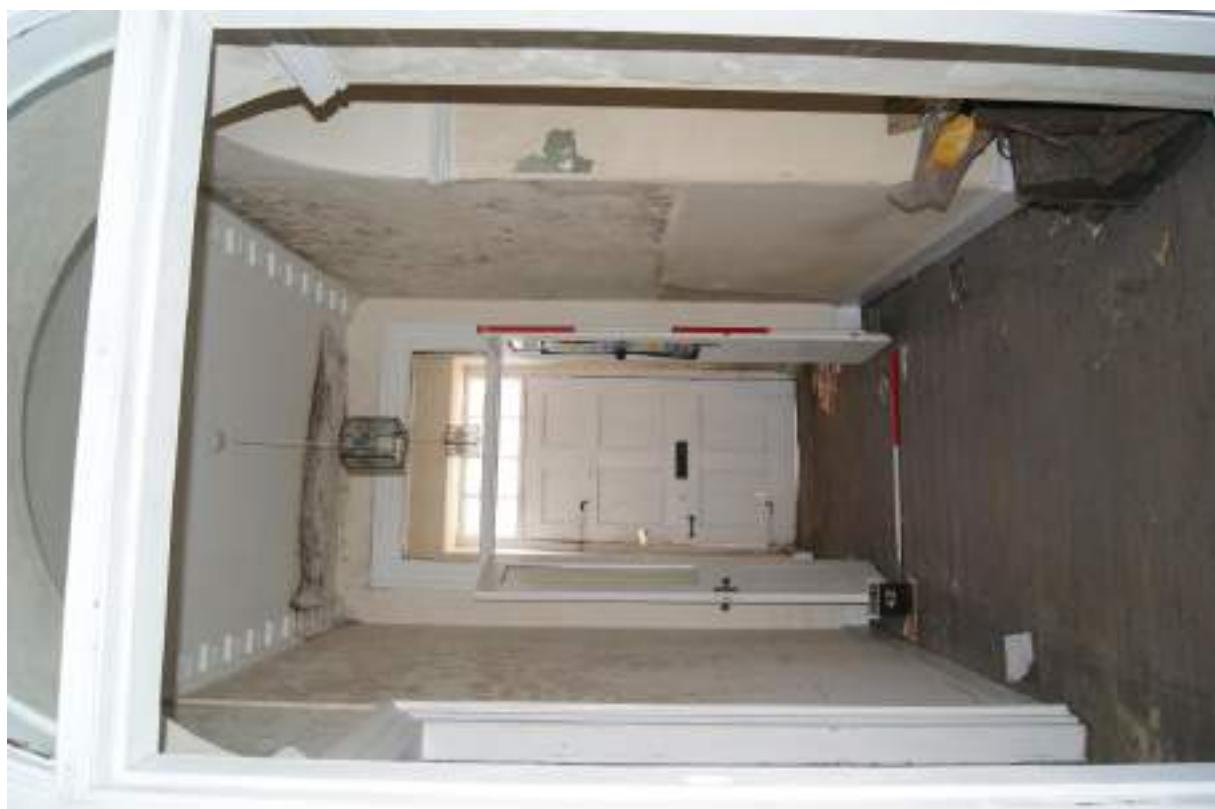
P46 (below). Room 2 looking east from doorway [45], showing lobby partition [42] cutting frieze. Scales 1m and 2m.

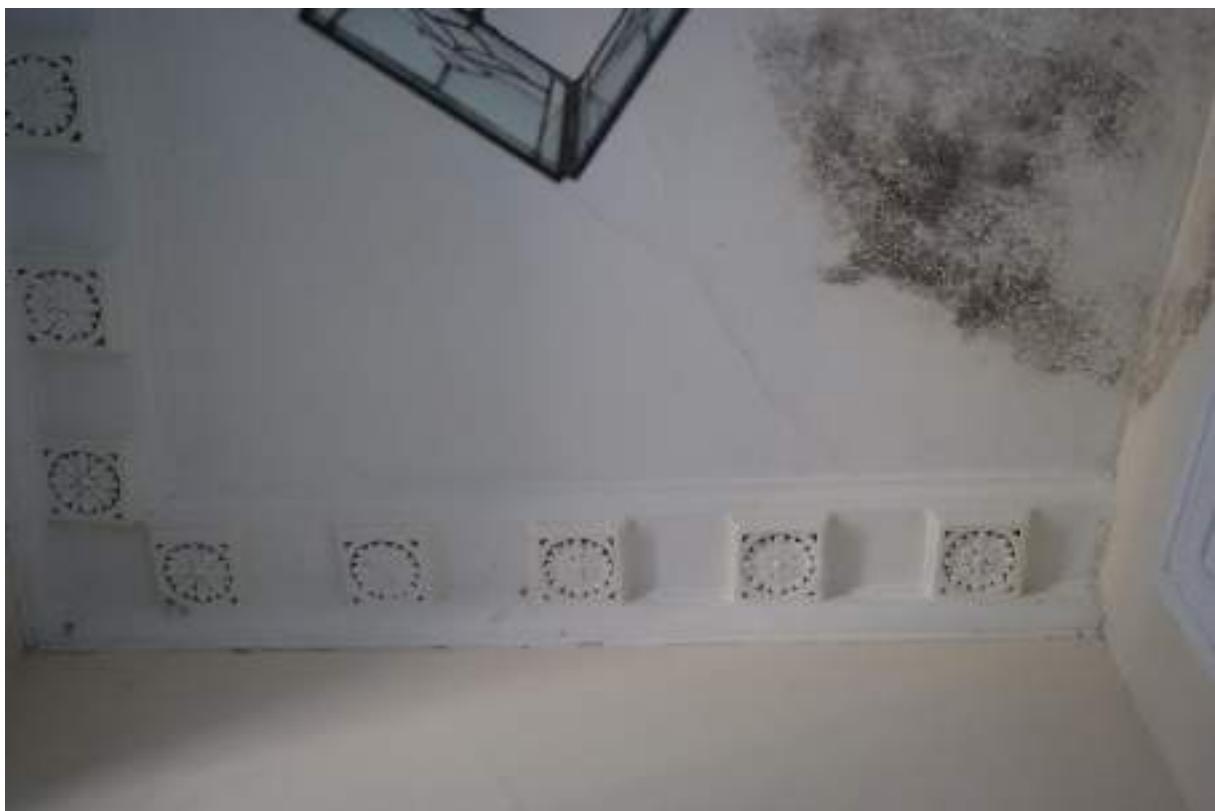
P47 (top). Room 2, ceiling showing a detail of the frieze cut by lobby partition [42] (on the right. Also showing damp staining from Room 18 above. No scale.

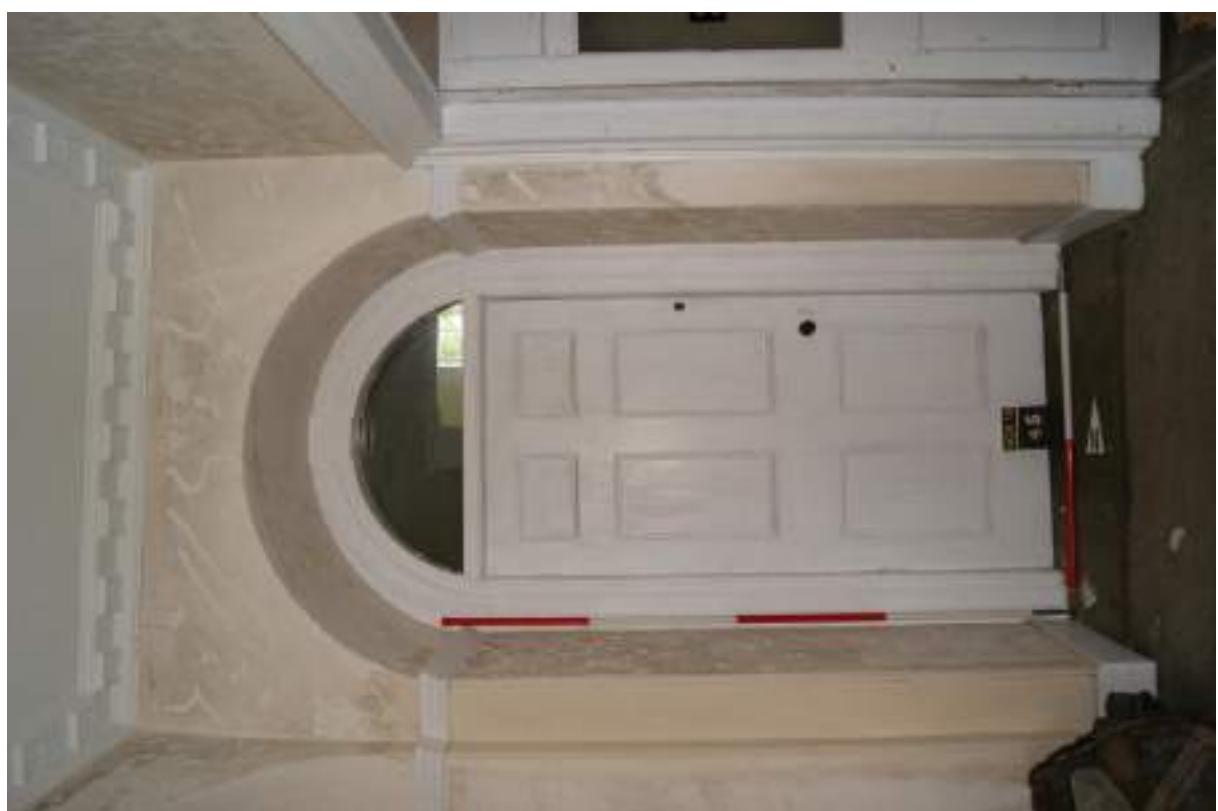
P48 (below). Room 2 looking west , showing door [45], alcove [44] to the left, and door [54] to Room 3 on the right. Scales 1m and 2m.

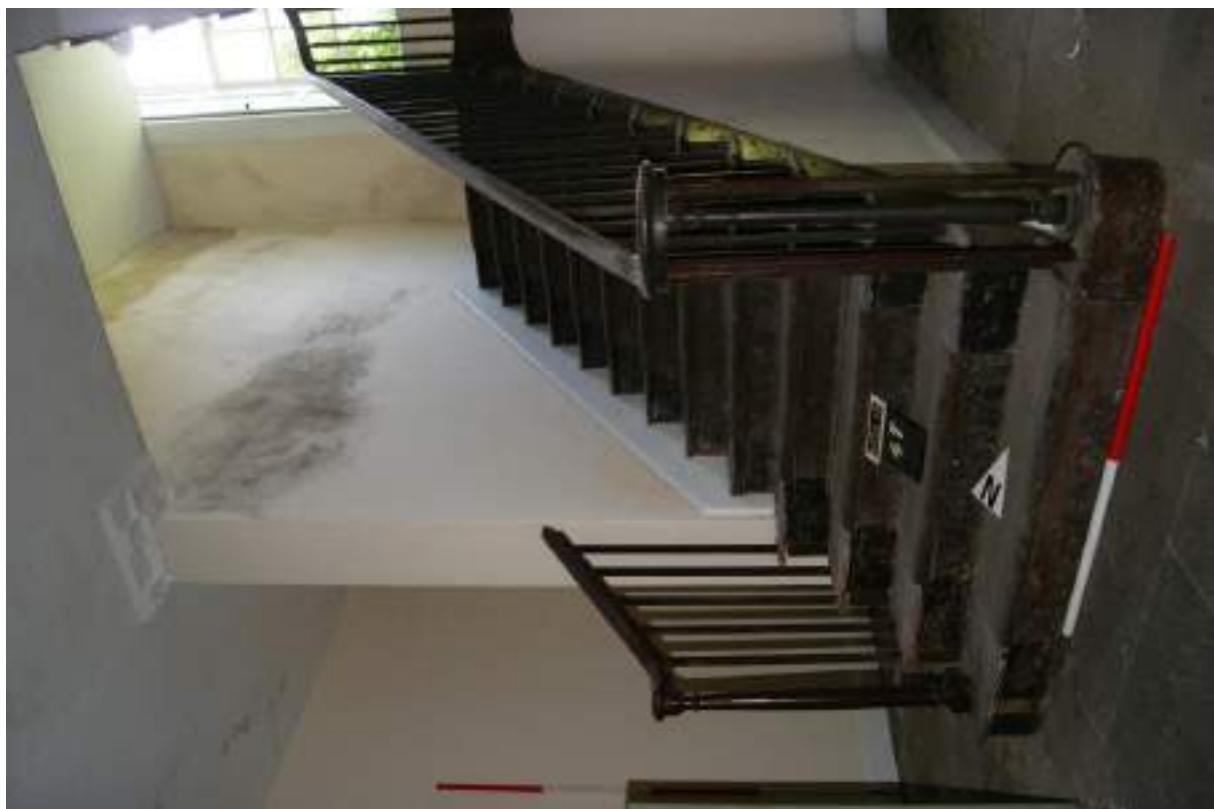
P49 (top.) Room 8/9 looking south-west, showing first flight of main stair [47] and altered southern handrail. Scale 1m.

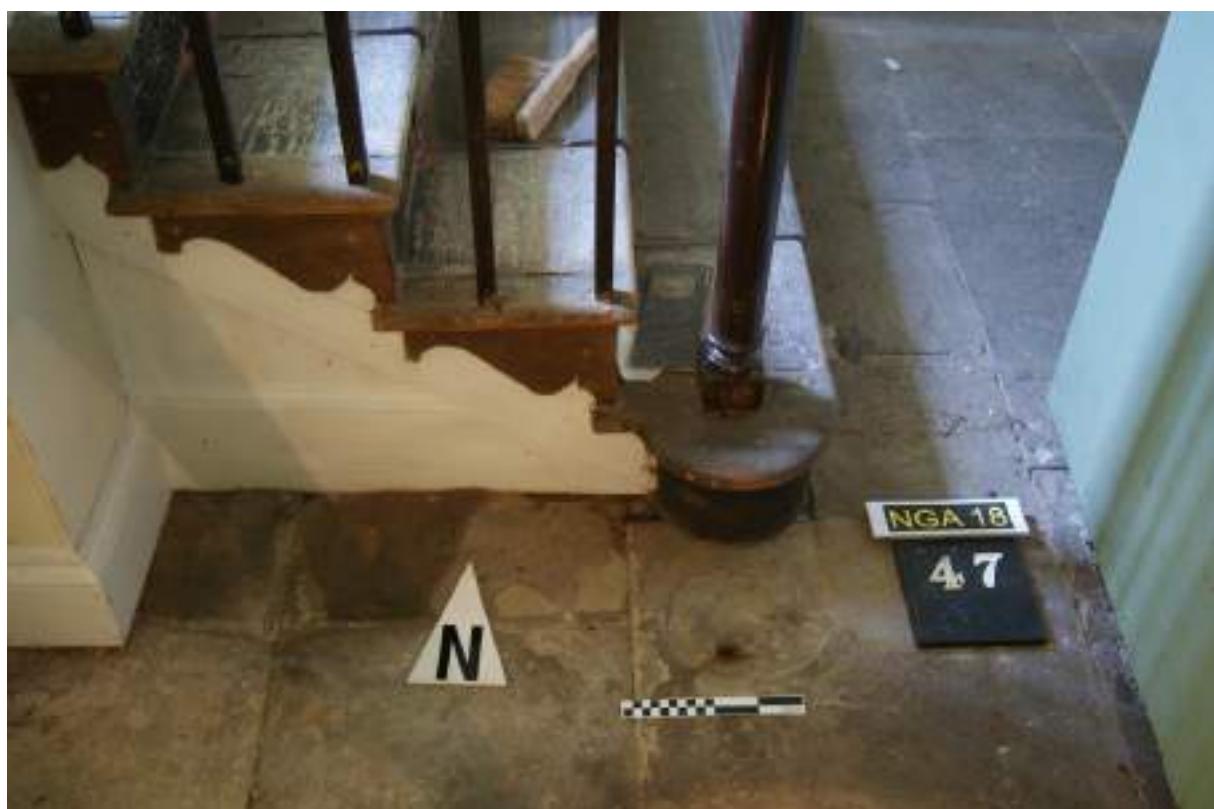
P50 (below). Room 8/9 showing scar of former curtail step on the south side of stair [47] with iron fixing in the flagged floor. Scale 20cm.

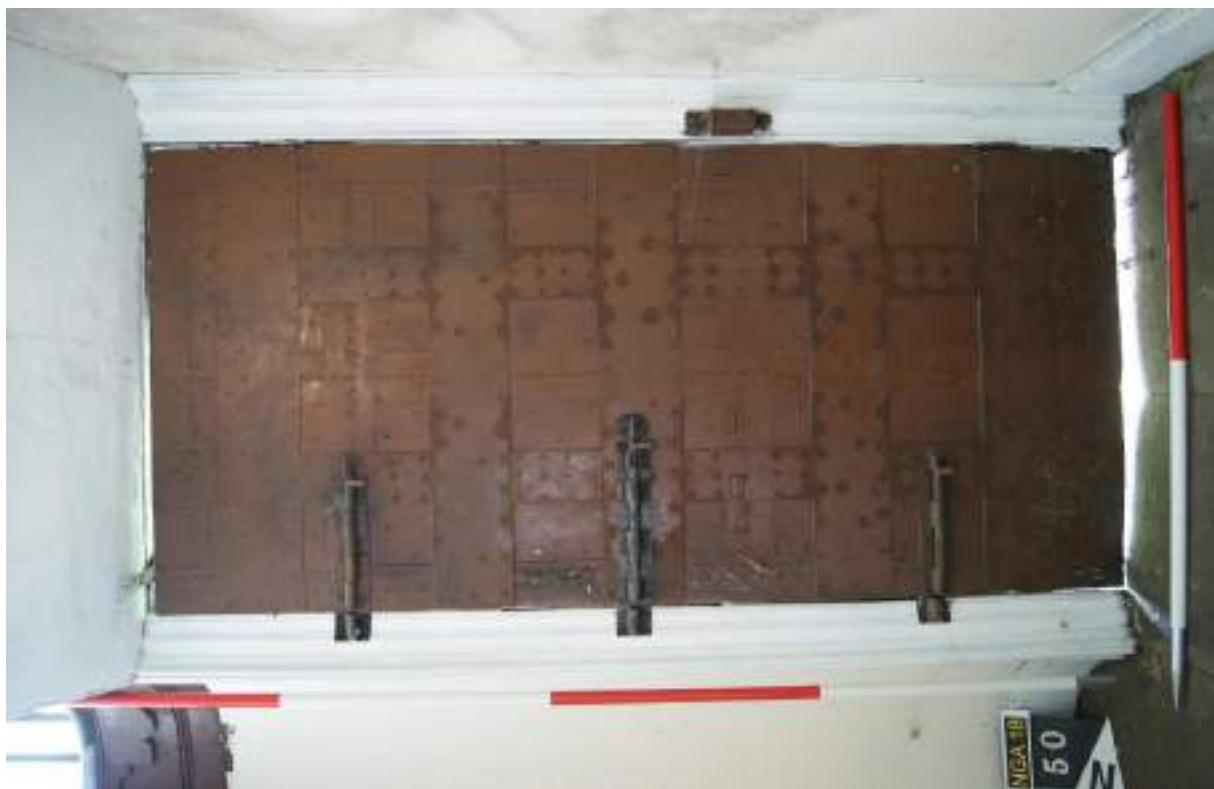
P51 (top). Room 8, looking west to the inner face of door [50] showing iron sheeting. Scales 1m and 2m.

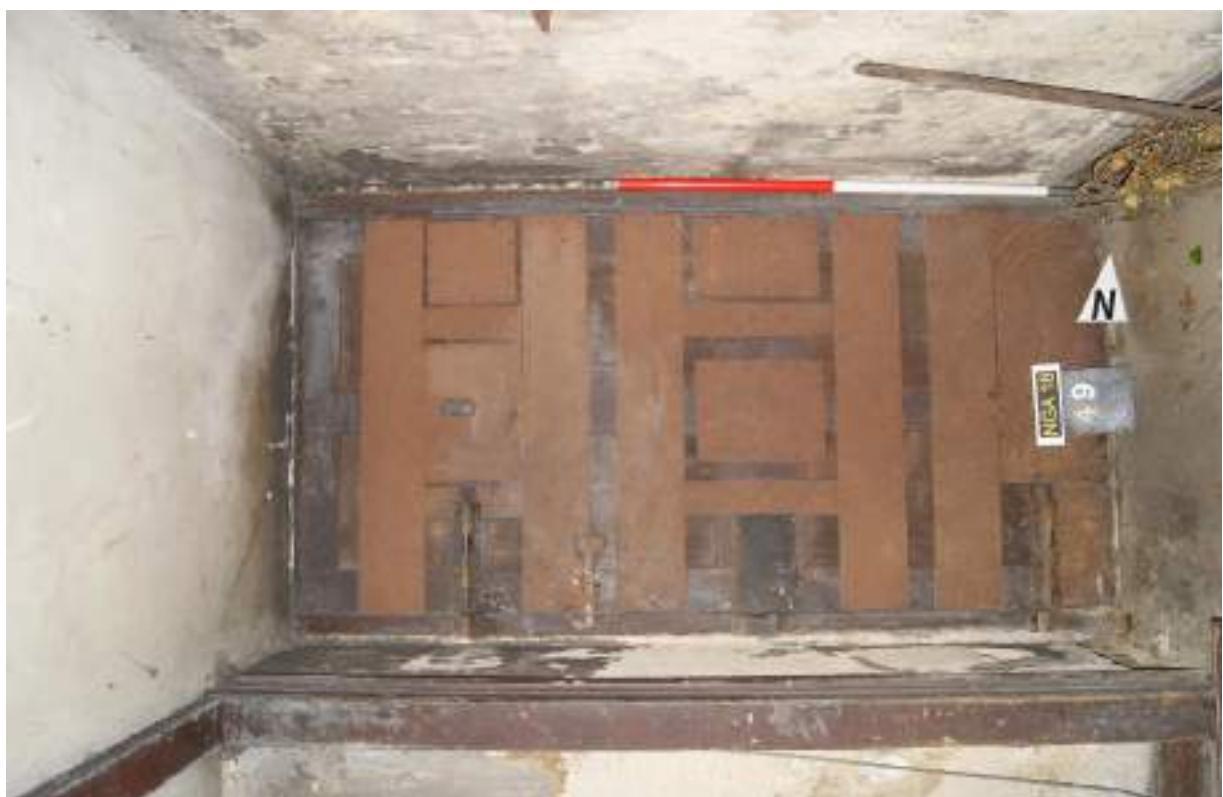
P52 (below). Room 26, looking west to the inner face of door [49] showing iron sheeting. Door [185] to the south cellar steps on left. Scale 1m.

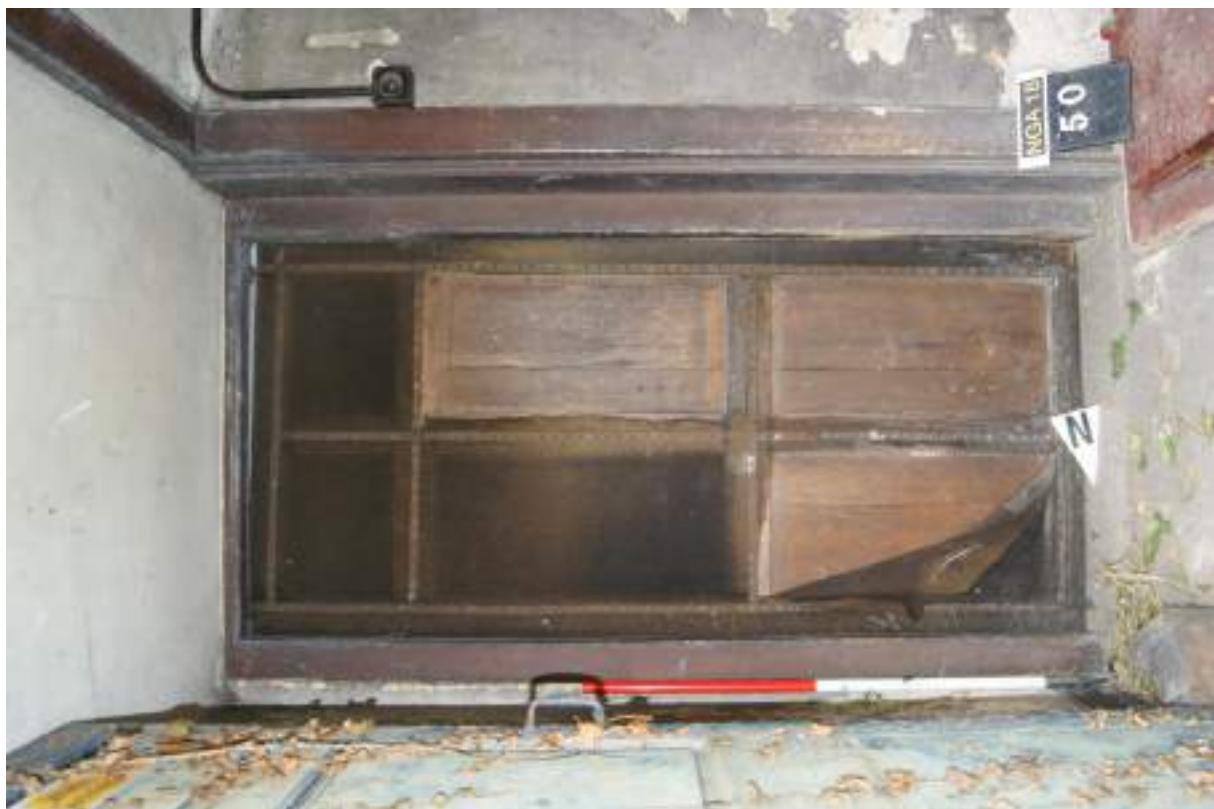
P53 (top). Room 26, looking east to door [50] showing the remains of a baize covering. To its outer face. Door [185] to south cellar steps is on the right. Scale 1m.
