**Narrowgate House ('General Lambert's House' – HER 4522)
31 and 33 Narrowgate, Alnwick, Northumberland NE66 1 JN
(House centred on NGR 4186299 6134983)**

**Historic Building Recording
by
Northern Counties Archaeological Services
on behalf of
Stablewood Leisure Ltd.**

Historic Building Recording

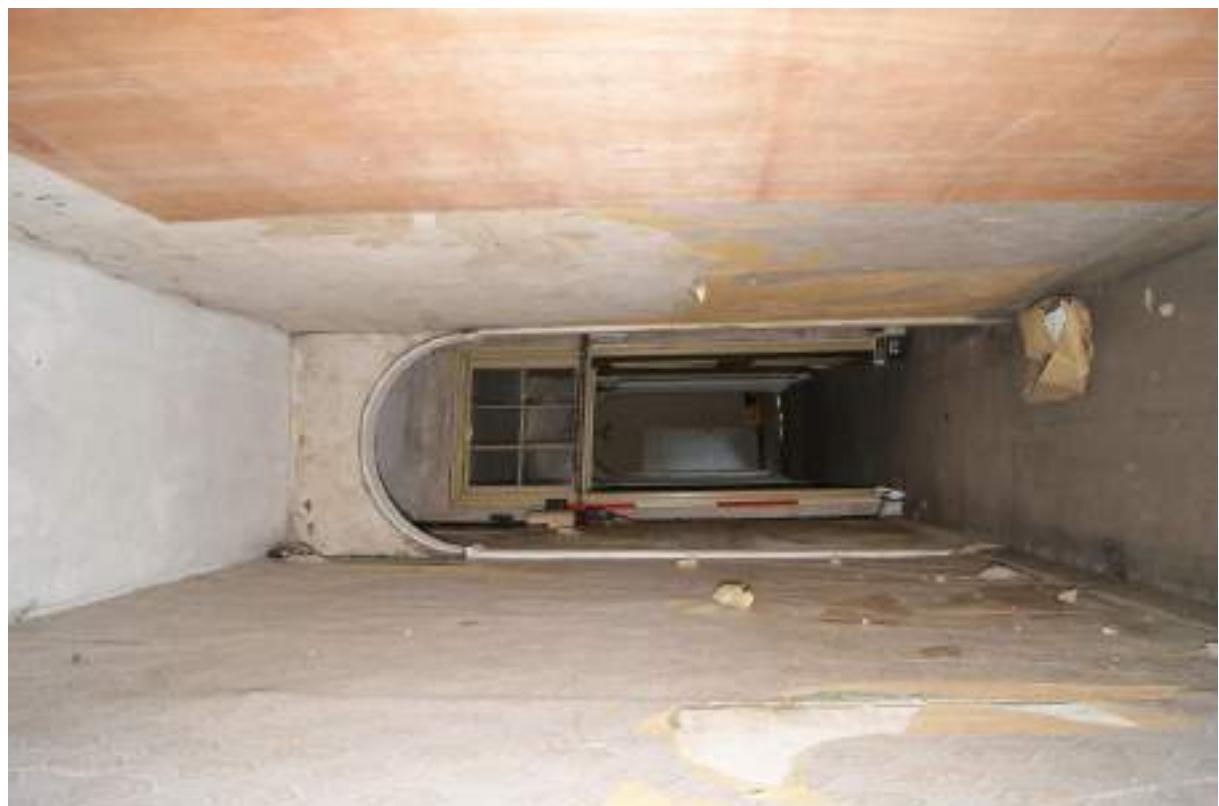
P54 (below). Room 6, north-south passageway looking south to inserted partition [70], with the door to Room 15b [76] (boarded-over) in the right foreground, and scar of former doorway [67] just visible on the left. Scale 2m.

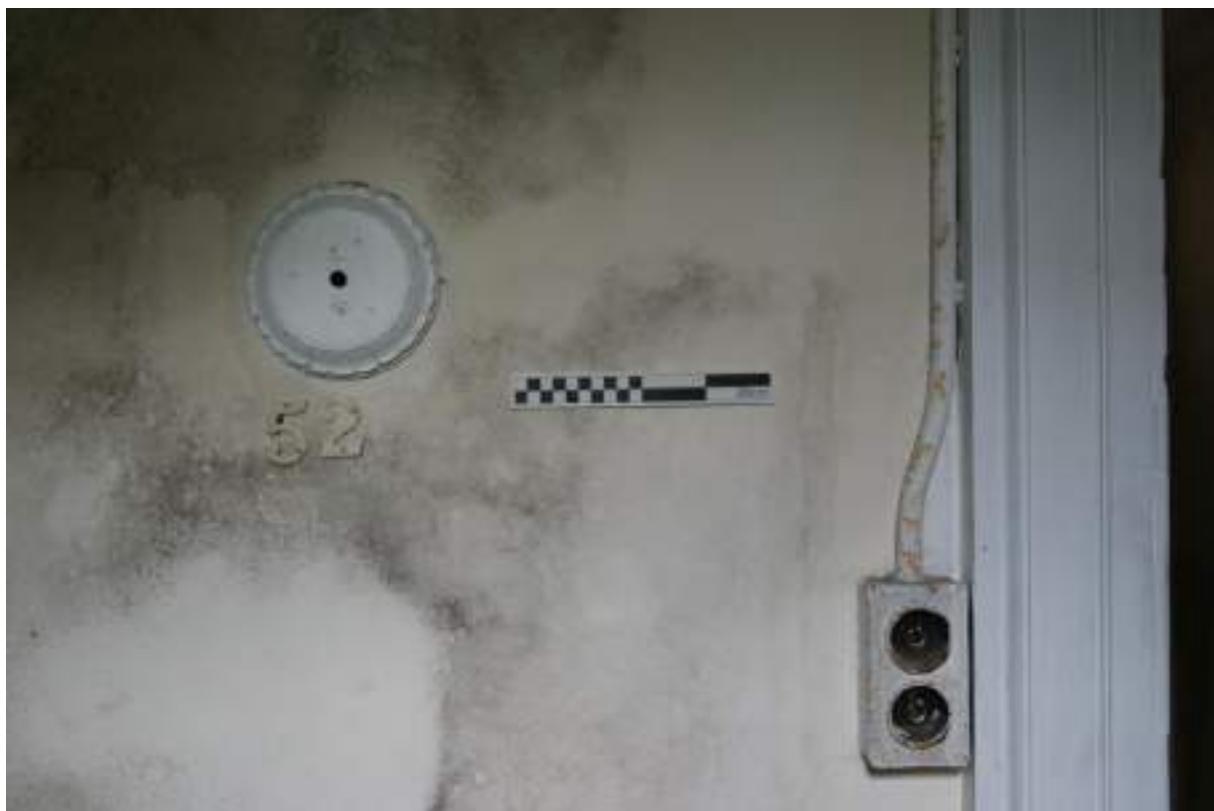
P55 (top). Room 8/9, east wall, north of door [45], showing a decorative wooden gas-light mounting [52] and late 1950s-early 1960s electric light switches and ducting. Scale 20cm.

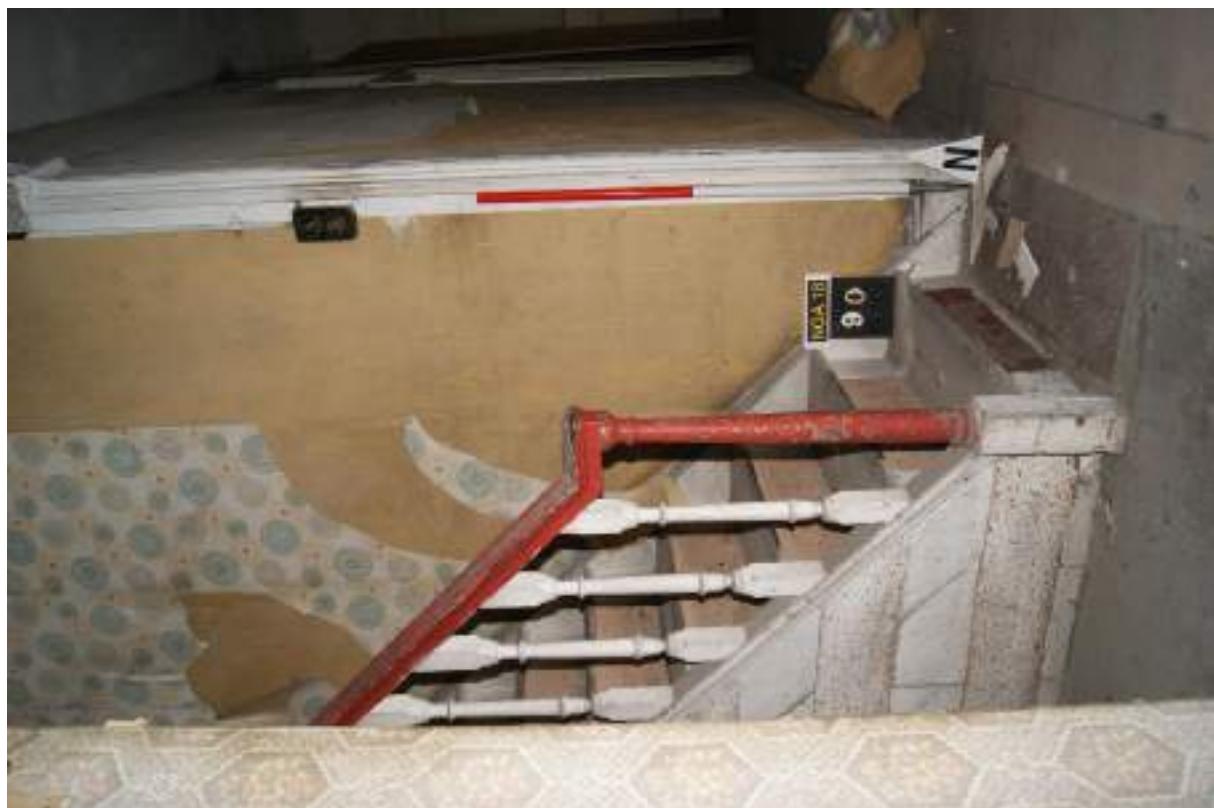
P56 (below). Room 6 looking north, showing lower flight of service stairs [90] to first floor. Scale 1m.

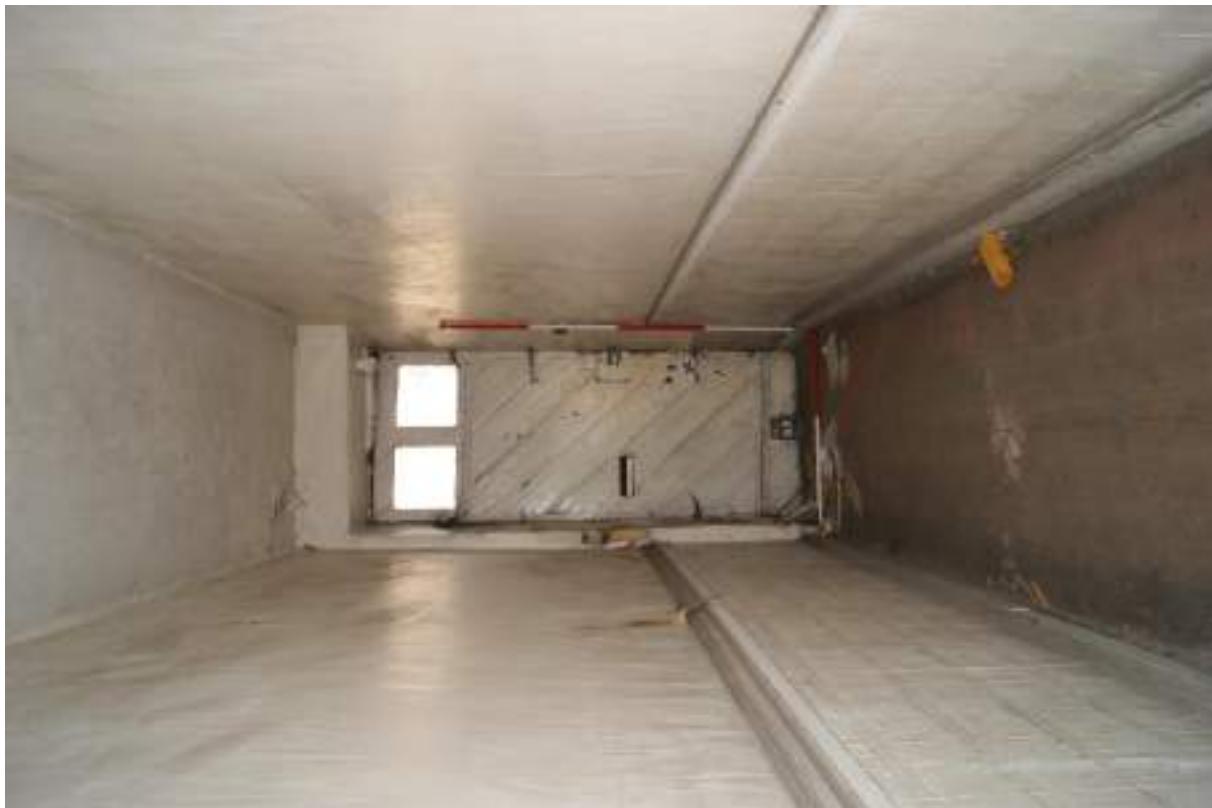
P57 (top). Room 5, looking east showing diagonally-planked door [69]. Scales 1m and 2m.

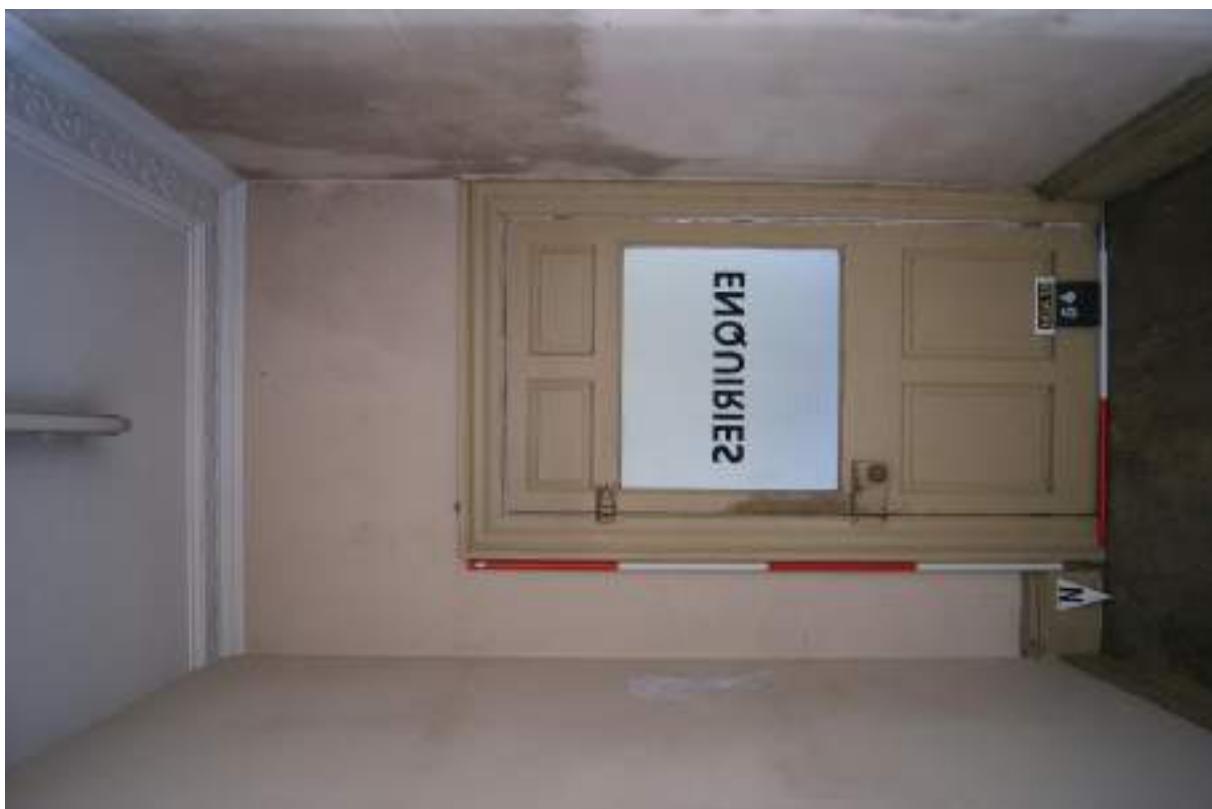
P58 (below). Room 3, looking south to door [54] showing the decorative cornice cut by the west partition wall of Room 3.1. Scales 1m and 2m.

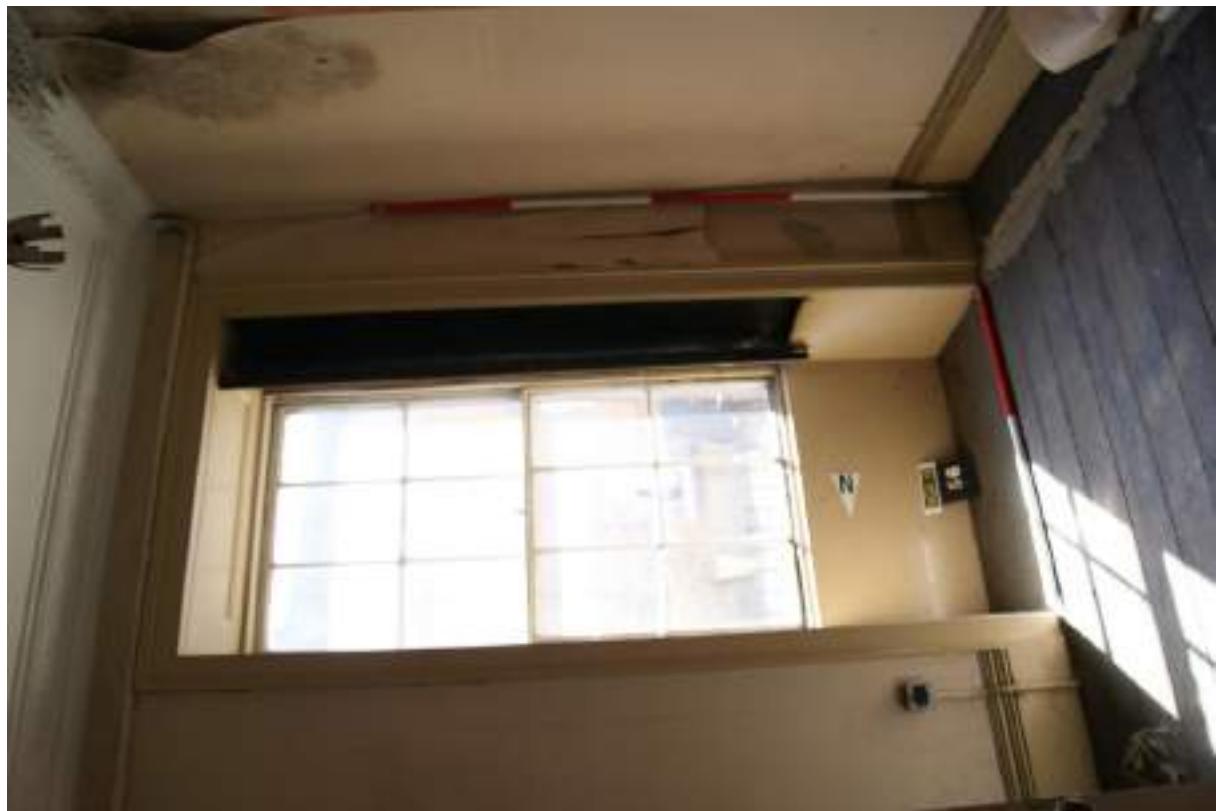
P59 (top). Room 3.1, partitioned area of Room 3, looking south-east to window [56] showing cornice and skirting running through from Room 3 . Scales 1m and 2m.

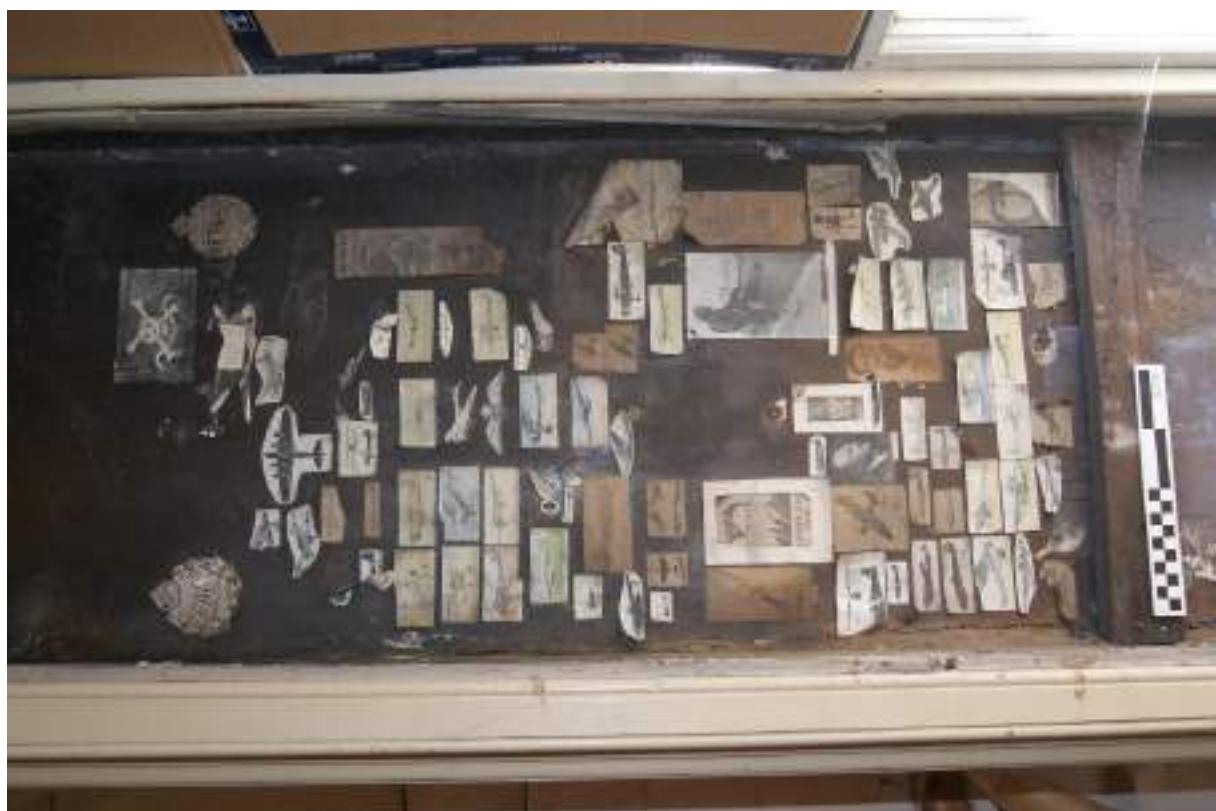
P60 (below). Northern reveal of window [56] (shutter detached) showing WW2 cuttings relating to air forces. Scale 20cm.

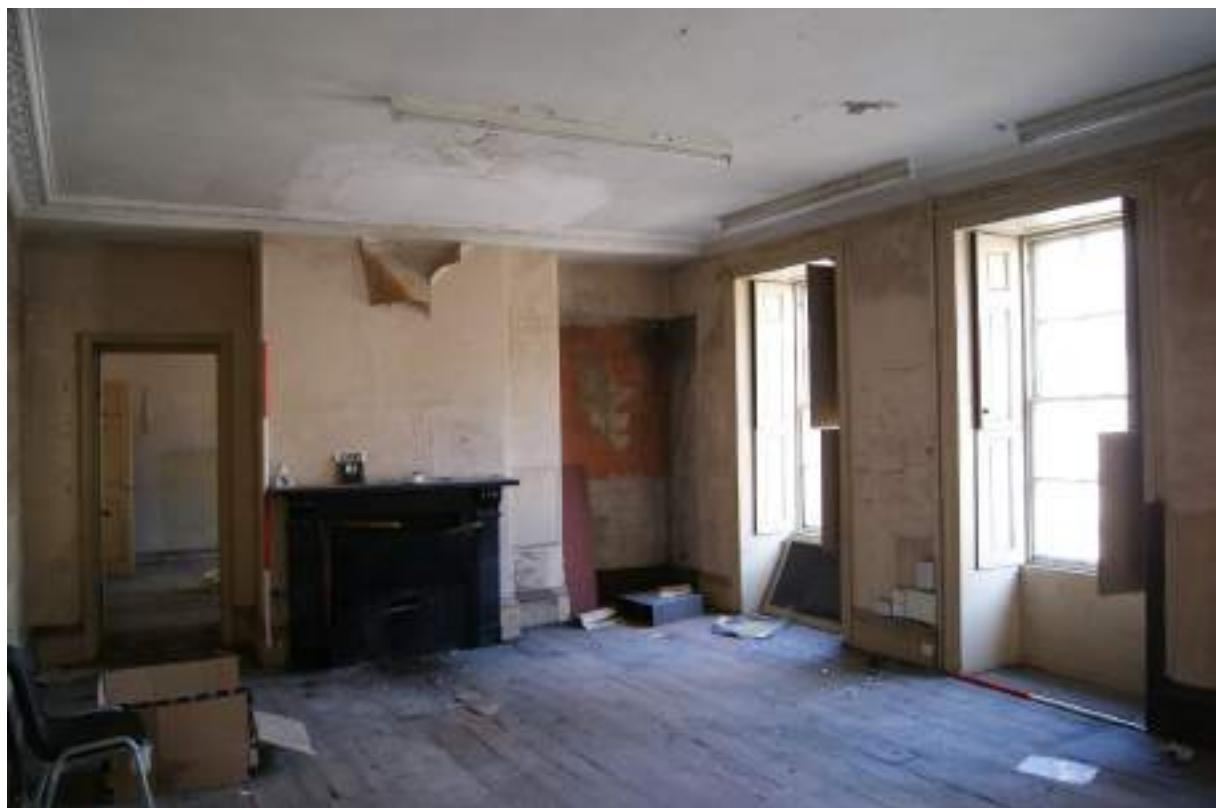
P61 (top). Room 3 looking north-east showing fire [61], door [62] to Room 4 on its left, alcove [60] to the right, windows [58] and [59], and decorative cornice. Scales 1m and 2m.

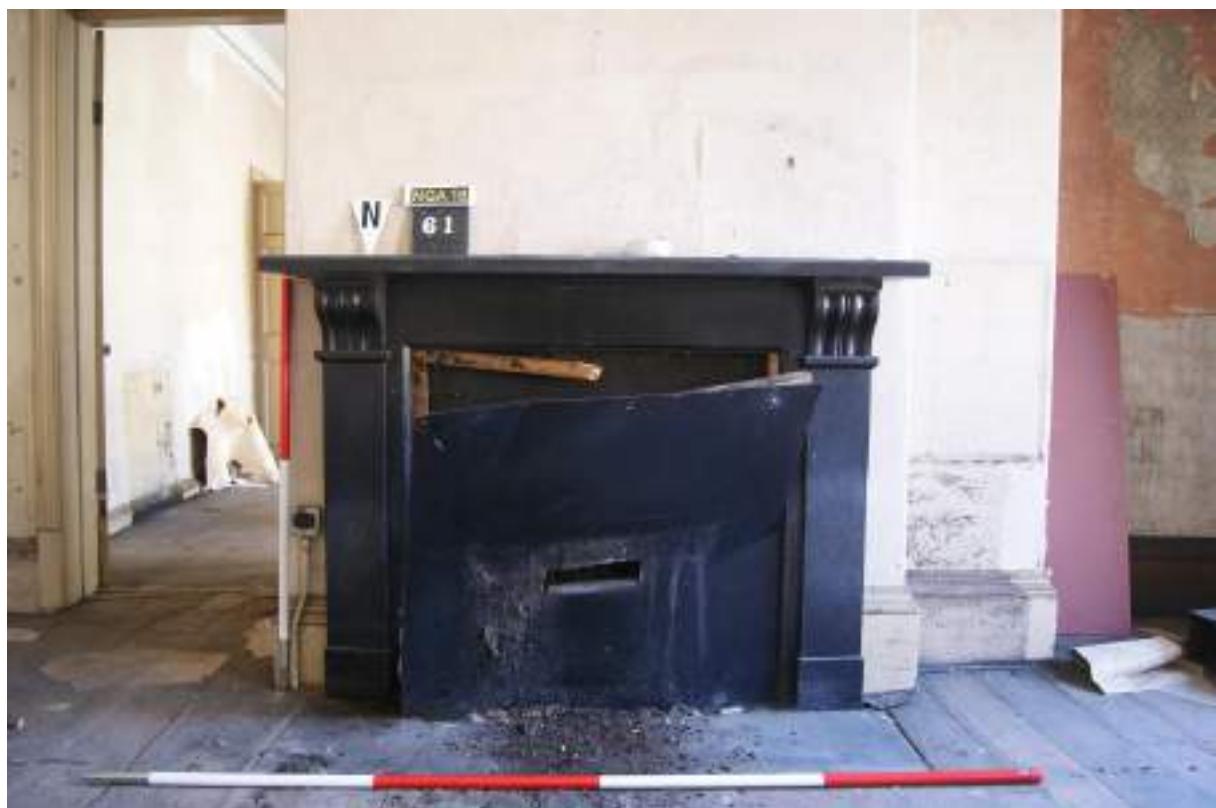
P62 (below). Room 3. Detail of fire [61] showing sheet iron blanking-plate associated with a late 20th century gas fire (removed). Scales 1m and 2m.

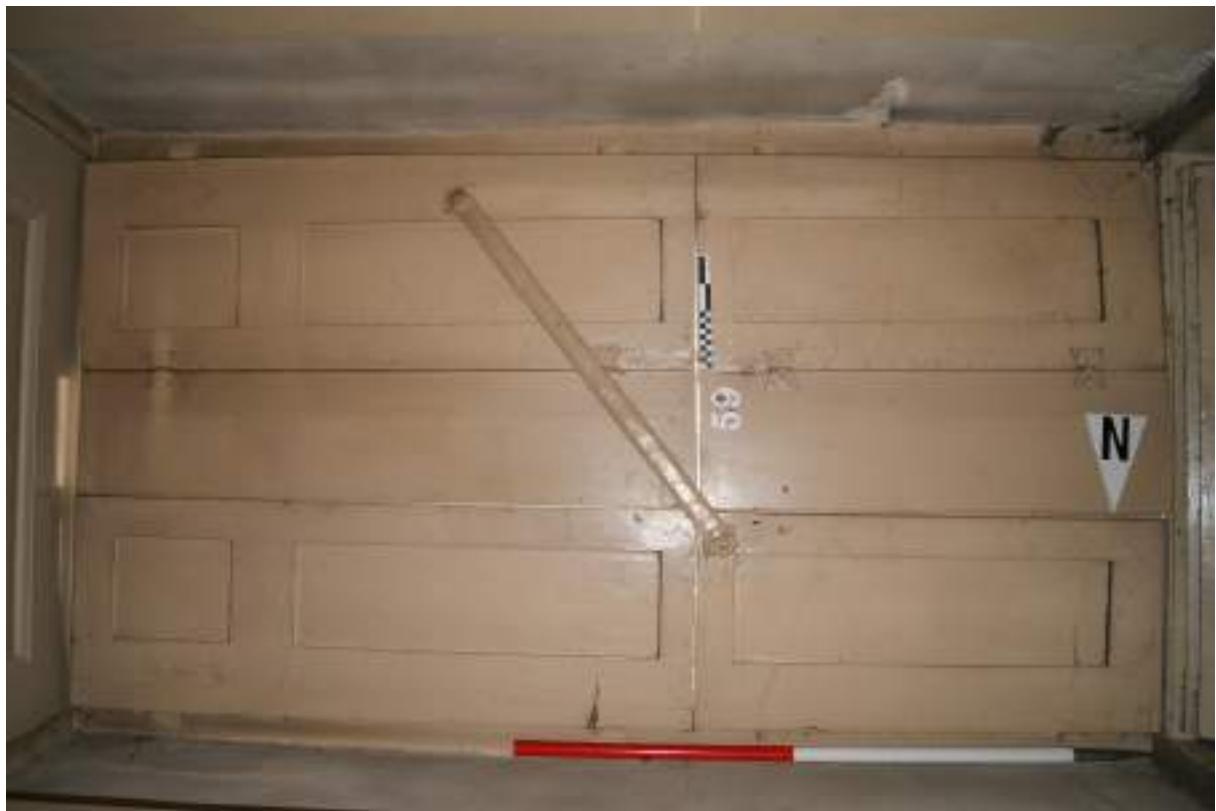
P63 (top). Room 3, window [59] showing internal view of shutters with plain central leaf and locking bar. Scale 1m.

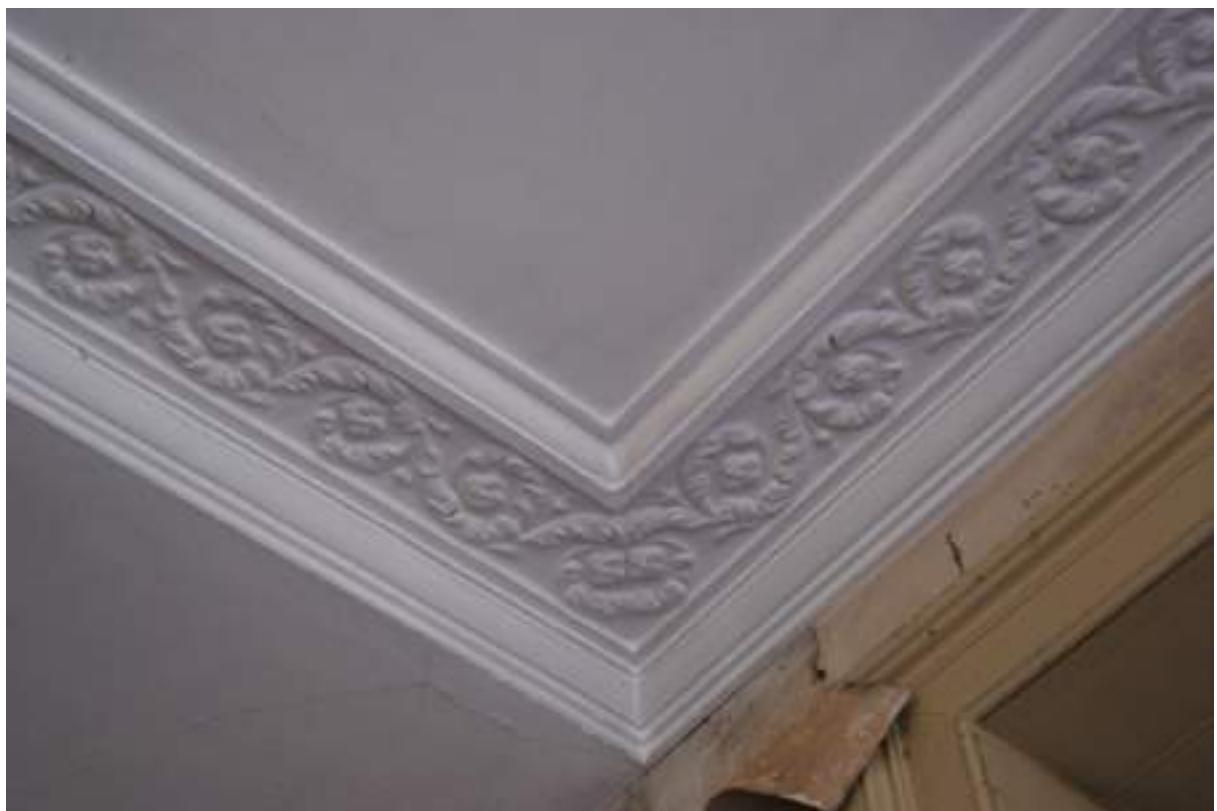
P64 (below). Room 3, north-east corner of ceiling showing cornice and frieze running across alcove [60]. No scale.

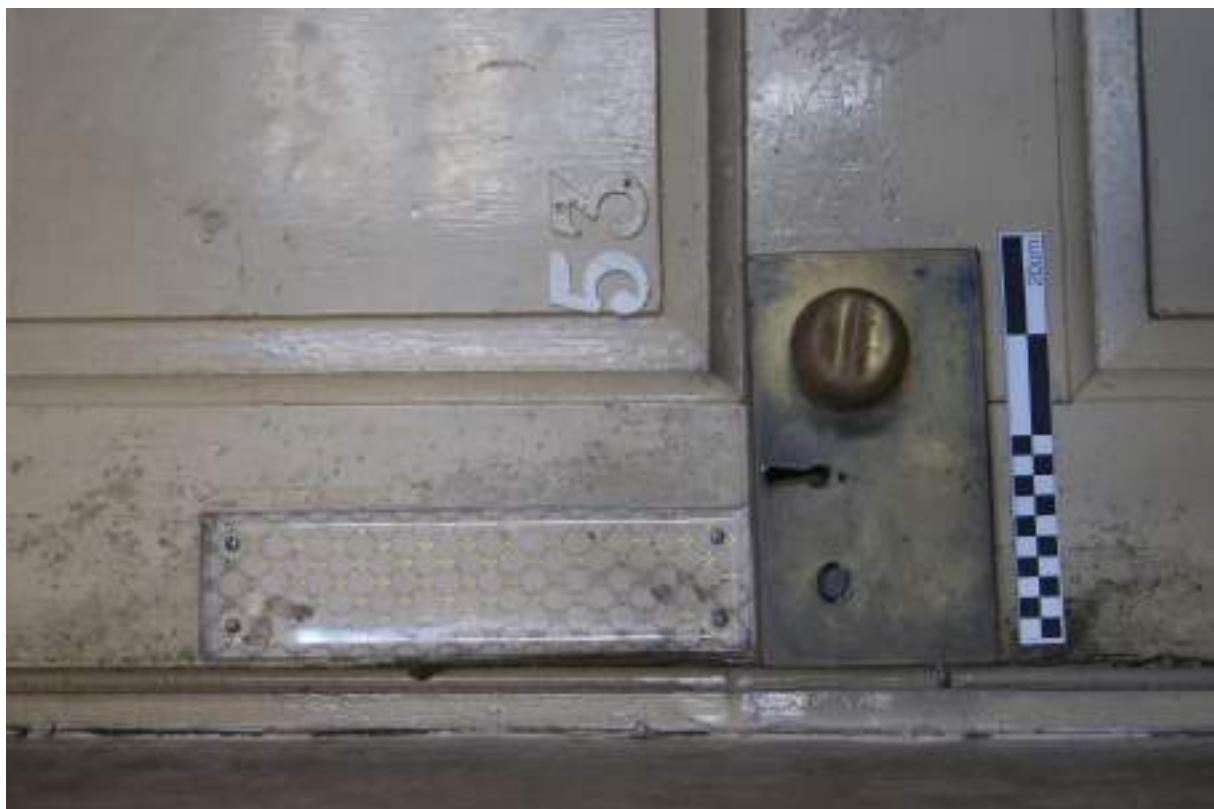
P65 (top). Room 3, detail of door [53] showing 19th century brass-cased lock (inverted) with ball handle and late 20th century perspex finger plate. Scale 20cm.

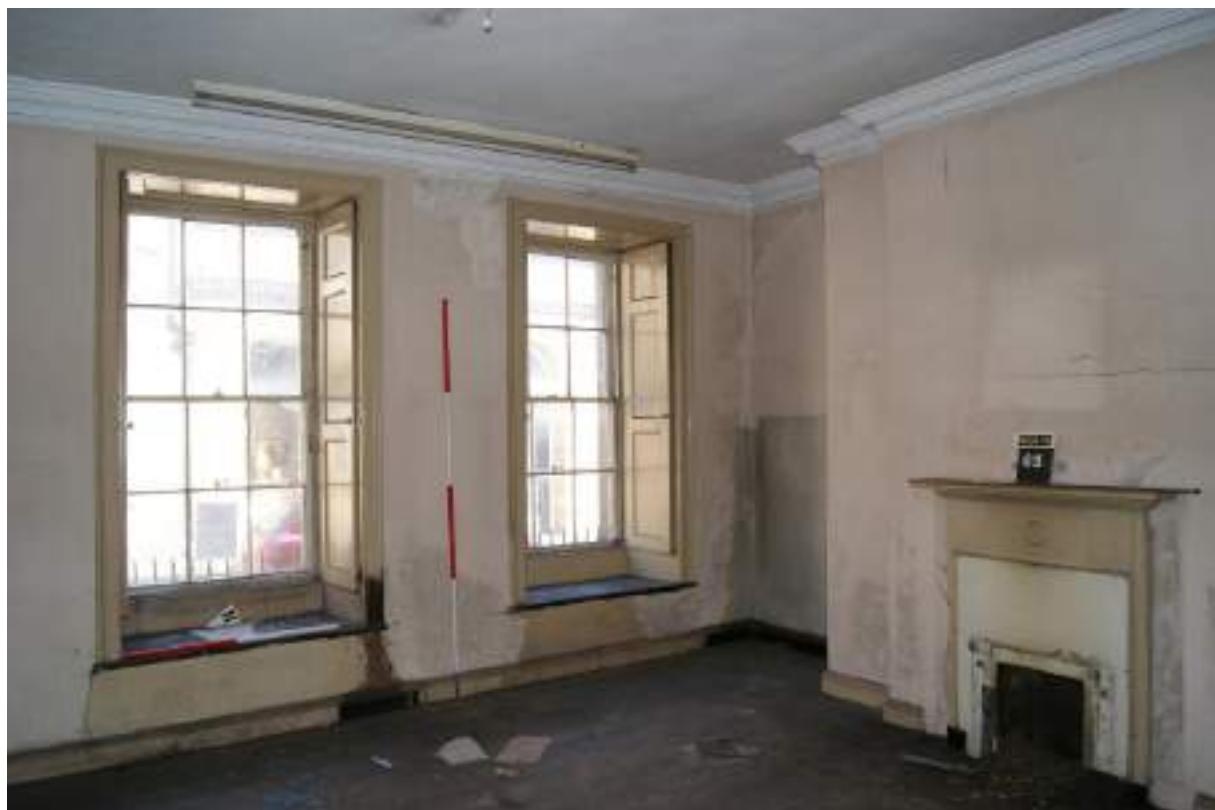
P66 (below). Room 4 looking south-east, showing fire [63], windows [64] and [65], and cornice. Scales 1m and 2m.

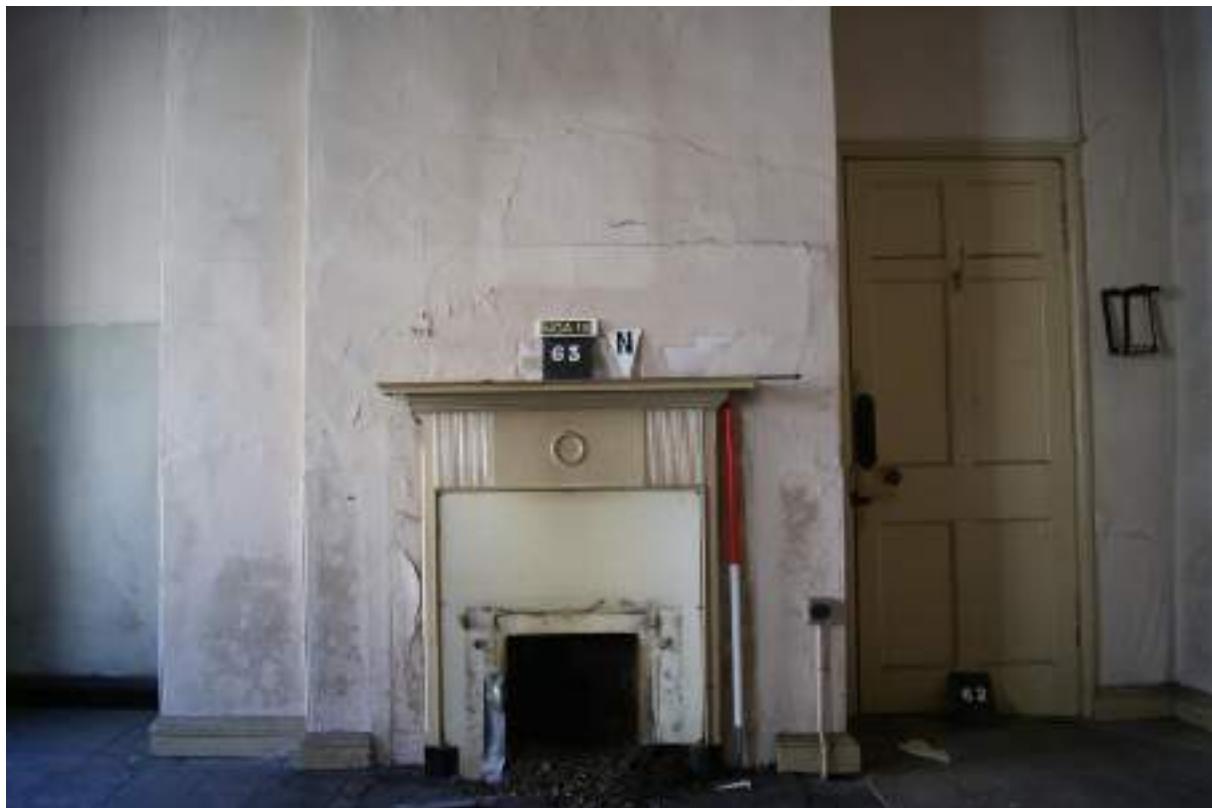
P67 (top). Room 4 looking south, showing fire [63] and door [62] leading from Room 3. Scale 1m.

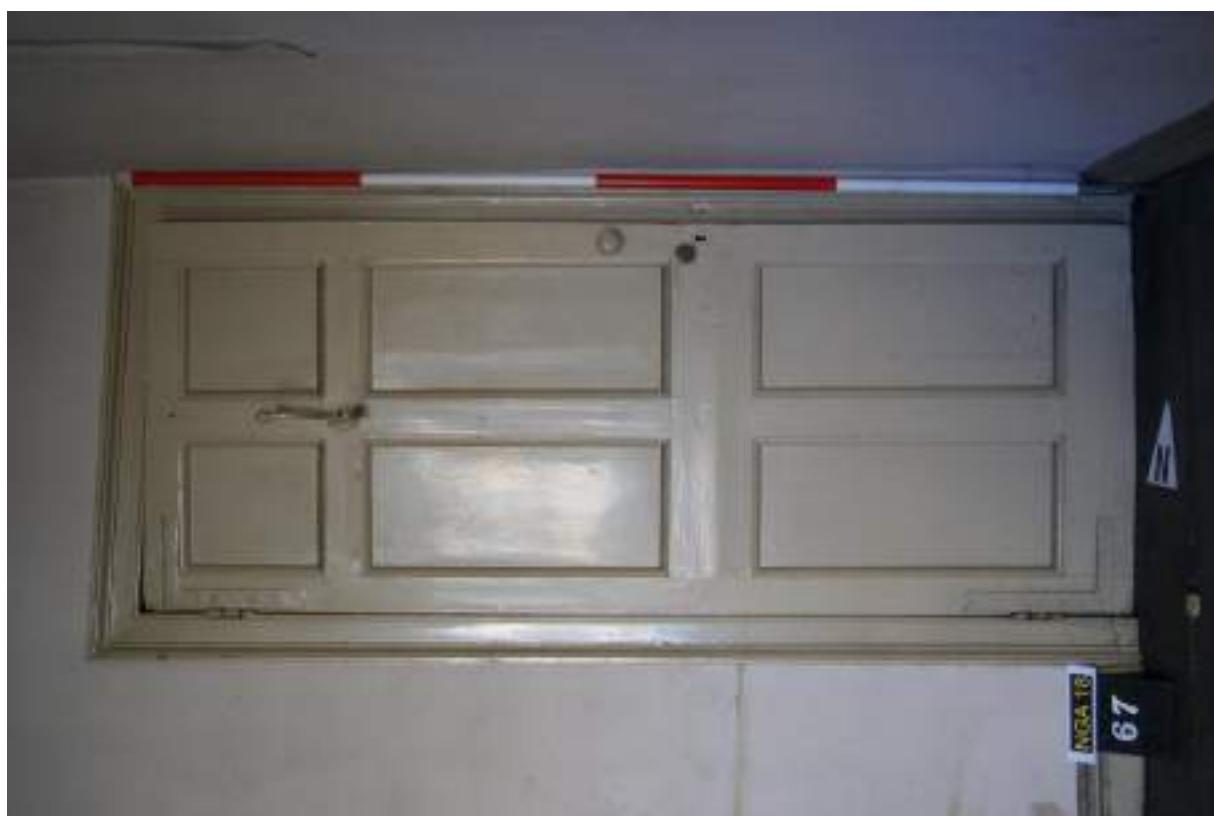
P68 (below). Room 4 showing door [67] formerly leading to passage Room 6.1, subsequently converted into a wall-cupboard. Scale 2m.

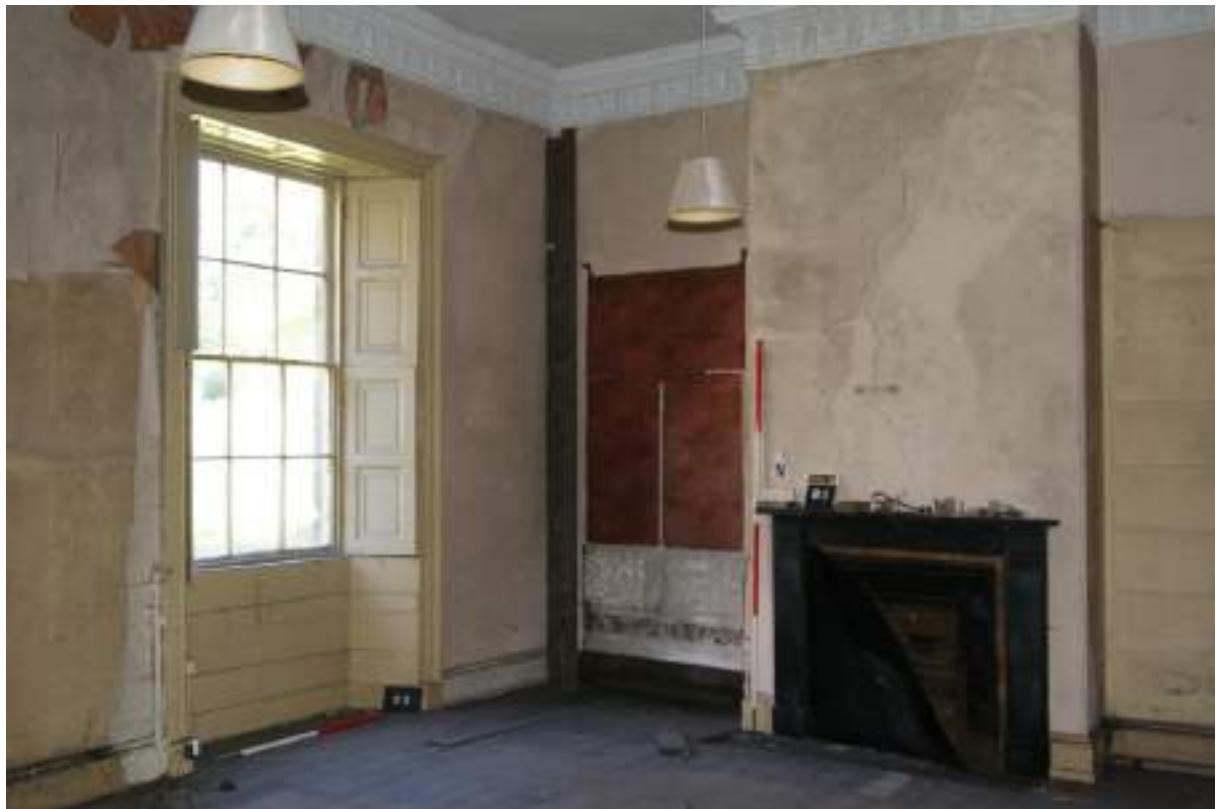
P69 (top). Room 7 looking north-west, showing fire [85], window [83] and decorative cornice. An area of wallpaper formerly concealed by shelving is visible in alcove [87] to the left of fire. Scales 1m and 2m.

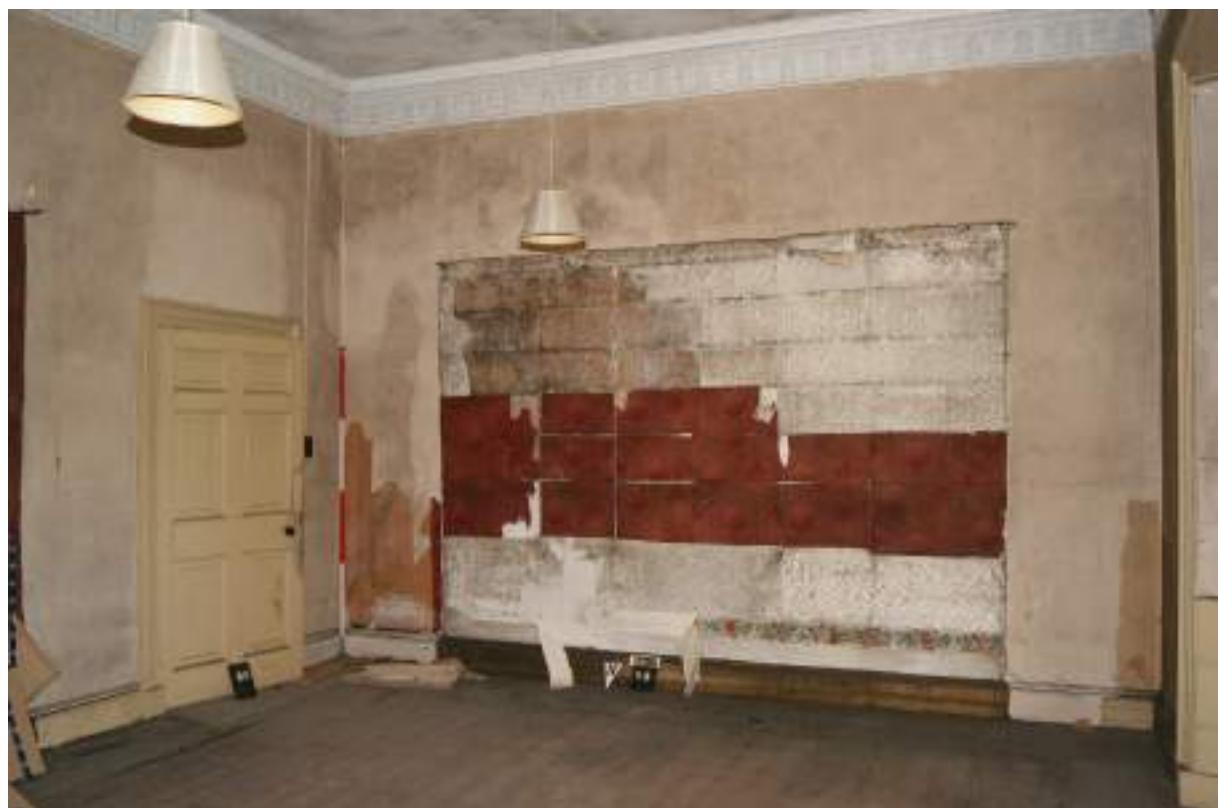
P70 (below). Room 7 looking south-east, showing door [88], decorative cornice, and wallpapers on the south wall exposed by the removal of bookcases. Scale 2m.

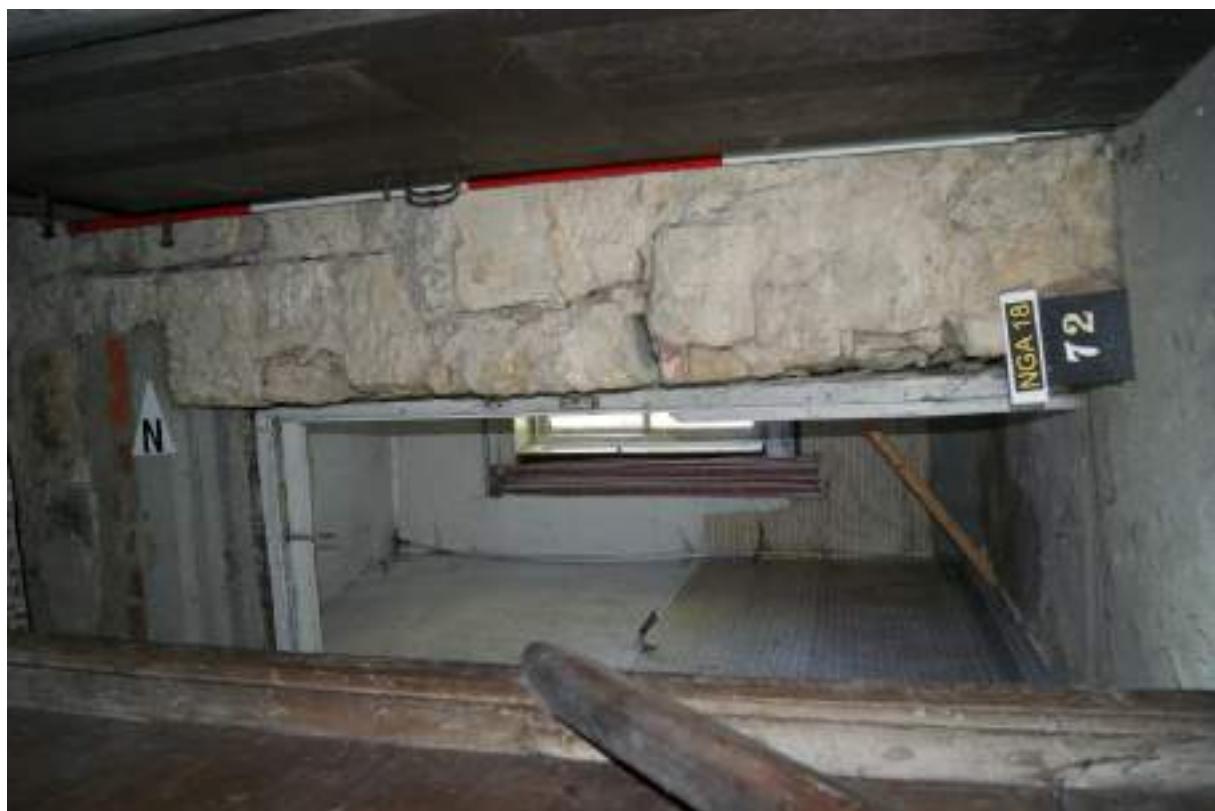
P72 (below). Room 15, looking west from the north stairs to the basement, showing vertical joint on masonry exposed by removal of wall-plaster. Door [72] to Room 15a is on the left, with inserted concrete lintels. Scale 2m

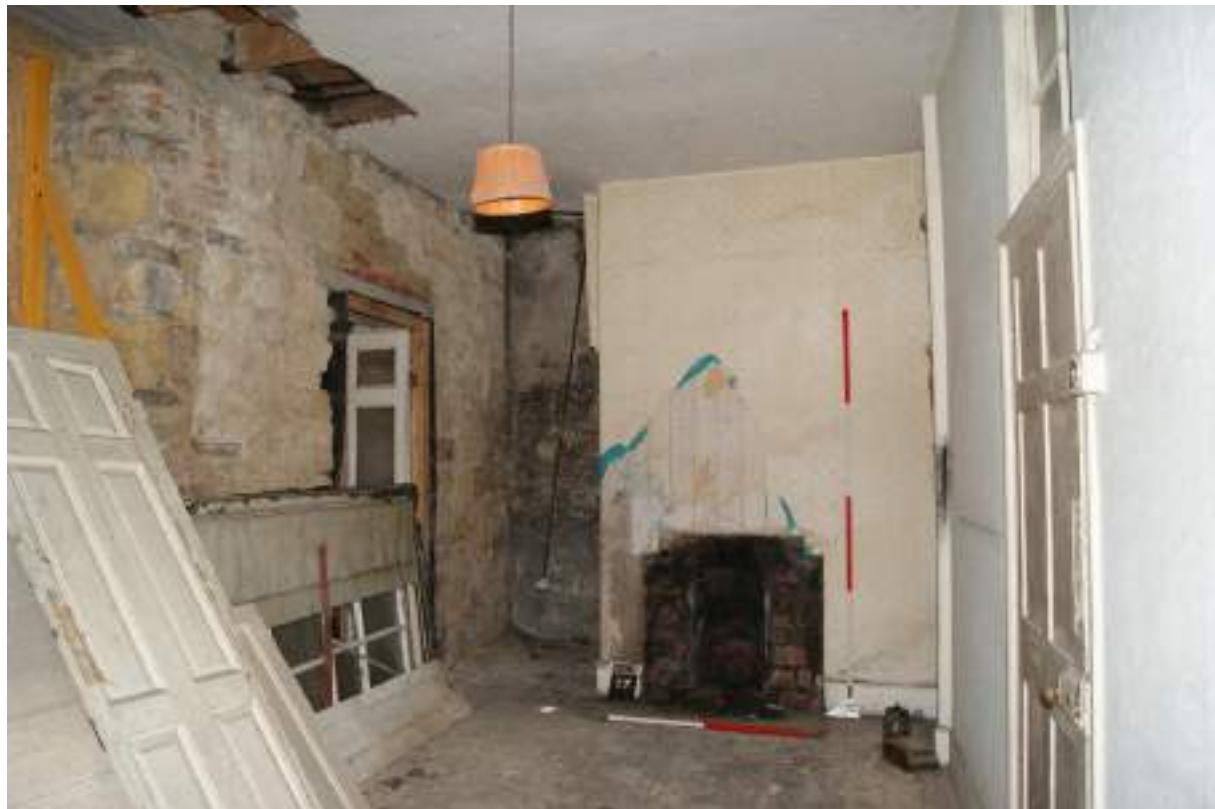
P73 (top). Room 15b looking north-west. Door [76] from passageway Room 6.1 on the right, fire [81] with former wall-cupboard [129] to left, and door [181] to Room 15c in the west wall, with inserted concrete lintel above, and detached fittings Scales 1m and 2m.

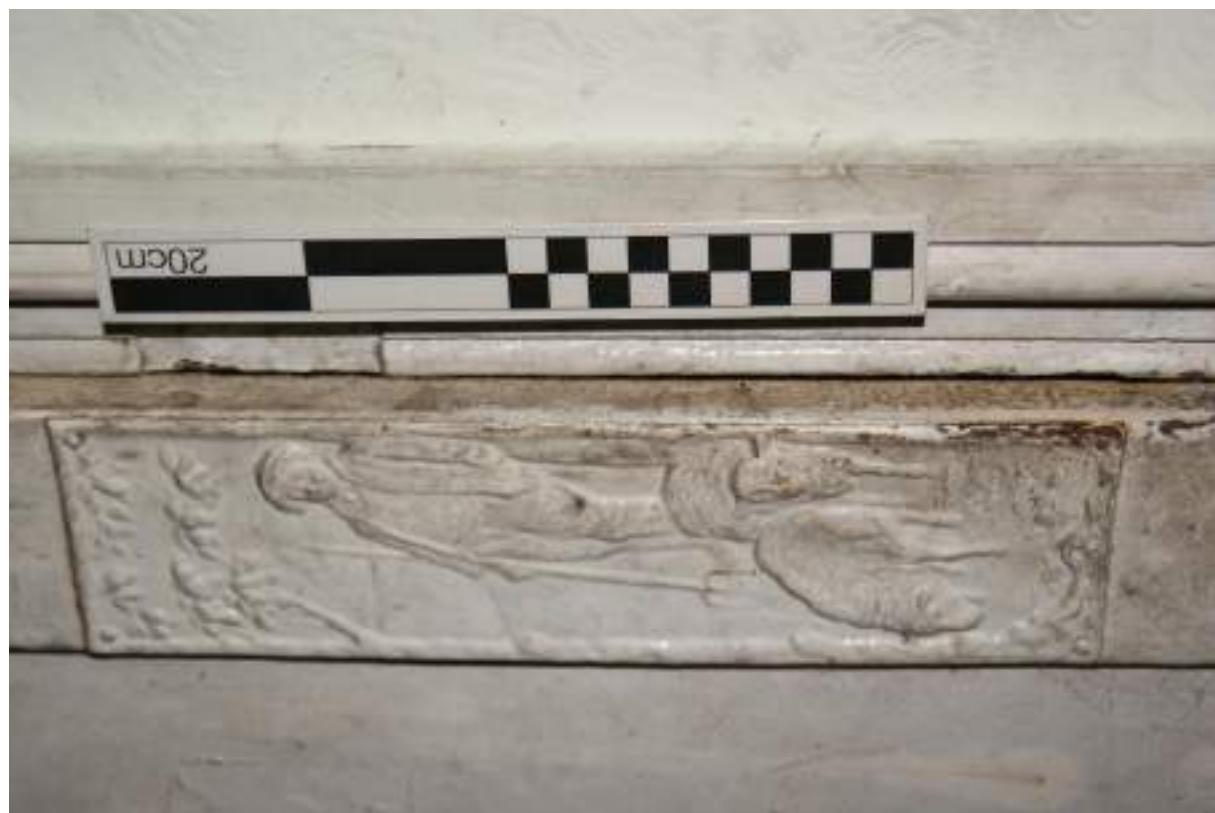
P74 (below). Detail of embossed finger-plate on the inside of door [76]. Scale 20cm.

Doors – in the east wall is [76], thin-framed, six-panelled, with a four-pane overlight, leading from Room 6.1. On inside of the locking stile is an embossed brass or copper finger-plate showing a shepherd and sheep, probably of late 19th century date (**P74**). This door is proposed for removal (Approved drawing M561/10). In the west wall doorway [181] with a modern softwood frame and earlier six-panelled leaf may partly occupy the position of an earlier window. The centre and upper panels have been replaced with frosted glass (P75).

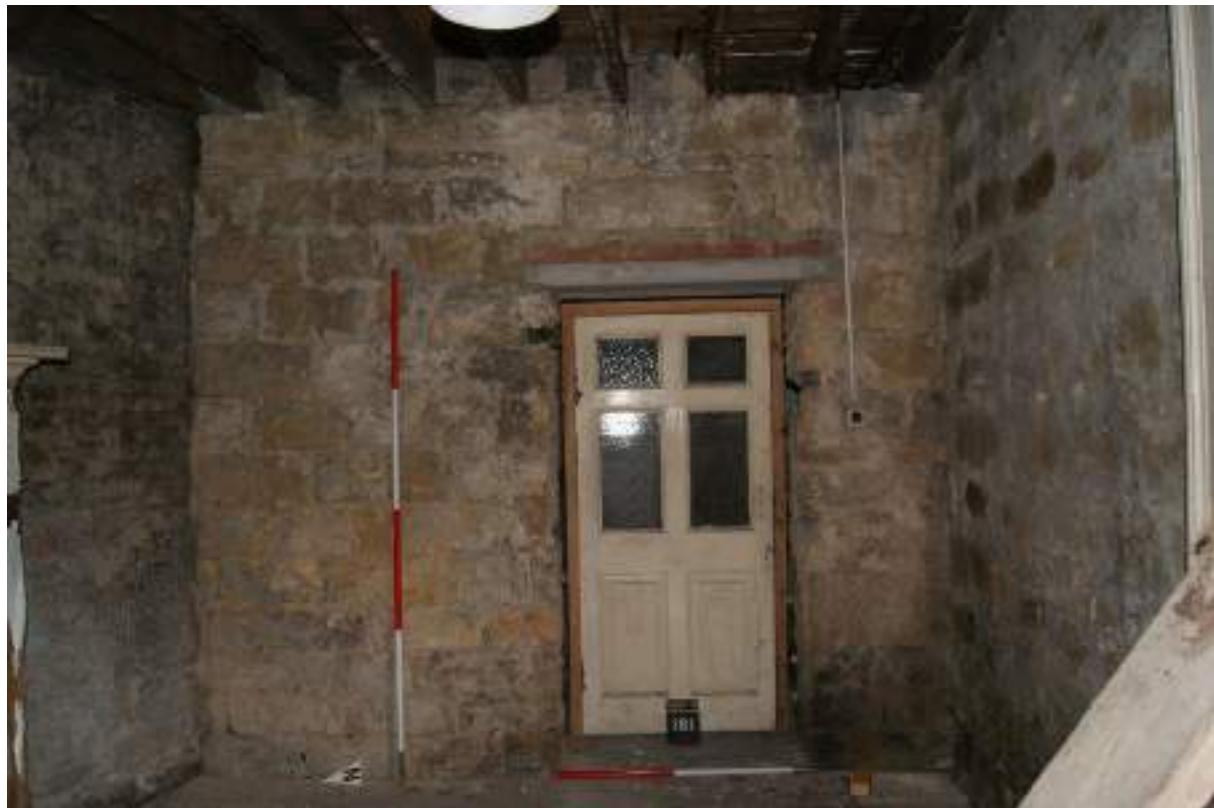
P75 (top). Room 15c looking east to door [181], showing butt joint between west and north walls, and ceiling joists exposed by removal of lath and plaster soffit. Scales 1n and 2m.

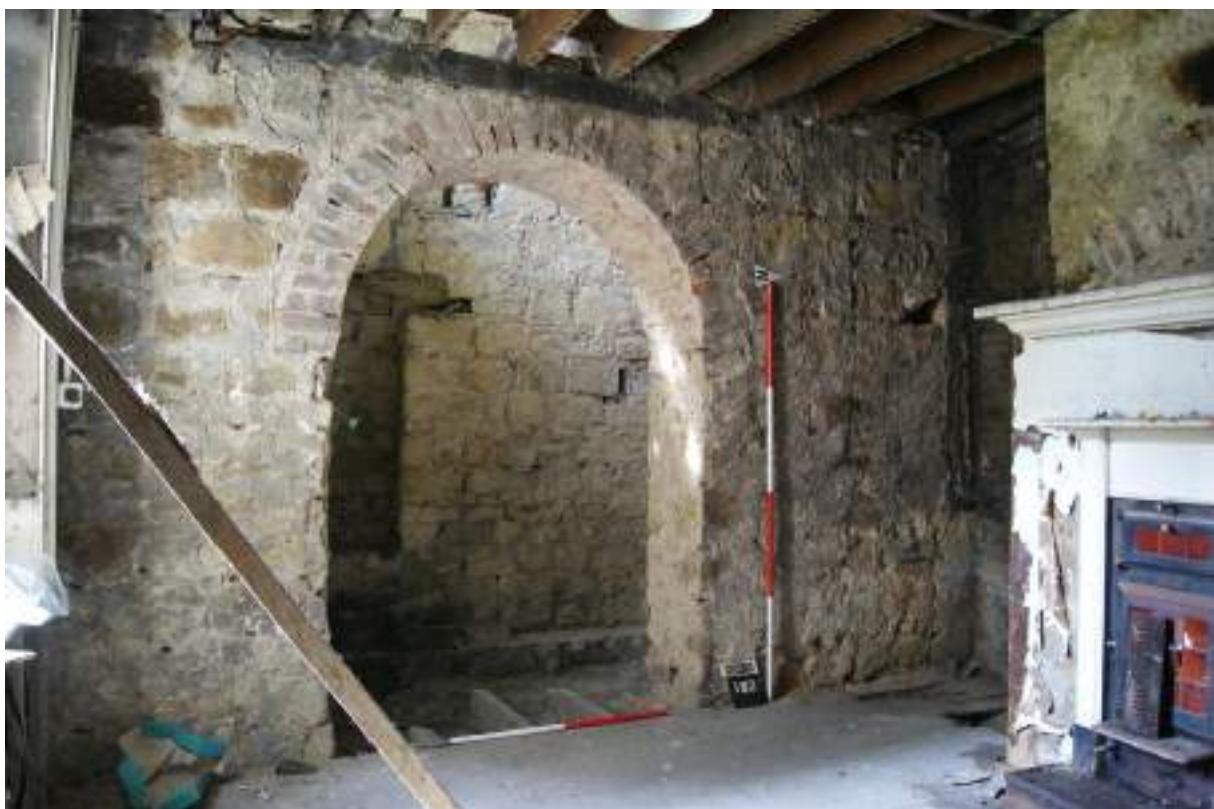
P76 (below) . Room 15c looking west into Room 15d, showing opening [182], range [81] and. butt joint between west and north walls on the right. Scales 1m and 2m.

Walls – the south, east, and part of the west walls, are of rough coursed sandstone. The west wall ends in a face of a tooled ashlar with a small gap between that face and a similarly-faced ashlar pilaster embedded in the north wall (**P76**). The pilaster may be associated with the 'hot-wall' described under the backland/garden (see paragraphs 3.2 - 3.4) as similarly sized piers projecting from the brick face of the hot-wall at Belsay Hall conceal chimney outlets (Green, 226). The north wall is brick which is soot-stained, also suggesting an association with the hot-wall, and butts the pilaster and runs behind the fire, and through the east wall into Room 15b. On either

Door – the room is accessed from R15b through [181], broken through the east wall. There is another much larger opening [182] with a brick-arched head in the west wall (**P76**), which the 2005 English Heritage report states was blocked at that time, though it is unclear if the blocking contained a doorway for access to the staircase in Rooms 15d and 21. The brick dimensions are 235 x 115 x 65mm, broadly of late 18th or early 19th century form. This opening is not shown on approved drawing M561/05, which shows a new doorway through the wall further to the north.
