**Narrowgate House ('General Lambert's House' – HER 4522)
31 and 33 Narrowgate, Alnwick, Northumberland NE66 1 JN
(House centred on NGR 4186299 6134983)**

**Historic Building Recording
by
Northern Counties Archaeological Services
on behalf of
Stablewood Leisure Ltd.**

Historic Building Recording

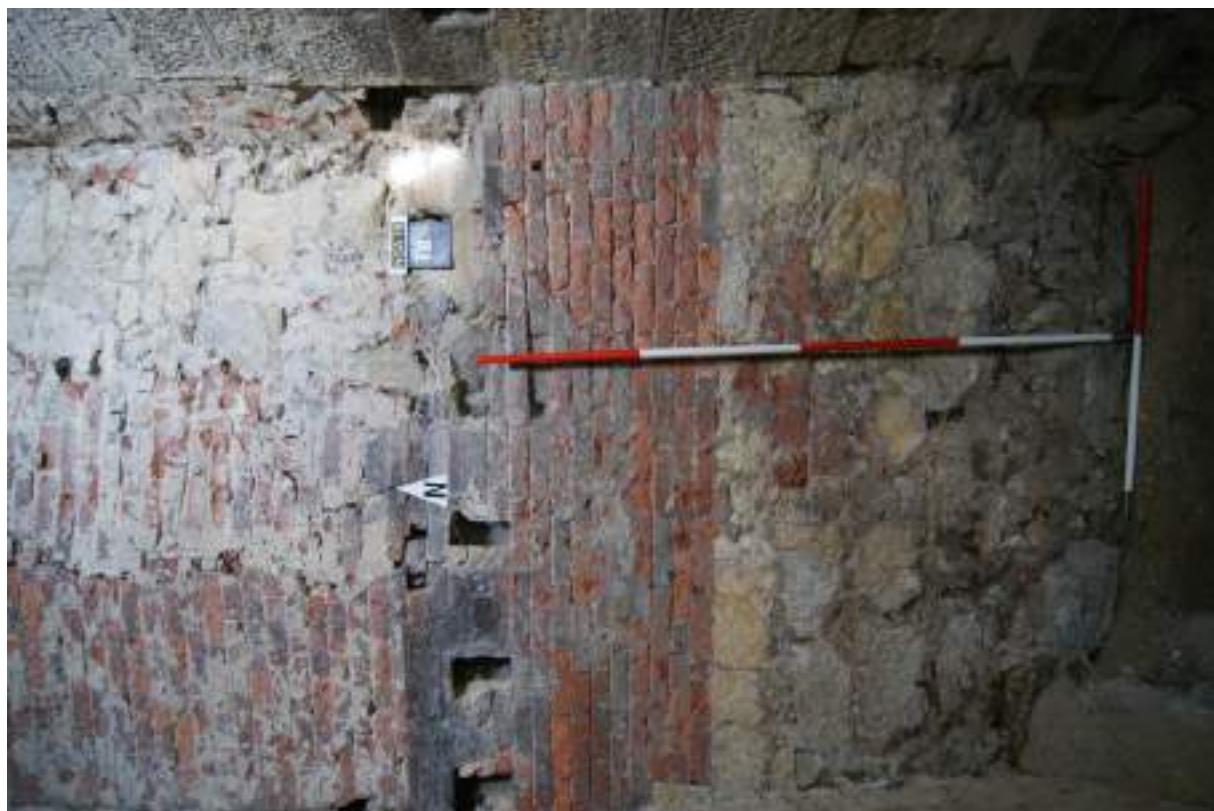
P78 (below). Room 15d. North wall, showing sandstone base with brickwork above containing sockets for former floor joists, and patched brickwork forming part of the external 'hot wall', cut back to accommodate (missing) timber stairs. Scale 1m and 2m.

perhaps a continuation of the brick-faced hot-wall, containing joist sockets. In approximately the middle of the wall, the brickwork and sandstone rubble wall behind has been cut back, presumably to facilitate insertion of the former staircase. The brickwork has been roughly faced-up and there is a suggestion that this was to seal off the voids left by cutting the flues of the 'hot-wall'. There is a chase for a too-fall roof on the face. At the north-east corner, the vertically-tooled ashlar pilaster noted in Room 15c is again visible (P78), buried within later rubble and brick. There is a small gap, between the south face of the pilaster and the east wall which is similarly vertically-tooled ashlar with dressed margins, which has clearly been an external wall-face.

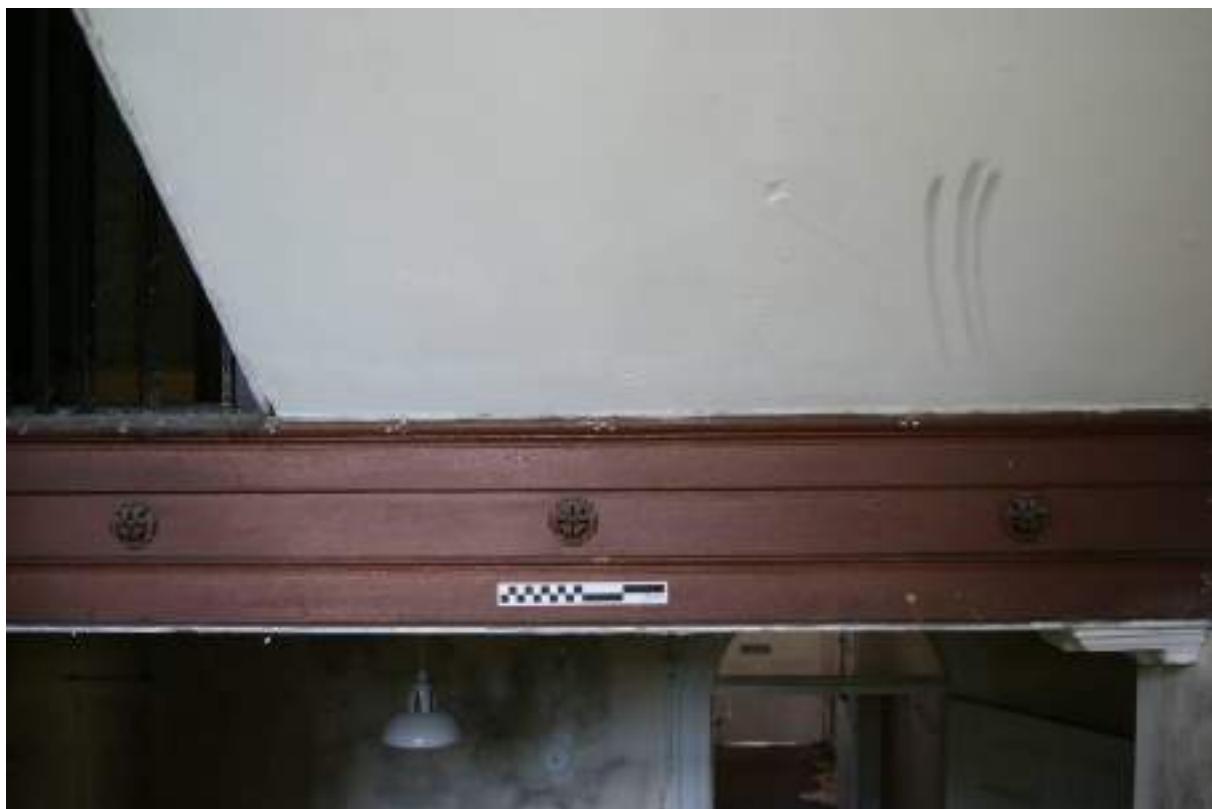
P79 (top). Room 8, moulded wooden rosettes on beam supporting the third flight of the principal stairs [91]. Scale 20cm.

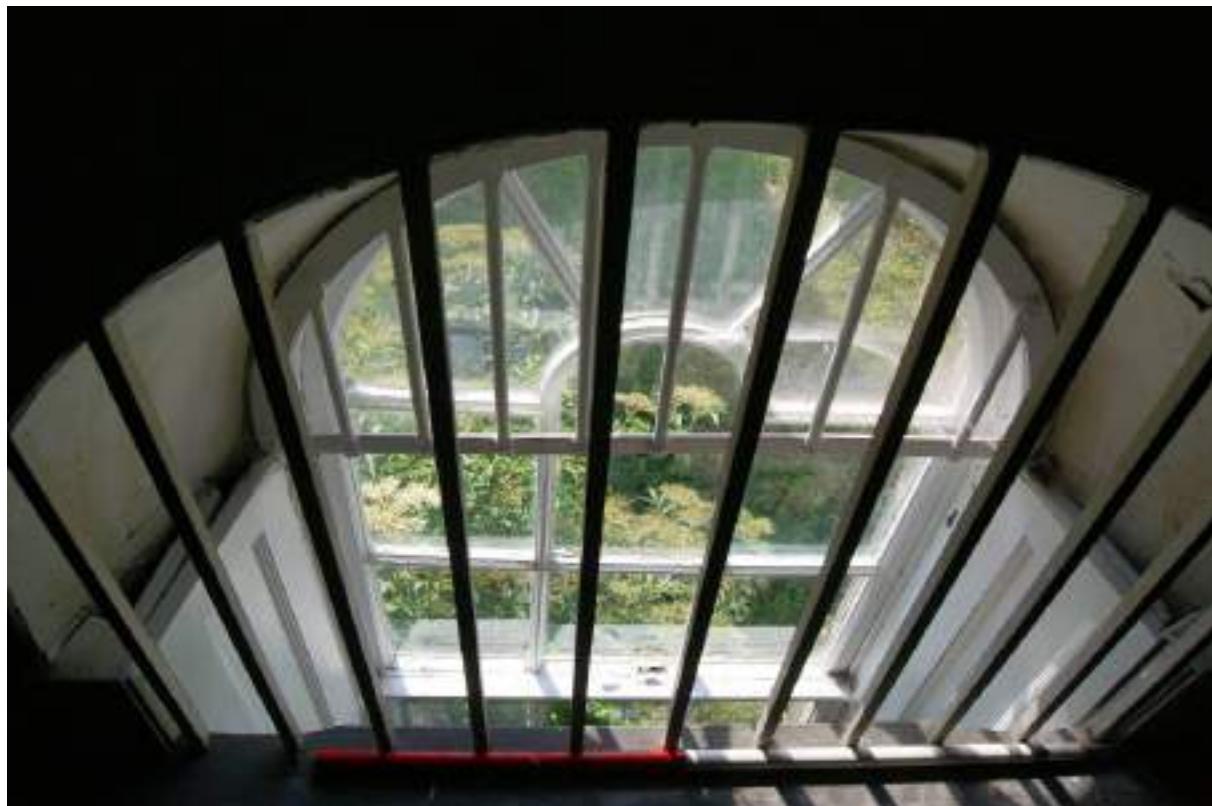
P80 (below). Window [92] transected by the half-landing of the lower flights of the principal stairs [47], showing iron grille and robust glazing bars. Scale 1m.

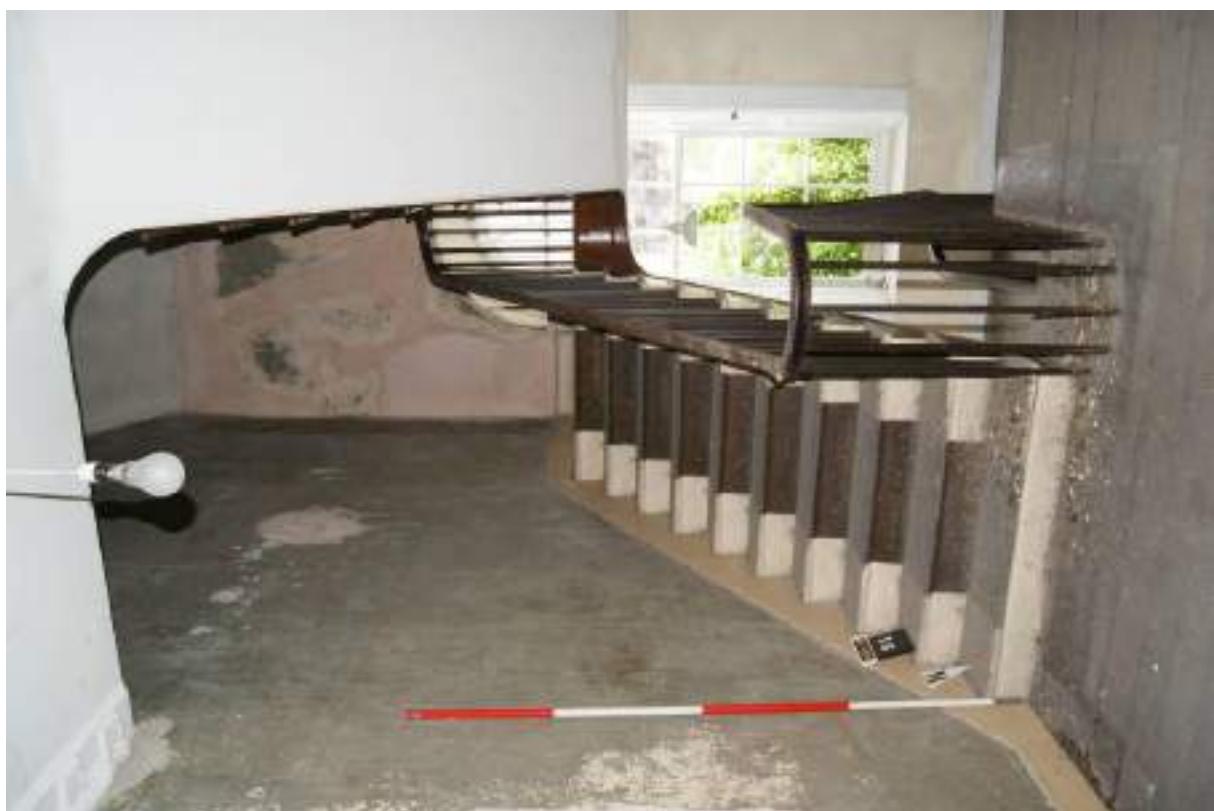
P81 (top). Room 8, looking south-west to the third flight of the principal stairs [91] showing bannister, balusters, and areas of modern plaster patching. Window [92] in background. Scale 2m.

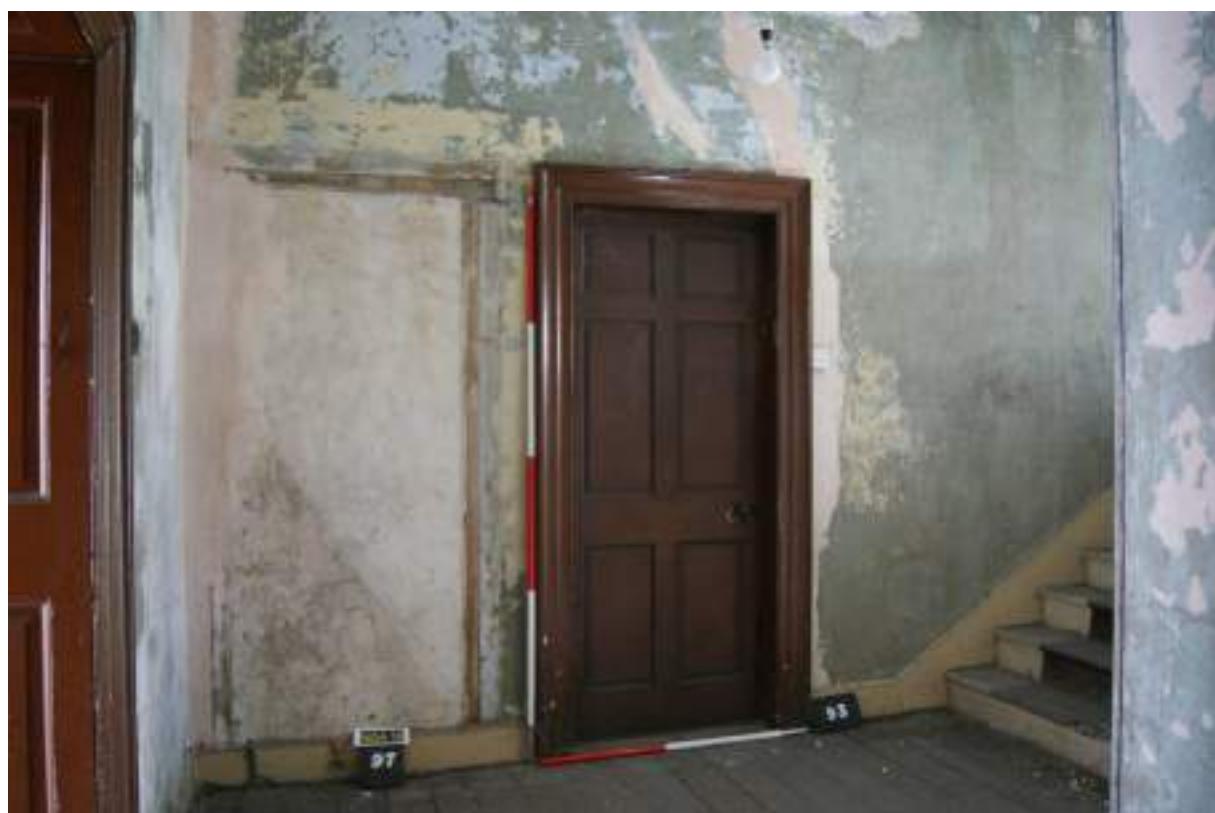
P82 (below). Room 8, looking south to doorway [93] into Room 10, also showing outline of blocked door [97]. Scales 1m and 2m.

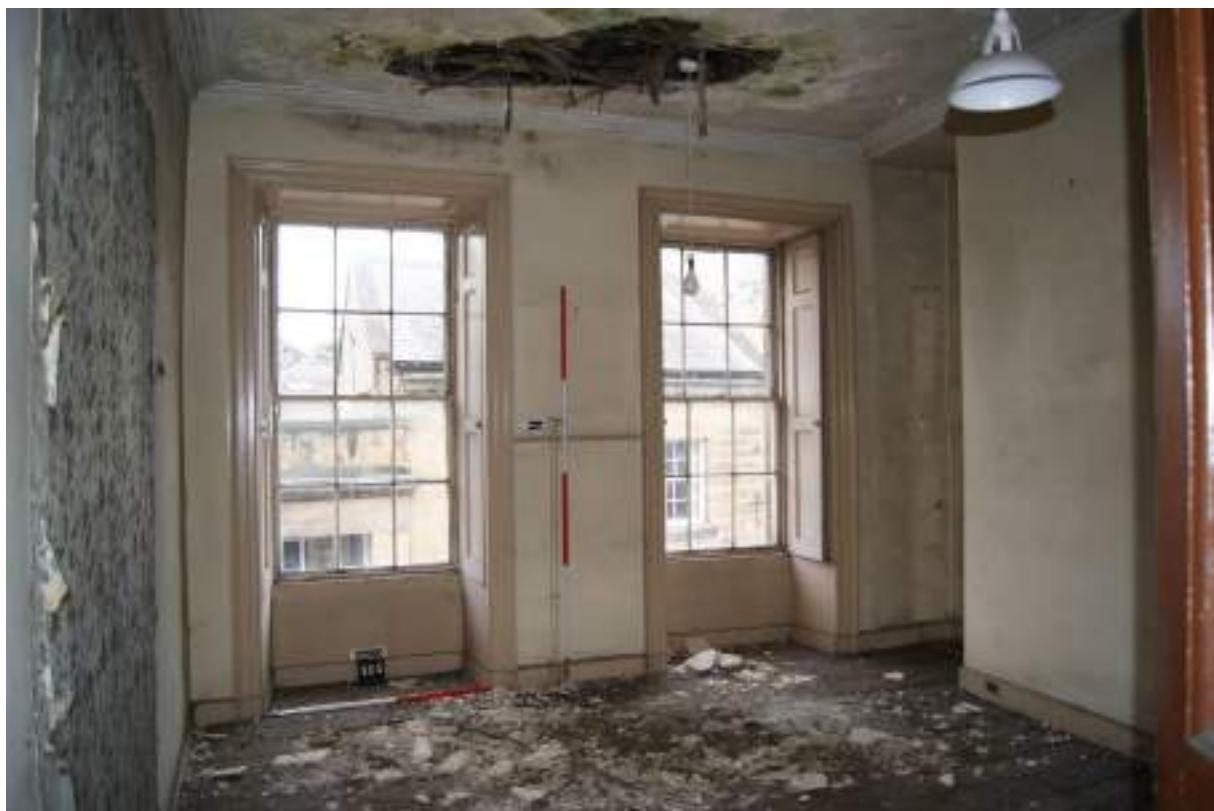
P83 (top). Room 18 looking south-east, showing windows [100] and [101] and collapsed ceiling. Scales 1m and 2m.

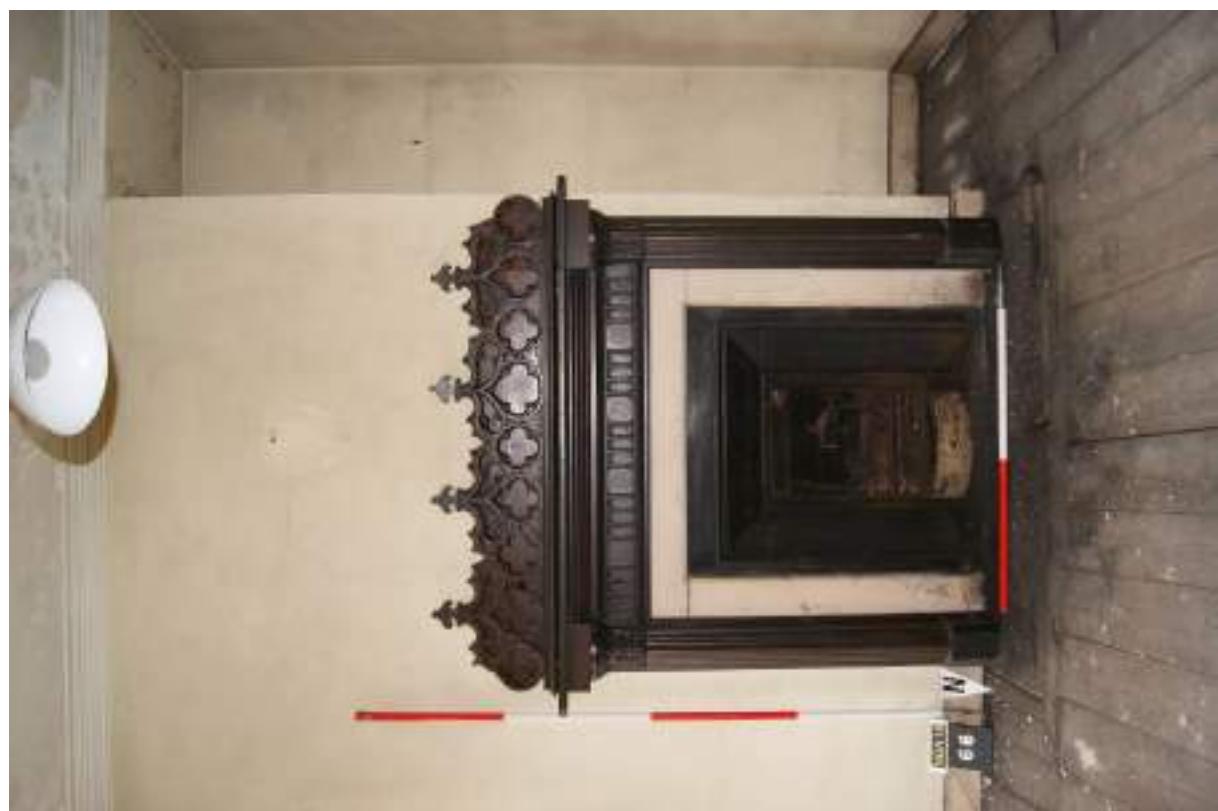
P84 (below). Room 18, fire [99] (photoboard inverted) with Gothic moulded timber surround. Scales 1m and 2m.

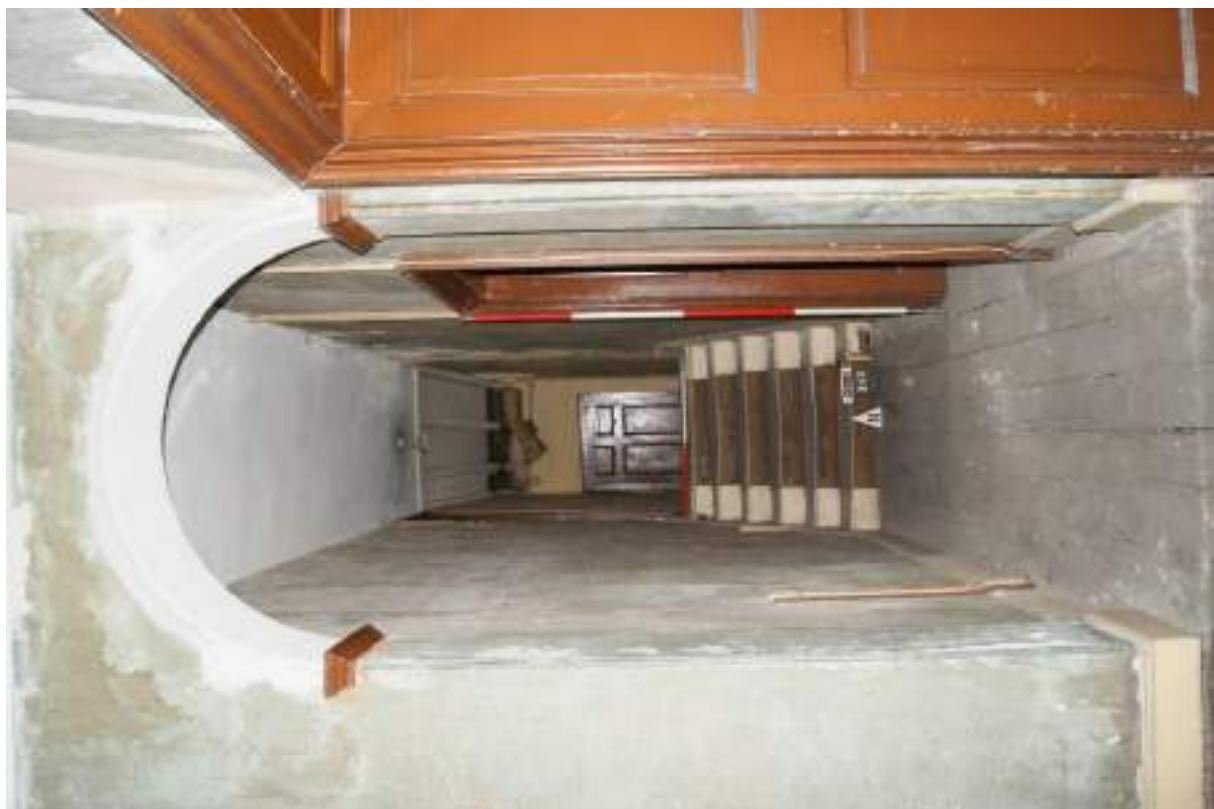
P85 (top). Room 11 looking north, showing steps to raised floor levels of Rooms 12 and 13, door [104] to Room 17 on the right, and door [131] in an inserted partition in the background. Scales 1m and 2m.

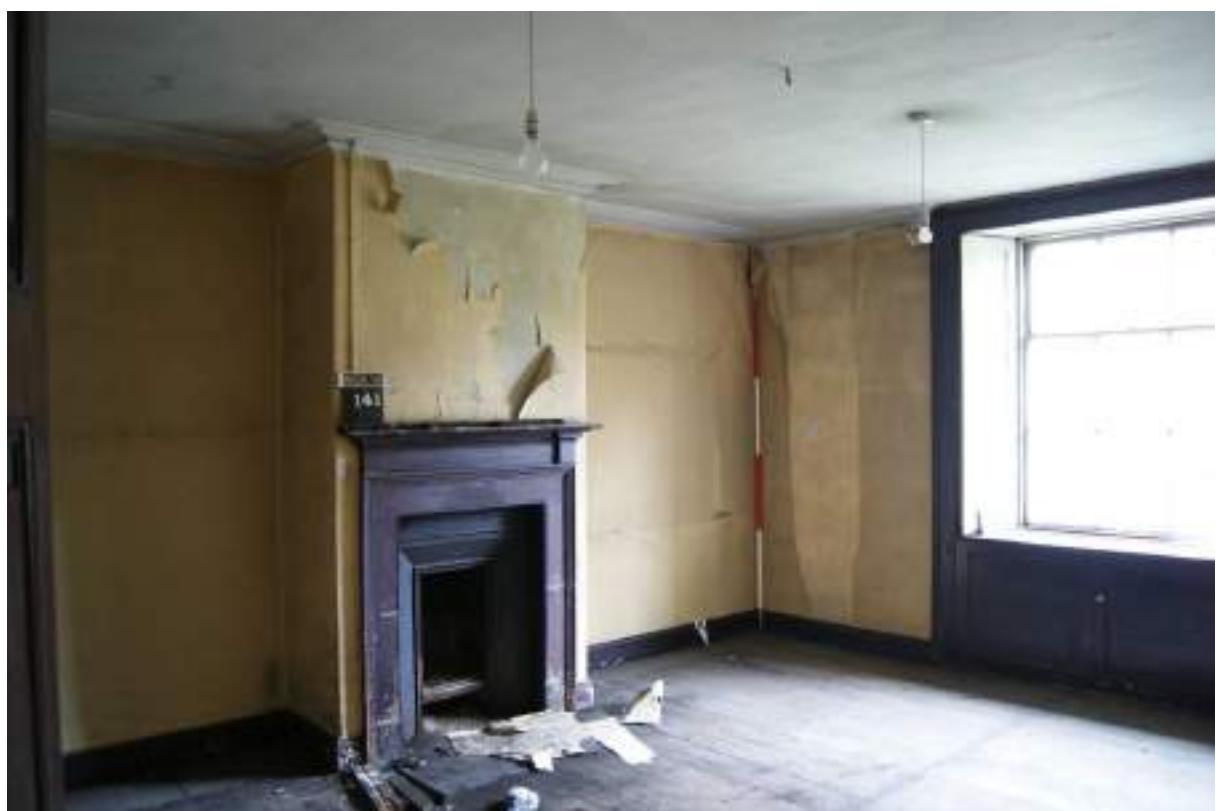
P86 (below). Room 12 looking south-west showing fire [141], window [140] and cornice. Scale 2m.

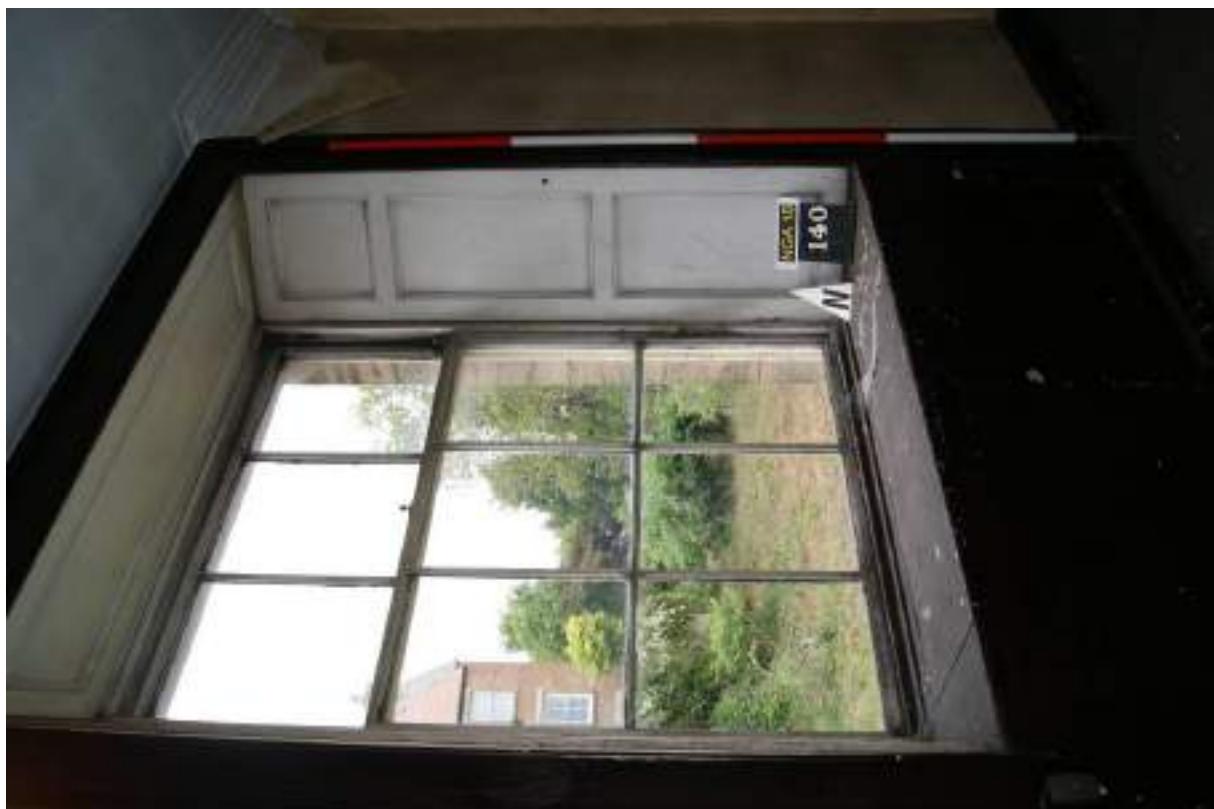
P87 (top). Room 12, detail of window [140] showing 6/3 sash, shutters, and window seat with hinged lid for storage. Scale 2m.

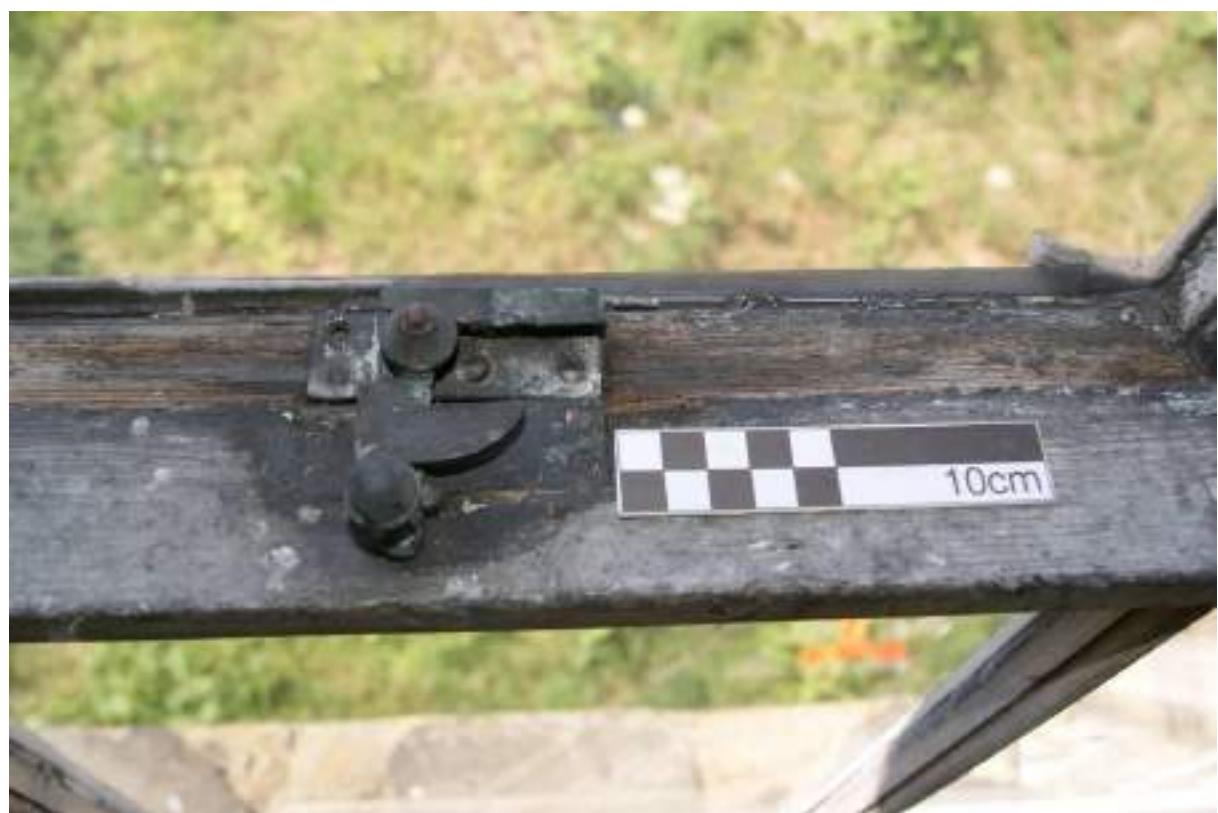
P88 (below). Room 12, detail of original cast brass catch on sash frames. Scale 10cm.

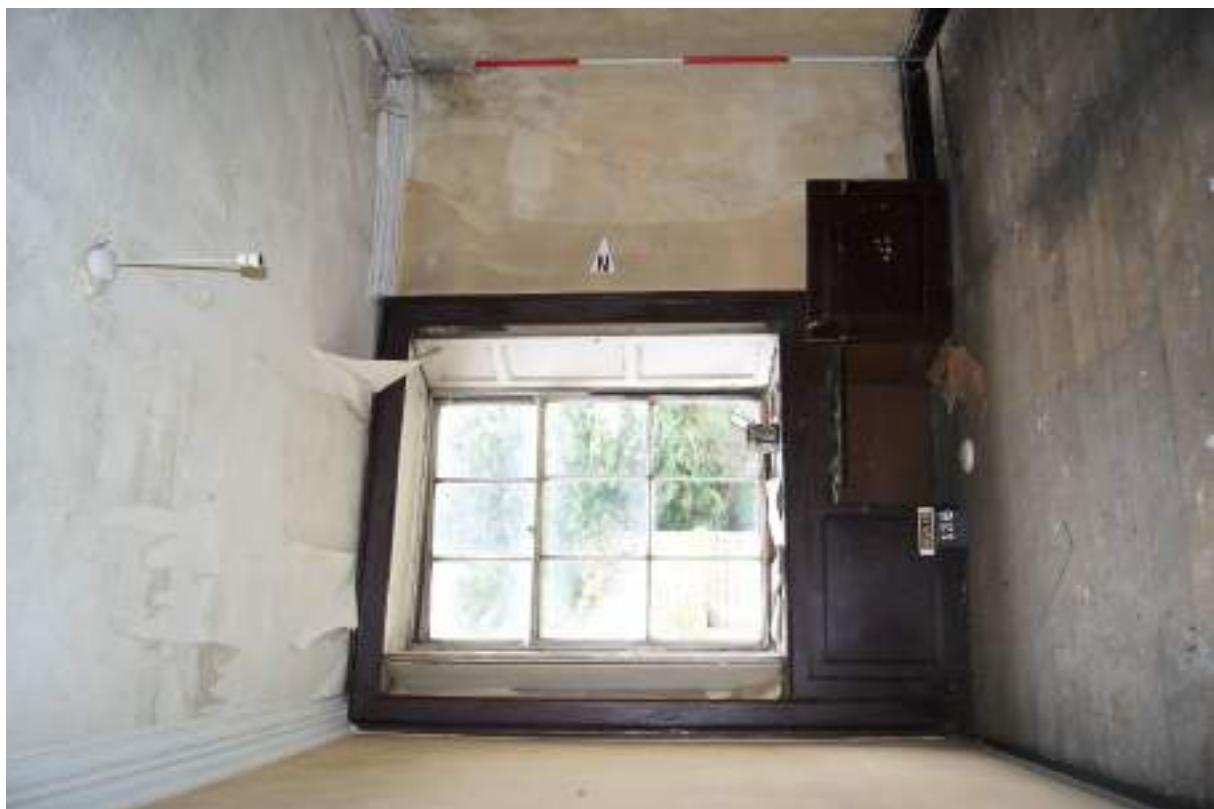
P89 (top). Room 13, looking west showing 3/6 sash window with storage below sill, and cornice to inserted south partition wall. Scale 2m.

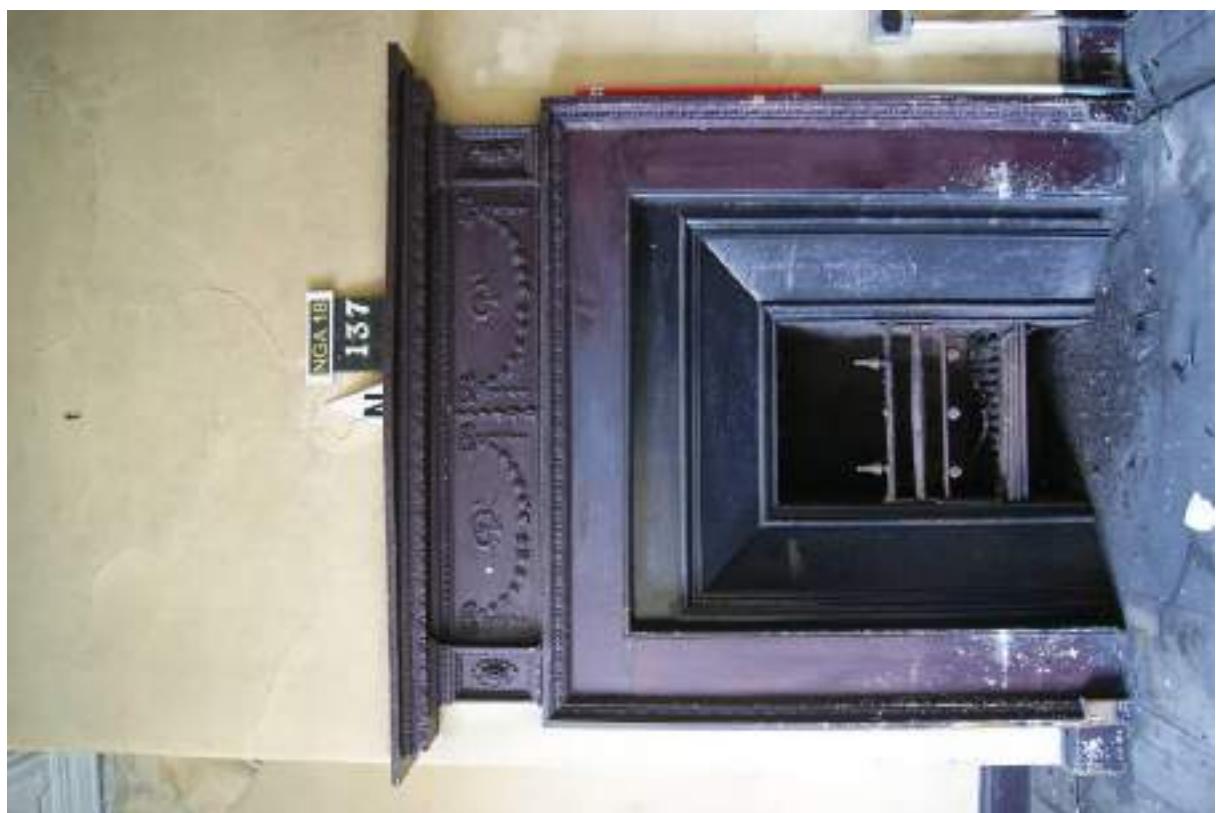
P90 (below). Fire [137] showing decorative overmantle and grate, probably c.1830. Scale 1m.

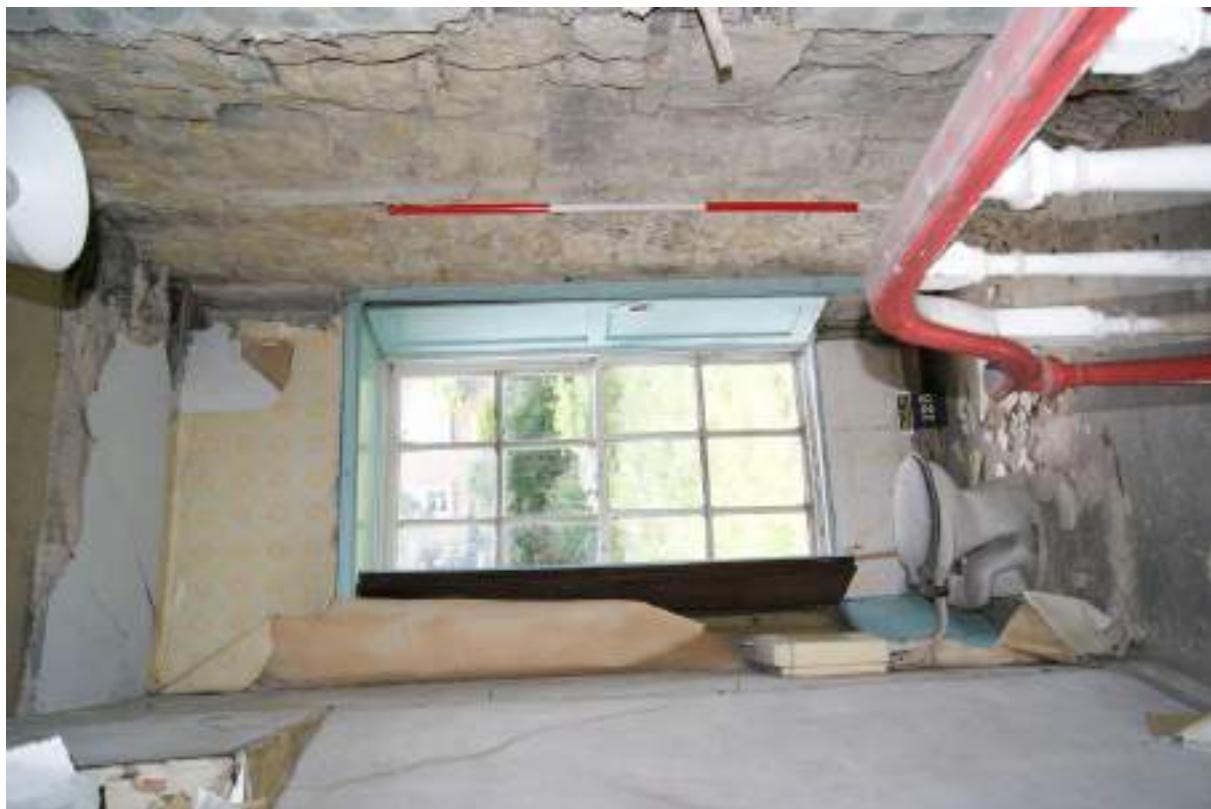
P91 (top). Rooms 11a and 11b, looking west from [130] to window [128] showing scars of former partition, and cut through the west wall of the first western extension to No.33 (right). Scale 2m.

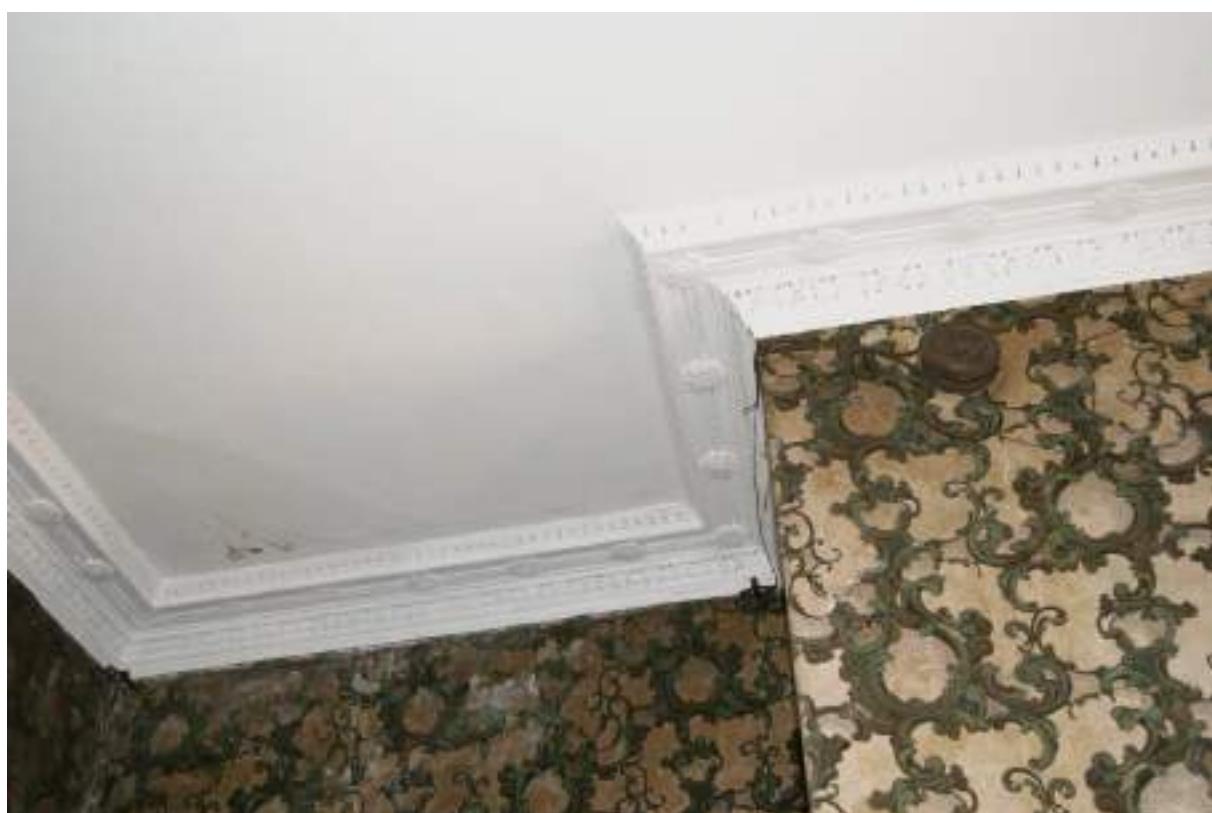
P93 (top). Room 17, detail of wallpaper, cornice, and brass-faced bell [108] on the east side of the chimney breast. No scale.

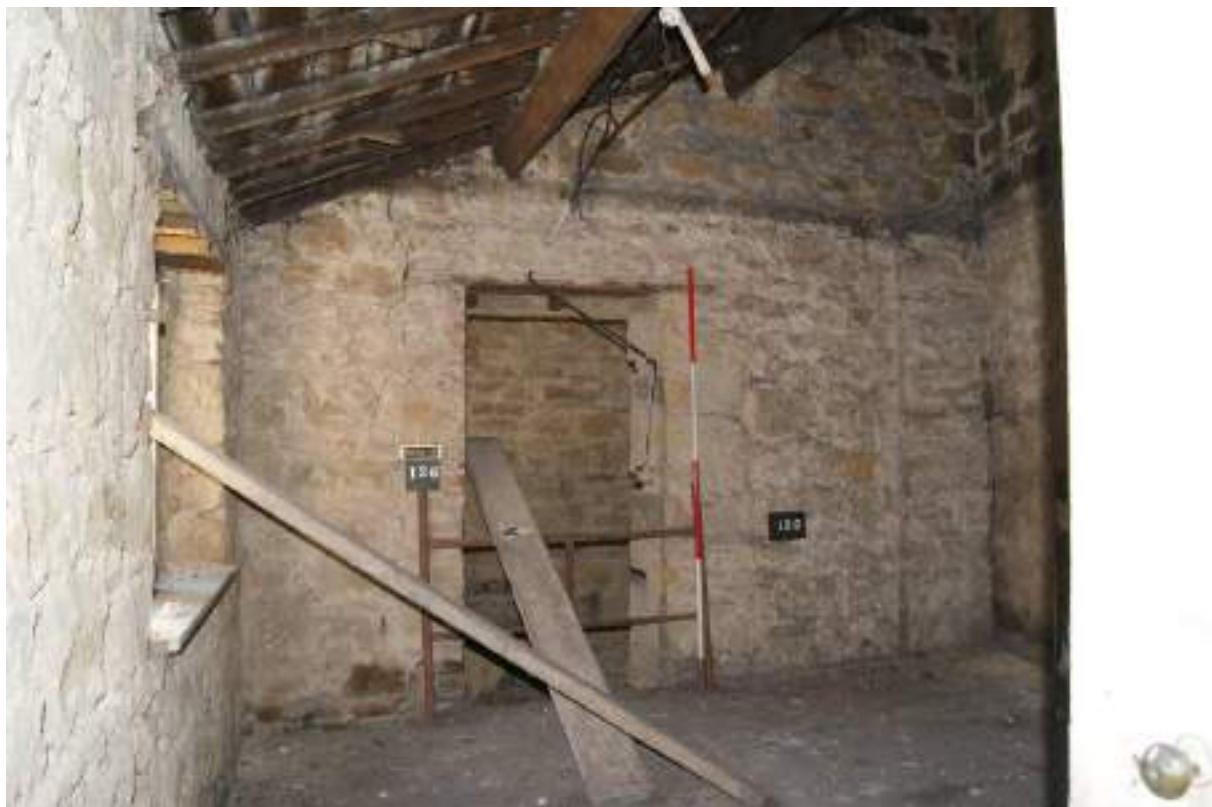
P104 (below). Room 20, looking east to door [122] in modern frame, butt-joint between east and north walls on the left, and brickwork raising the roof level above. Scale 2m.

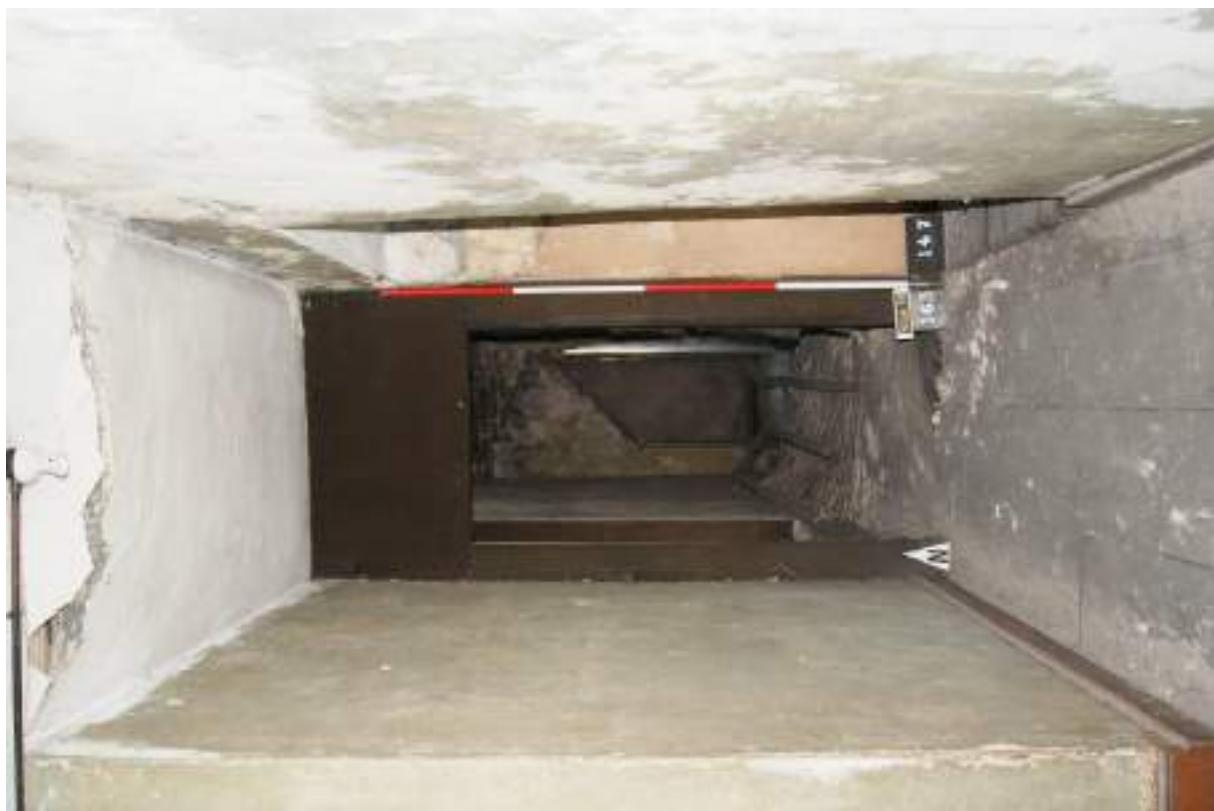
Ceiling – lath and plaster, in an unstable condition. It is proposed to install a rooflight at the south-east corner.

P107 (top). North-south passageway Room 33, looking north showing baize door [163] opening [147] leading to Rooms 34, 36 and 37] and fallen lath and plaster ceiling Scales 2m.

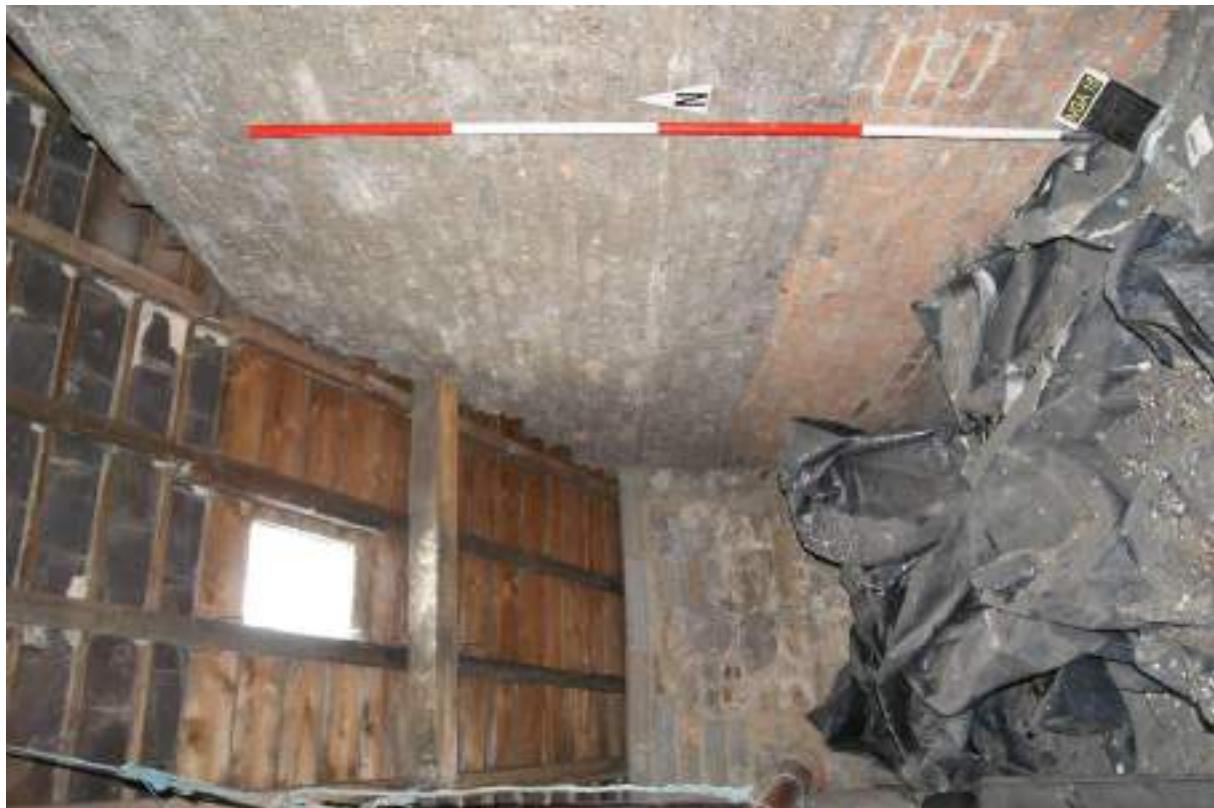
P108 (below). Room 40 looking east showing quoins of single pile house, ladder to rooftop, and 2003 breezeblock rebuilt south gable to the right. Scale 2m.

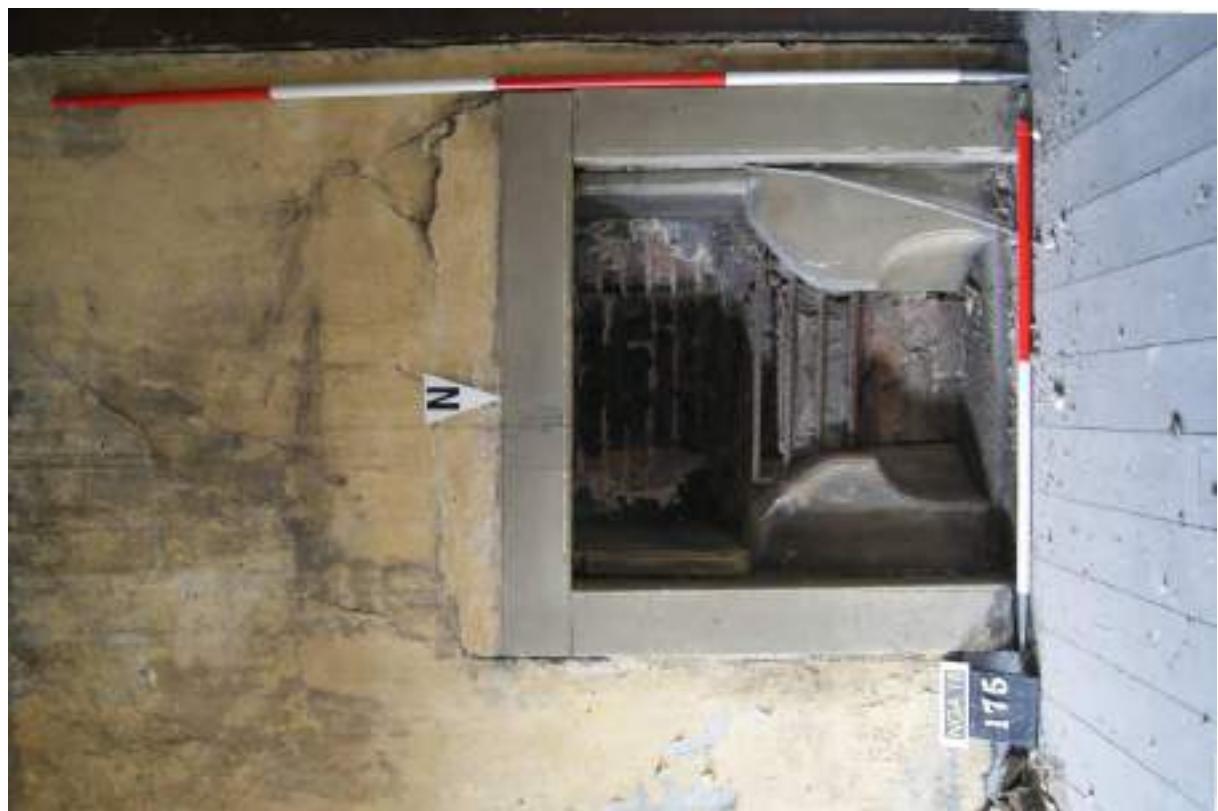
P125 (top). Room 38. Doorway [171] from passage 33 looking towards door [177] to room 41. Scales 1m and 2m.

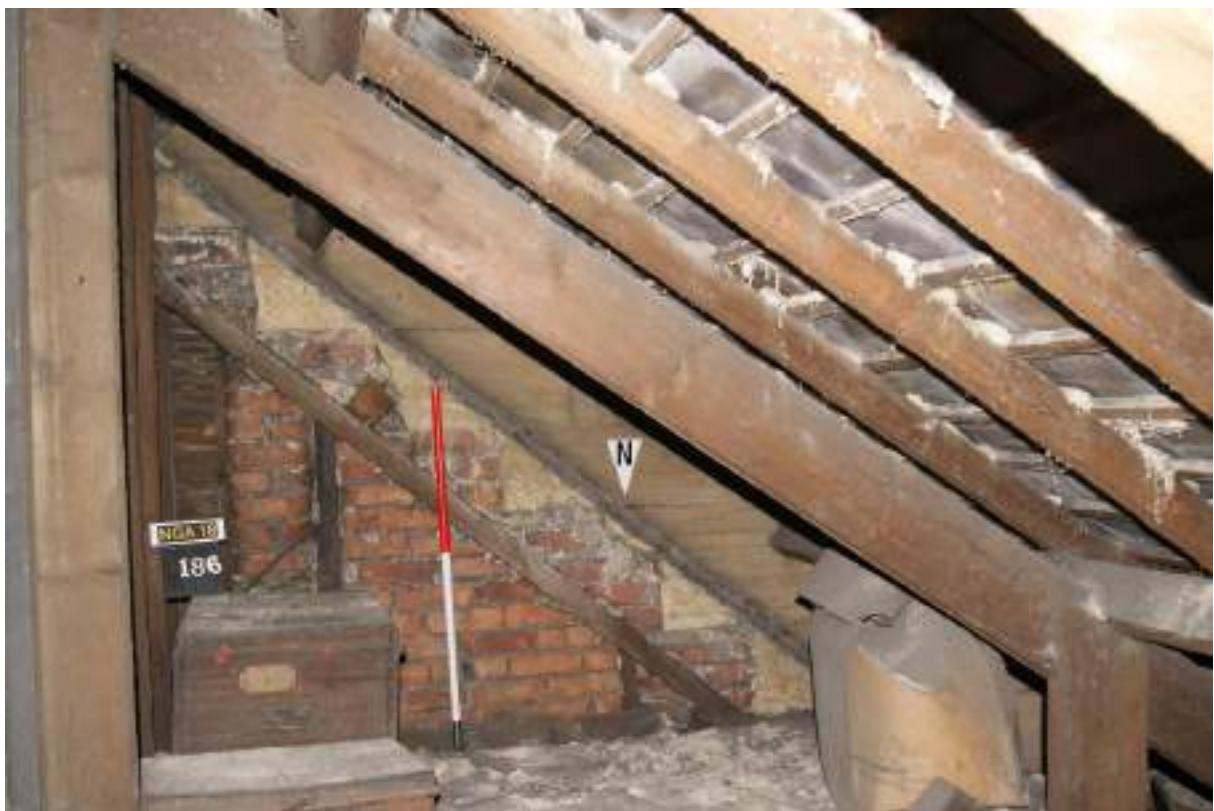
P128 (below). Room 41. Looking north to brick arch and flue in north wall. Scale 1m.
