**Narrowgate House ('General Lambert's House' – HER 4522)
31 and 33 Narrowgate, Alnwick, Northumberland NE66 1 JN
(House centred on NGR 4186299 6134983)**

**Historic Building Recording
by
Northern Counties Archaeological Services
on behalf of
Stablewood Leisure Ltd.**

Historic Building Recording

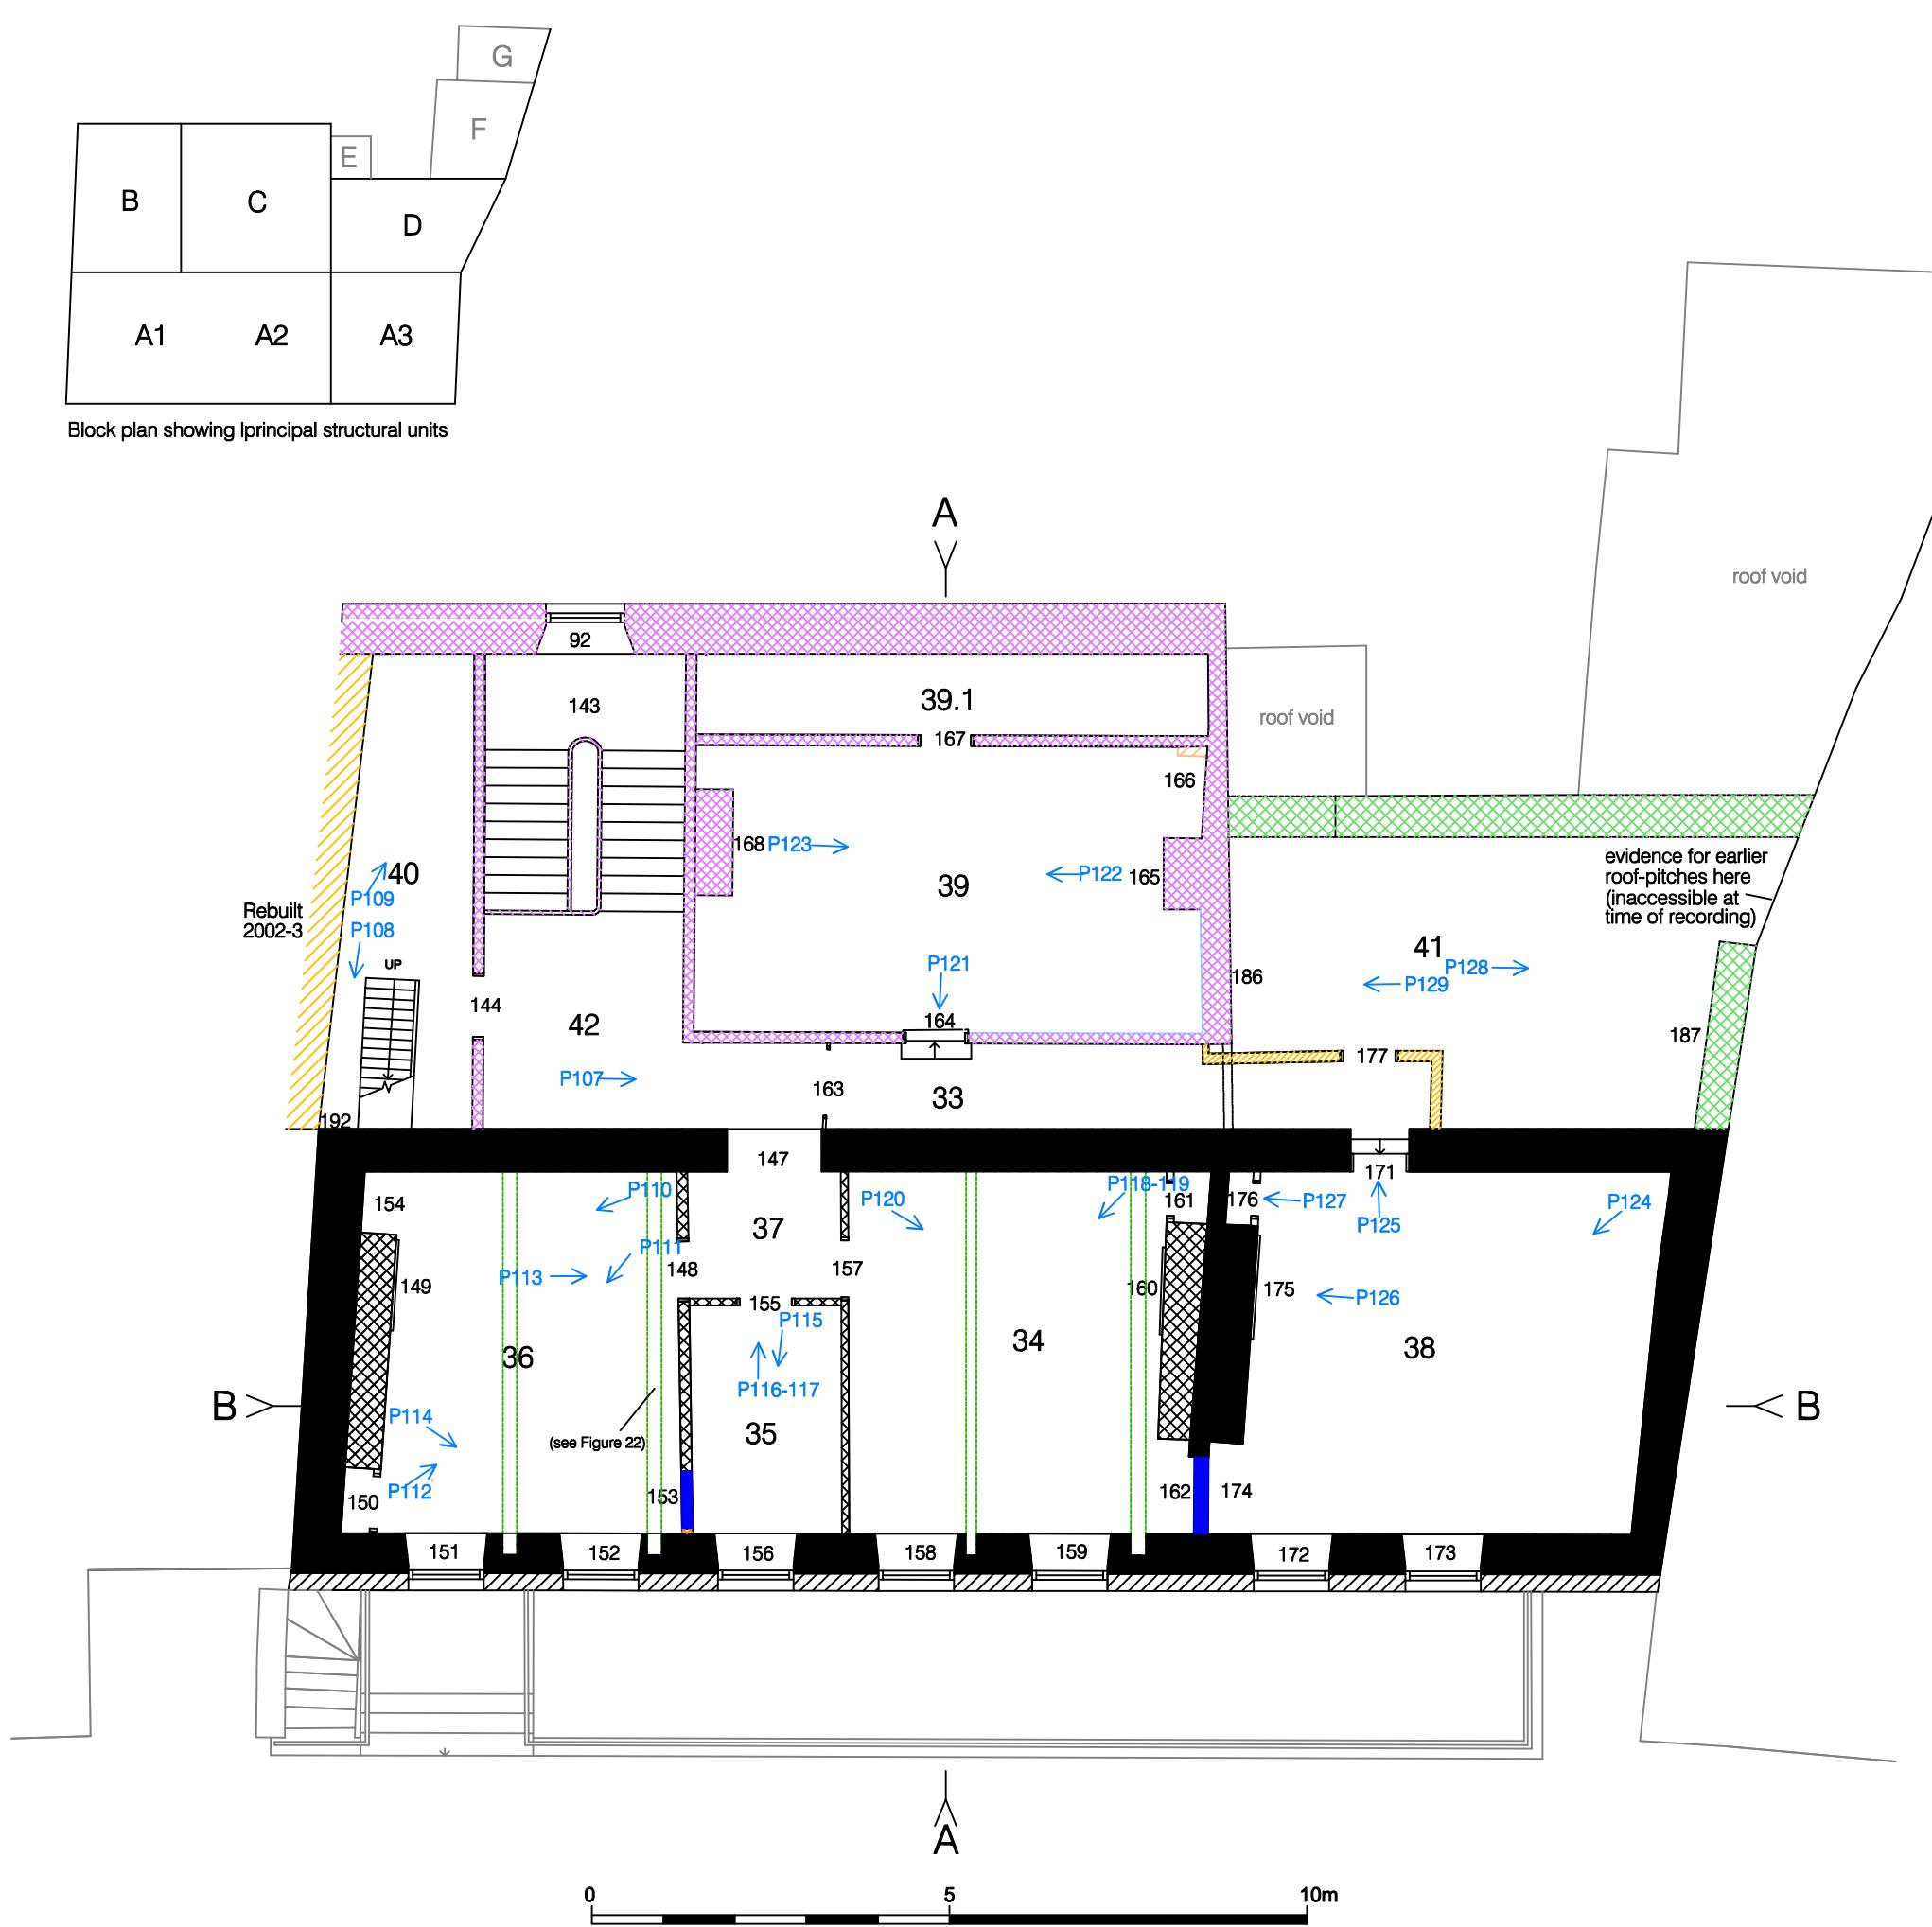
Figure 18

Based on a survey by Eriis Ltd., for
Spence & Dower LLP, with amendments
and additions by NCAS 2018

4.2.7 SECOND (ATTIC) FLOOR ROOMS (Figure 18)

- 7.3 Principally these relate to apparently un-cellared areas within the footprint of the house where deposits or artefacts relating to phases of the house development, or pre-construction land use, may survive. These are marked on Figure 15 as 'area of no known cellaring'. Another area is the second floor Room 41 where traces of earlier roof pitches are visible in the brickwork of the north wall, but cannot currently be safely accessed or adequately recorded. This is indicated of Figure 18.

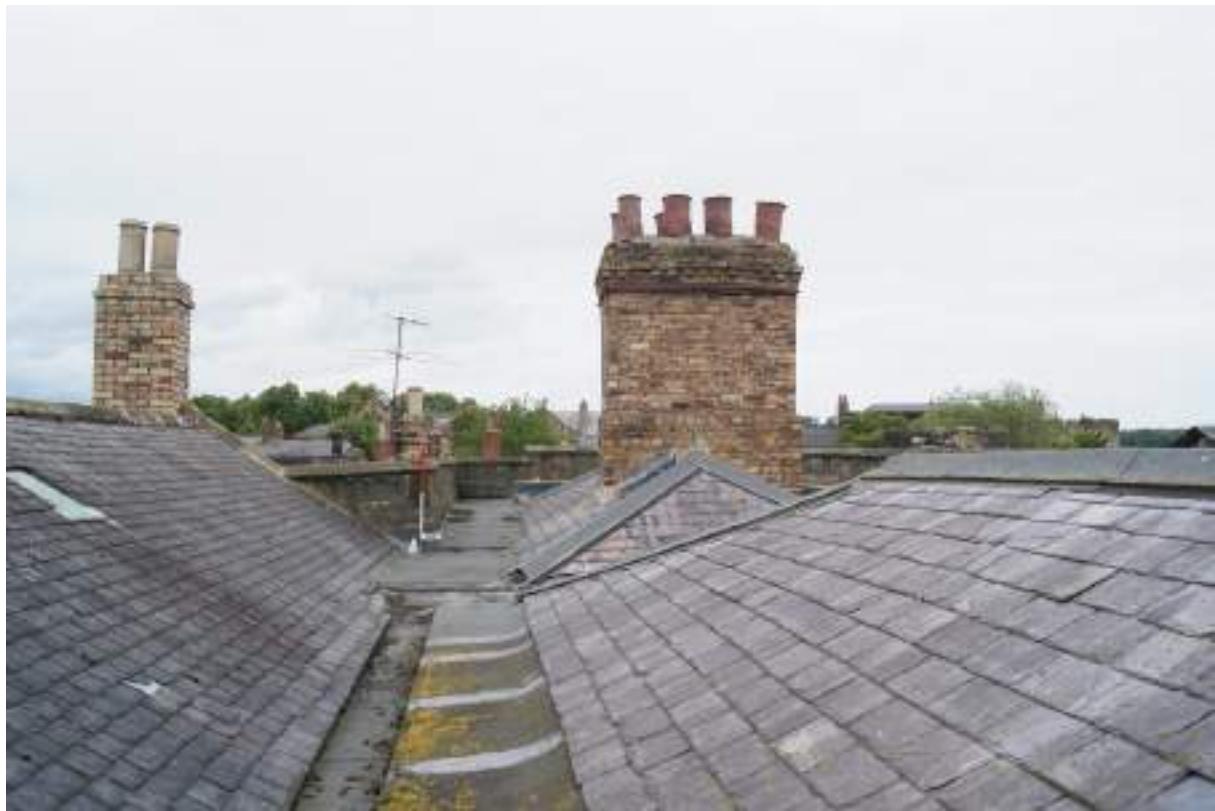
parapet level with 'Broomhill' stamped bricks (P131). There is a single ceramic pot. The head of this stack is in an unstable condition. This chimney served fires [77] (ground) and [119] (1st floor). Rising from the northern boundary wall coping on the north side of Build F is a narrow chimney [192] of possibly 18th century brick (P136). This served fires [81] (ground) and [124] (1st floor).

P130 (top). Looking north along the valley gutter from roof access door [194], showing (left) chimney [191] serving Rooms 39, 13 and 7 of the western extension, and (right) chimney [193] serving Rooms 34/38, 16/173/4 and 23/24, and the hipped roofs of the single-pile house. Scale 1m.

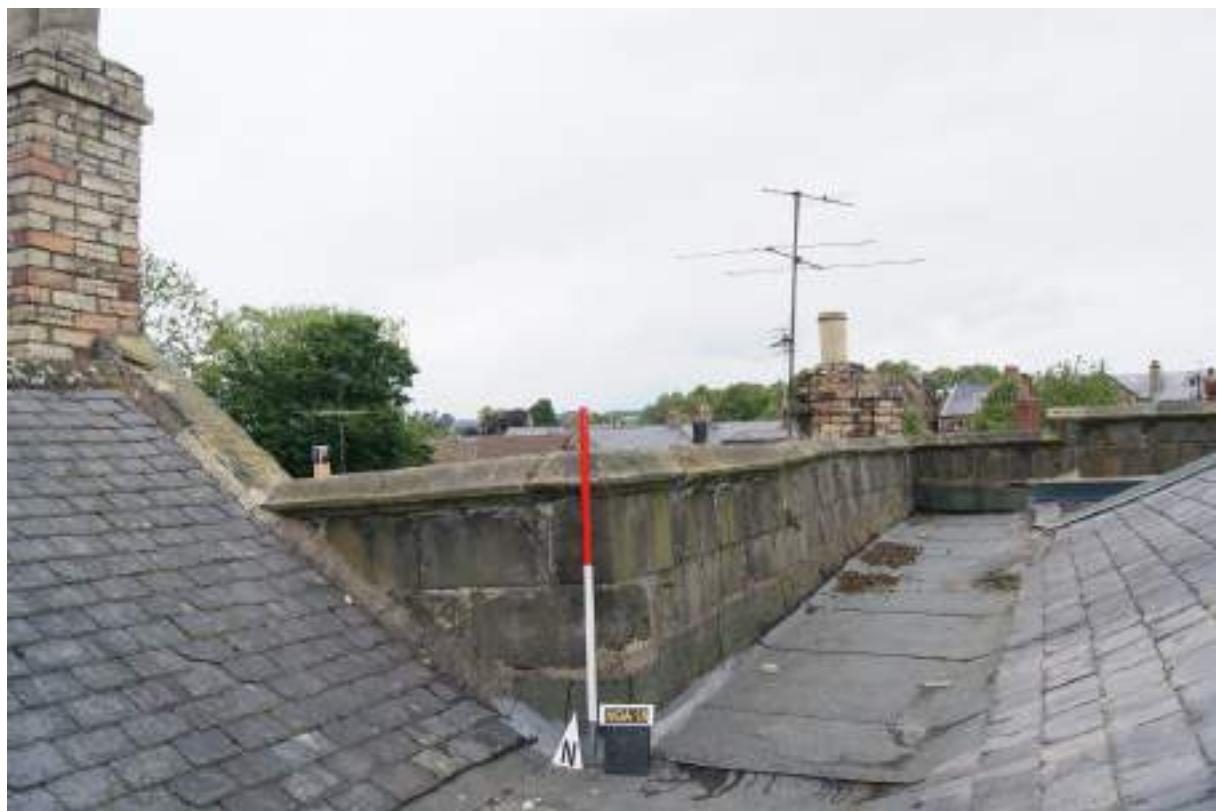
P131 (below). Detail, looking north, showing the return on the western parapet to join the north wall of the western extension, Chimney [191] and the 'step' on the northern parapet. Scale 1m.

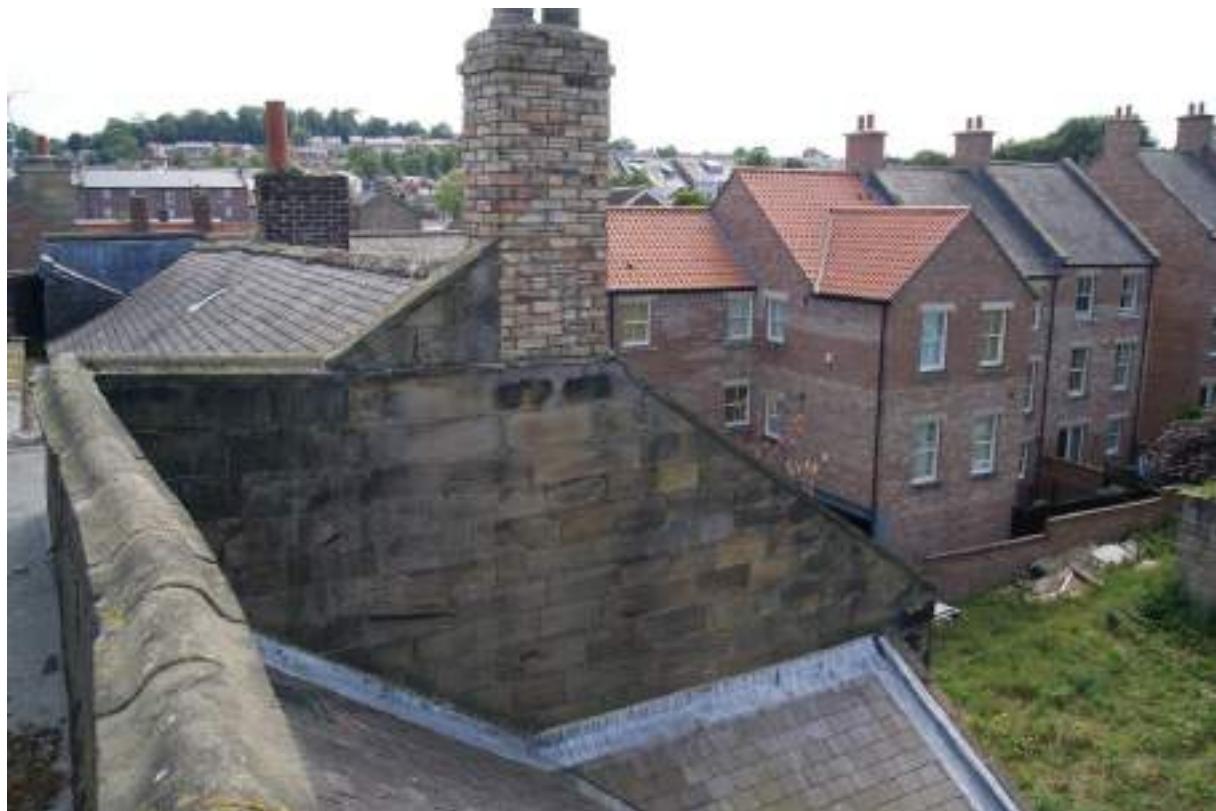
P132 (top). The western parapet looking south-east, showing deflection in the stonework, chimney [191] and junction of the parapet with the ashlar facing of the western extension. No scale.

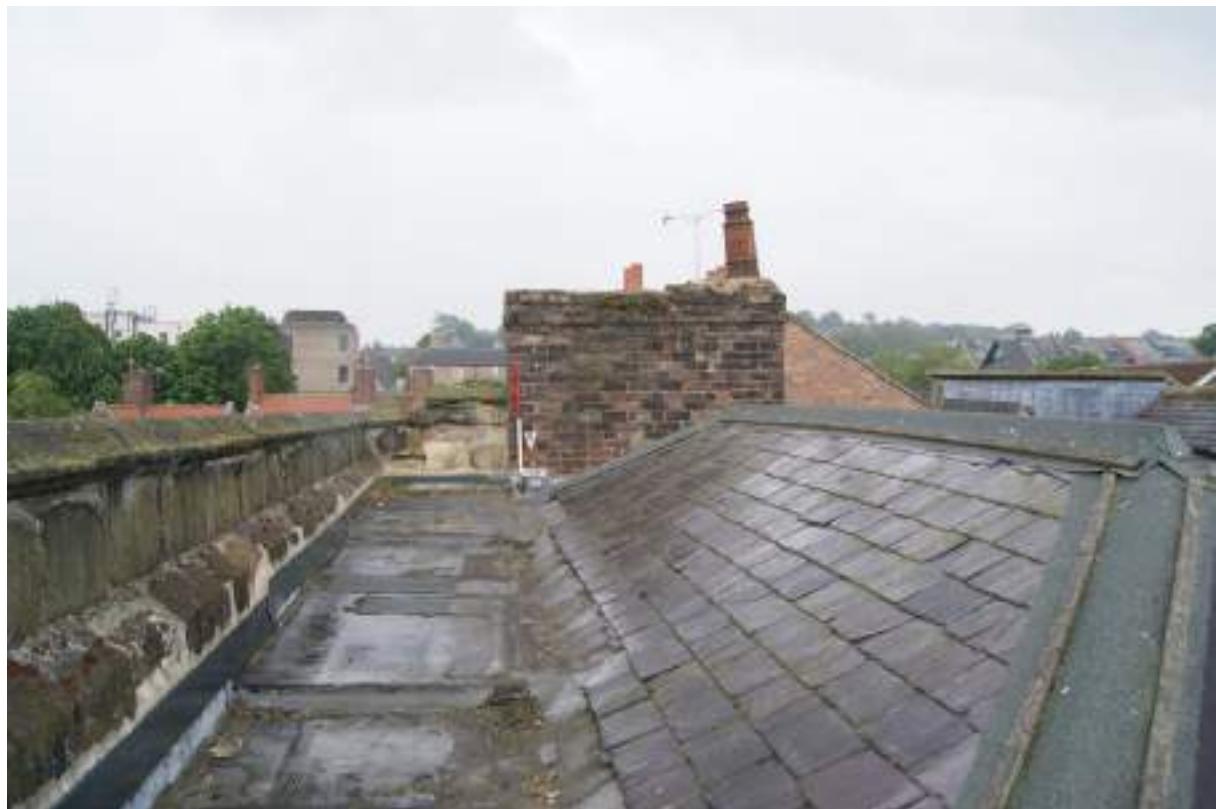
P133 (below). The north-eastern angle of the parapet looking north, showing base chamfer to the eastern parapet and evidence for remodelling shown in the 'step' on the coping. Scale 1m.

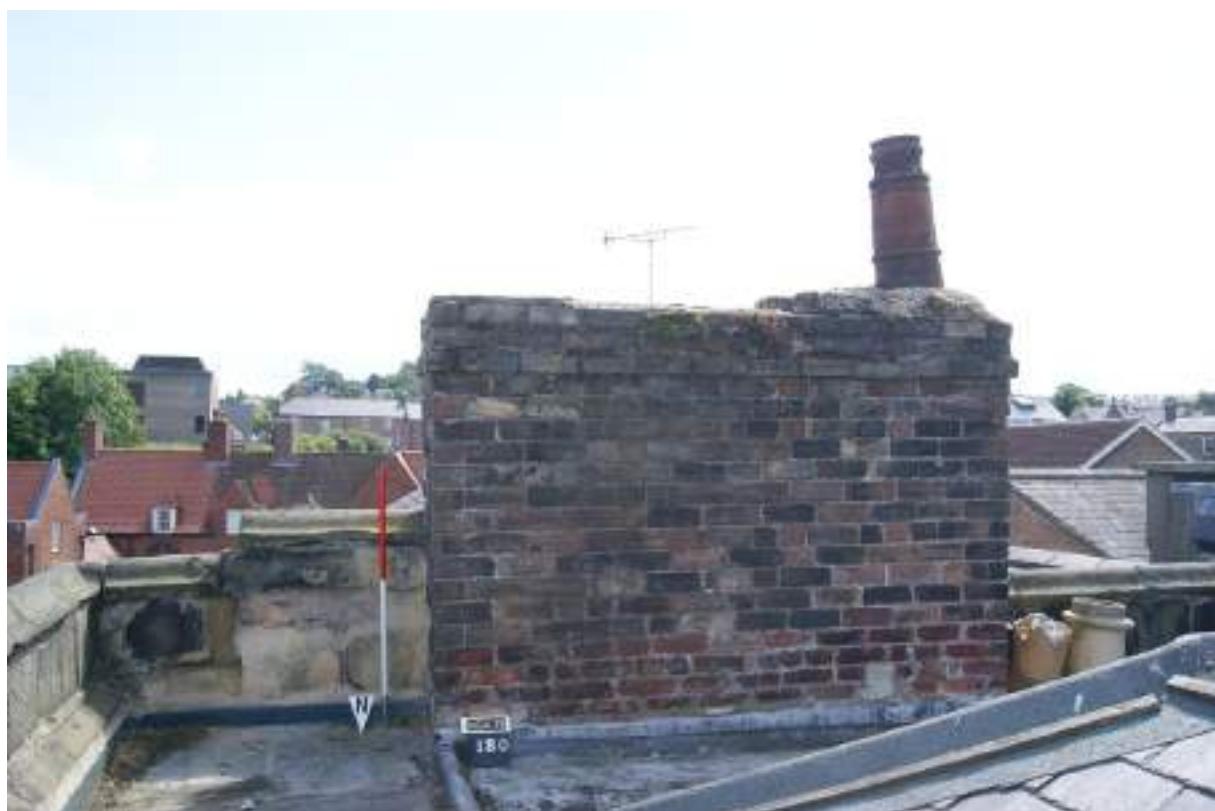
P134 (top). Looking south along the eastern parapet showing base chamfer, chimney [180] serving fires in Rooms 36, 18 and 22, and the slated hipped roof over 31 Narrowgate. Scale 1m.

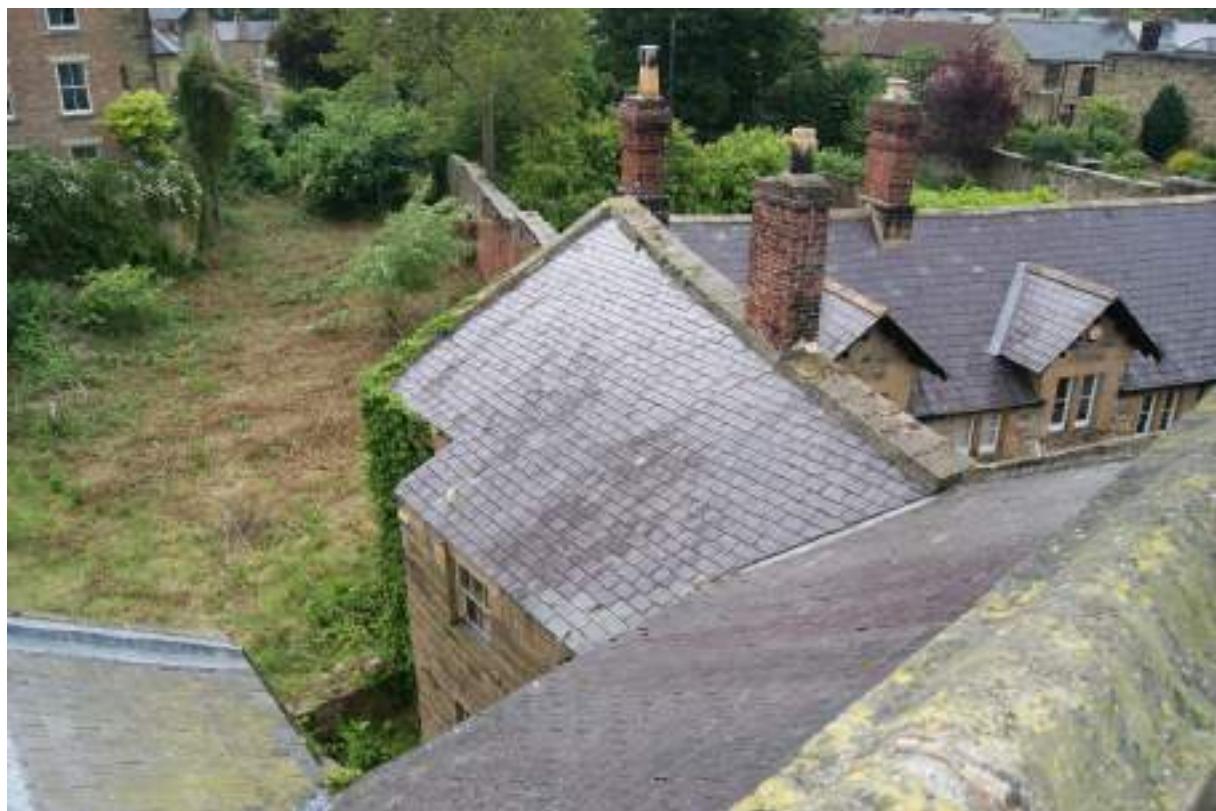
P135 (below). Detail of the south-eastern angle of the parapet showing evidence for remodelling, and chimney [180]. Scale 1m.

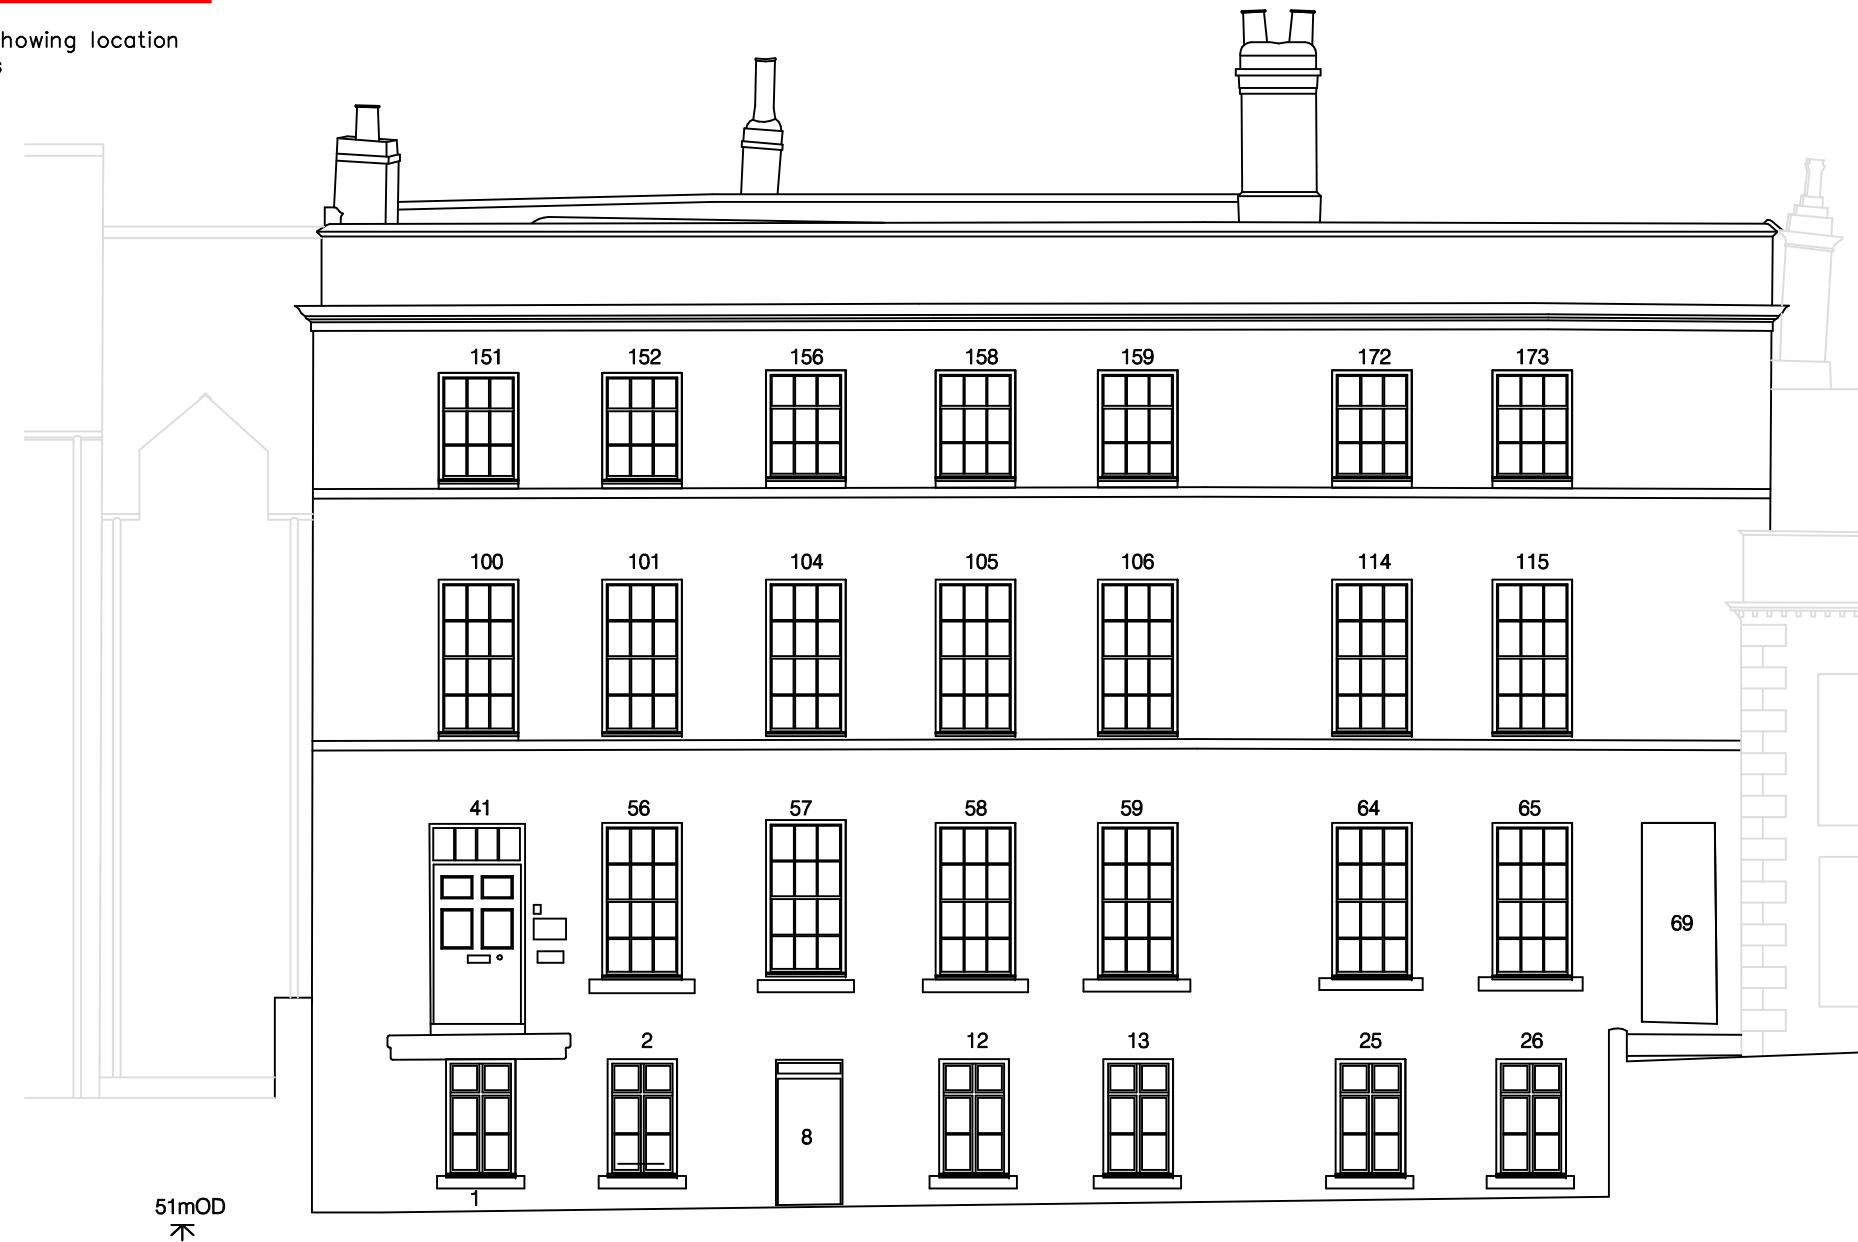
East Elevation

Block plan showing location of elevations

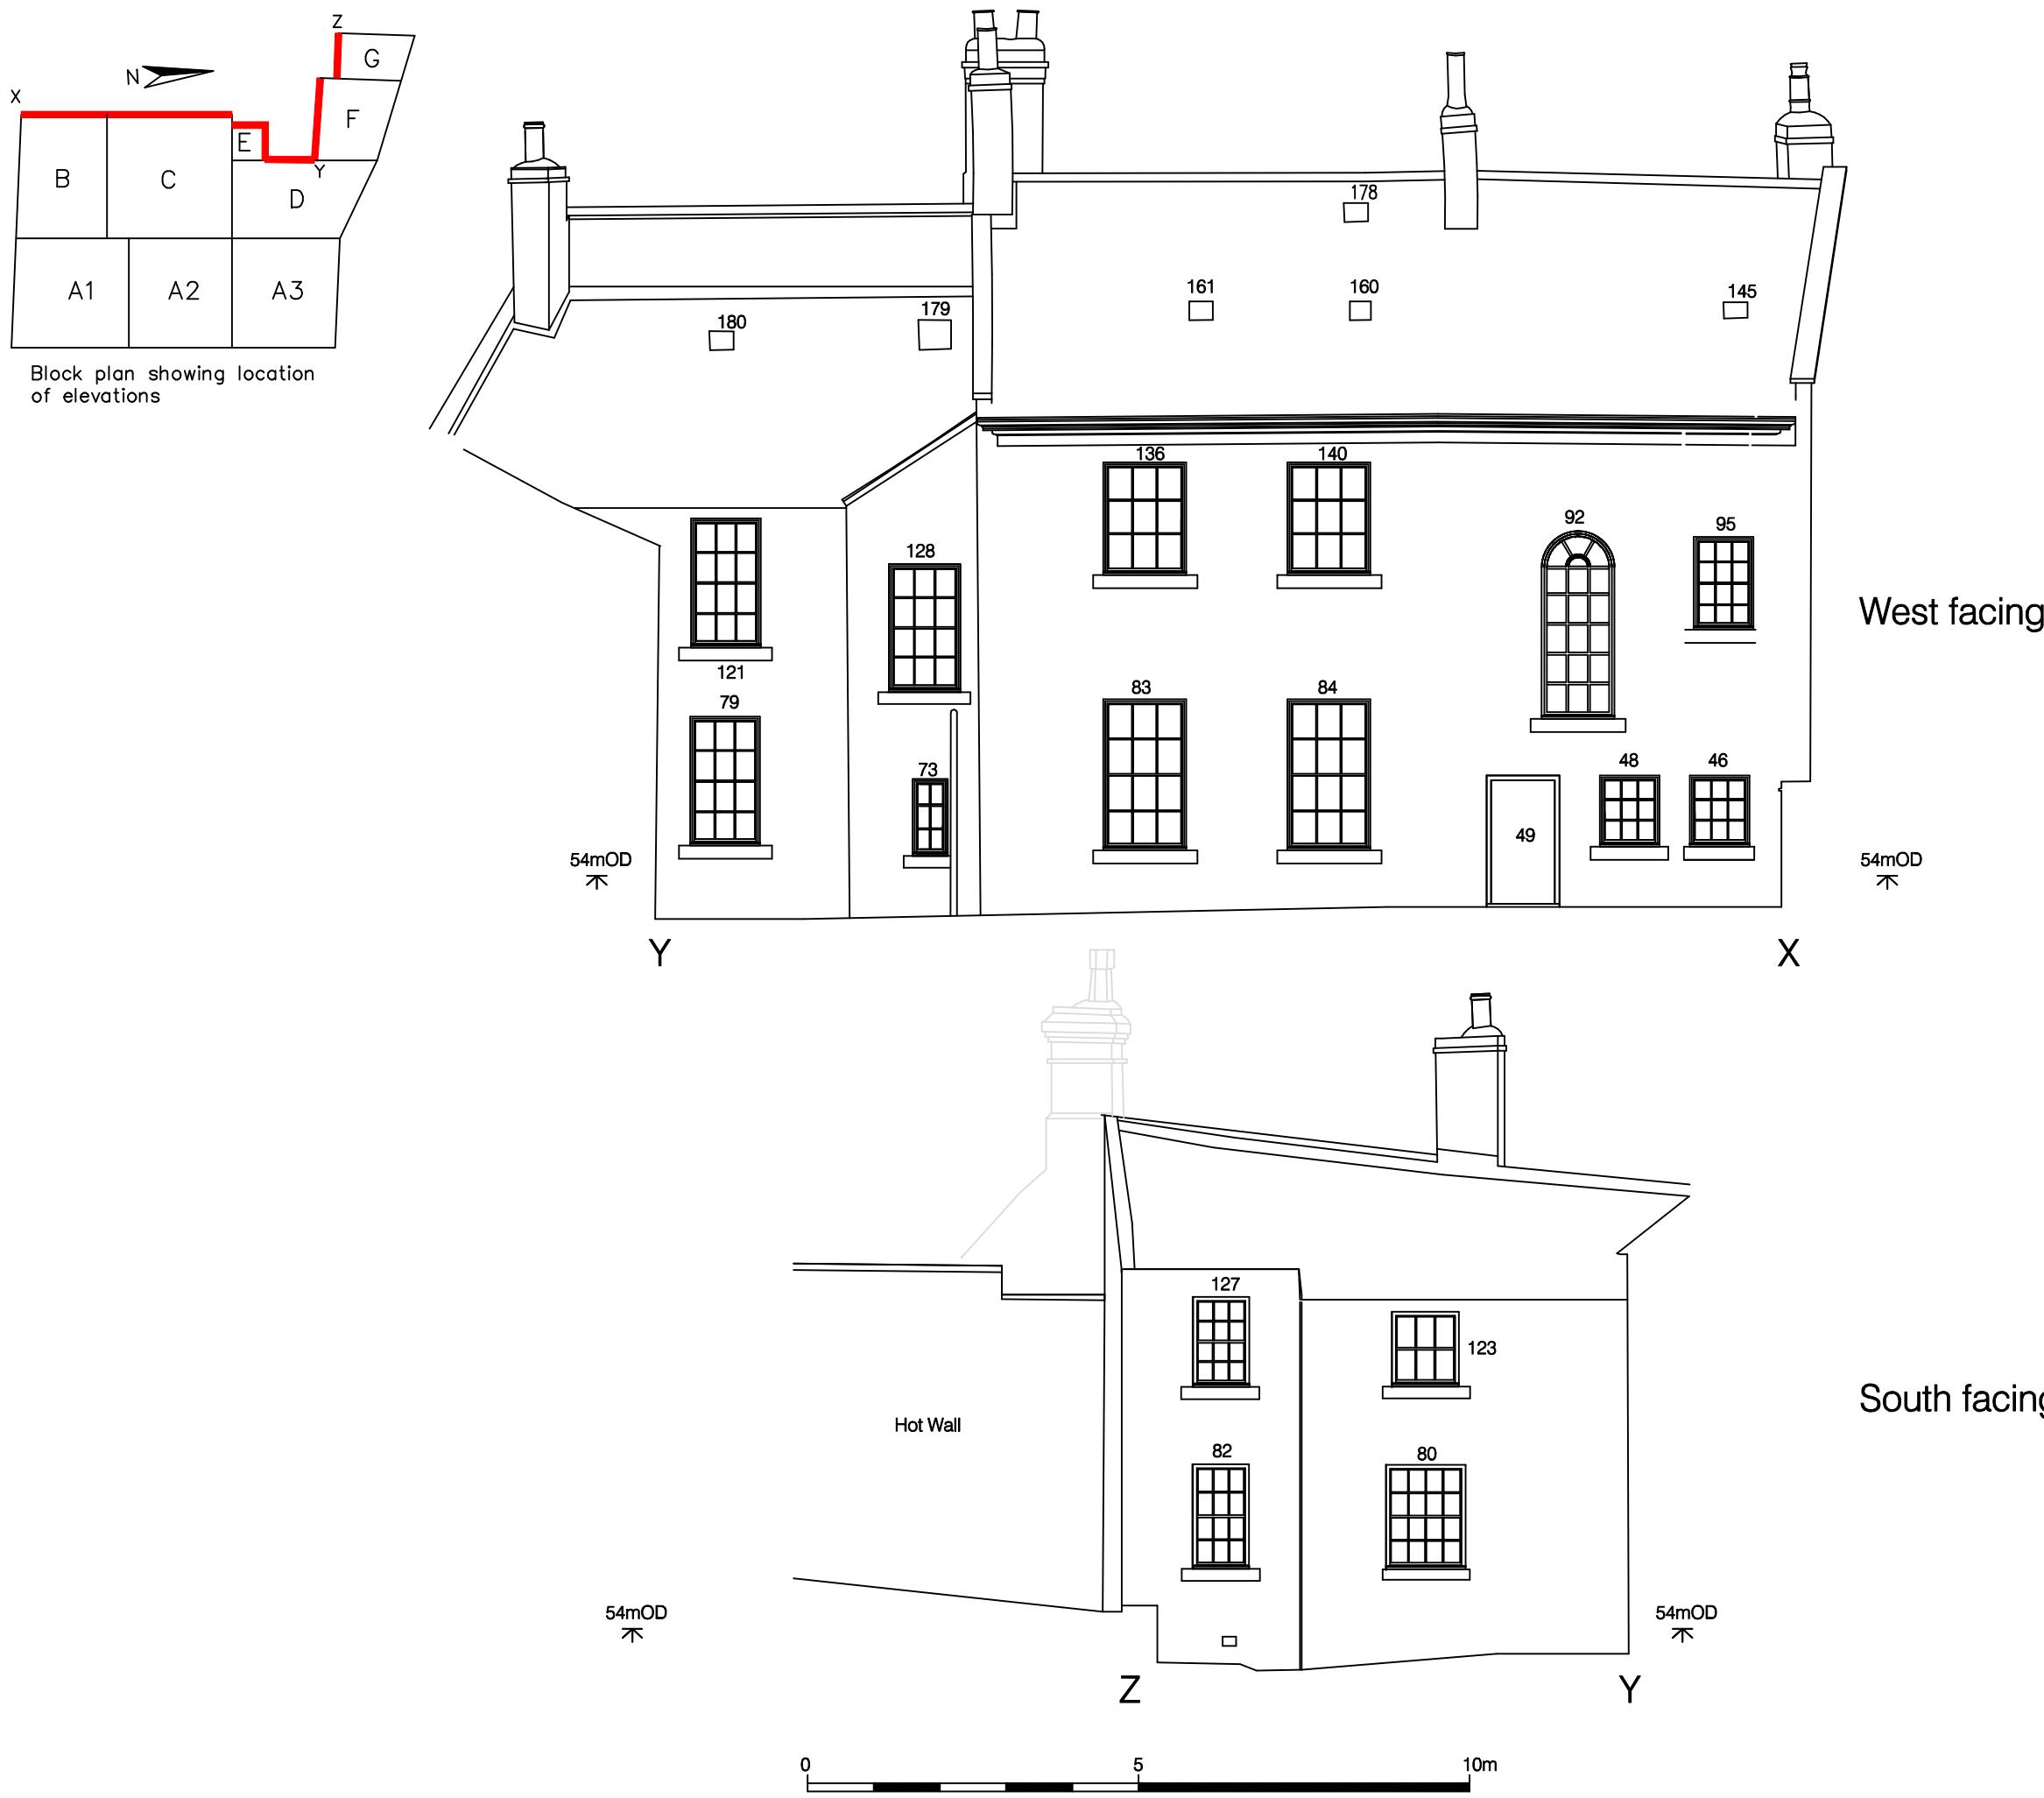
Figure 21
Narrowgate House, Alnwick
Rear elevations

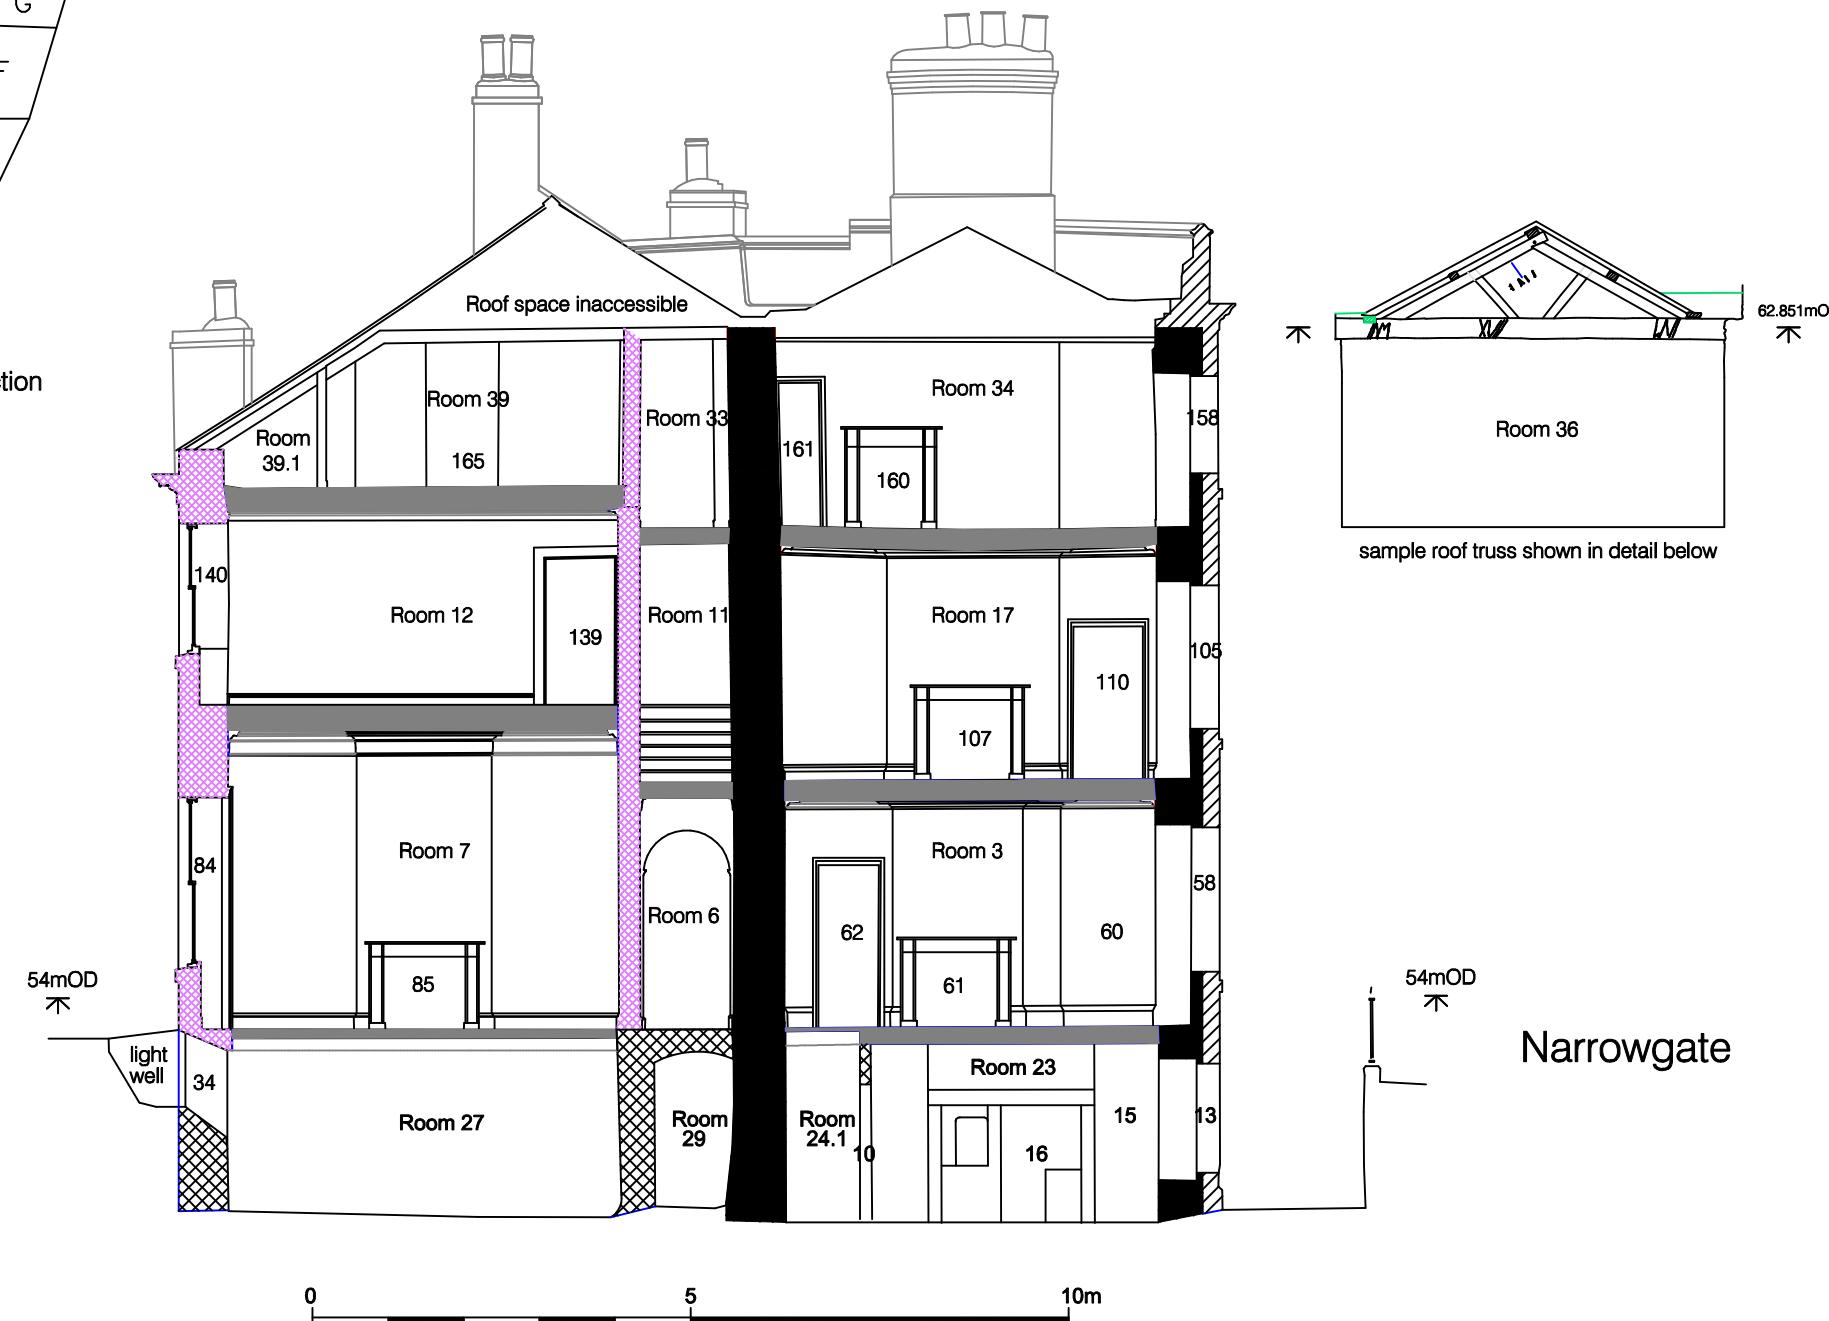
Detail of northern roof truss (south face) in Room 36 @ 1:20
(modern timberwork shown in green)

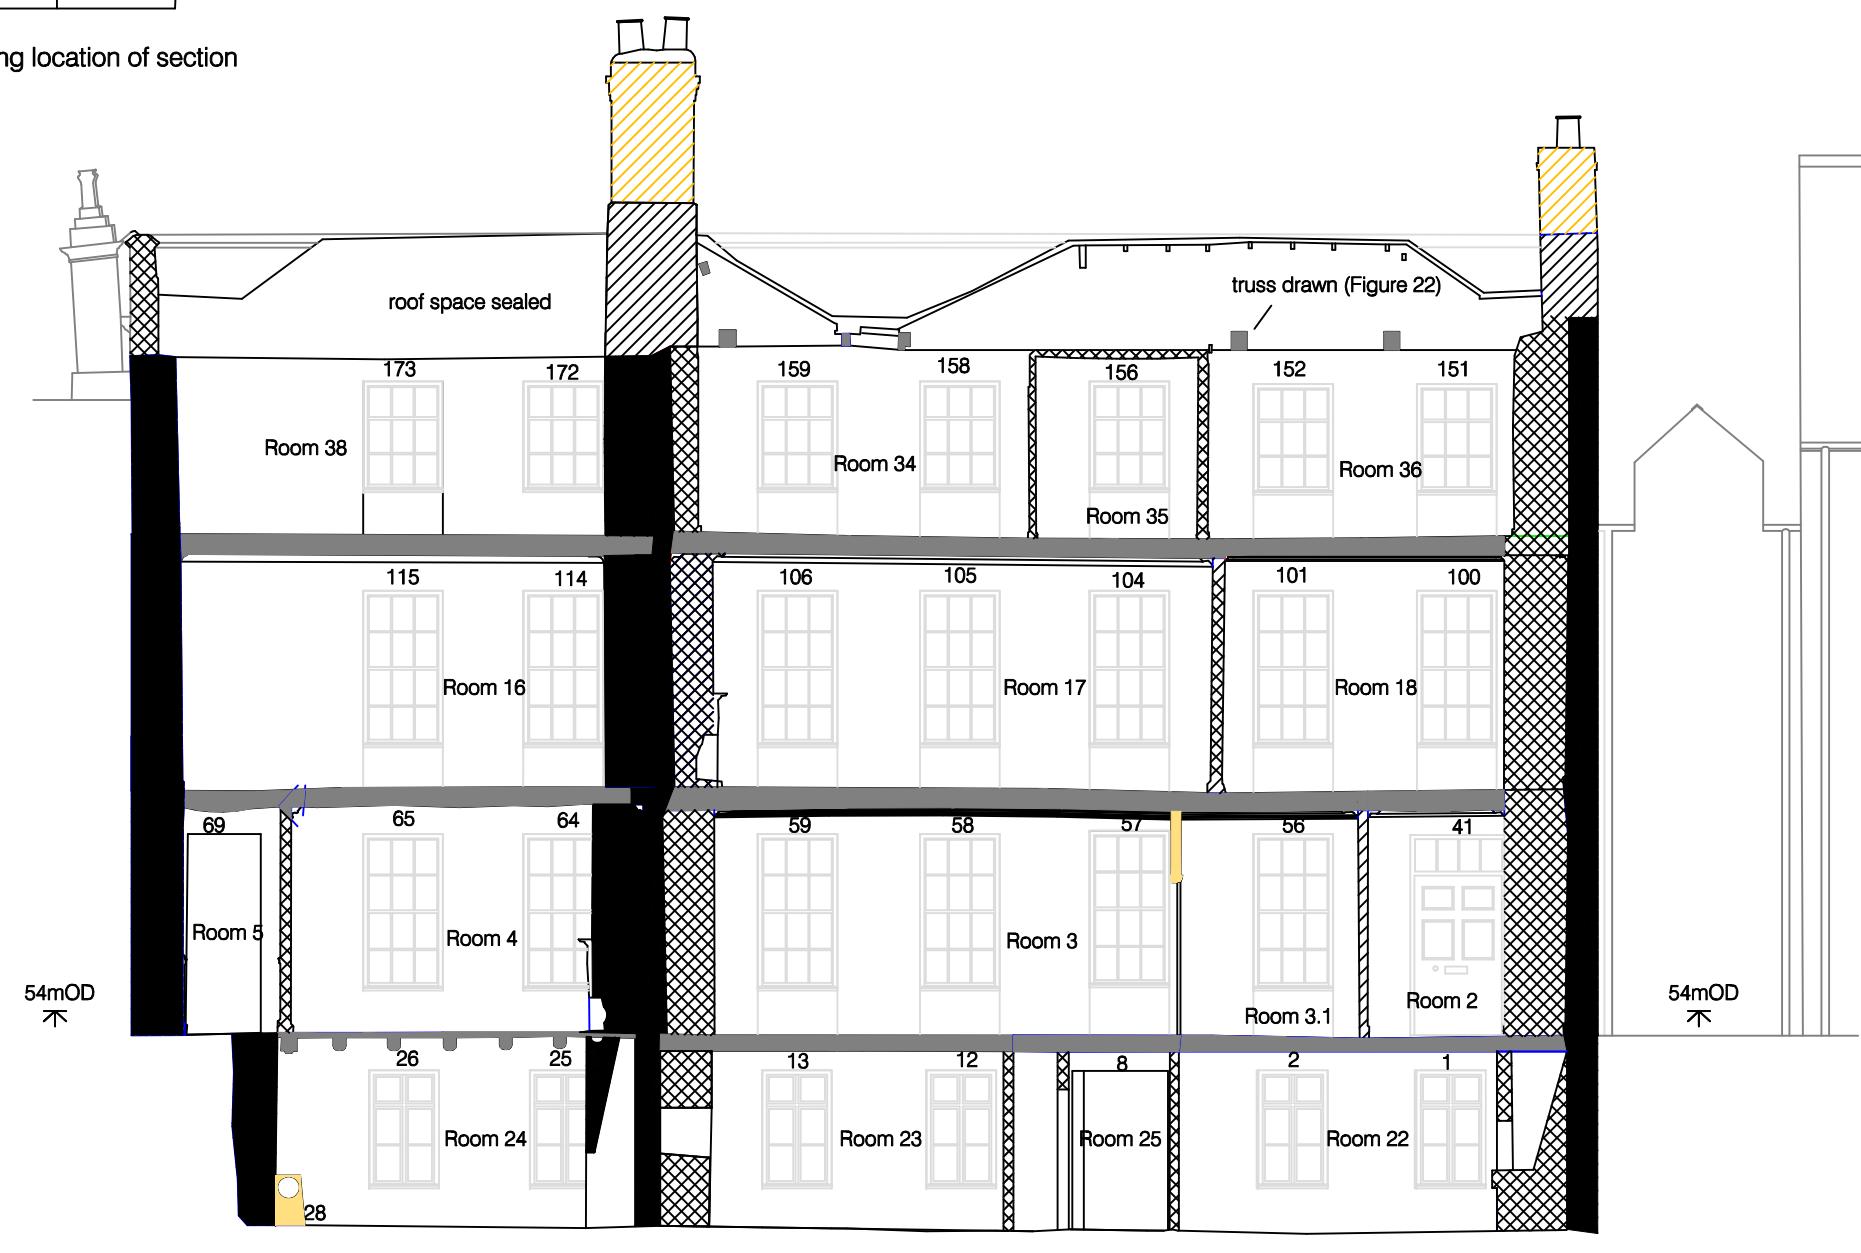
Block plan showing location of section
