BOLAMS MILL, ALNWICK

PROPOSED RESTORATION AND CONVERSION OF MALTHOUSE KILN
TOGETHER WITH BOLAMS MILL AND BOLAMS WAREHOUSE.
PARTIAL DEMOLITION AND NEW BUILD TO PROVIDE A TOTAL OF 33
FLATS WITH OFFICE / RETAIL ACCOMMODATION AND 25 ASSOCIATED
CAR PARKING SPACES.

The Maltings and Bolams Mill, Alnwick

archaeological desk-top and buildings assessment

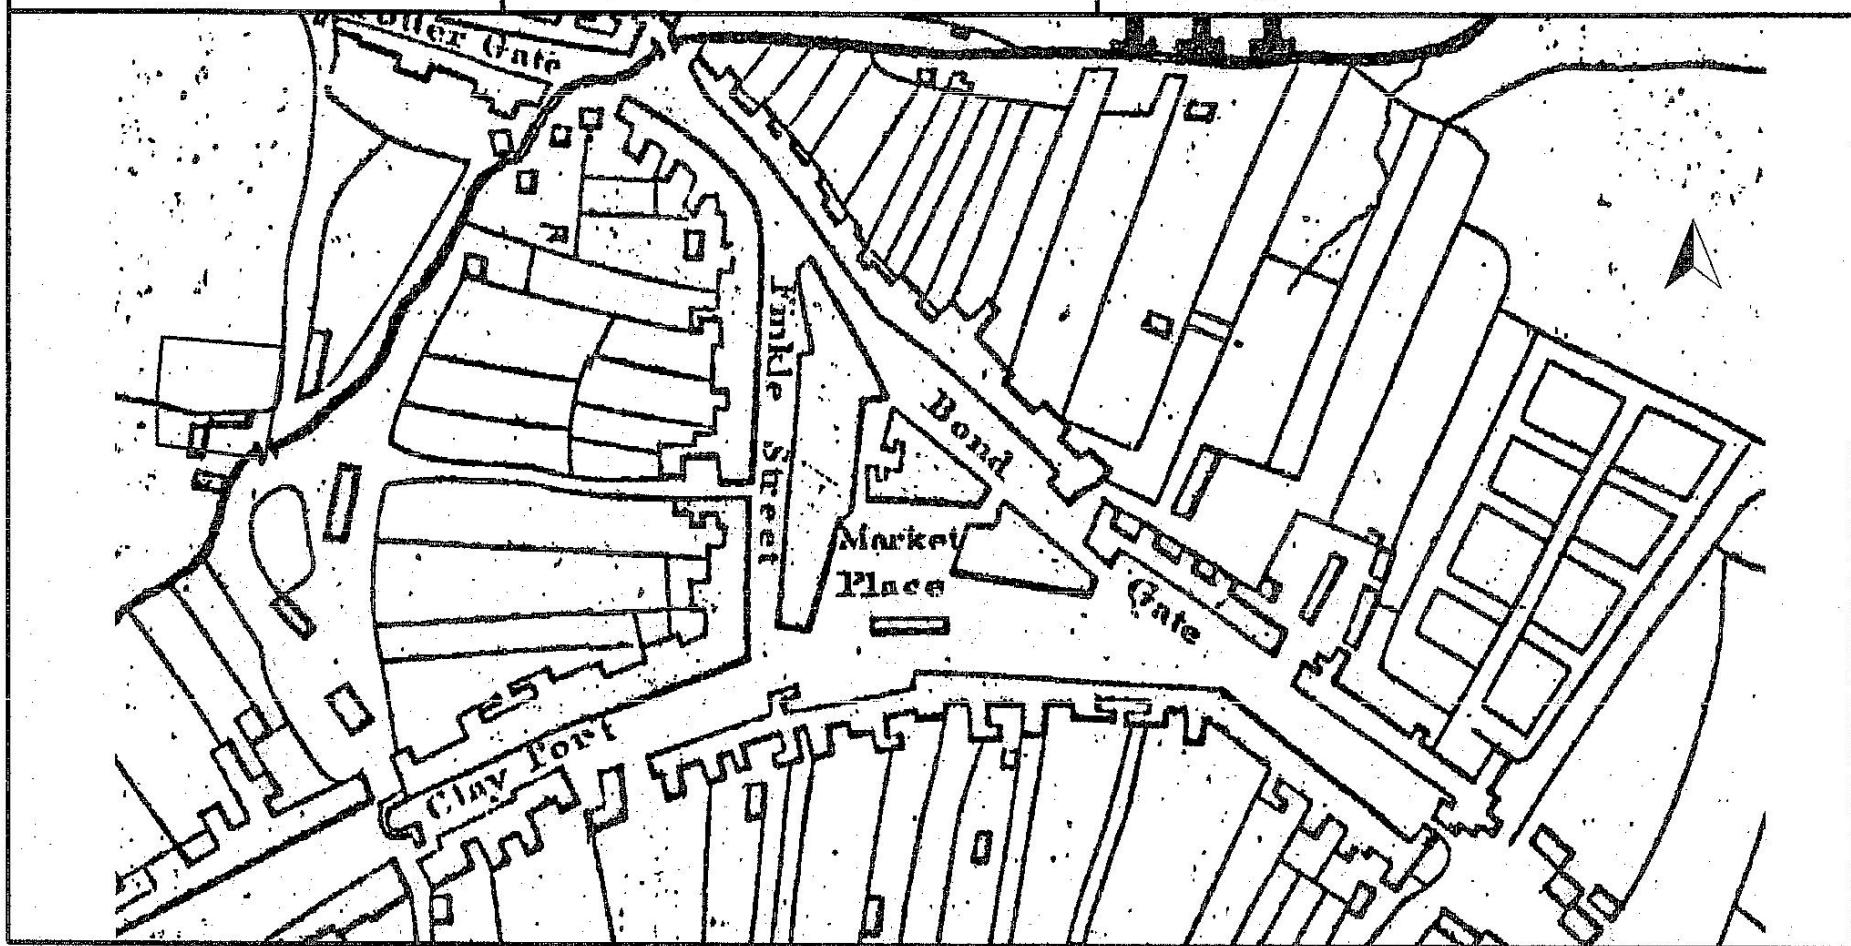
Figure 2

Extract from Armstrong's plan of Alnwick (1792). The proposed development area is marked in red (approximate)

4.9 The town of Alnwick is shown as a detailed inset on Armstrong's 1792 map of Northumberland (Figure 2). The site appears to be located primarily within a field, possibly incorporating two of the adjacent buildings, which appear to be associated with a watermill over Bow Burn. The course of the stream, and the associated bridge may also be within the site. Dispensary Street is not shown, although a gap between field boundaries leading from Pottergate to the bridge over Bow Burn suggests some form of lane. A map by Thompson is a slightly modified copy of this map (Figure 3). The map is undated although the paper contains the watermark 'Green 1822'. It appears to be a copy of an earlier map prepared by Tate for his book on Alnwick. The map shows the field belongs to Elizabeth Gray and gives greater detail to the mill buildings, showing seven smaller structures within the yard.

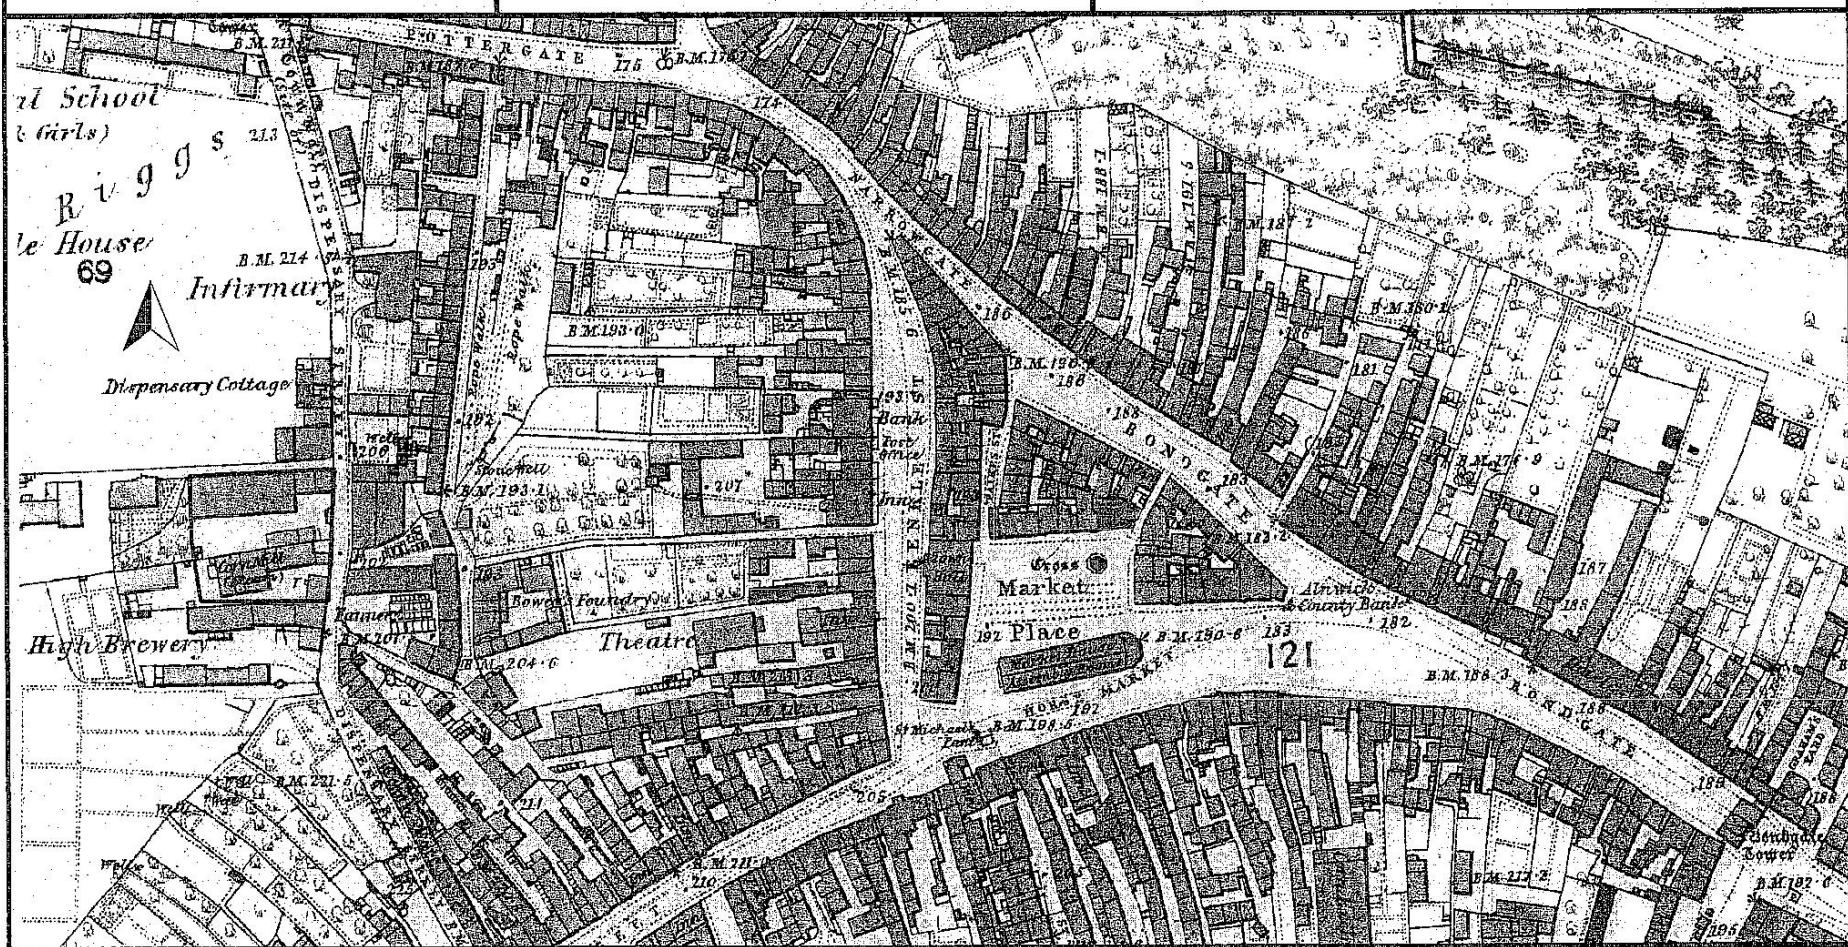
Figure 5

*Extract from the 1st Edition O.S. 25 inch map of
c.1860 (the proposed development area is marked in
red)*

4.12 The First Edition Ordnance Survey map (c.1860, Figure 5) shows further changes to the buildings. The Maltings includes an extension to the east and the building associated with the tannery appears to have been replaced, or at least significantly altered, and is now marked as a corn mill. It is noted that the mill is powered by steam. The brewery is now shown as High Brewery. Back Way is now Dispensary Street and the site of the Town Wall is shown at the northern end. A back lane appears to run along the north side of the Maltings, linking Dispensary Street with the new school.

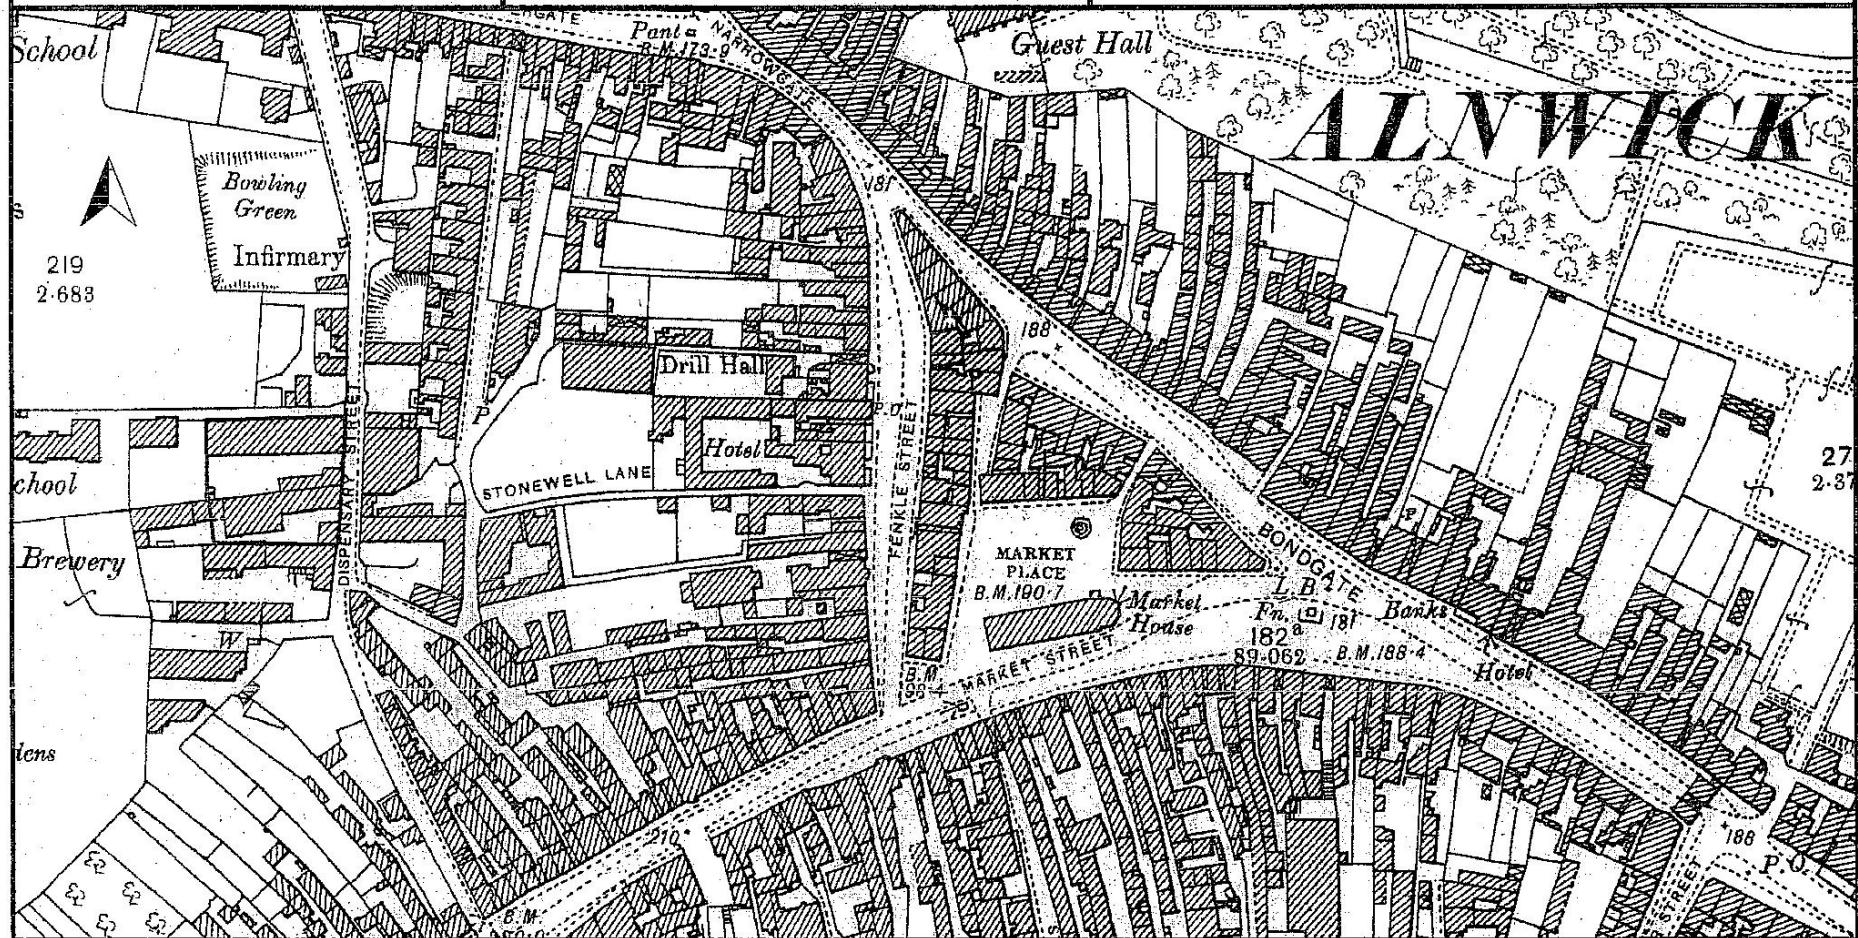
Figure 6

*Extract from the 2nd Edition O.S. 25 inch map of 1897.
The proposed development area is marked in red*

4.13 The Second Edition O.S. map (1897, Figure 6) shows little difference from the first edition. The Maltings has been redeveloped at the eastern end, as has the corn mill. The smaller building between has also been extended. Building plans (see section 11) show proposals were approved for alterations to Alnwick Brewery in 1870, 1881, 1886 and 1897. Significantly the proposal from 1886 was for the construction of a two storey building with an open shade below, a barrel steaming house and a cooperage for Mr J Bolam. This indicates that Bolams Mill was a part of the brewery. In 1891 Mr James

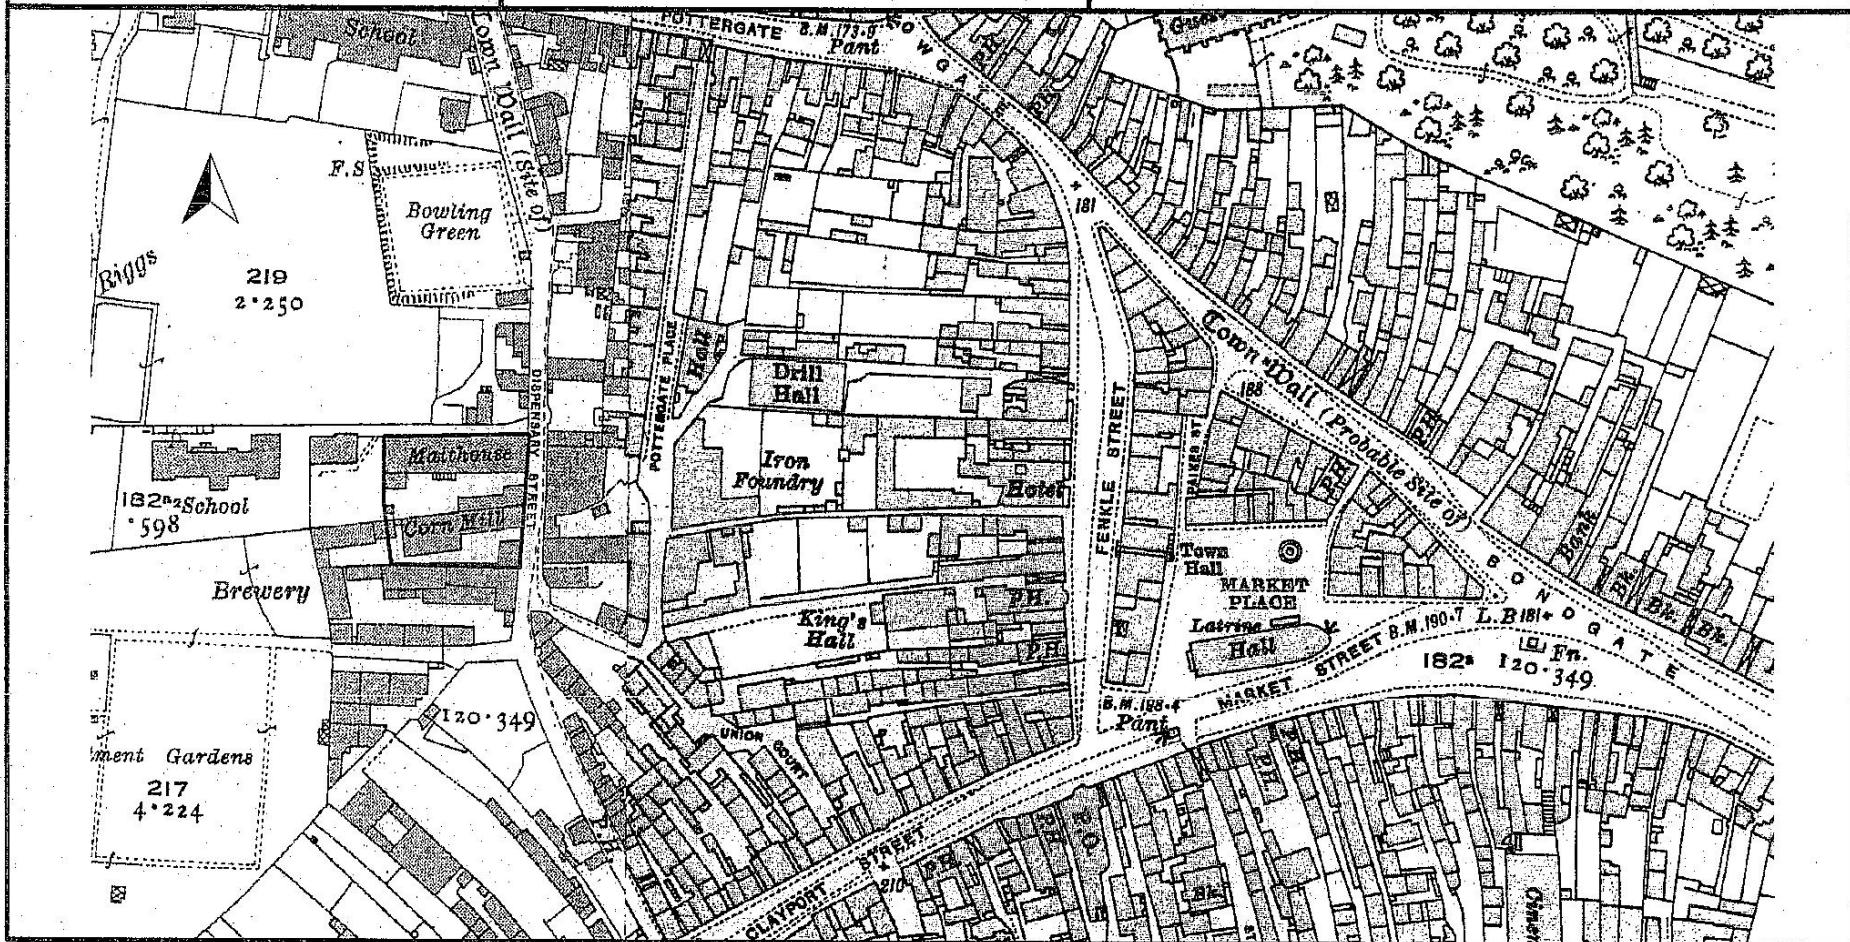
Figure 7

*Extract from the 3rd Edition O.S. 25 inch map of 1923.
The proposed development area is marked in red*

4.14 The Maltings is also marked as a malthouse in the third edition OS Map (1923, Figure 7). There are additional buildings on the brewery site, but no apparent changes to the study area.

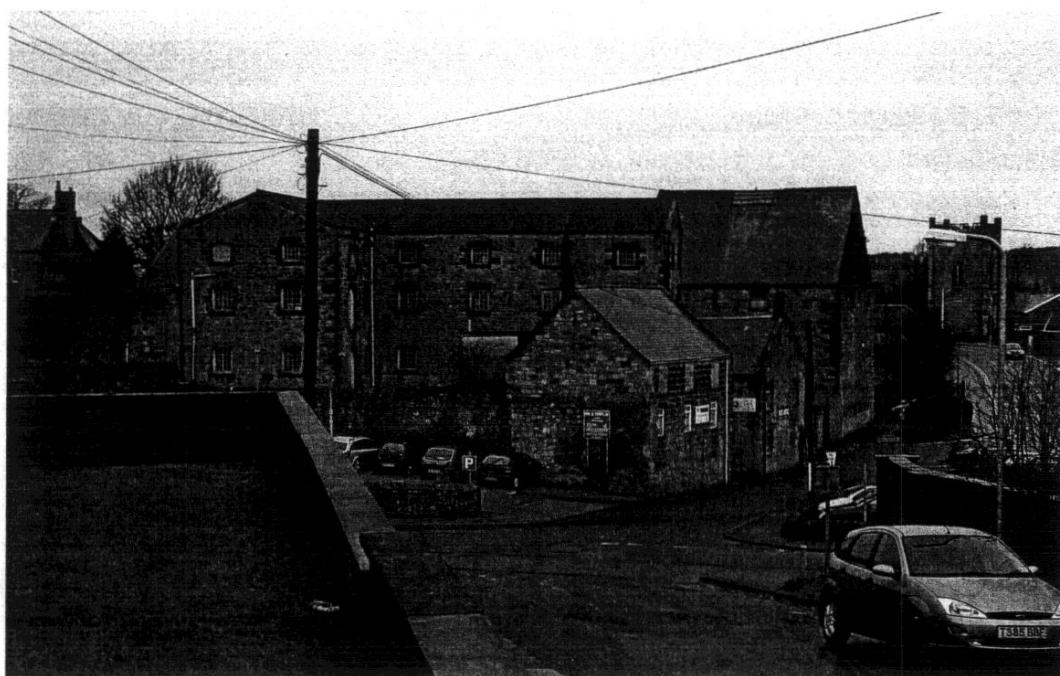
Figure 8 General view of the site from the south. Bolam's Mill is at the centre, hiding The Maltings: the malt kiln is under the large slated roof at the right.

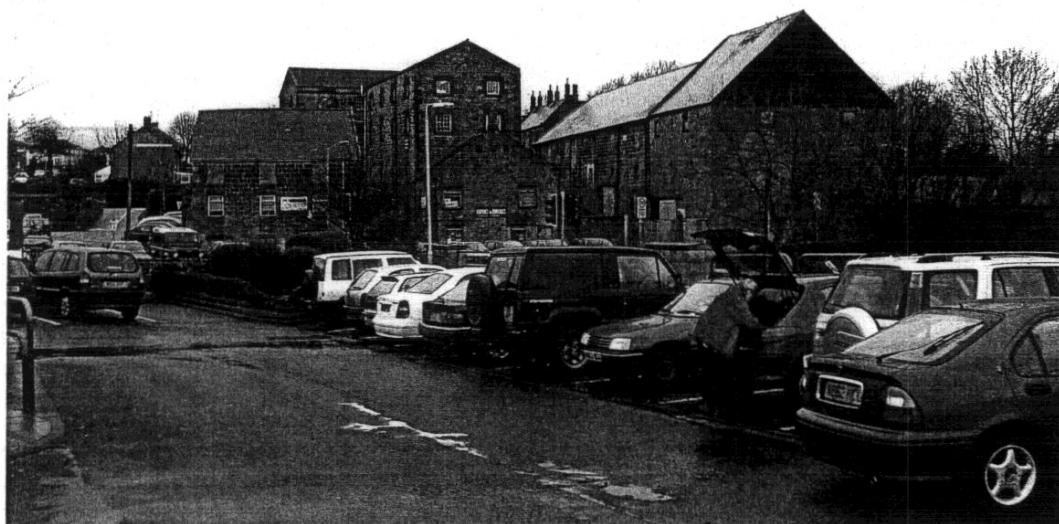
Figure 9 General view from the east. A slight fall is visible from this point near the supermarket into the valley of the Bow Burn; the land rises again across the study area. The tall mill building at the centre lies behind the former manager's house and the south-eastern building; The Maltings lies to the right.

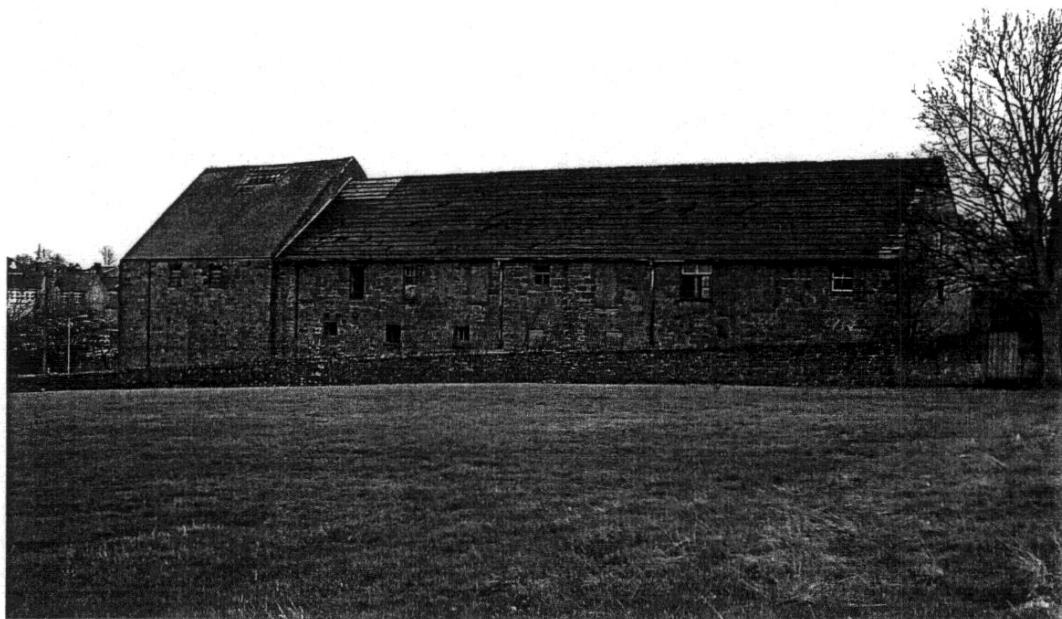
Figure 10 The Maltings, from the north-west. The irregularity of the fenestration can be seen in this view; the malt kiln to the left has no original openings left. The lower row of windows serves the upper growing floor, and the west end of the ground floor is below ground level.

5.2 The north, west and east faces of the main malthouse building are made of coursed sandstone rubble with big lintels and projecting cills (Figure 10). The south face is made from dressed sandstone blocks (Figures 14 & 15). There have been numerous alterations to the original fenestration; on the north side there were originally nine bays, with tall windows to the second floor, and a quite differently-spaced series of seven square windows on the first floor. A similar range of square windows lit the eastern part of the ground floor. Of these original openings all but seven have been blocked up, and of those, three have been altered in size. In the south wall, there is a very irregular series of windows, some of which match the shape of those in the second floor at the north. There has been much alteration here, and there is evidence of an external stair, shown on a plan of 1891 (Figure 22), but now vanished. The roof is slated, but all of the slates on the northern pitch have gone.

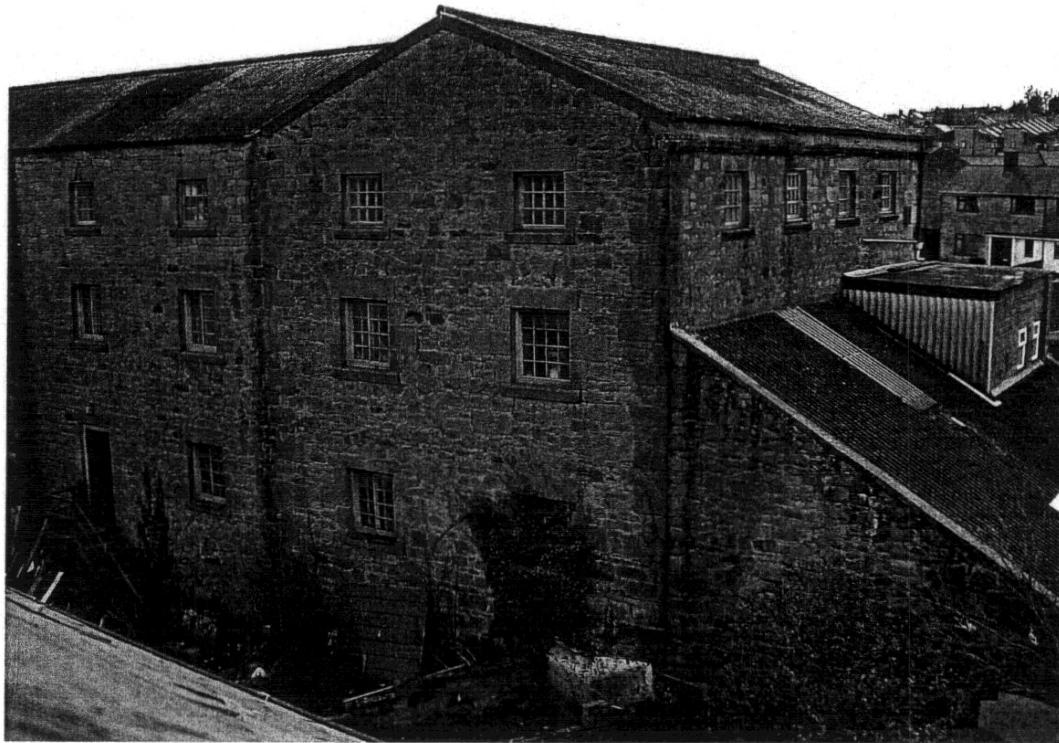
Figure 11 Bolams Mill. A view from the roof of The Maltings, looking south-eastwards. The fabric of the mill shows few alterations other than the addition of the lean-to at the left. The flat-roofed structure is the rebuilt top of the entry stairs.

- 6.1 The L-shaped mill building stands on the south side of the yard by the malting. It is built of sandstone rubble, with dressed quoins and dressings to the windows and doors (Figures 8, 9, 11). Most of the latter have arched heads, including those in the east face of the projecting part, where there are doors for goods raised by a pulley on a lifting beam. The mill dates from before 1851; it is largely unaltered, but for the addition of a large lean-to extension on the west side. The entrance stairs are in a small projection on the west face of the

south wing. The upper part of this has been rebuilt, possibly as a result of a fire that occurred over 30 years ago; the evidence of this can be seen in heavily-scorched beams at the head of the main stair and in the first floor.

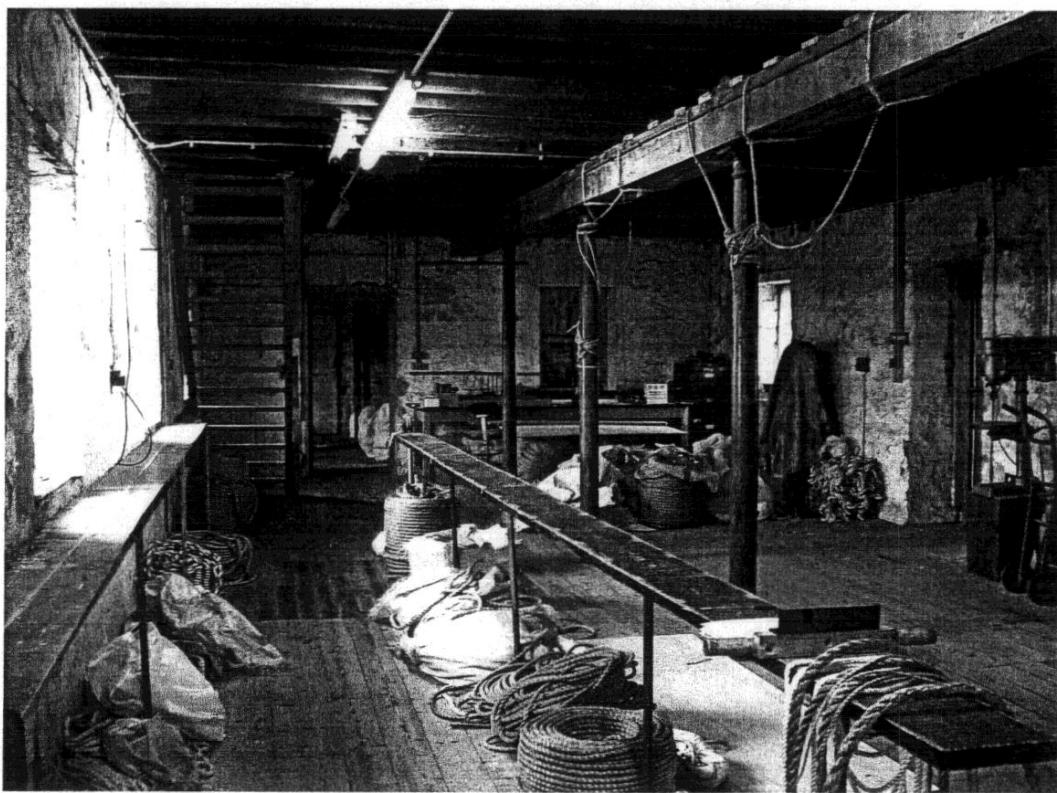
Figure 12 Bolams Mill. A view of the western workroom of the Border Cordage company, on the first floor. This interior is much as it would have been when the mill was first in use.

- 6.2 It was only possible to visit the first and third floors of the building for this study (Figures 12 & 13). The interior is largely unaltered, but for the insertion of some light partitions and ceilings, and the creation of internal staircases between each floor. The whole of the original roof structure has been replaced with modern softwood trusses and a covering of corrugate asbestos sheets. No access was possible to the lean-to at the west side of the mill.

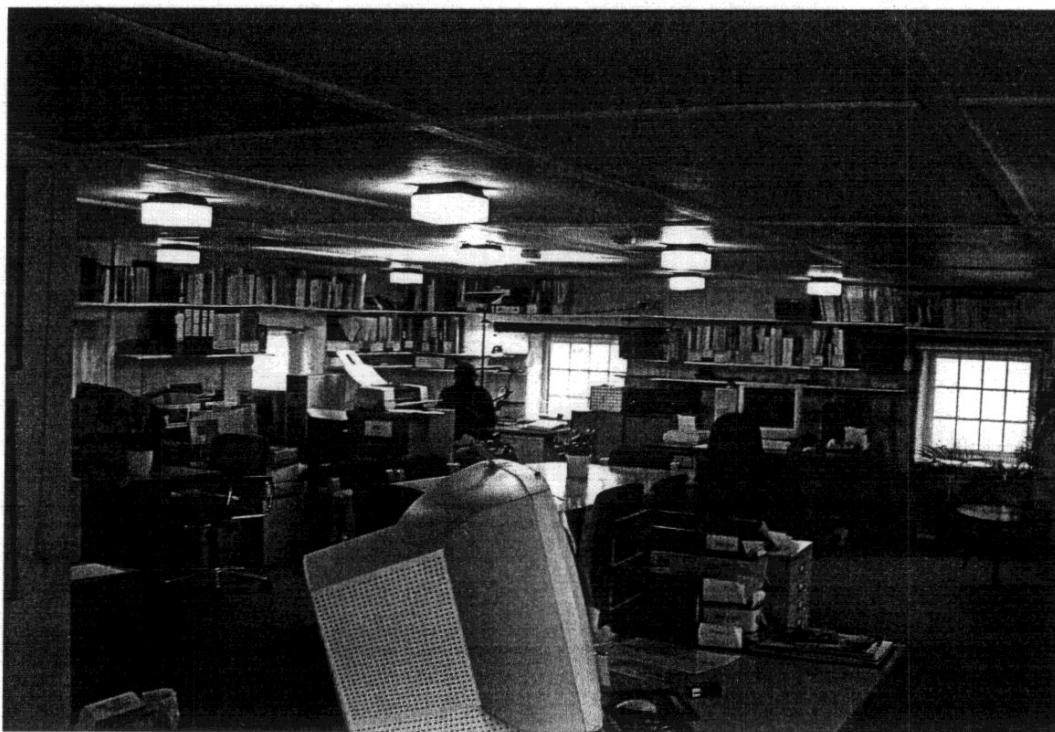
Figure 13 Bolams Mill. The western office of the Tagish suite on the top floor. The windows are all of the original pattern; the interior has been subdivided and new ceilings have been installed.

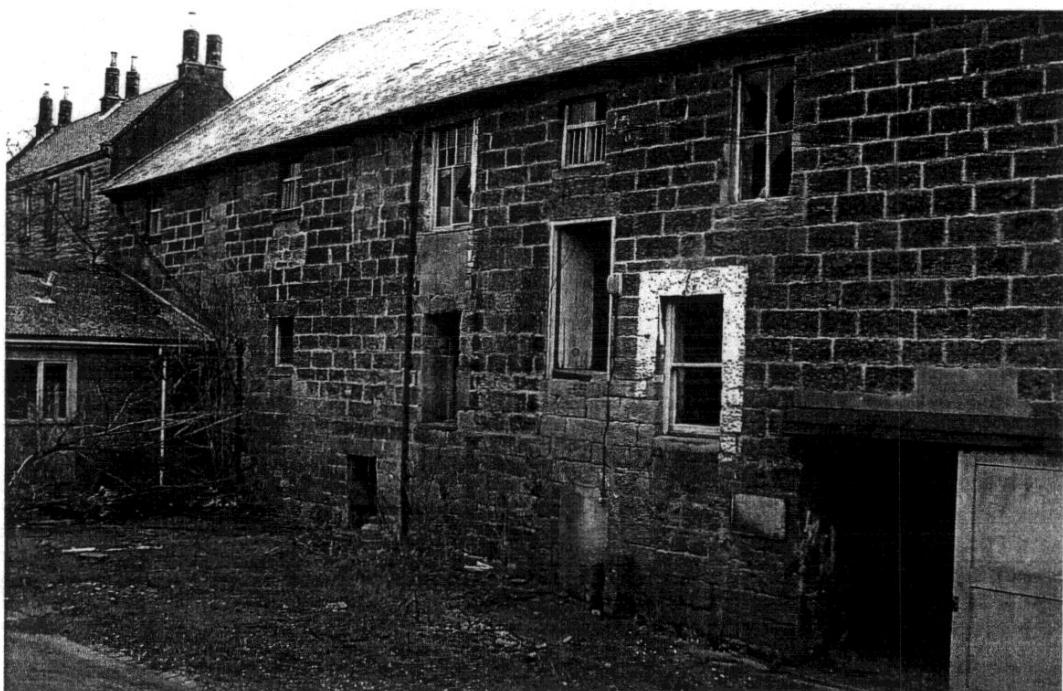
Figure 14 The Maltings: west end of the south front. Contrast the squared masonry with the rubble seen in Figure 10. A regular pattern of tall upper windows can be made out, despite later changes.

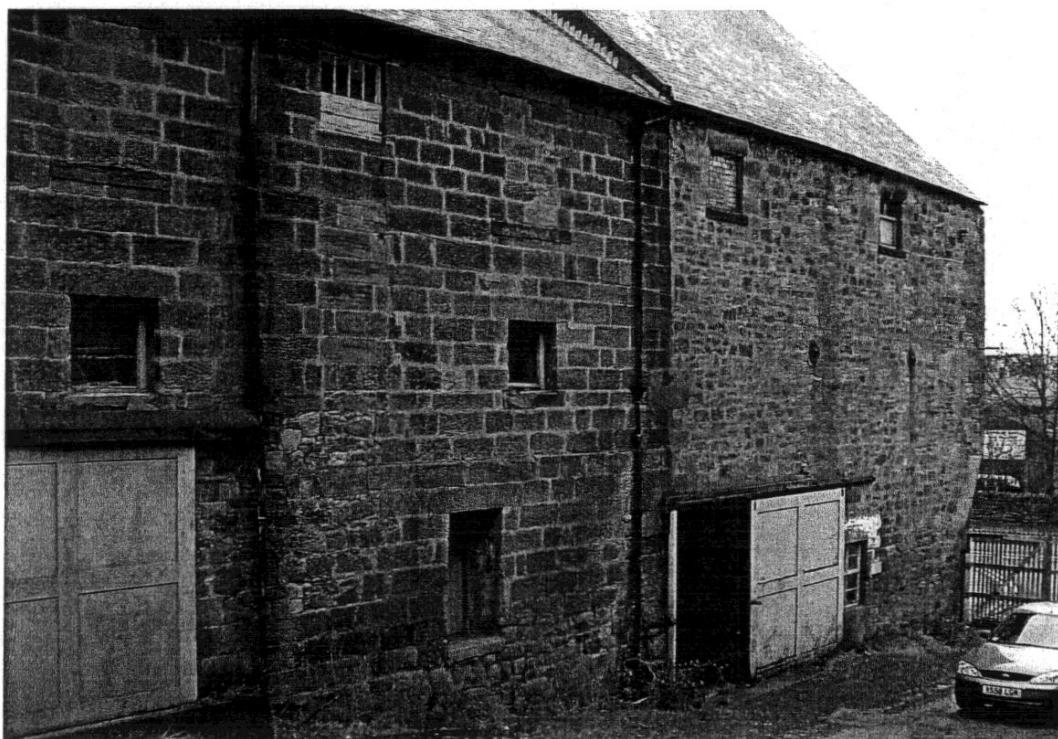
Figure 15 The Maltings: the east end of the south front. The straight joint between the between the fabric of the malting and the kiln is clear here. Altered windows, like those seen in Figure 14 are visible on the upper floor. Behind the left-hand downpipe the ends of a flight of stone steps rise towards a blocked door. This gave access to the upper growing floor.

5.3 The eastern part of the building is built entirely of sandstone rubble, and is a later addition, as can be seen from straight joints in the north and south faces. Its slate roof springs from eaves a little higher than those of the main block, but its pitch is much steeper. There are two blocked windows in each face at second-floor level, and an altered door and window in the south face of the ground floor.

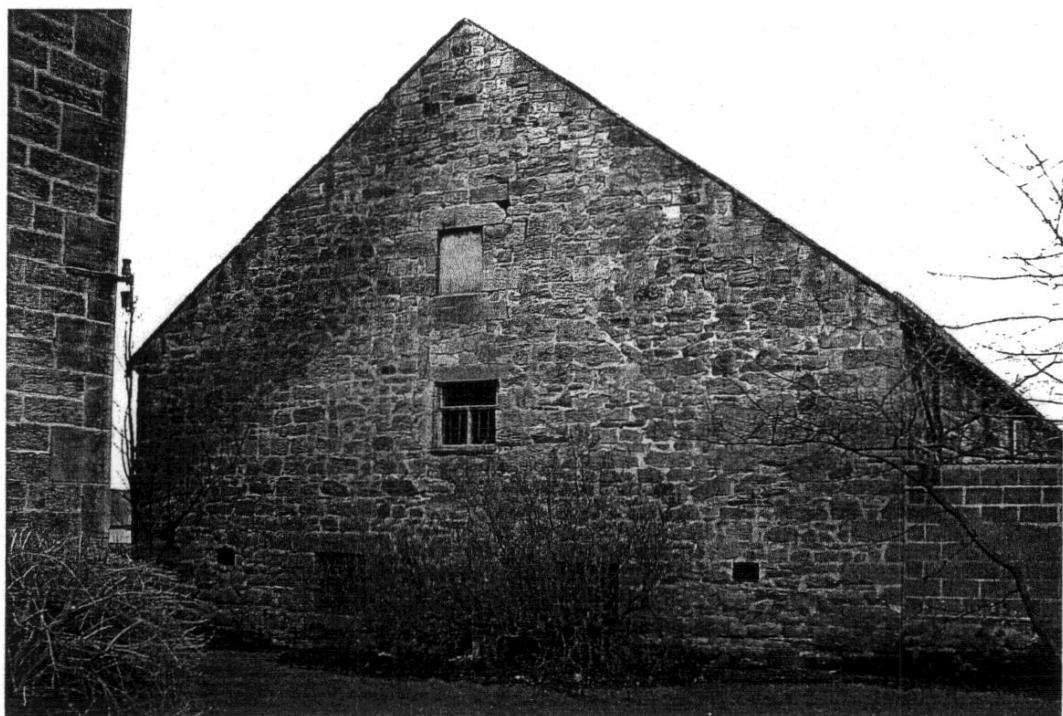
Figure 16 The Maltings: the west gable, seen from the school house garden. An earlier gable end is visible here between the levels of the sill of the upper window and the lintel of the lower one.

- 5.7 The earliest evidence is visible only in the west end of the maltings, where the gable of a much smaller building can still be made out (Figures 16 & 17). At either side of the gable window, triangular blocks show the roof line of a building both lower and narrower than the present structure. The presence of two coping stones on the southern slope indicates that this is a gable and not the scar of an adjoining building. Nothing more is known of this early predecessor of the present building. Map evidence shows that a linear building occupied this site from at least 1769. The building was incorporated into the present structure before 1827, when Wood's map was made; this unambiguously labels the building as a malting, whereas the 1891 proposal drawing suggests that it was used as a warehouse, and was only at that date to be converted to a malting. The present kiln was built between 1860 and 1897; its site was occupied by one, and later two, smaller buildings abutting the northern part of the east wall. Its gabled roof is similar to that shown in elevations of 1891, though it lacks the louvre that runs along the ridge in that drawing. The internal pyramidal structure might be what remains of an earlier kiln house, though this cannot have been more than about 30 years old when the alterations were proposed. The details of how the building was used in the 130-odd years between Wood's map of 1827 and the closure of the malting in the 1960s cannot be determined. It appears from the 1891 plans that the building might have ceased to be used as a malting for a time, before alterations were made to the kiln and its original use was taken up again.

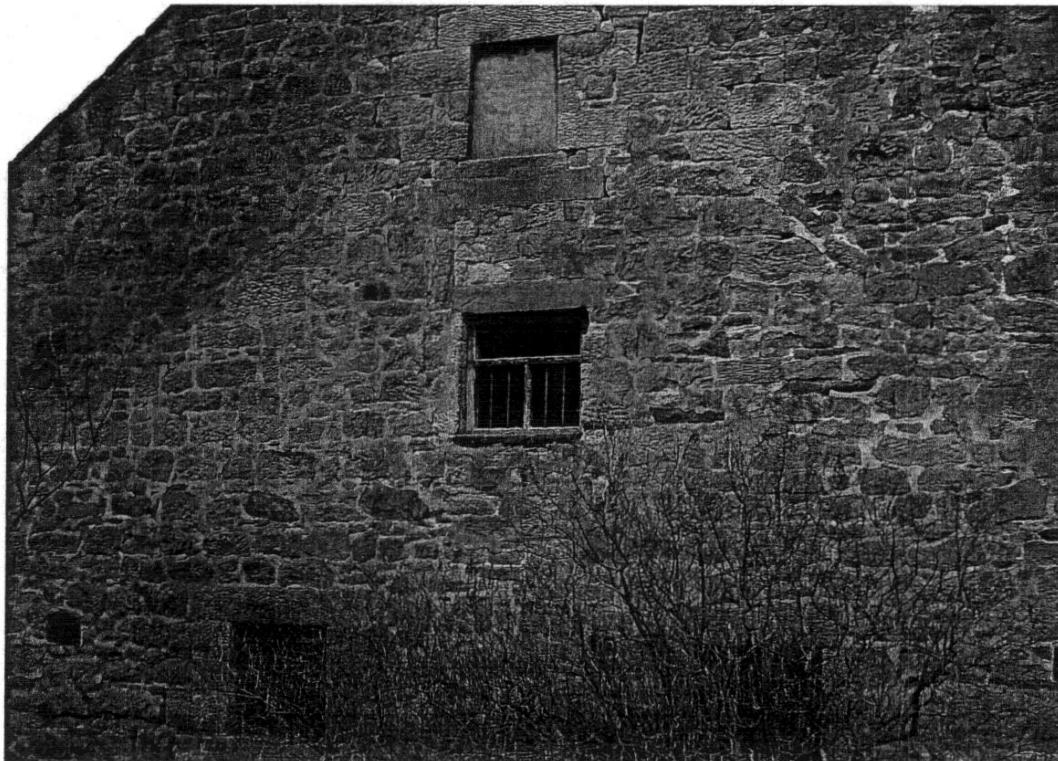
Figure 17 A detail of the gable end built into the present west end of The Maltings. Note the coping stones at the right hand side.

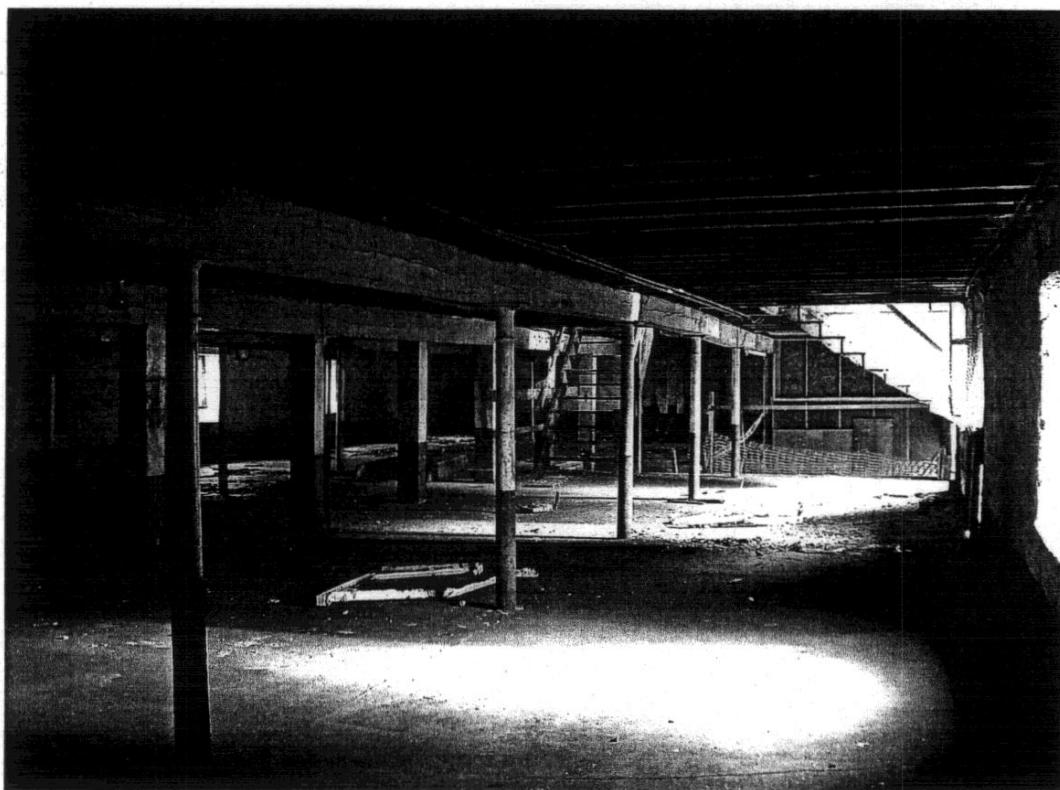
Figure 18 The upper growing floor of the malthouse, looking north-east. Cast iron and timber supports to the floor above are carried by iron and stone columns on the ground floor.

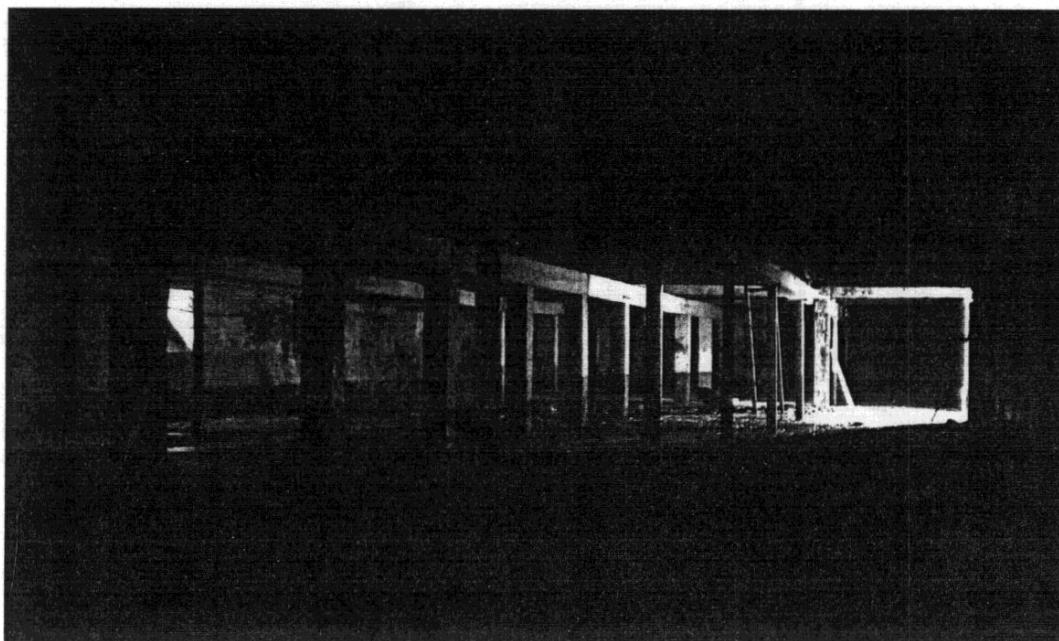
Figure 19 A view of the lower growing floor (the ground floor) in the malthouse. This view, from the same relative position as Figure 18, shows the dark state of this part-buried room. The floor, like that above, is a concrete screed. The square columns along the centre of the floor are made of sandstone.

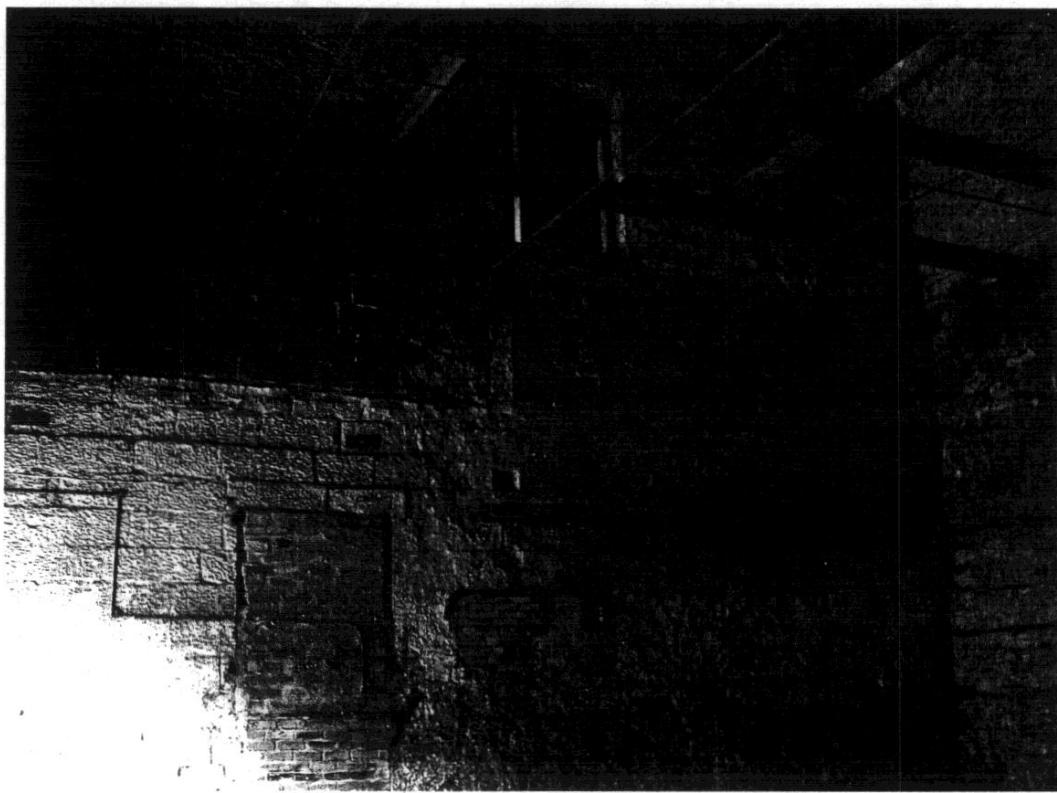
Figure 20 The malt kiln. A view from the south-east corner, looking at the east end of the malthouse. The lower door led to the hearths, and the upper gave access to the drying floor, which lay at the level of the steel joists. Between the levels of the doors there was once a row of four windows across the width of the wall.

5.4 The buildings show most of the features required for the malting process described above. The original layout is shown in Figure 22, a plan drawn up in 1891 to show proposals for the creation of the malting 'in an existing warehouse'. There are two screeded growing floors, on which the grain was sprouted, at ground and first-floor levels (Figures 18 & 19). The soaking tank, or steep, was perhaps originally on the ground floor, but there is no sign of this today; instead, a gap at the western end of the first floor shows the position of a shallow iron tank, supported on a large cross-beam and some large stones that project as rough corbels from the face of gable wall. Perhaps as a result of inadequate support, the ends of the joists have been supported on additional timbers that run the length of the south wall and for the western part of the north. These are supported on wooden braces that are let into tapered slots in the walls, so their feet are kept above the floor. In the east wall on this floor there are four blocked windows with wooden lintels; these show that the whole of the end wall at this height was at one time open (Figure 20). The
