Carlton, R. J. & Ryder, P.F., 2002, St. Mary's Chantry, Alnwick: Structural Record and Historical Survey.

ST. MARY'S CHANTRY, ALNWICK

STRUCTURAL RECORD AND HISTORICAL SURVEY

March 2002

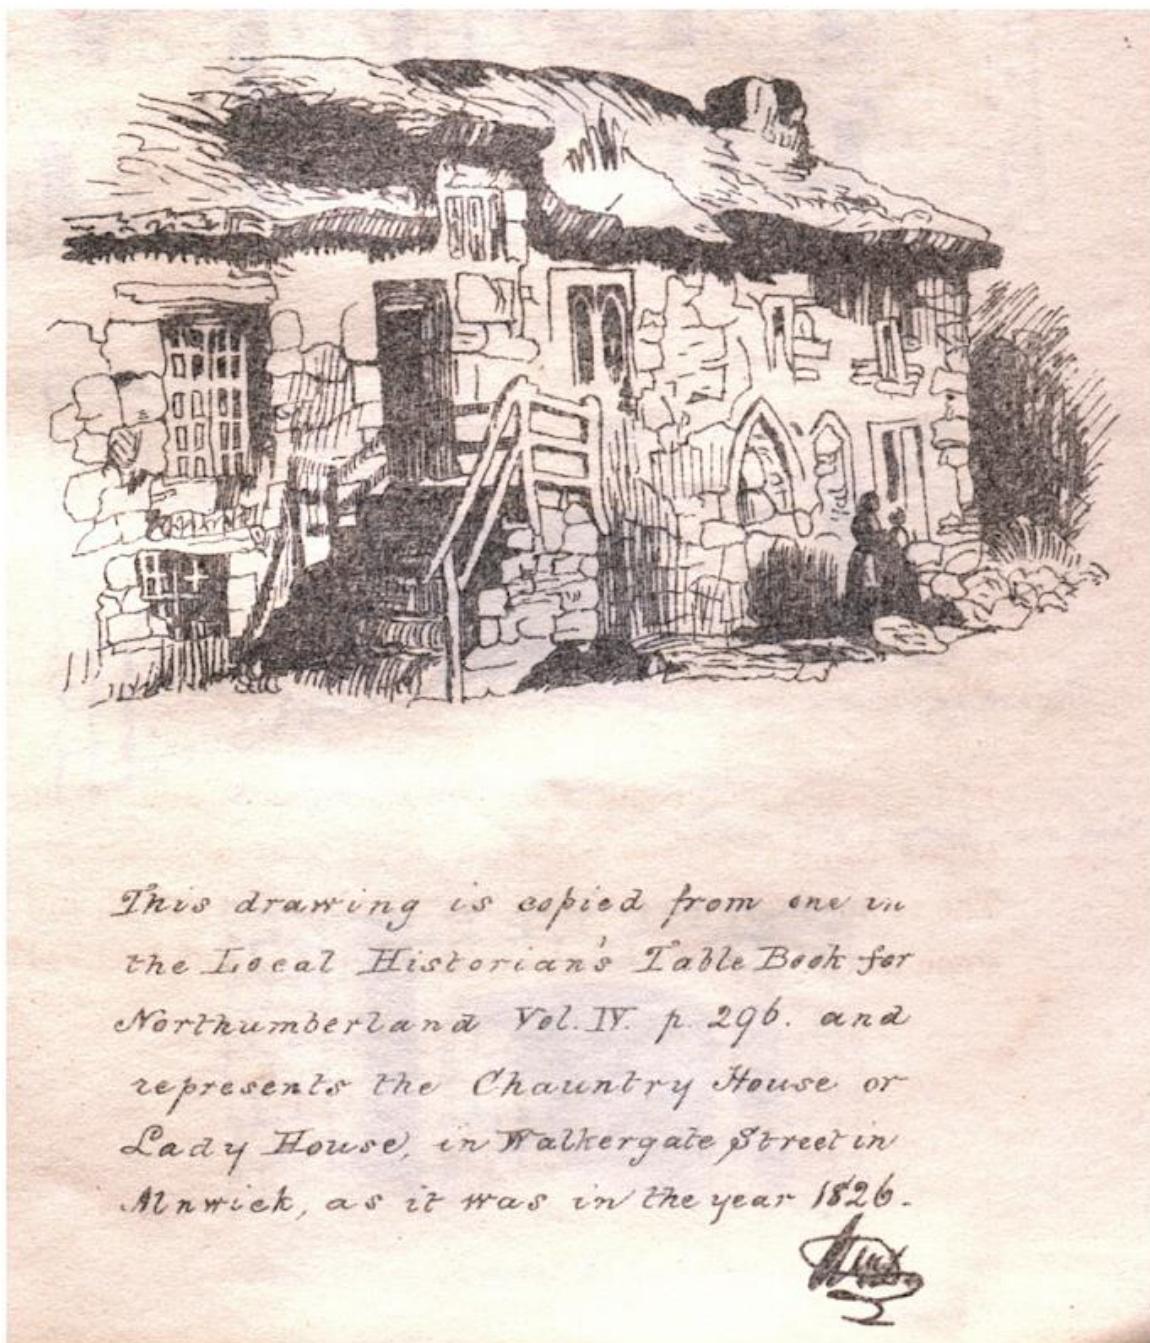
Figure 6: Sketch of St Mary's Chantry c.1826 (in Dickson 1852)

The sketch of 1826 is the most important (*Figure 6*), showing the building with a dilapidated thatched roof and a stone stairway giving access to the building via a first story doorway which is virtually unrecognisable as such in the surviving fabric of the building. A dormer window, all traces of which have disappeared, projects from the sloping roof above the doorway, suggesting a living space in the roof. West of the first story door is a large first floor window, also barely traceable in the surviving external masonry. The 1852 sketch shows the structure roofless (*Figure 9*), indicating that sometime in the period after 1826 it had been abandoned and become ruinous. Also included with this sketch are a plan of the building and details of both internal fireplaces. The later sketches of Tate (*Figure 12*) and, a century later, Brown (*Figures 15 & 16*), show that the condition of the Walkergate frontage of the building degraded very slowly and was not subject to intensive stone robbing after its abandonment. Most of this degradation, particularly to the upper stone courses, can be put down to the unchecked growth of ivy which is visible on Brown's sketch spilling over from the interior of the building.

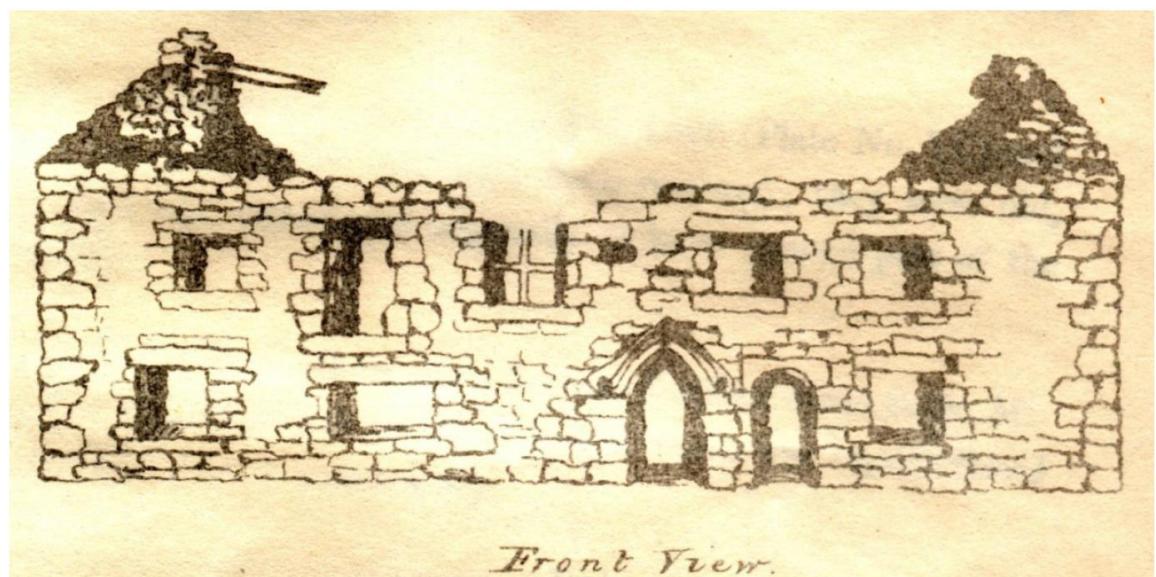
Figure 9: Sketch of St Mary's Chantry, Walkergate frontage c.1852 (in Dickson 1852)

The 1852 sketch shows the building roofless and in ruinous condition, but with a similar range of features externally. The main differences are that the dormer window has disappeared above the surviving bricked-up window (**A8**), as has the external doorway towards the west end of the building. The internal plan is shown much as it now appears, with the addition of an internal partition wall dividing into two unequal parts the present, large room west of the through passage. The dividing wall, complete with a blocked stone arch, is shown crossing the building immediately west of the north wall fireplace and forms one of the two internal divisions depicted by Wood in 1827 (*Figure 7*), the other being the surviving through passage.

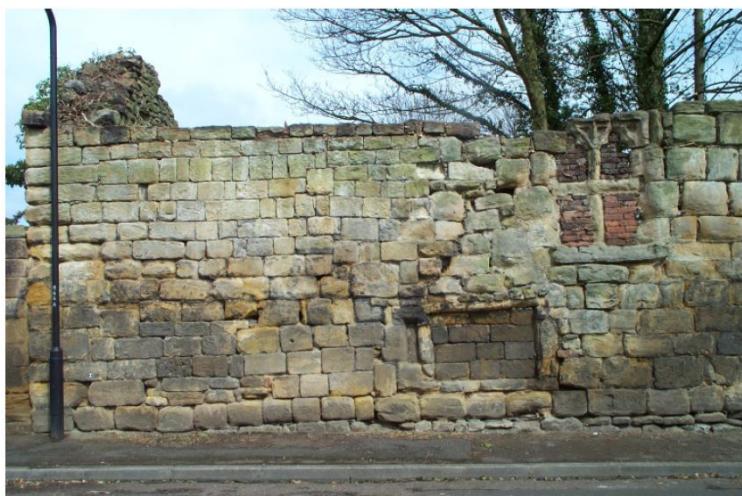
Plate 1:
St Mary's Chantry House, South frontage, west end

A 8 West of doorway A 1, above a section of undisturbed phase I walling, is a window of two trefoil-headed lights with a broad transom at mid-height, now blocked in quite old brickwork. There is a broad chamfer to the jambs, but the dressings are all very weathered. The heads of the lights have sunk rather than pierced spandrels, and are recessed within a square sunk frame. The western half of the head of the western light has gone; there seem to be remains of the east end of a hoodmould, of the usual late medieval type with a turned-back end.

A 9 Immediately to the west of A 8 and at a lower level is a broad blocked window (perhaps once of three lights?); its very worn lintel retains nothing of its original section but its east jamb seems to have had a double chamfer. The blocking is of neatly-squared coursed blocks, like those blocking openings A2 and A7. Internally the blocked opening A28 c 0.90 m wide, with a timber lintel, seems to correlate with the western half of the window; might this represent a mural locker or recess formed after the window was blocked? Further east what seems to be the eastern internal jamb of this window is visible as a ragged joint A29 below the western internal jamb of the large two-light window A8.

A 11 Immediately west of A 9 and at the same level is a small upright loop with chamfered surround, also now blocked. Its east jamb has been replaced by west jamb of a larger window immediately adjacent, and its sill partly cut down to the level of that of the larger window. There is no clear indication of its position on the internal face of the wall.

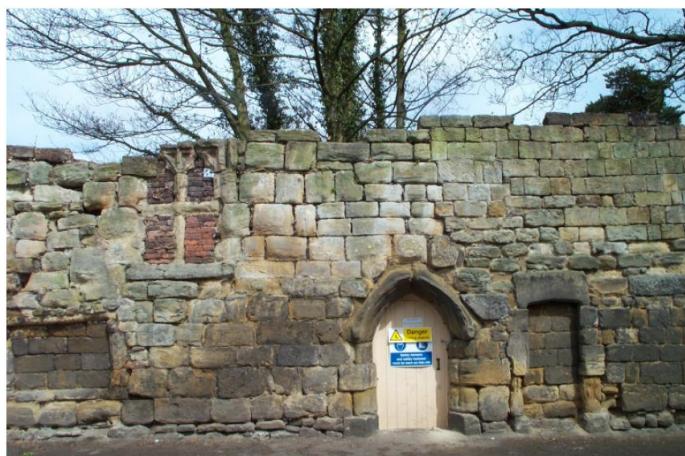
Plate 2:
St Mary's Chantry House, South frontage, doorways

A 1 The doorway, to the cross passage, has a two-centred arched head cut from two large blocks laid diagonally; the mouldings of the arch - apparently two hollow chamfers, and the hood mould, concave below and convex above (which has had either mask or shield stops, now very worn) are all cut from the same blocks. The modern wooden doorframe conceals part of the internal faces of the jambs (which have been patched in brick); it is not clear whether a draw bar tunnel or other evidences of original fittings survive. The internal lintel or rear arch have fallen, together with a section of wall above, but the uppermost stone of each internal jamb projects, rather like a corbel, as if the rear arch was set forward from the wall face.

A 2 East of the cross-passage doorway is a narrower blocked doorway which is clearly an insertion. It has a narrow chamfered surround, and a Tudor-arched head. Its jambs each have one upright block near the base; the actual chamfered jambs, of darker stone, only start above this. Its infill, set back a little so as to form a shallow recess, is of coursed and well-squared stone. Internally the opening is blocked in neatly squared stone (one stone low down having a socket cut into it) and has an old timber lintel.
