Narrowgate House, Coach-house and Stables

**REPORT ON: HISTORIC WALLPAPER RECORDING AND CONDITION SURVEY
WITH NOTES ON ASSOCIATED HISTORIC FINISHES SURVIVING IN-SITU
AT NARROWGATE HOUSE, ALNWICK**

The Front Façade of Narrowgate House, Alnwick, (Formerly General Lambert's House) 31 & 33 Narrowgate.

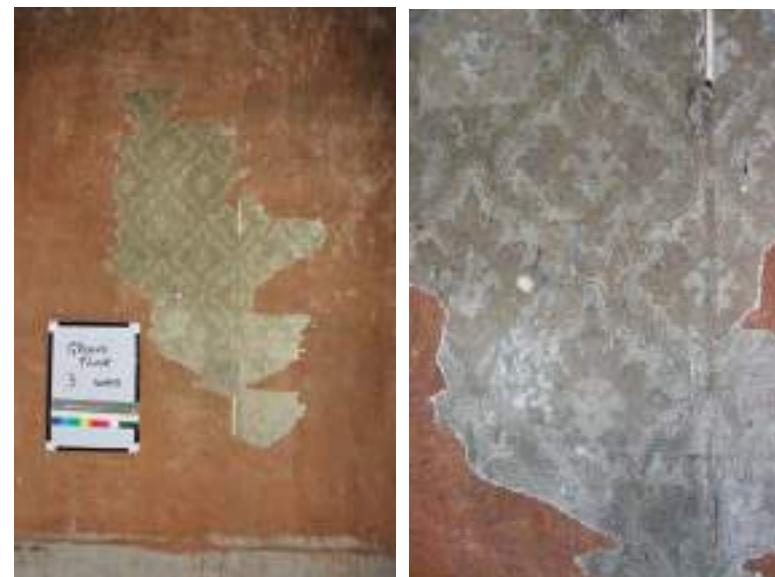
Surface print -	clear, some abrasion
Substrate -	damp, poor air circulation
Staining -	some mould stains and sooty deposits
Infestation/damp -	mould and some damp
Risk H&S -	mould
Testing -	none required
Friability -	embrittled
Approx. date -	c.1860

Detail of wallpapers on North wall

Section could be removed for archiving

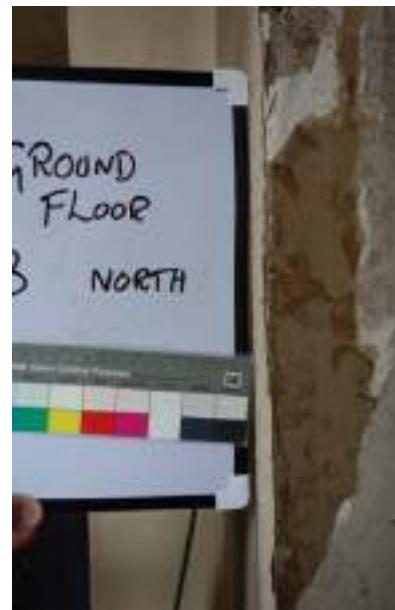
Detail of wallpapers on chimneybreast return

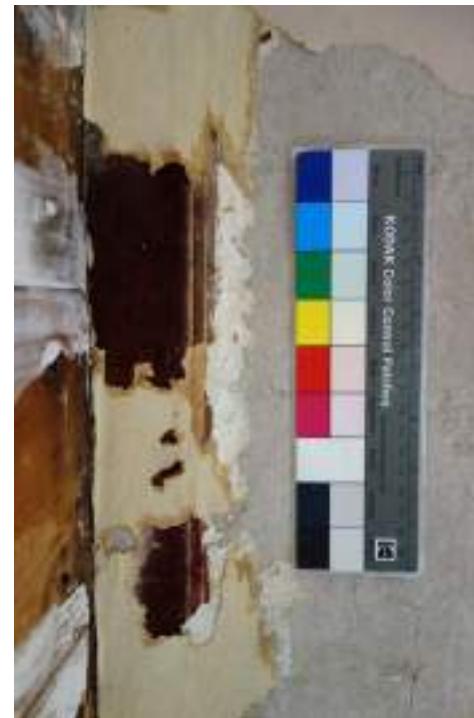
ROOM 3.1

East wall North corner. Flock border paper. Date not known.

May be more extensive survival behind the later lining paper

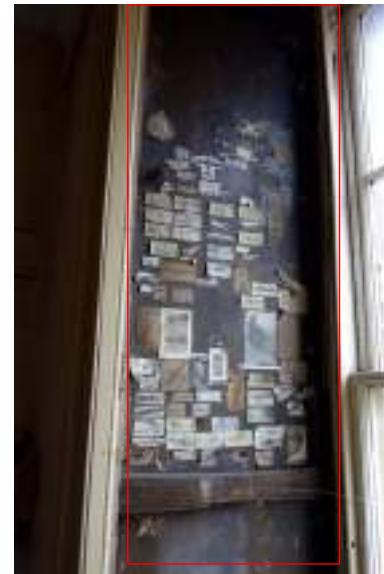
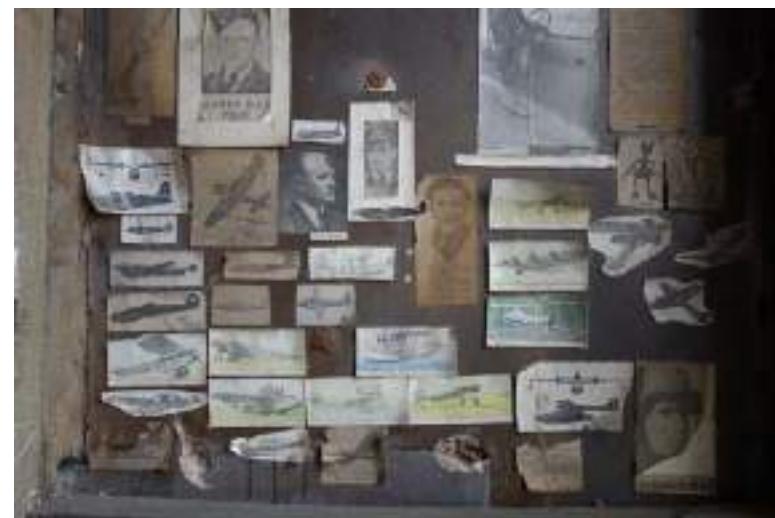
Surface print - very faded and degraded by UV

Friability - embrittled UV degraded surface

Detail of shutter box paper cards in-situ

Require detailed recording and removal by conservator, followed by conservation cleaning and appropriate storage / display. Option to remove whole board with cards in-situ.

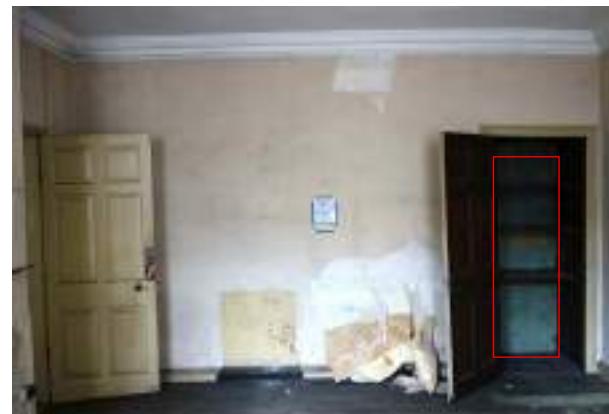
Surface print - surface dirt with ,mechanical abrasion and damage

Requires conservation cleaning detailed recording and removal of a section by conservator, followed by cleaning and appropriate archive storage.

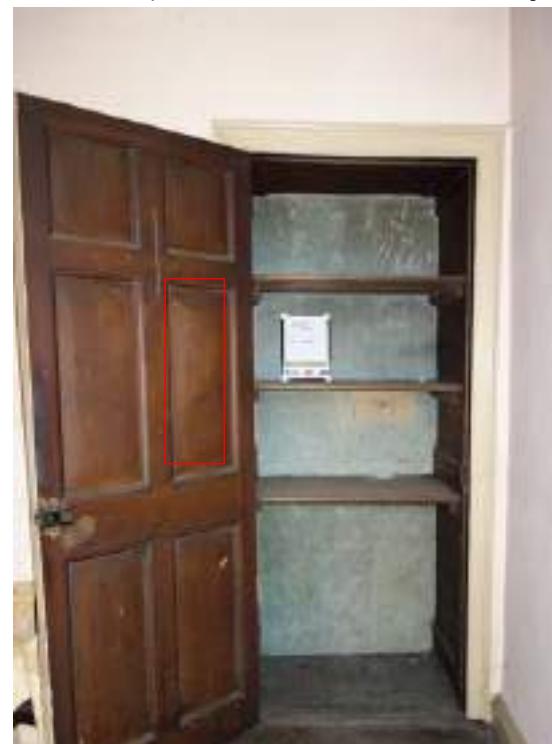
Interior of cupboard door with full historic woodgraining surviving

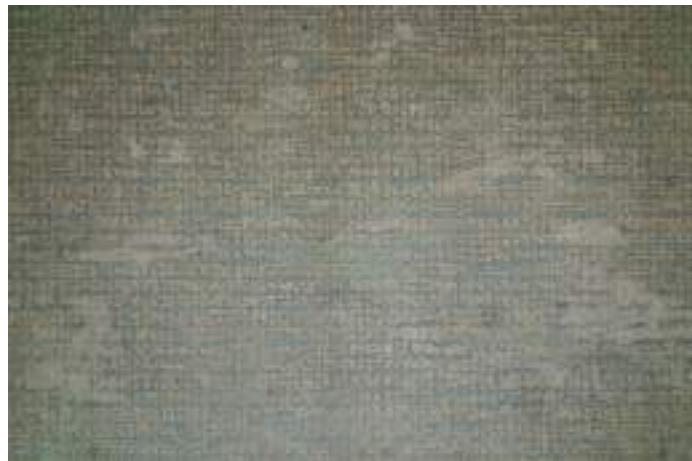
Detail of wallpaper lining to cupboard

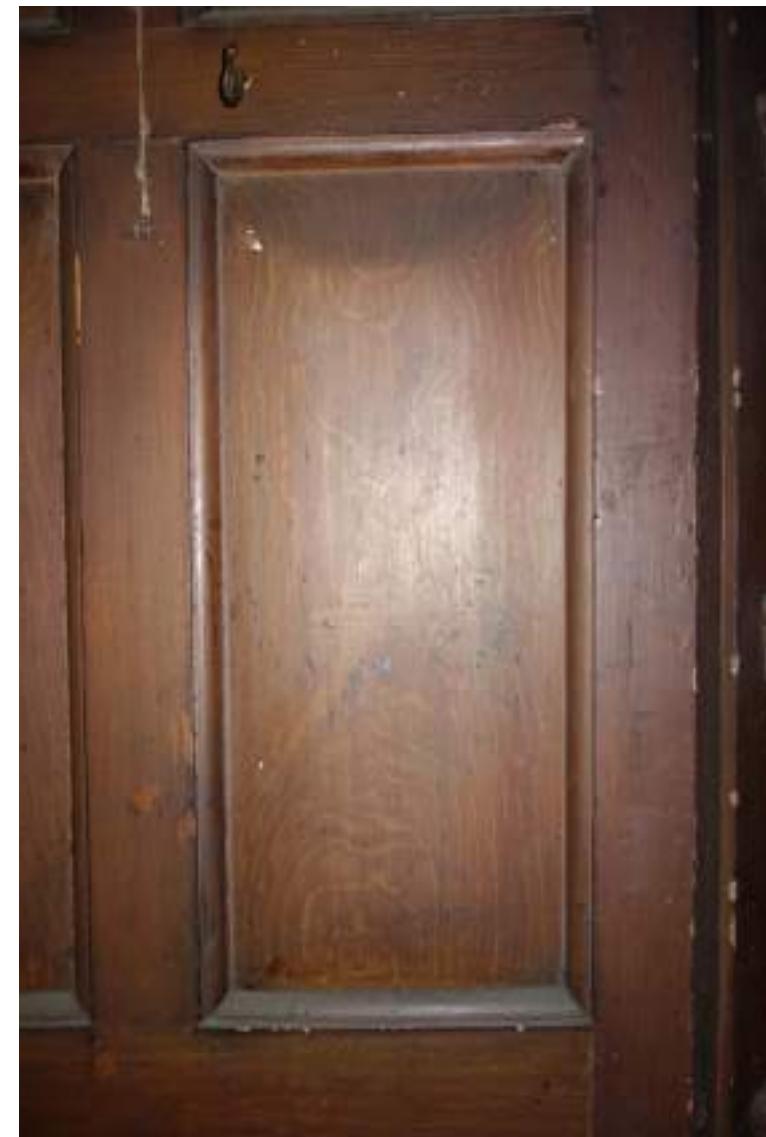
West wall, North corner, woodgrained interior of cupboard door

The wallpaper exists in association with a surviving painted woodgrained finish.

The oak woodgraining to the door is finely executed and appears to be later 19th century. It was retained and extant at the time the wallpaper was inserted.

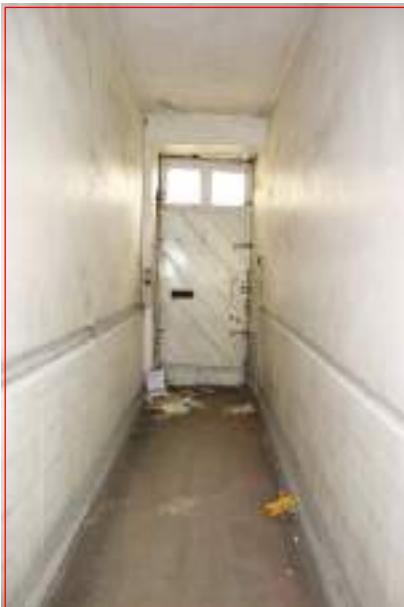
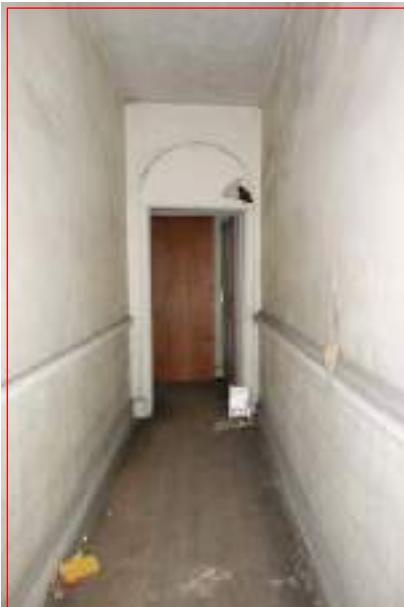
ROOM 5 – Dado wall face. - Anaglypta (type) embossed paper
Upper wall face - Two schemes of patterned wallpaper

Earliest paper in evidence (visible on North & West wall) is a floral trellis pattern paper about 1930s over this is a random pattern paper of the late 1950s – 1960s.

Surface print - where exposed, surface dirt with some buckling, mechanical abrasion and moisture damage

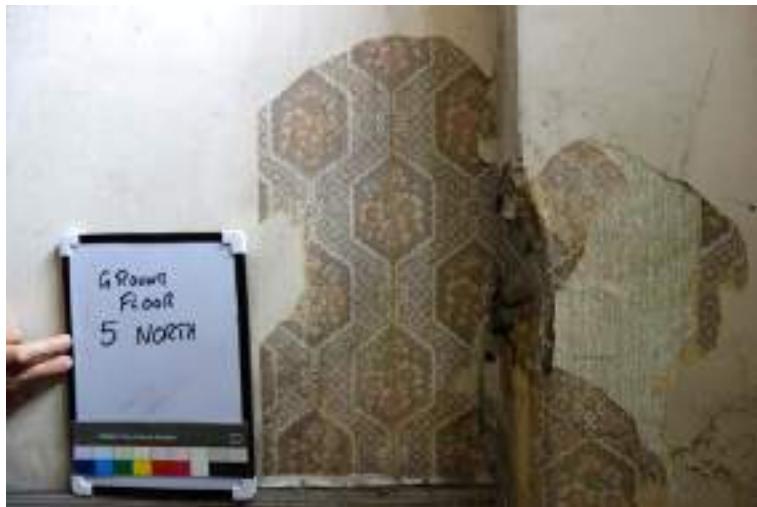
ROOM 5 – Upper wall face - Two schemes of patterned wallpaper

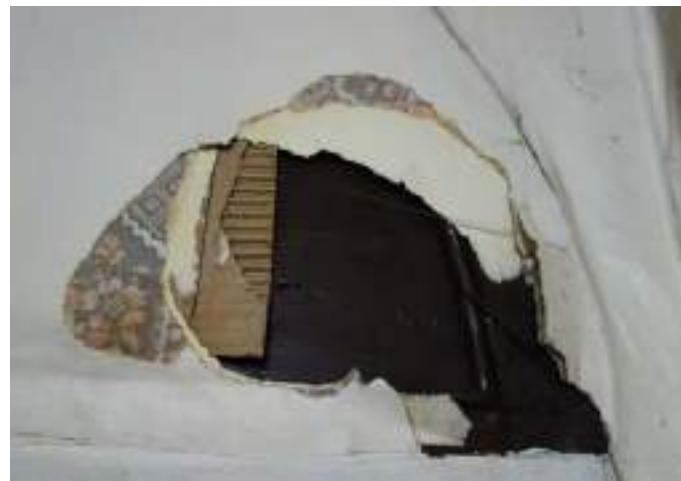
High-level West wall blocked overdoor fanlight.

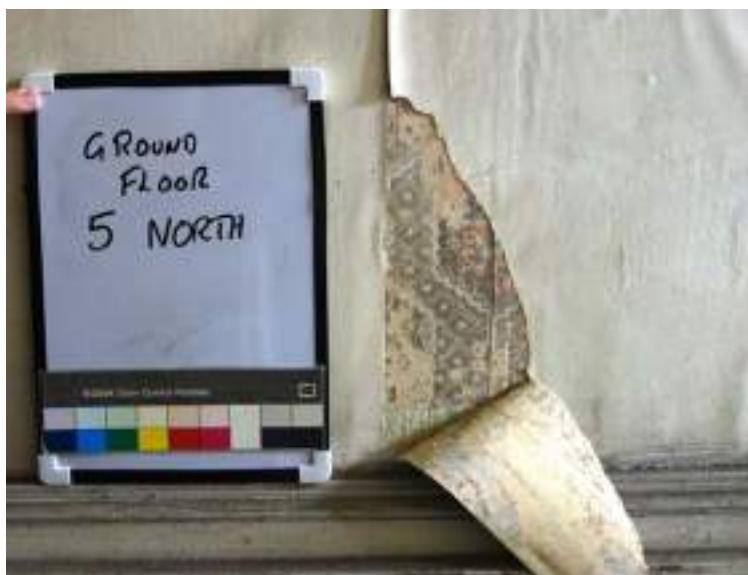
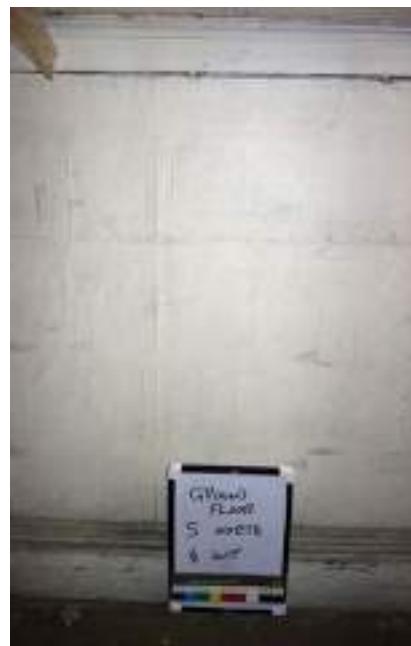
Detail from dado wall face, complete throughout interior

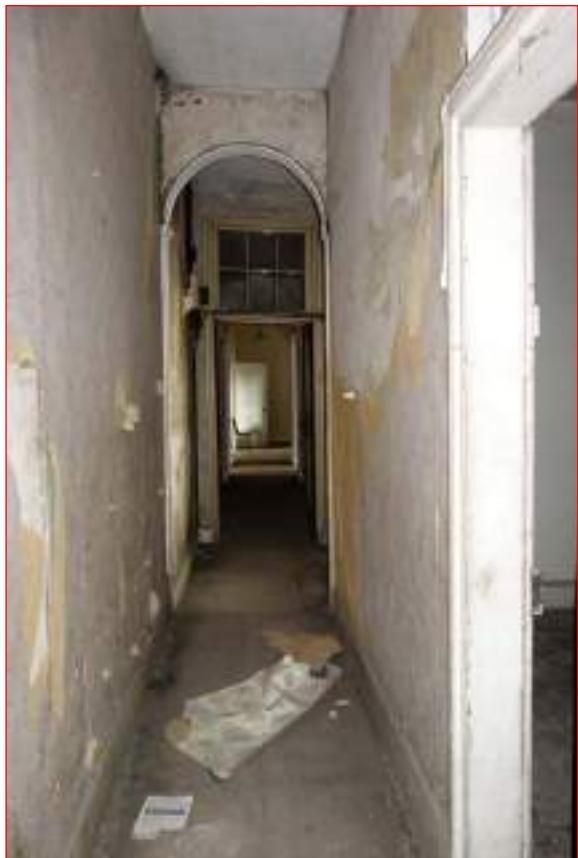
ROOM 6.1 – Two schemes of patterned wallpaper

Earliest paper in evidence on almost all areas from the entrance corridor through to the stairs in a floral trellis pattern paper about 1930s

Surface print - where exposed, surface dirt with some buckling, mechanical abrasion and moisture damage

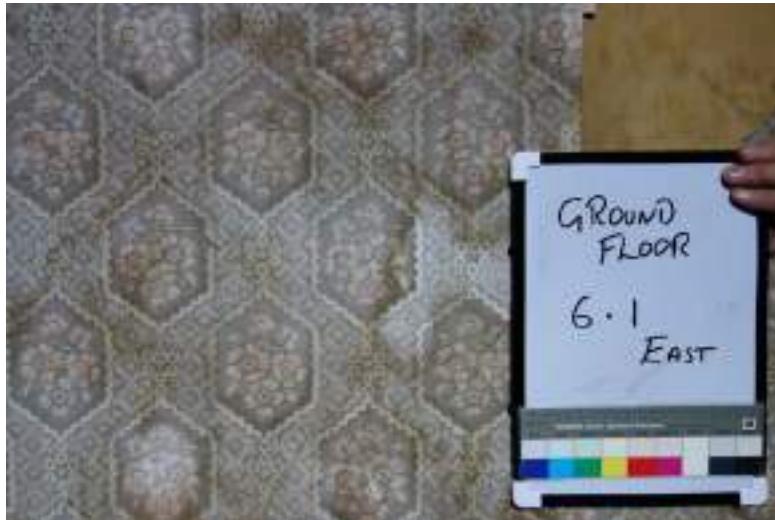
ROOM 6.1 – Upper wall face - Two schemes of patterned wallpaper

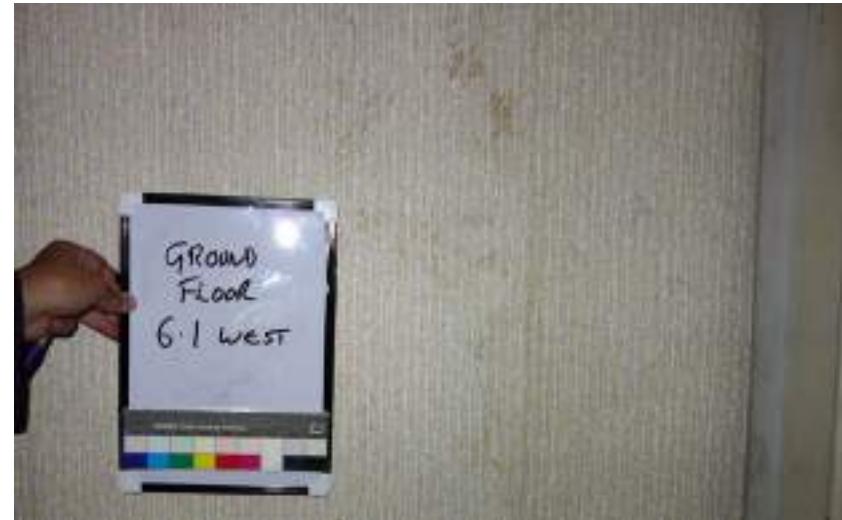
The green colourway 'weave' pattern paper of the late 1950s – 1960s.

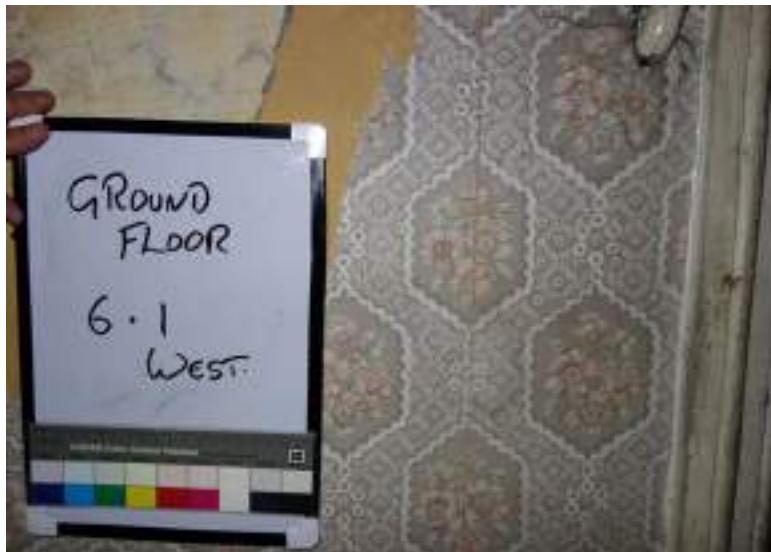
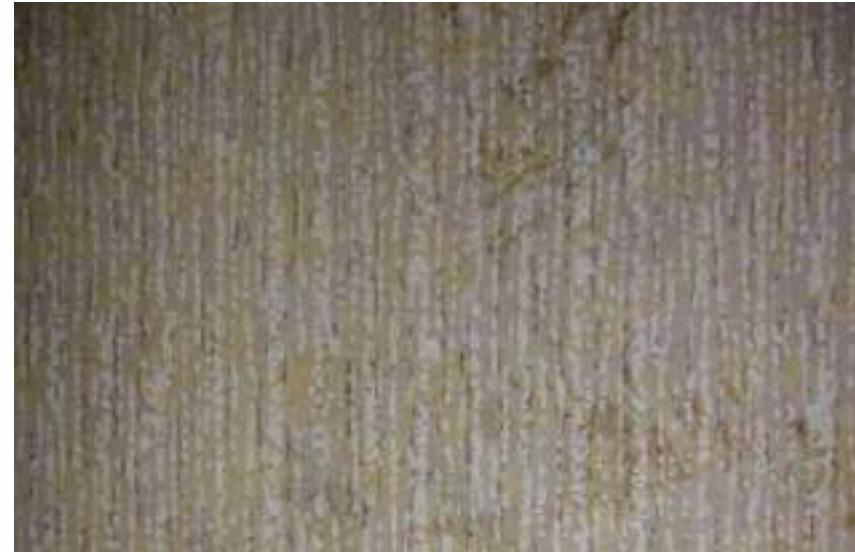
Magnified section of 'weave' design

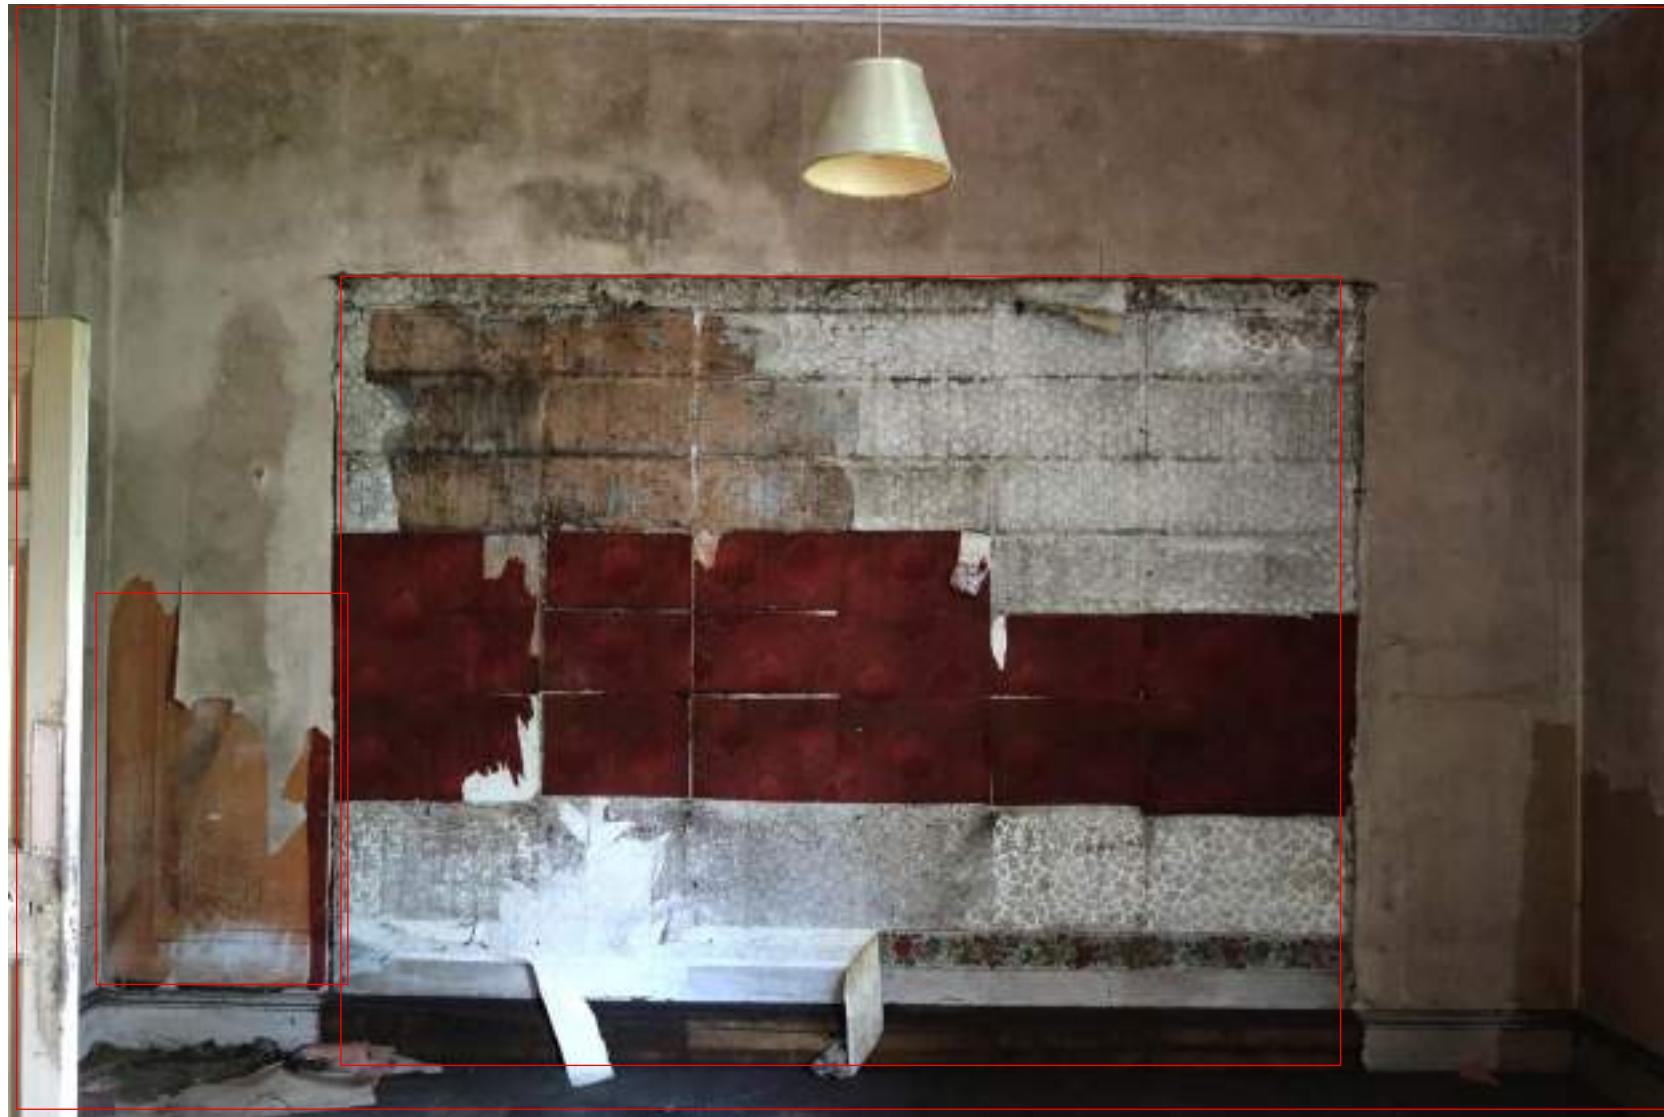
ROOM 7 south wall face (as representative)

ROOM 7 – Main wall faces retain 5 no. schemes of decoration

Surface print - where exposed, surface dirt with some buckling,
Some migrating salt damage but largely sound.

Requires conservation cleaning and detailed recording of the full scheme by conservator. Important decisions have to be made on preserving and protecting this complete scheme.

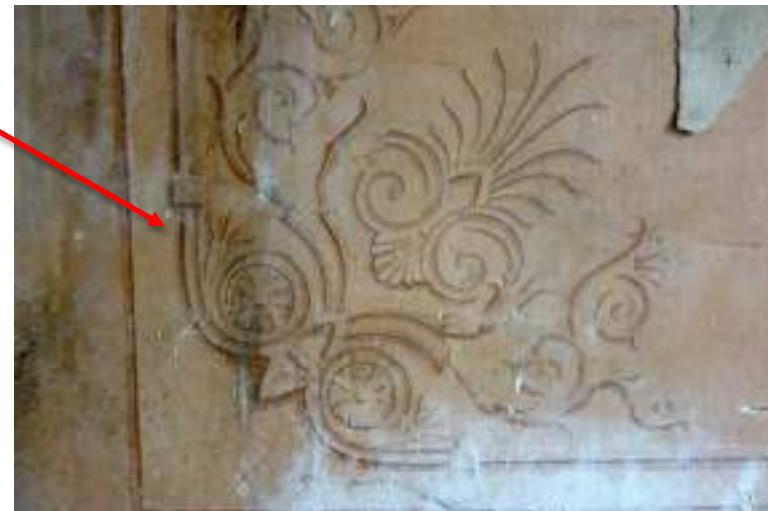
South wall face, east corner low level

When viewed by raking light the ceiling also appears to be lined out in the same decorative manner and then subsequently overpainted. Similar to a scheme found at Kenwood House, Hampstead where it was executed for a visit by William IV. This is a high-status scheme in a principal reception space .

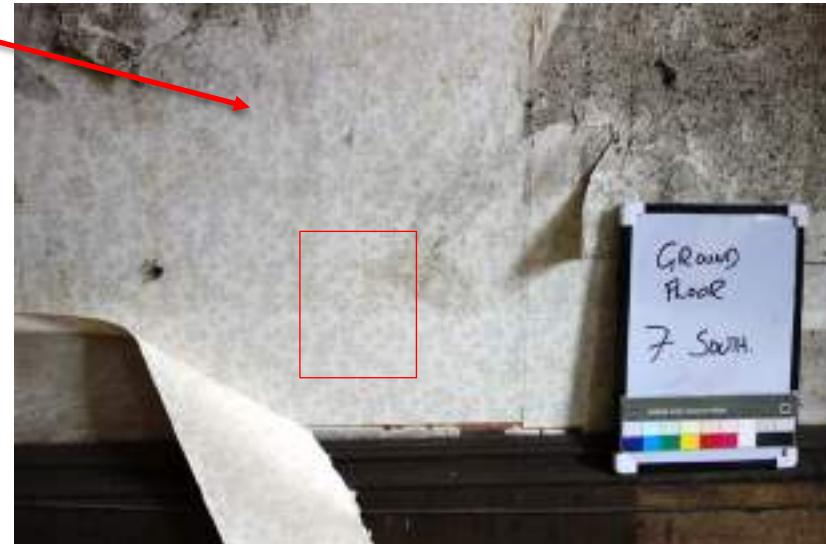
A very thin and friable paper with mechanical abrasion and moisture damage.

Coral and leaf distemper print wallpaper with border

Requires conservation cleaning detailed recording and removal by conservator,
followed by cleaning and appropriate archival storage.

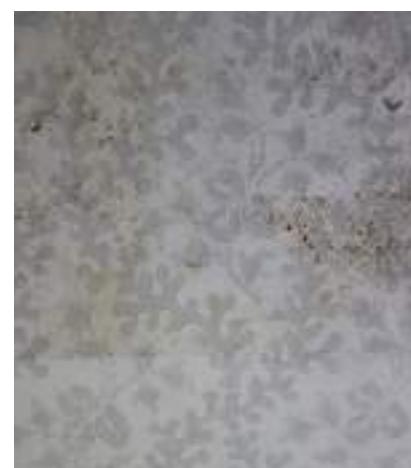
Detail of design, showing dirt, mould and extremely fragile surface decoration.

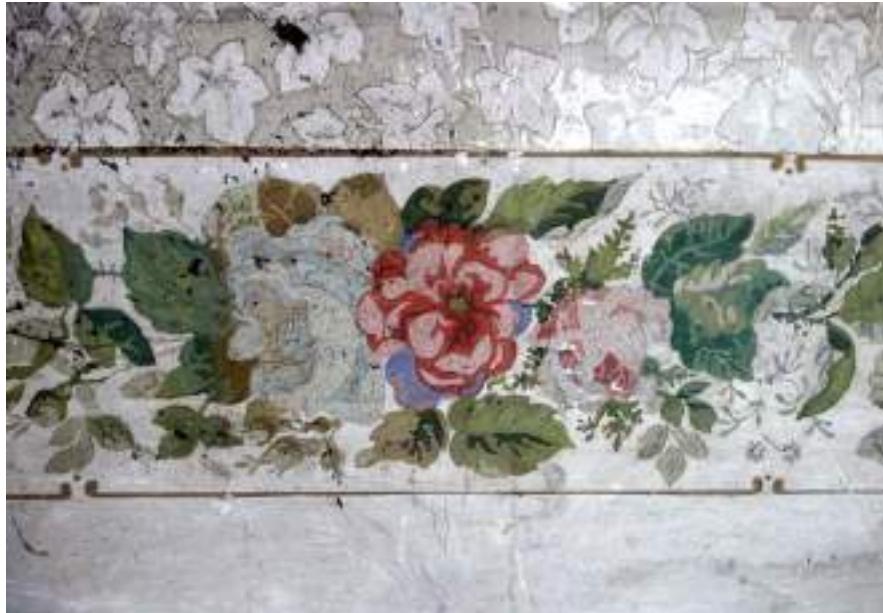
Friability - where exposed, surface dirt with tears and buckling,
with mechanical abrasion and moisture damage.

Detail of French Style rose border

This image shows the ivy leaf wallpaper, bordered by the rose paper, which in turn has a plainly painted perimeter

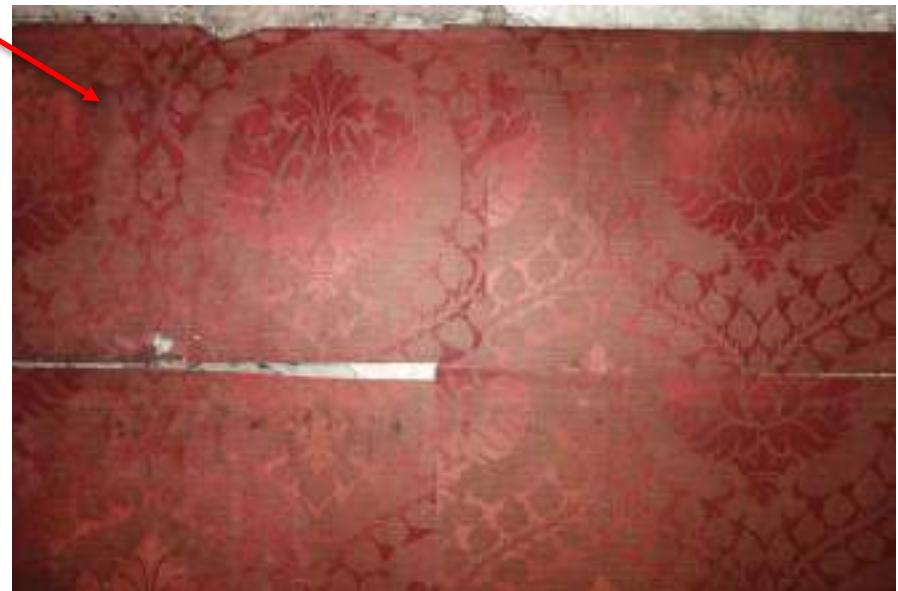
The final paper red patterned paper dates from the late 1930s-1940s. The paper is very thin and slightly acidic.

The rather unusual alignment of the paper seen here is due to it being fitted in between the shelves of a free-standing open back bookcase.

Requires conservation cleaning detailed recording and removal of a section by conservator, followed by cleaning and appropriate archive storage

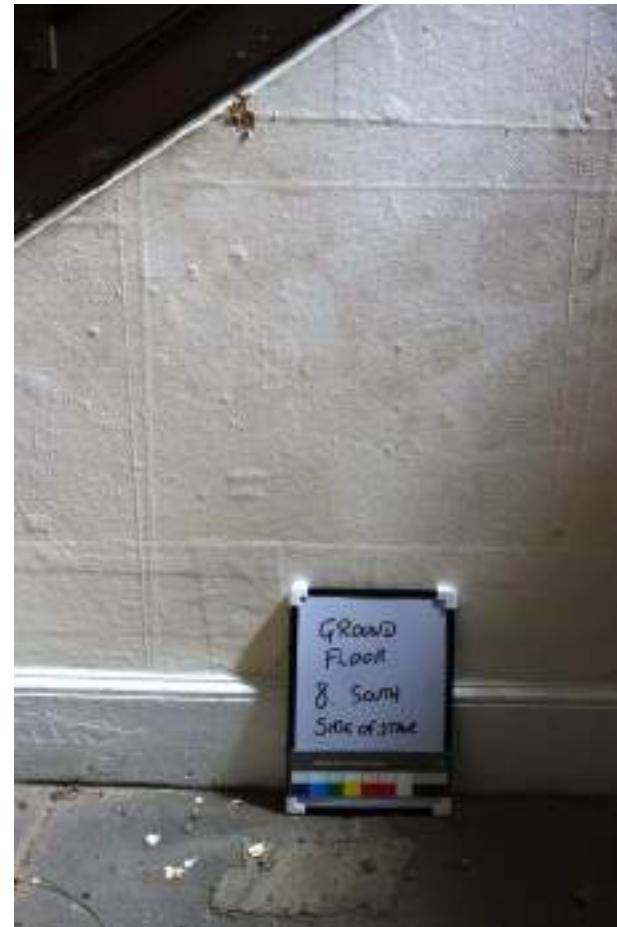
Detail of area 8/9 stair closing

In raking light, the stair closing area shows squares of wallpaper. As these appear random it is assumed that they are fragment used as infill rather than earlier printed square wallpaper sheets. The heavy overpainting is visible and is extremely difficult to remove.

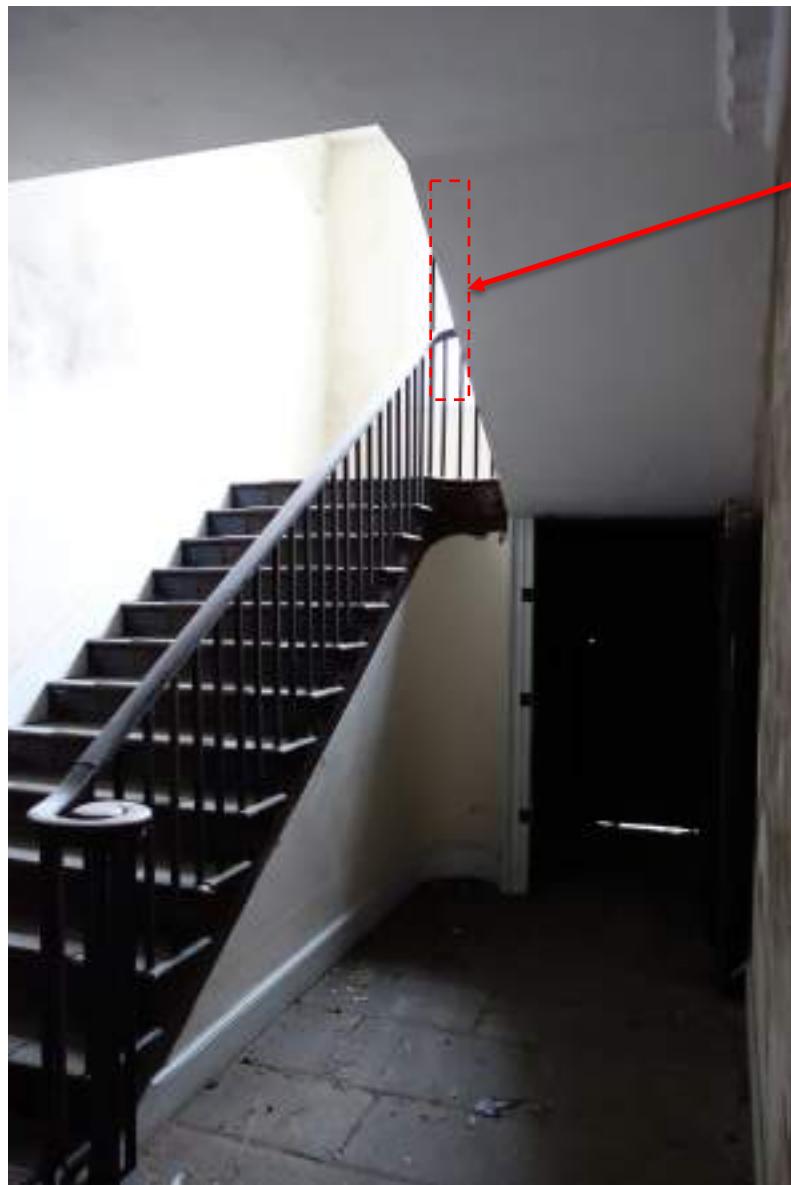
Area of dashed outline showing location of shutterbox

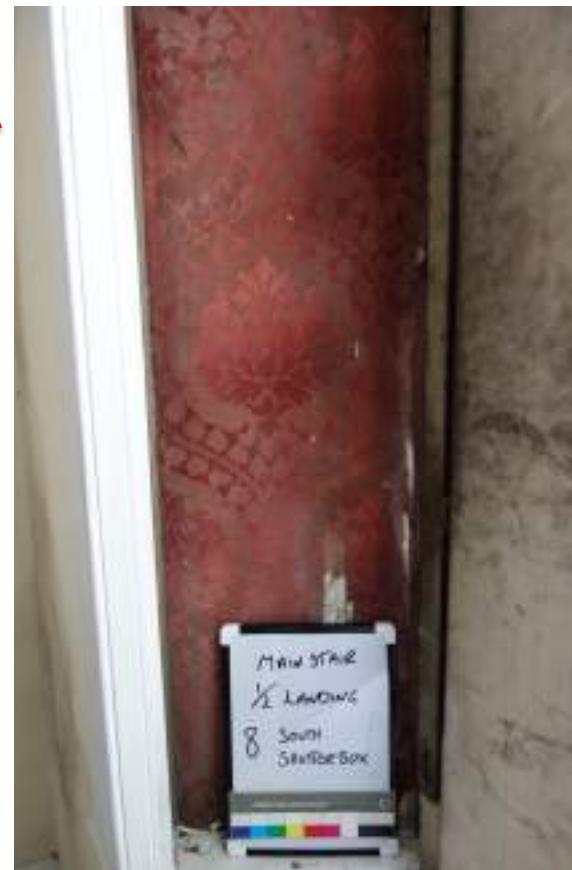
Interior of landing shutterbox

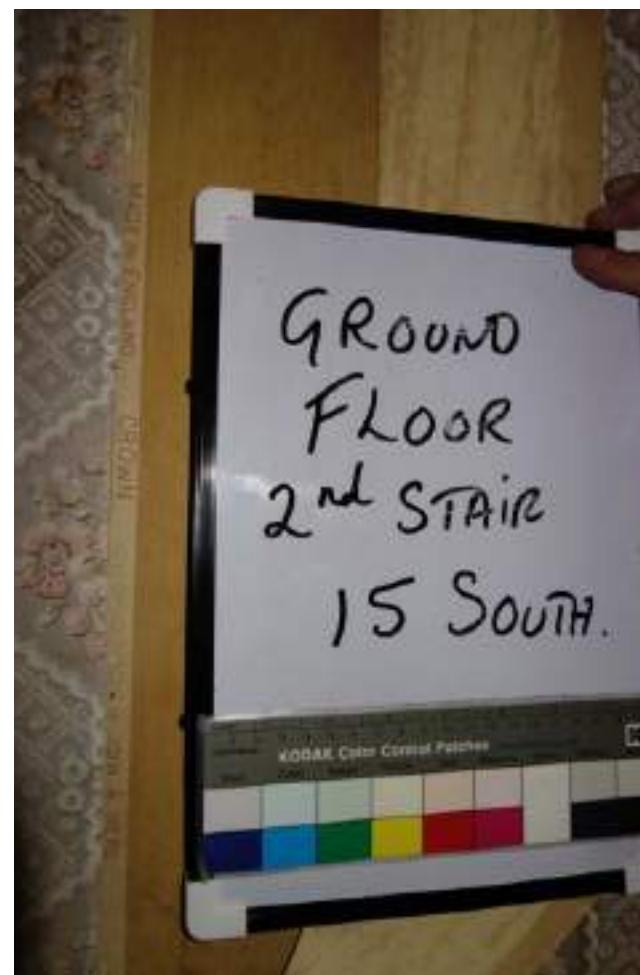
This area retains the cleanest examples of this 1930s trellis wallpaper, including the untrimmed edge. A section of this should be cleaned, conserved and storage in an archive. This paper could also be used as being representative for the previous associated interiors

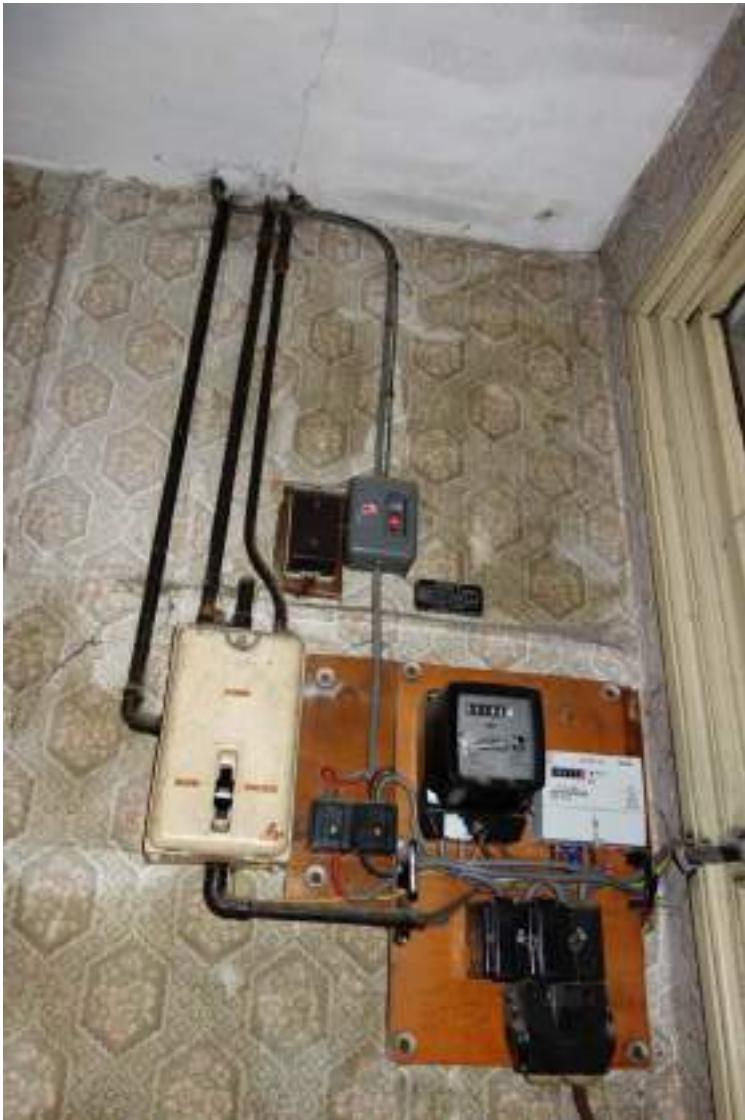
This wallpaper can be dated by its application behind and therefore previous to the electrical installations

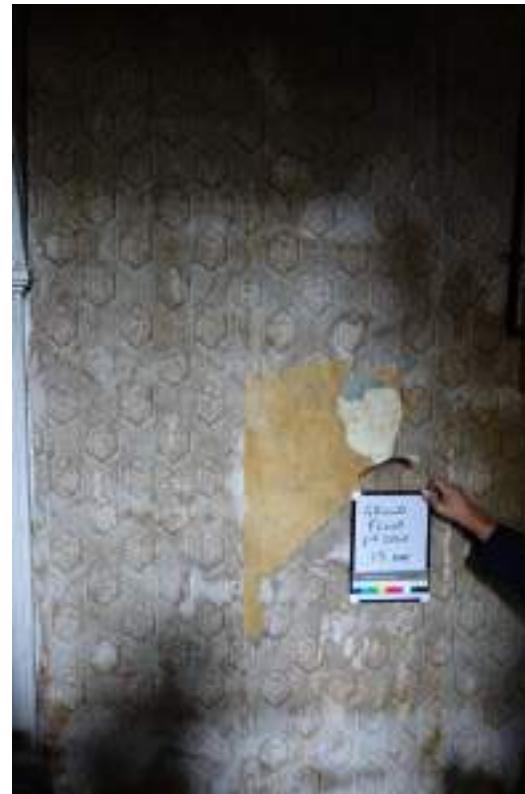
Side wall face of the stair showing the same wallpaper throughout

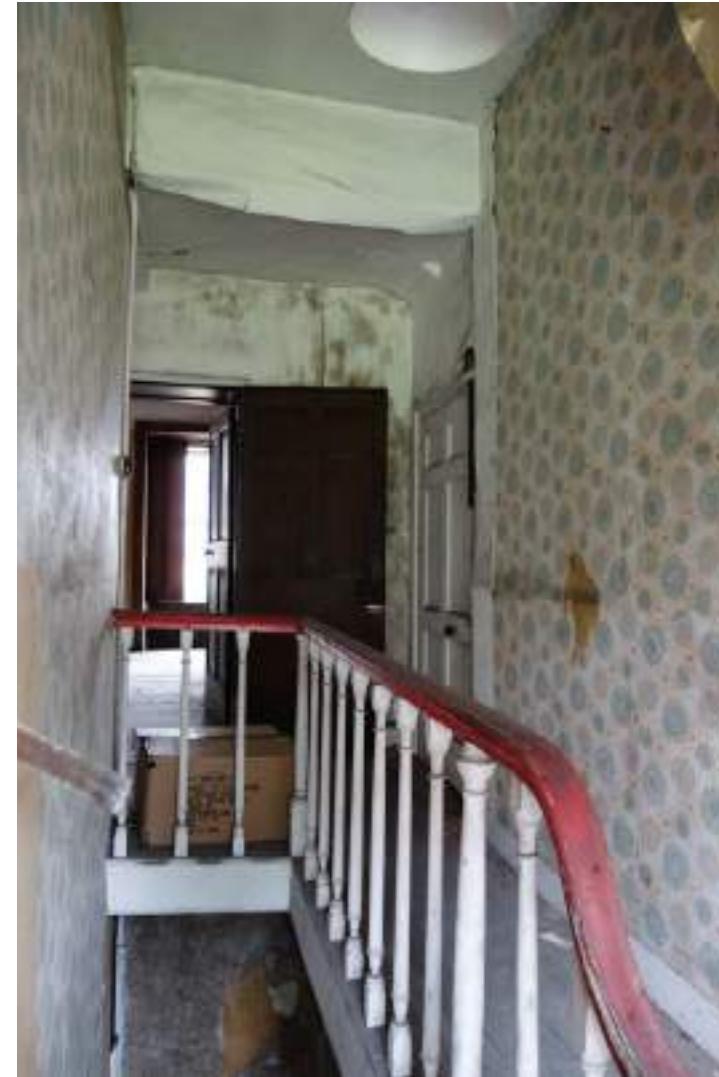
Continuation of the same wallpaper through to first floor level

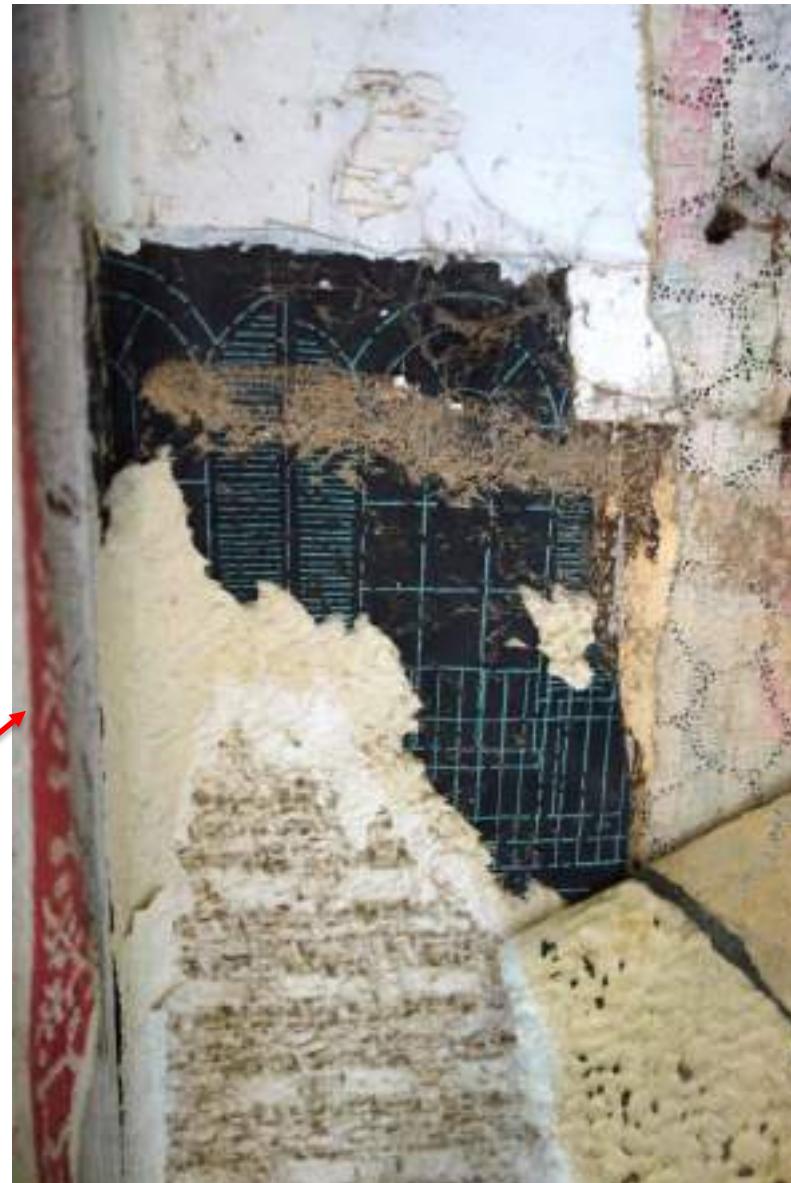
The most distinctive being a black paper with window and shutter design of the 1950s and on the stair walls a geometric foliate wallpaper, again of the 1950s. Fragments of earlier paper were visible at higher level where the paper had started to separate due to the damp conditions. These are recorded in the. Images on the following page.

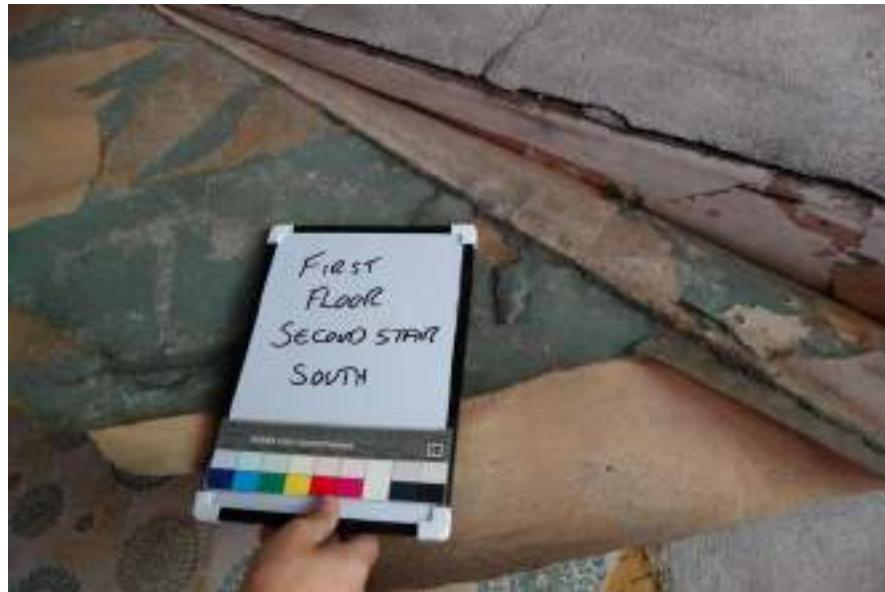
Areas of later twentieth century wallpapers

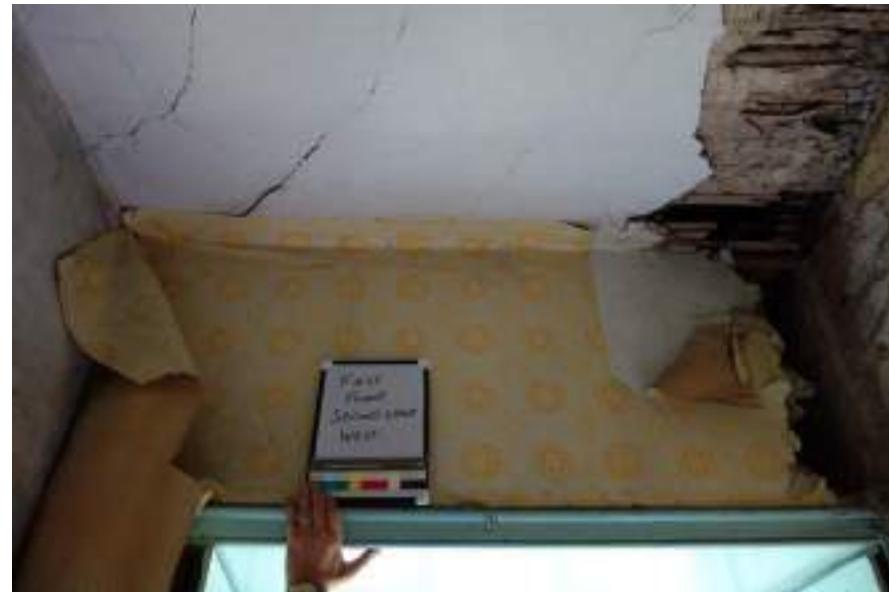
Floral wallpaper in yellow dating from the 1960s

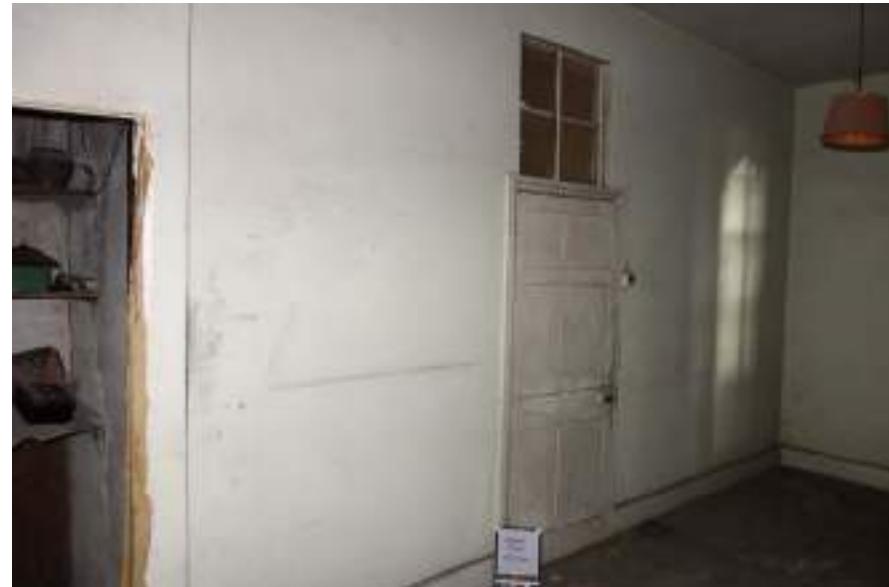
The papers on the West wall below are very firmly adhered. It is possible that during future removal works that additional papers may come to light on this wall face

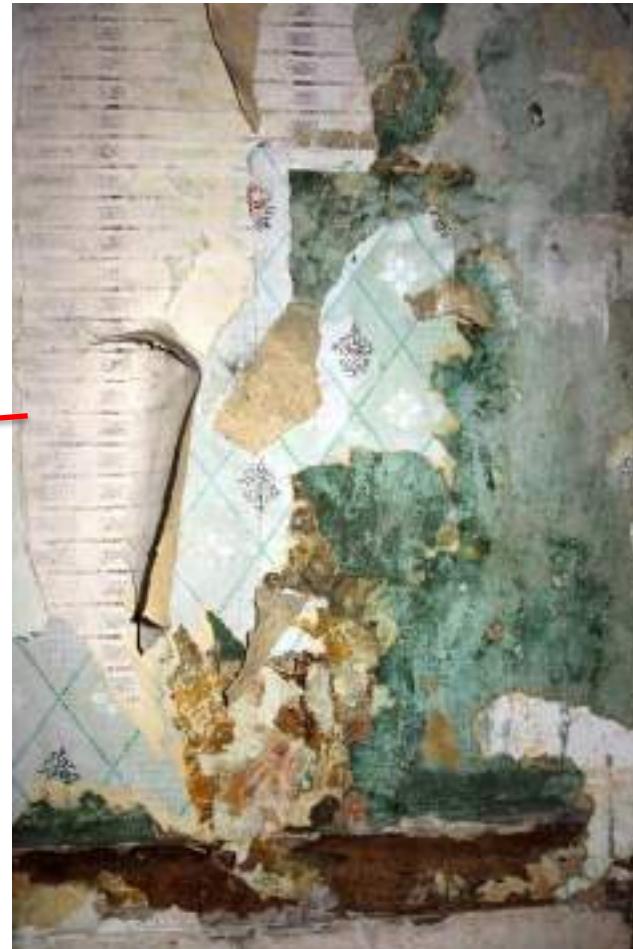
The complex chronology of wallpaper schemes is the same here on the South wall face. The area of wall is extremely damp resulting in the degradation of the wall papers. It is therefore not possible to identify each clearly here. The chronology is the same as the remainder of the interior and as detailed below.

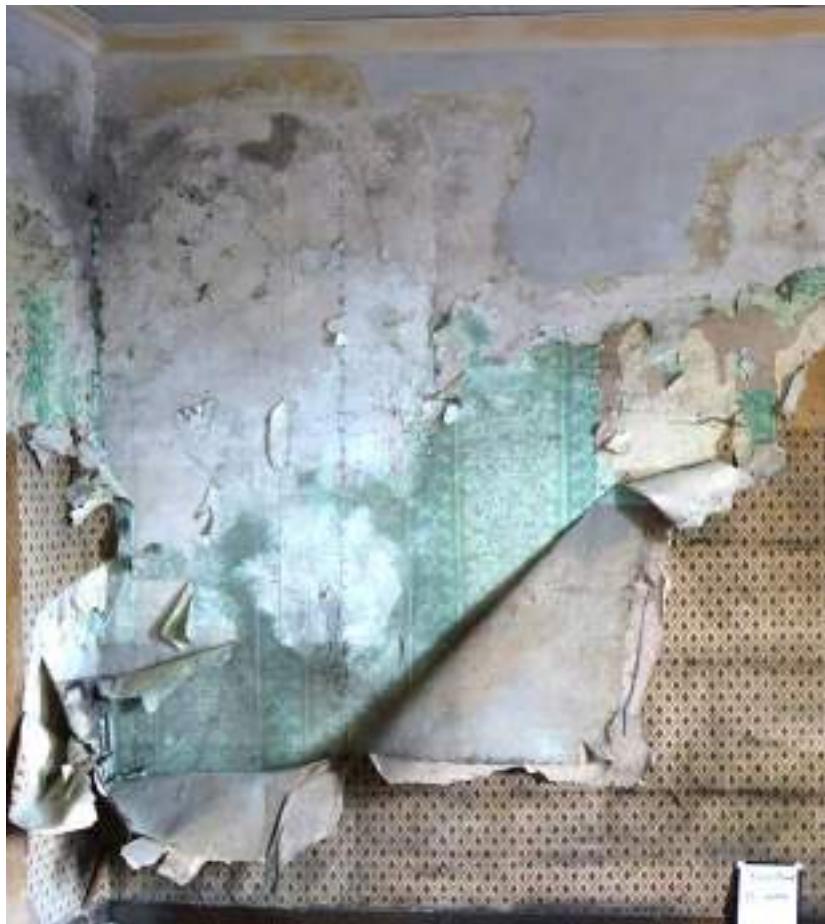
ROOM 16 – All wall face, six schemes of patterned wallpaper

Areas of damage relate to insertion of ceiling cove

Surface print - where exposed, surface dirt with some buckling, mechanical abrasion and moisture damage

Staining - some sooty deposits and damp ingress

All procedures must account for the presence of arsenic.

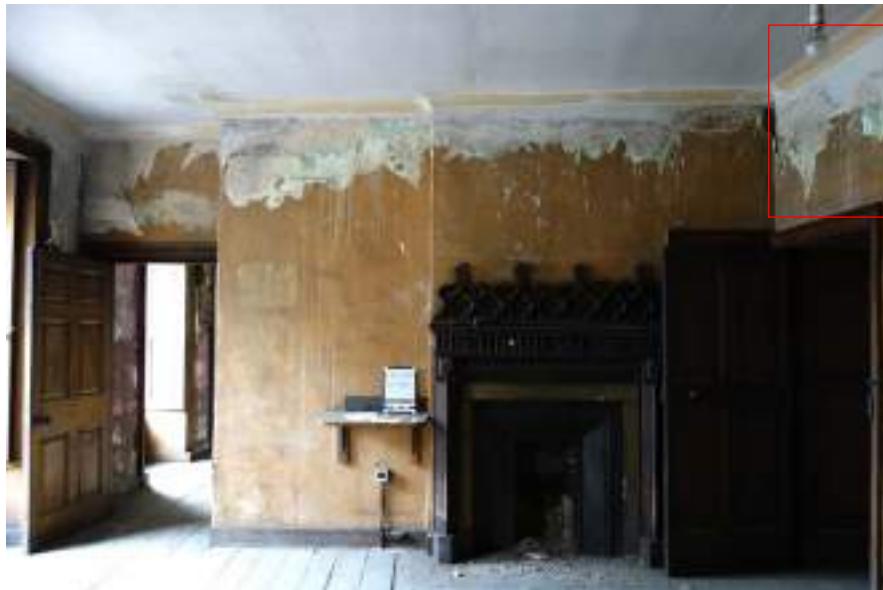
South wall face

This image shows where the wallpapers have been removed to allow for the insertion of the modern ceiling cove.

Fragments of the wallpapers can be seen along the torn edge of the South and West wall face

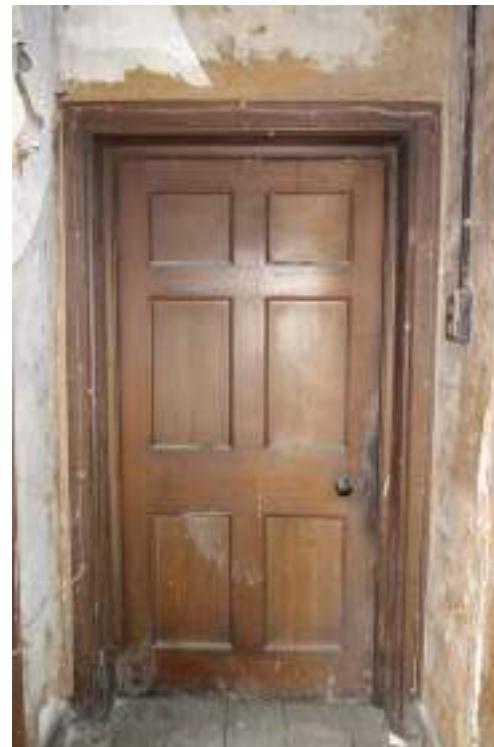
South wall face wood grained door, early date

The graining to the joinery is highly significant and is in fact more so due to its direct relationship with the earliest Regency wallpaper scheme. The significant of paint finishes can be easily overlooked, when in fact they are of even greater significance when surviving with the main wall finishes intact.

The grained finish on these doors in association with the green striped wallpaper identifies this as a highly fashionable Regency interior.
