Narrowgate House, Coach-house and Stables

**REPORT ON: HISTORIC WALLPAPER RECORDING AND CONDITION SURVEY
WITH NOTES ON ASSOCIATED HISTORIC FINISHES SURVIVING IN-SITU
AT NARROWGATE HOUSE, ALNWICK**

The Front Façade of Narrowgate House, Alnwick, (Formerly General Lambert's House) 31 & 33 Narrowgate.

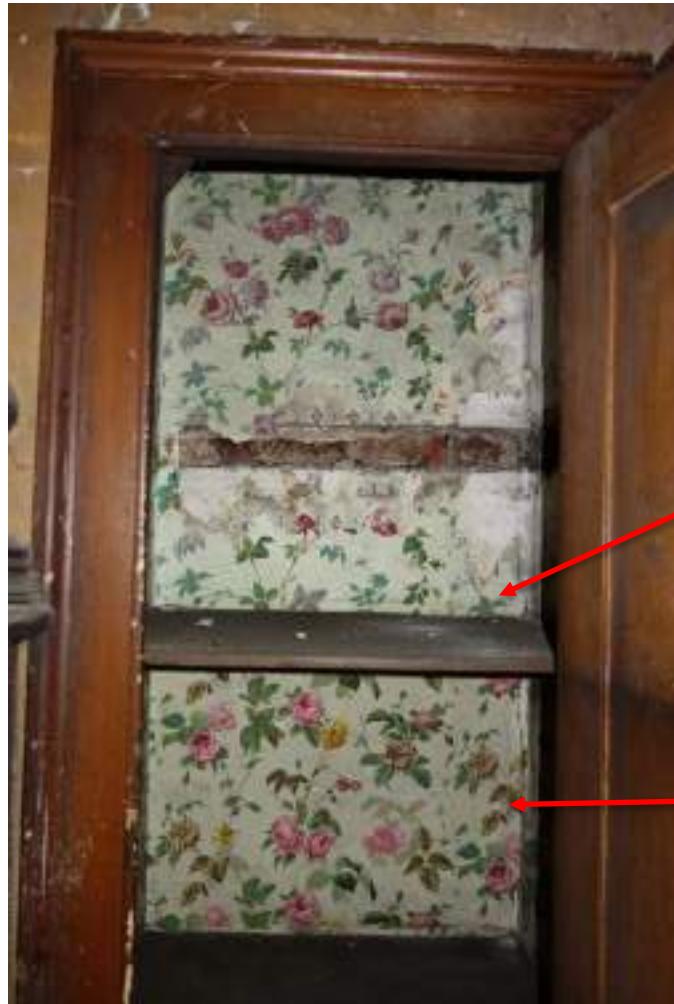
South wall face west corner, cupboard

This shows the fourth scheme

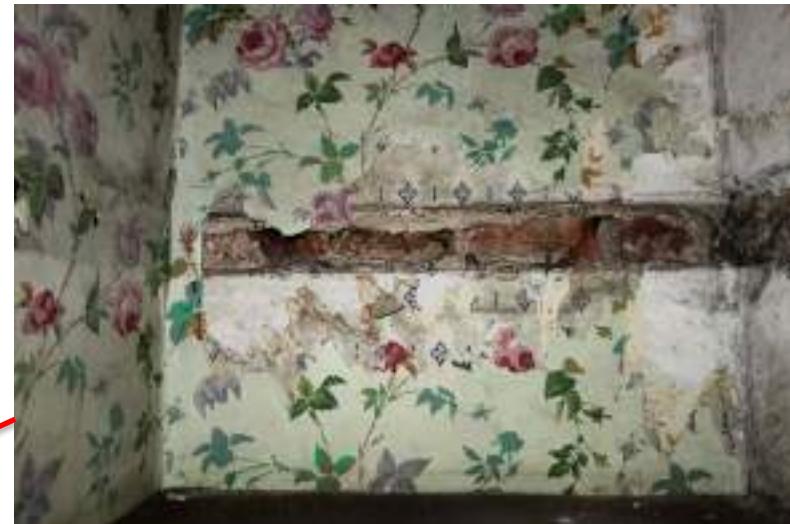
South wall, West corner, cupboard interior, detail of the two rose wallpapers

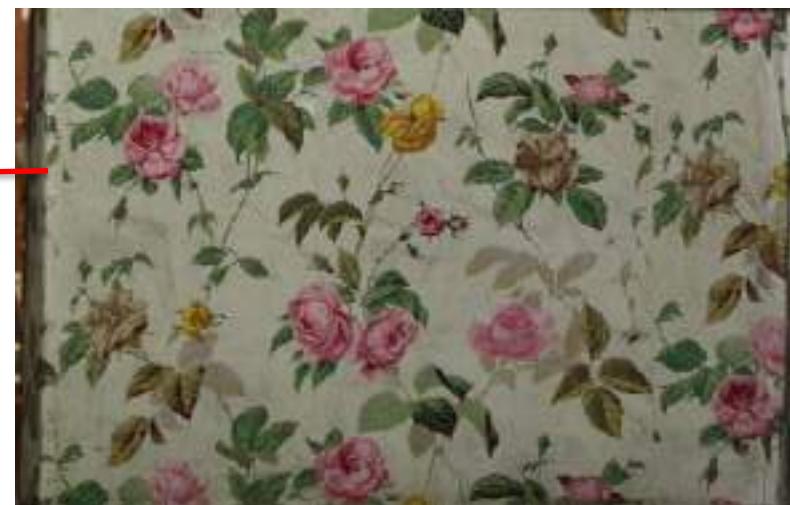
The wall paper in the image below may be slightly later than that shown above. However, the differences are very subtle and the two papers may have been used together deliberately in order to make up the quantity required

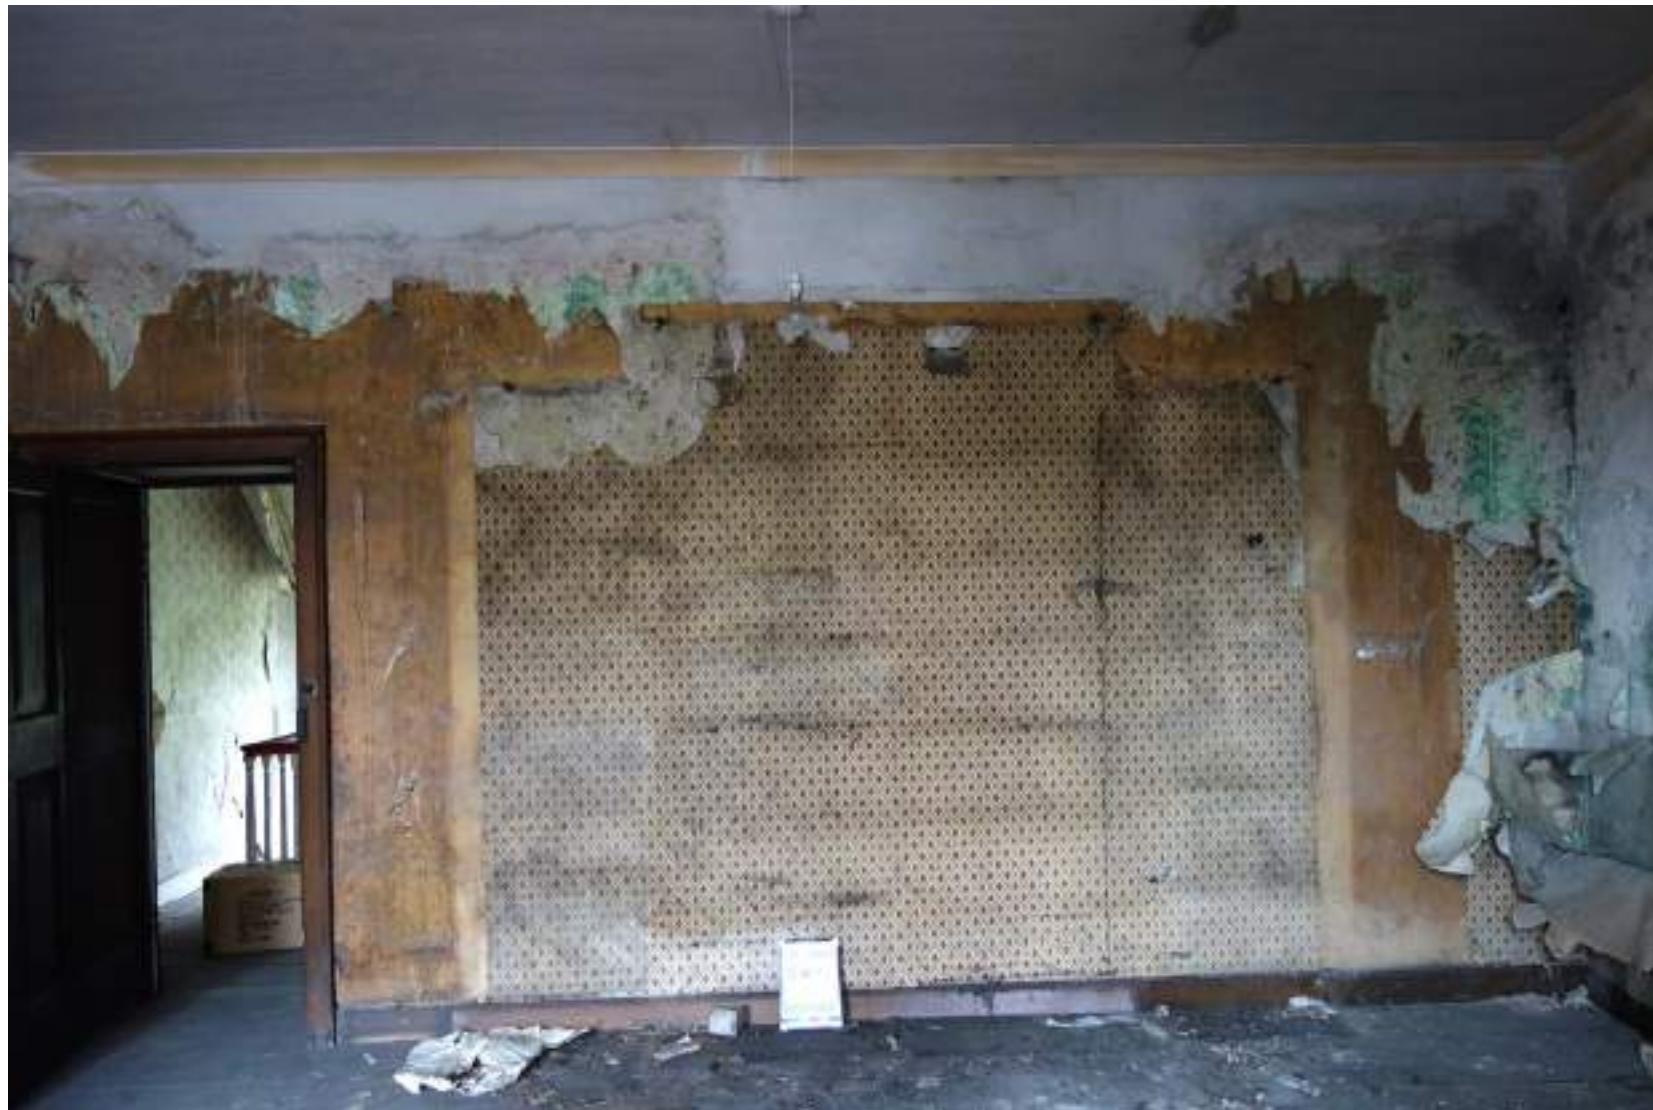
West wall face, showing scar of previous freestanding furniture and area to North, exposing the wall paper sequence. Areas of the green Regency strip can again be seen

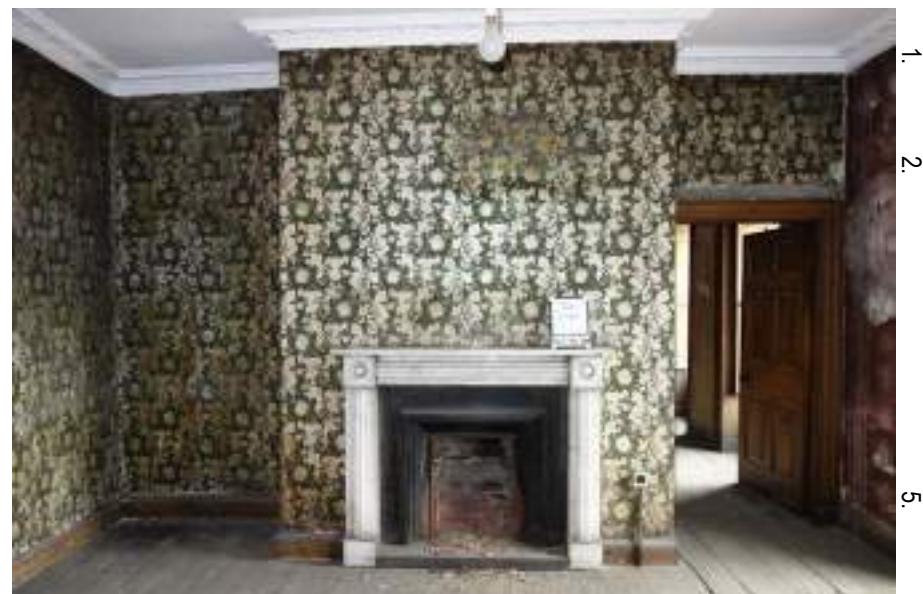
North wall face with virtually complete paper scheme in situ

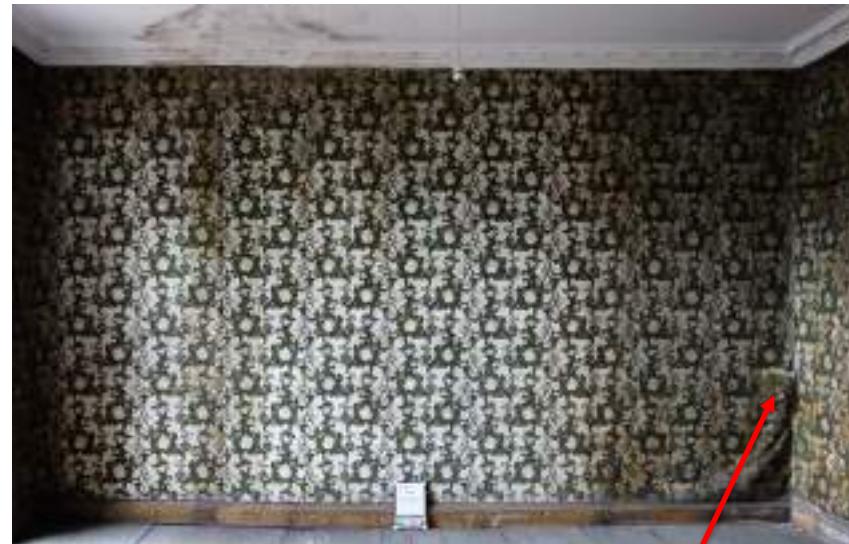
South wall face with virtually complete paper of scheme 3 surviving in situ

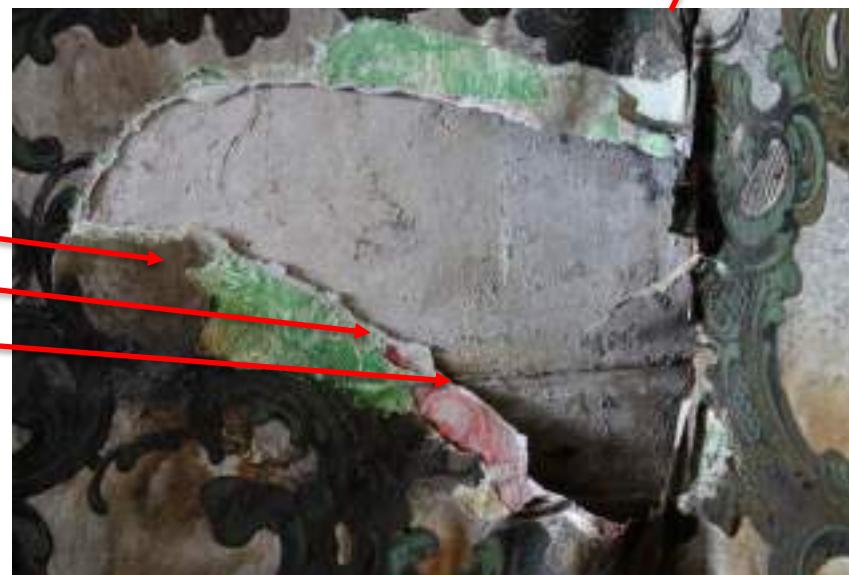
Detail of South wall, showing the sequencing of the wall paper's

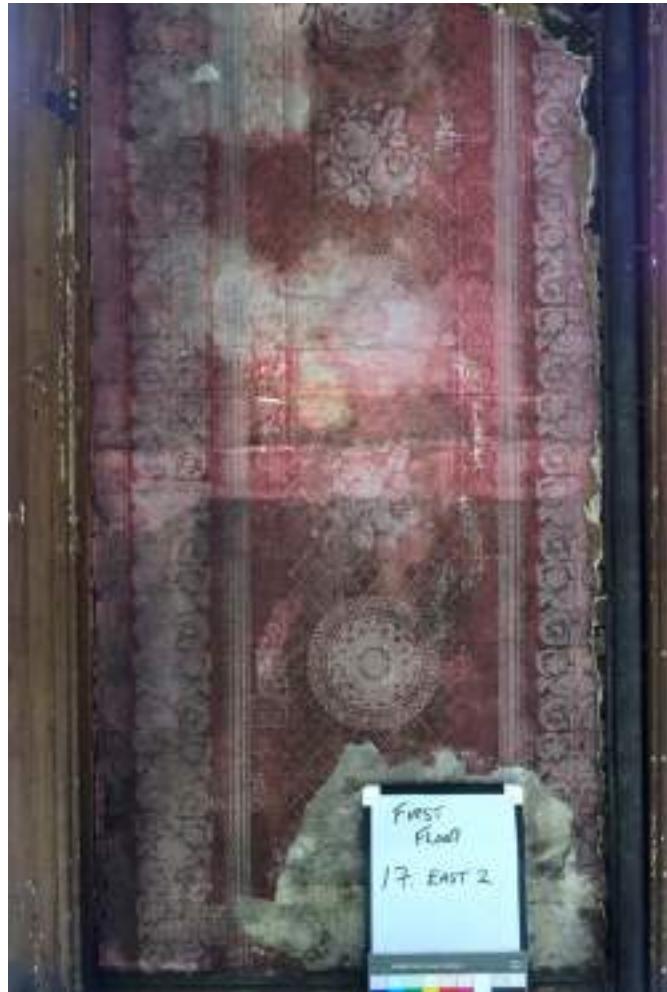
East wall face, North corner

Large exposed repeat of scheme 1, red Regency stripe design

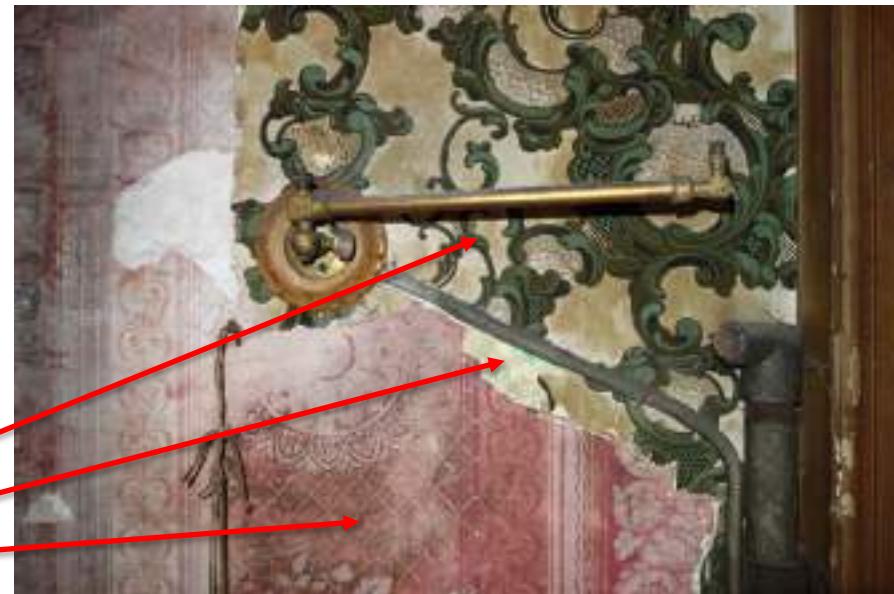
East wall, central section pier between windows

Clear sequencing of the three schemes with an early gas light fixture in-situ

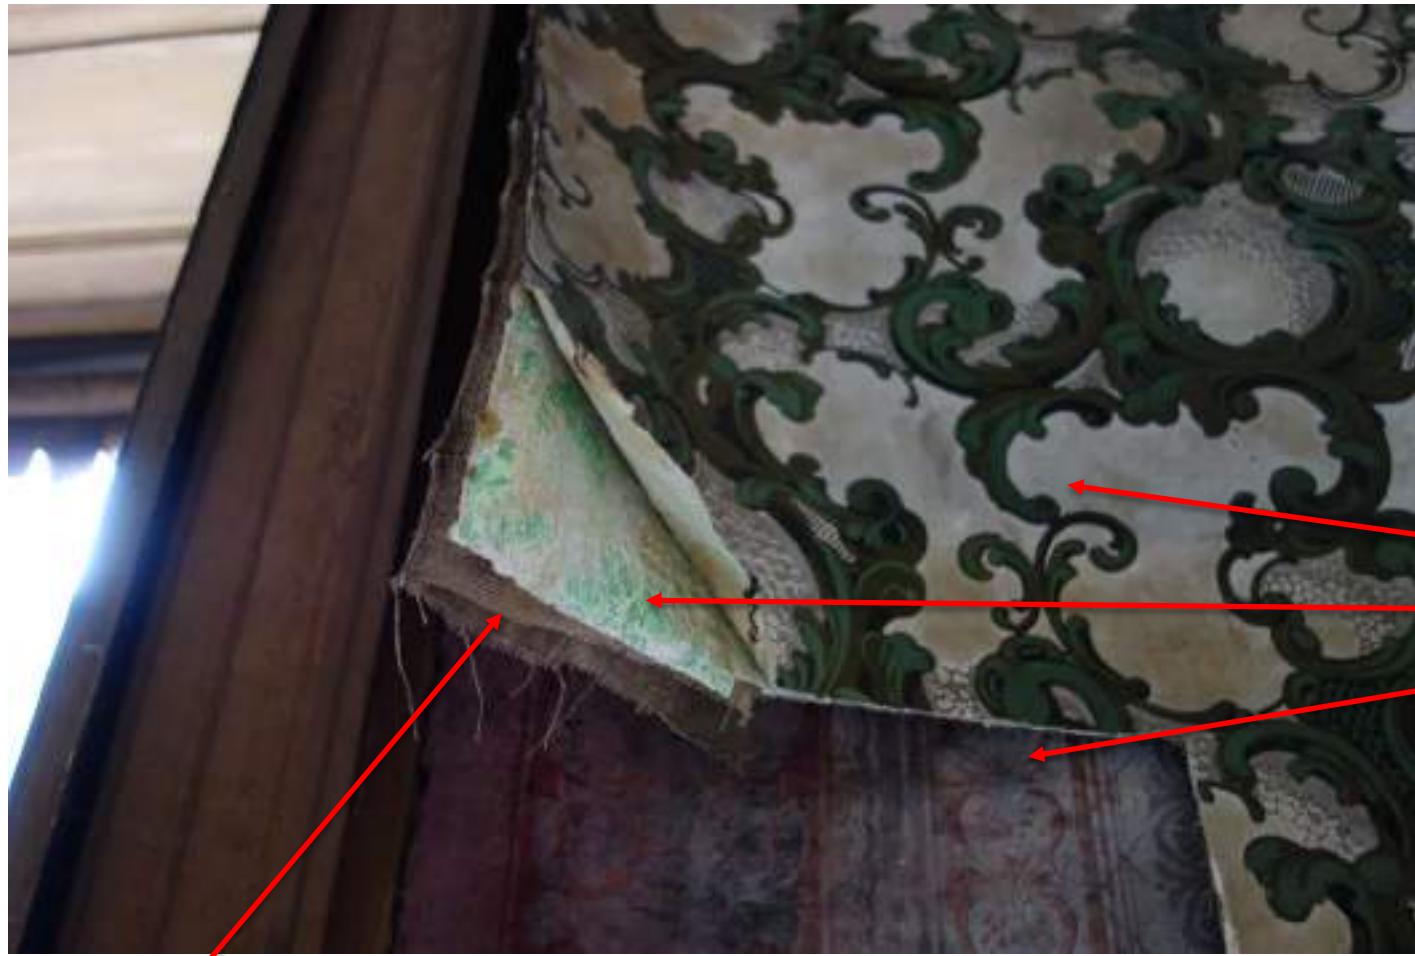
Detail showing the clear sequencing of the decorative schemes

Hessian backing applied prior to the second wall paper scheme

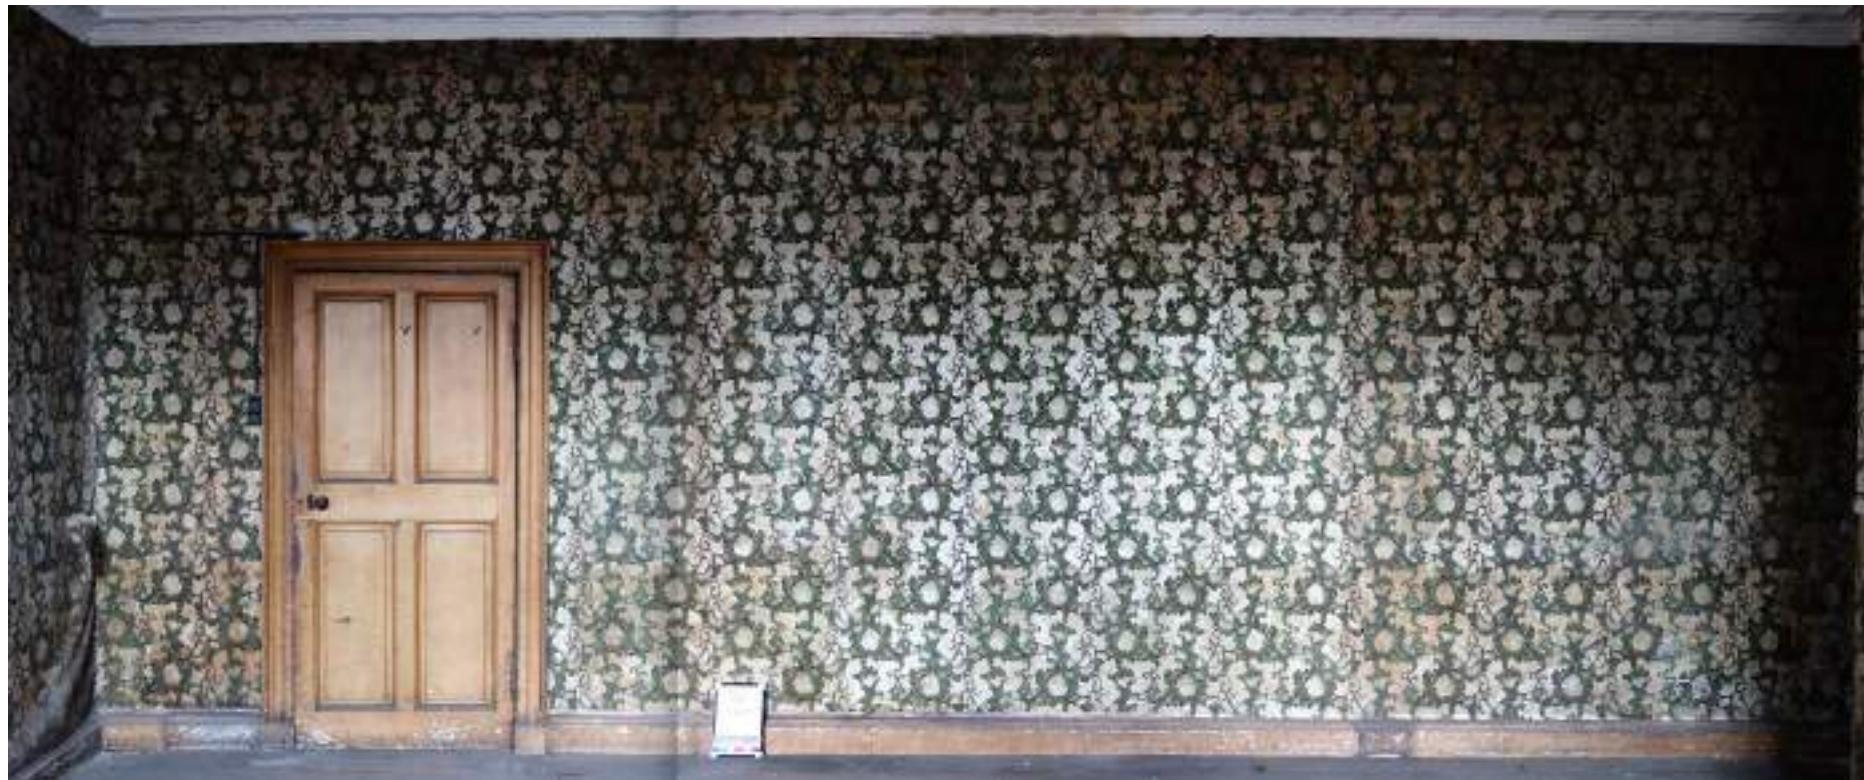
West wall, showing the third wall paper scheme surviving in its entirety

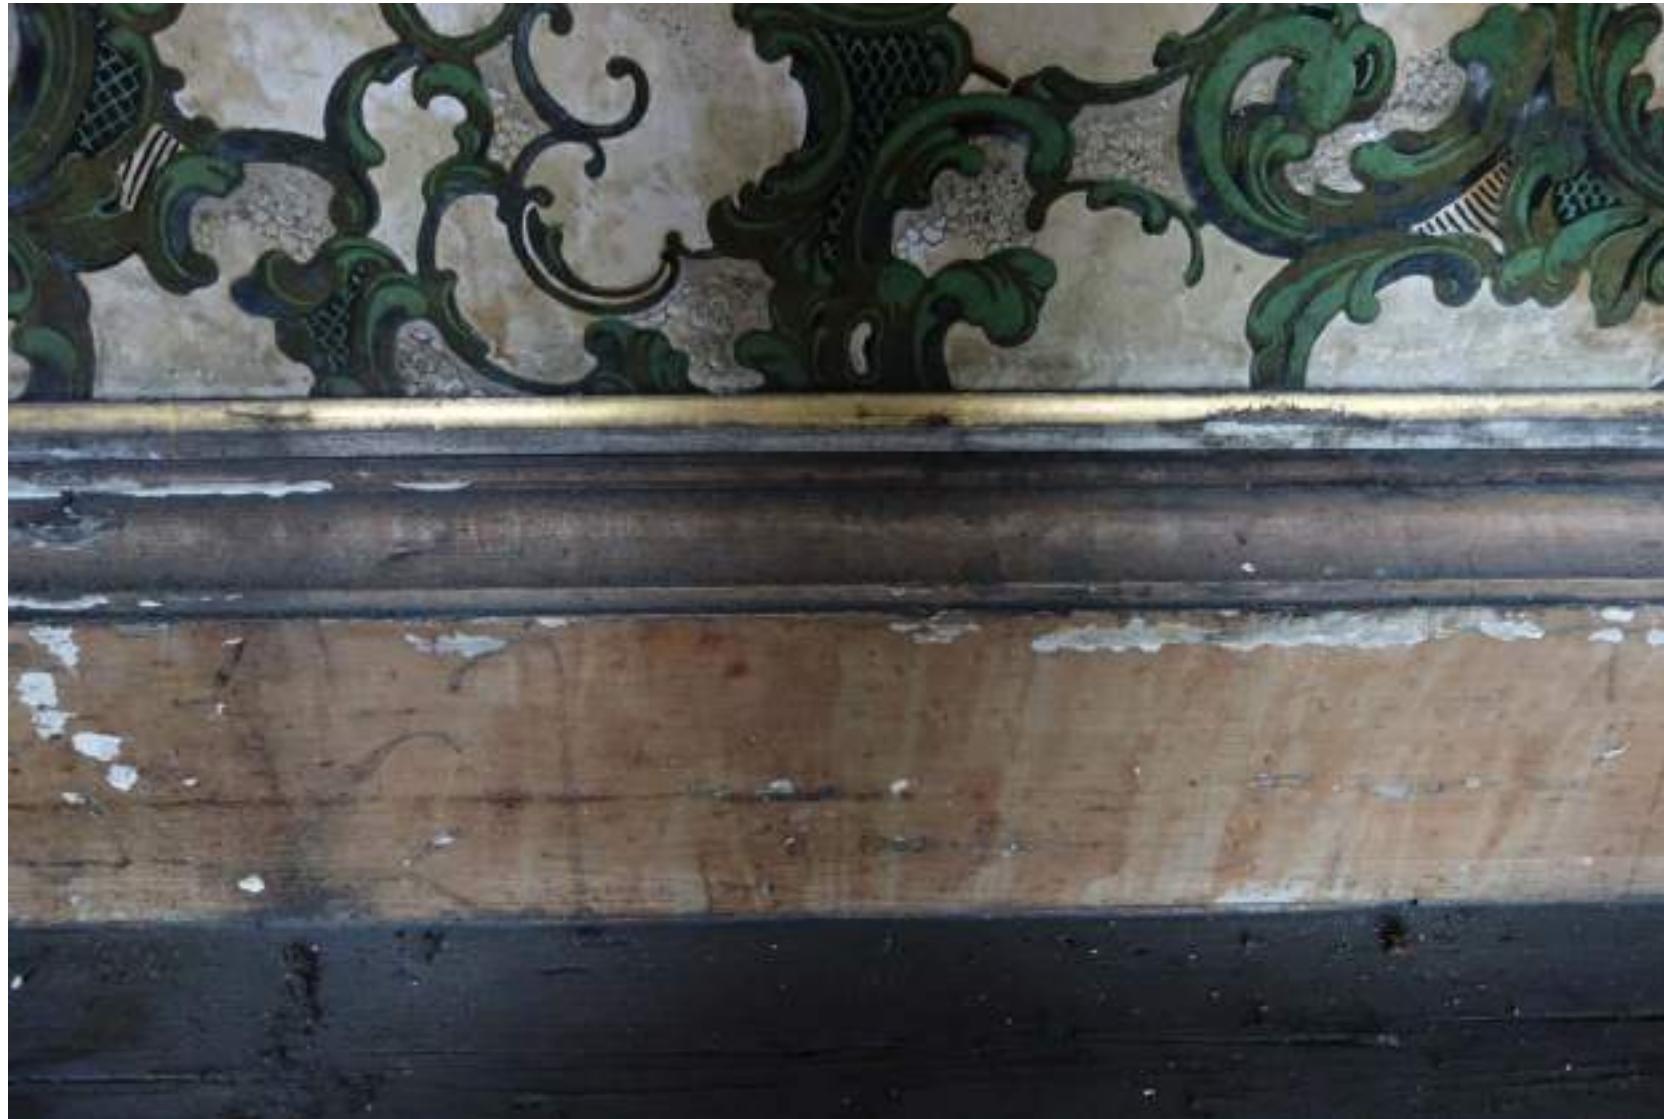
West wall skirting, showing the gilded top fillet moulding applied to the top edge of the skirting and the wood grained finish to the skirting riser.

The quality of the gilding, with the edges of the individual gold leaf sections visible is remarkable.

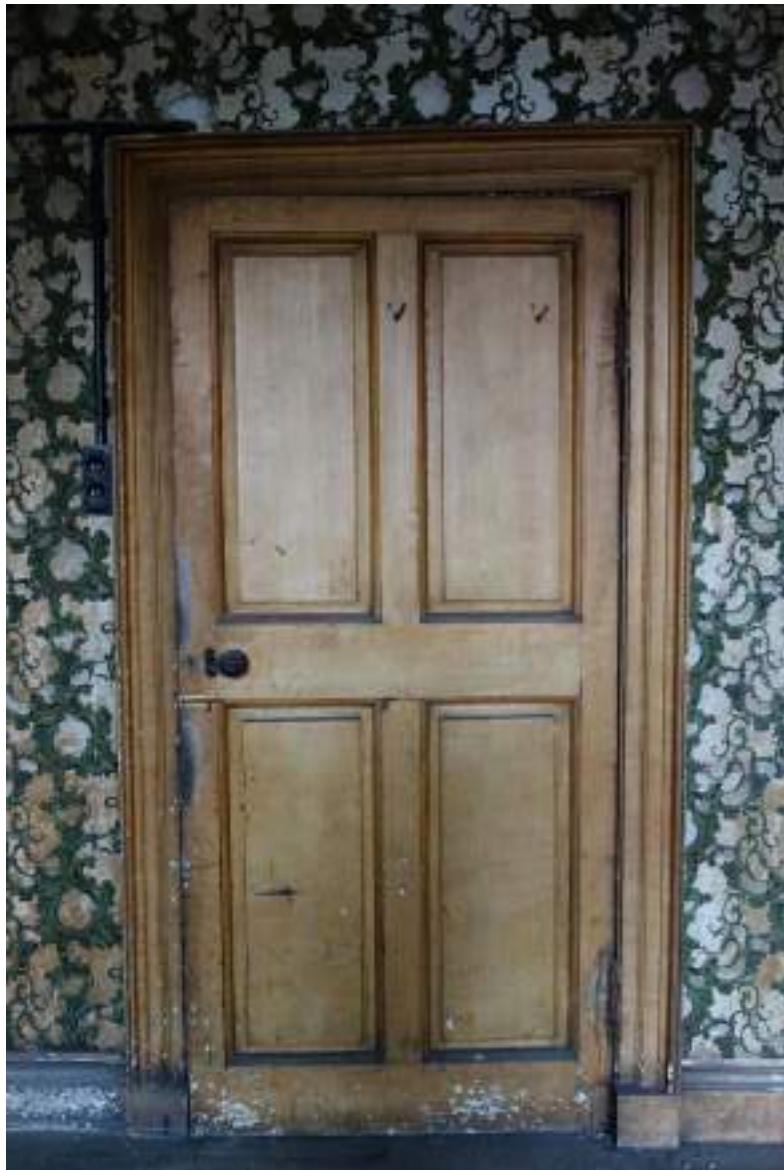
West wall, door to South. This shows the high-quality, Birdseye Maple paint finish applied throughout the interior

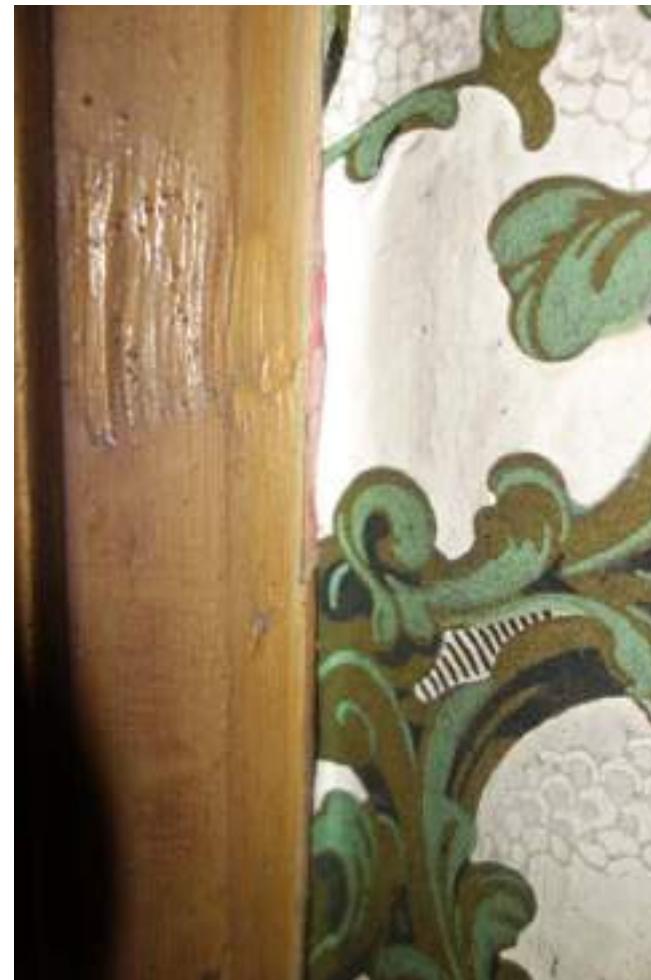
A small section of the earliest wall paper scheme exposed at the side of the door architrave. This suggests that the woodgrained finish may have been in evidence from this earlier date. If so then this is an example of a Regency woodgraining, possibly dating from the 1820s. The pale nature of the finish would certainly suggest that, with a mid-oak being more appropriate for the later 1850s-70s scheme.

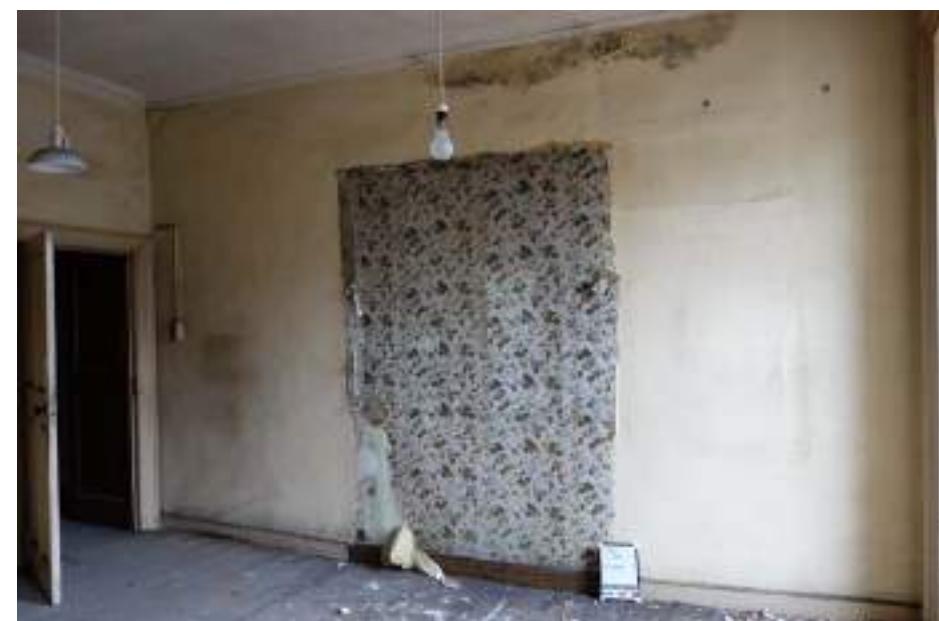
ROOM 18

Detail from North wall face

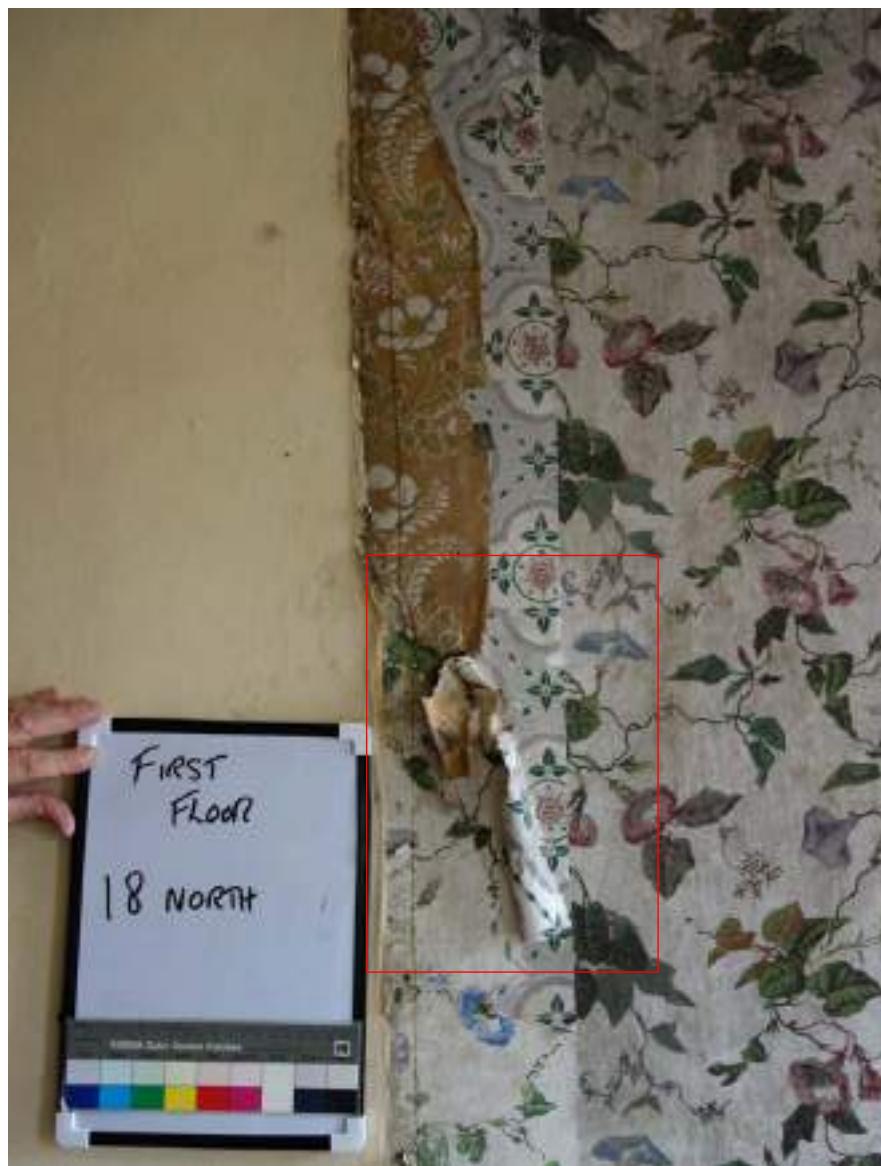
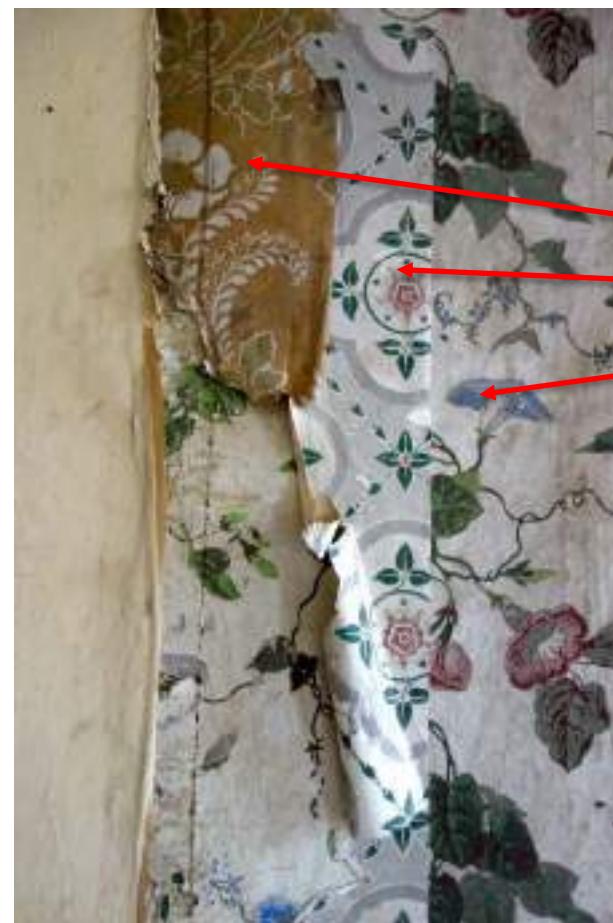
Schemes
6.
5.
4.

South wall overpainted scheme 4 on soffit

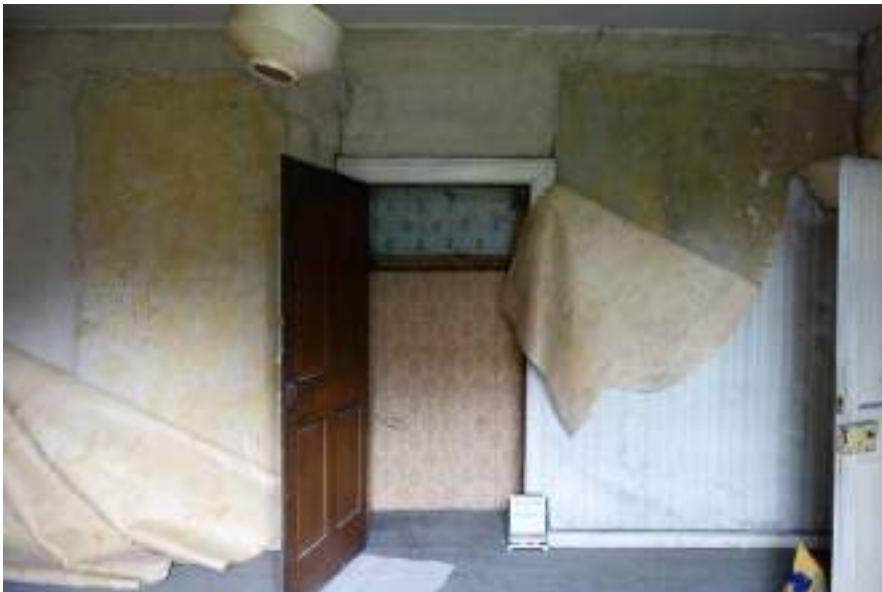
Room 19 East wall, showing falling papers and survival in the cupboard

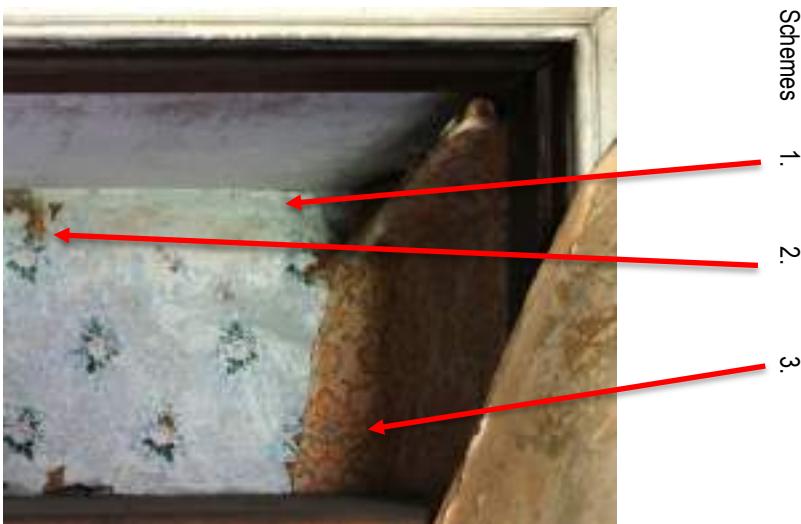
Room 19 East wall cupboard, upper shelf

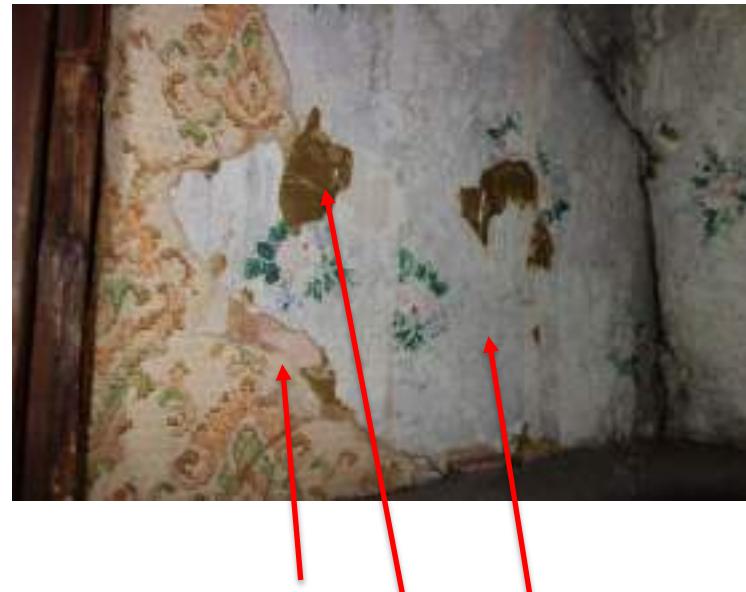
Room 19 East wall cupboard, upper shelf North corner

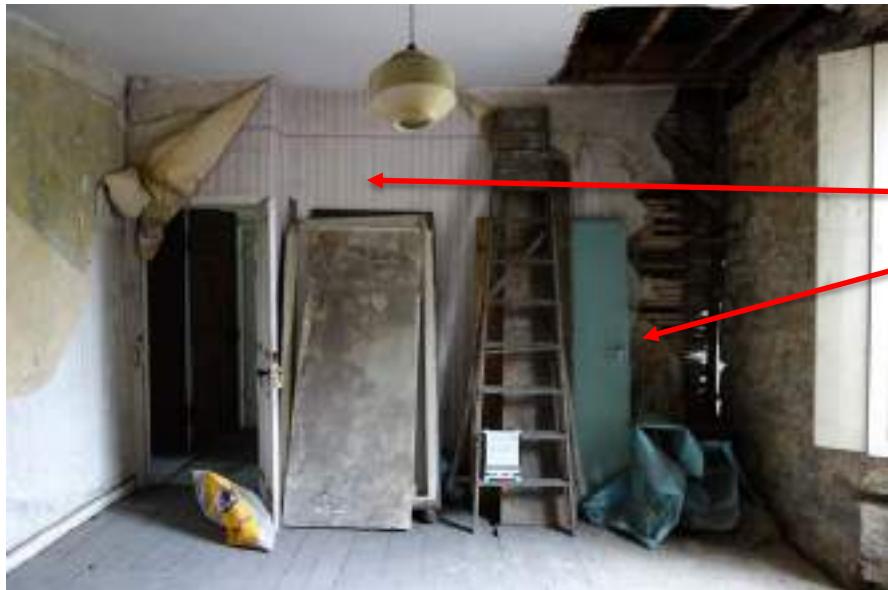
Room 19 South wall, evidence for schemes 4 and 5

The first paper is a delicate rose bouquet design within a faint leaf trellis design of the 1840s. This is best seen in the south wall face cupboard.

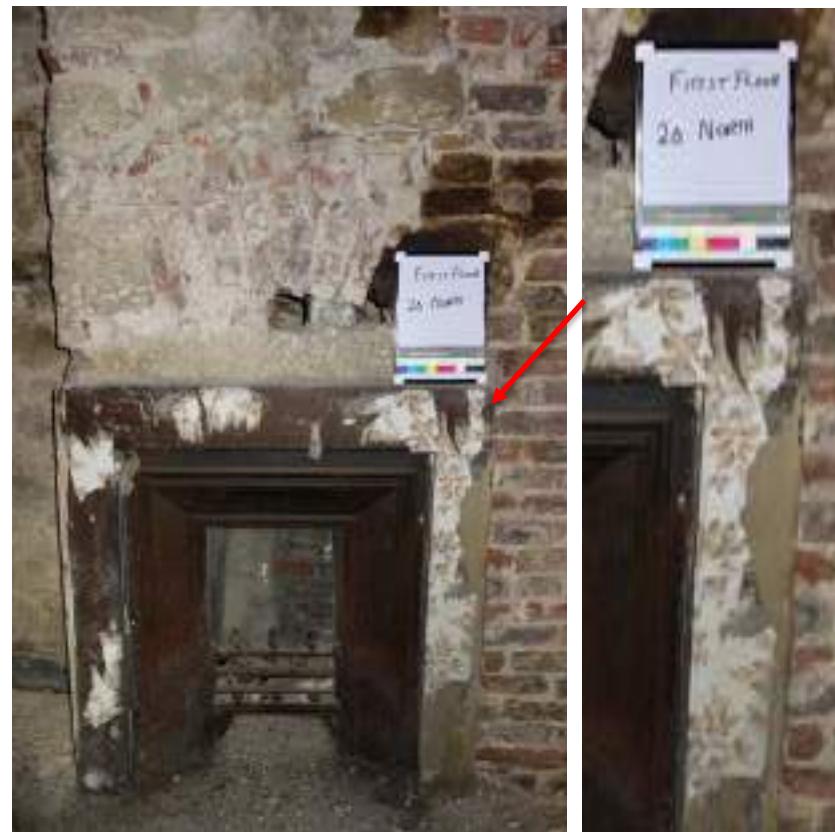
ROOM 20 North wall, fragments around fire register only

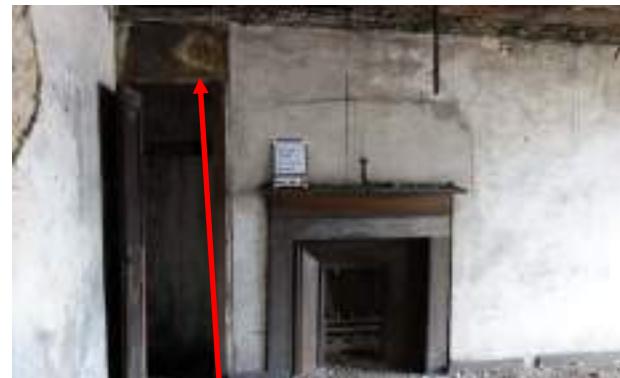
Room 34 North wall, stretched hessian over door panel

The only evidence is a small fragment of paper on a canvas backing over the cupboard on the north wall. The dating of this paper is problematic for such a small piece, however stylistically it suggests a date of the early part of the 19th century.

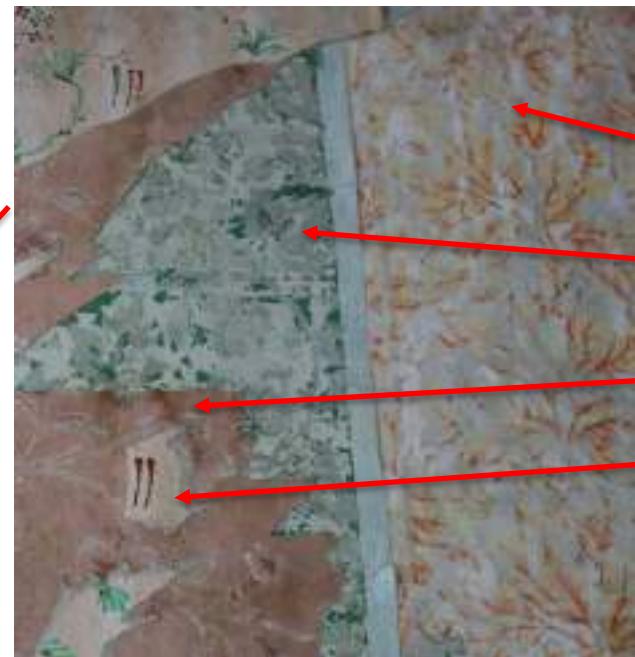
North wall, area of tearing showing earlier schemes

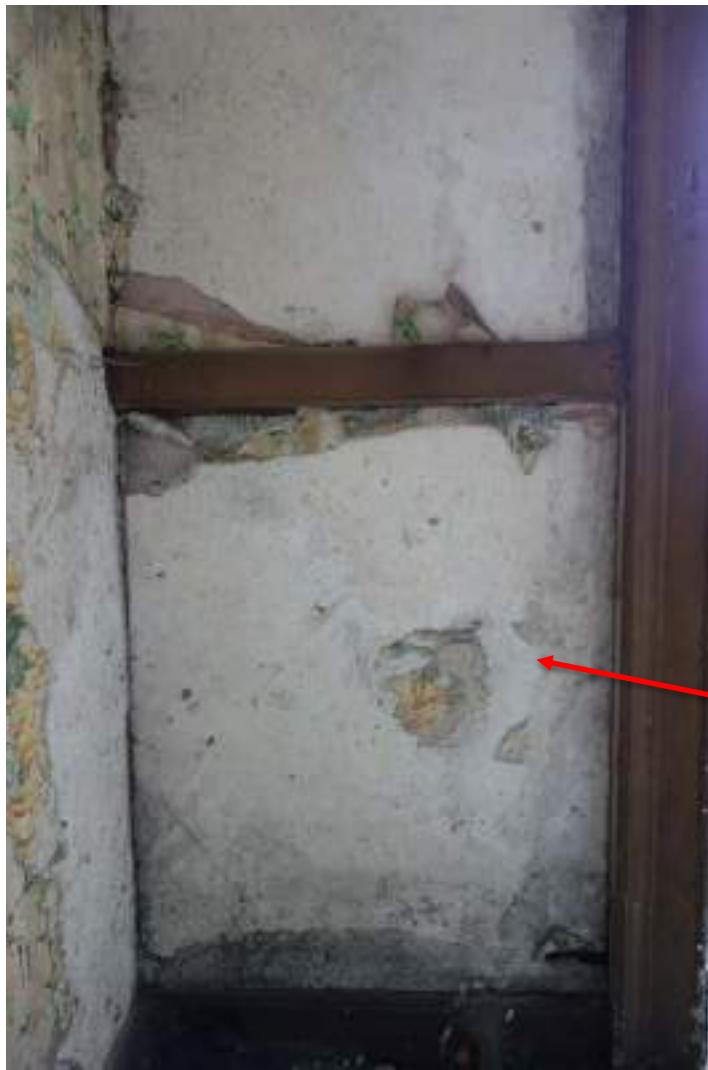
East wall, North end, showing survival respecting joinery work

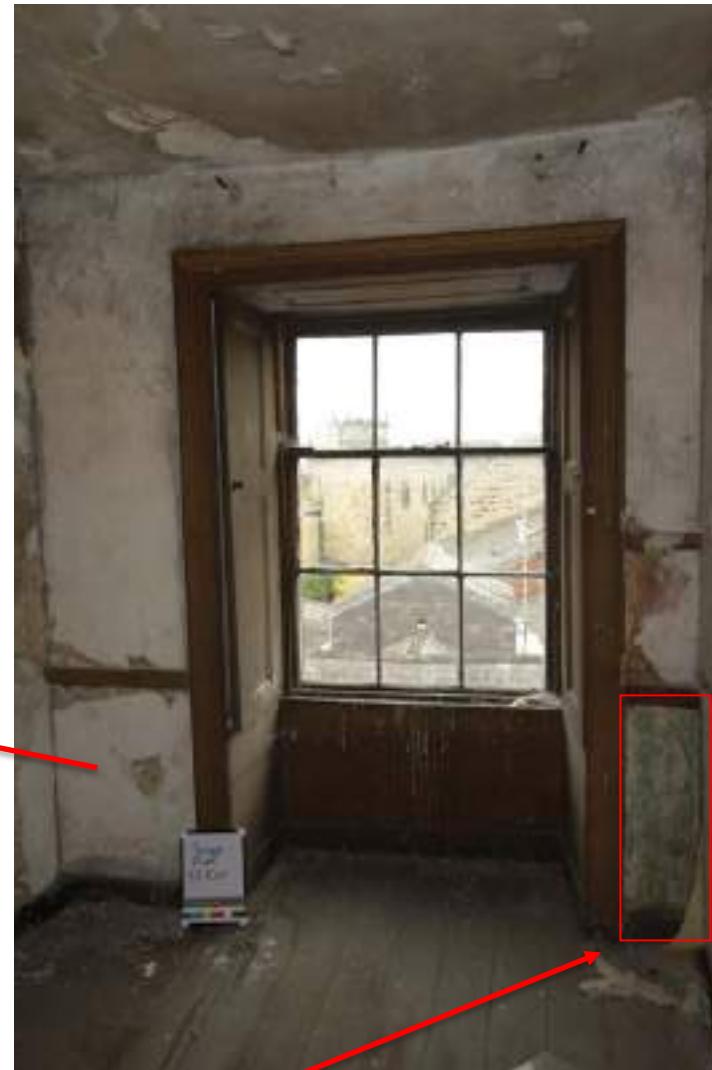
East wall showing survival at low levels

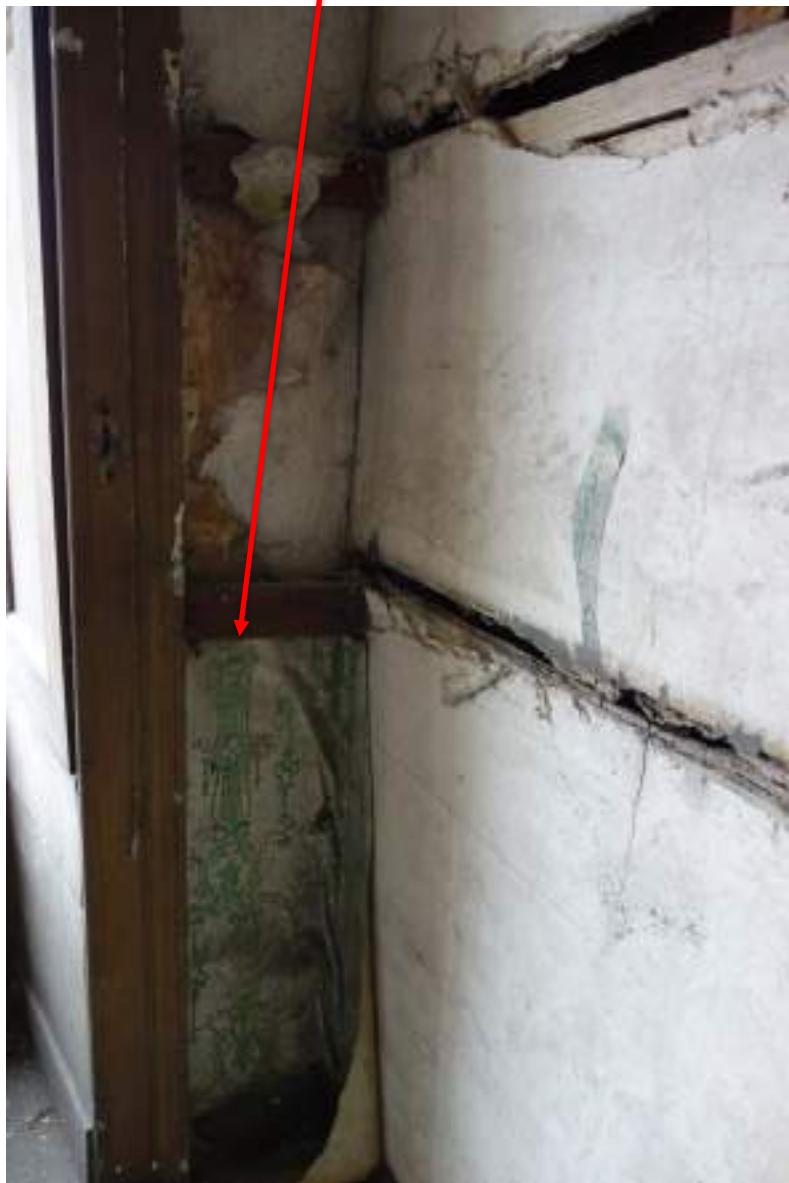
East wall, South end. This paper is tentatively dated at c.1910?

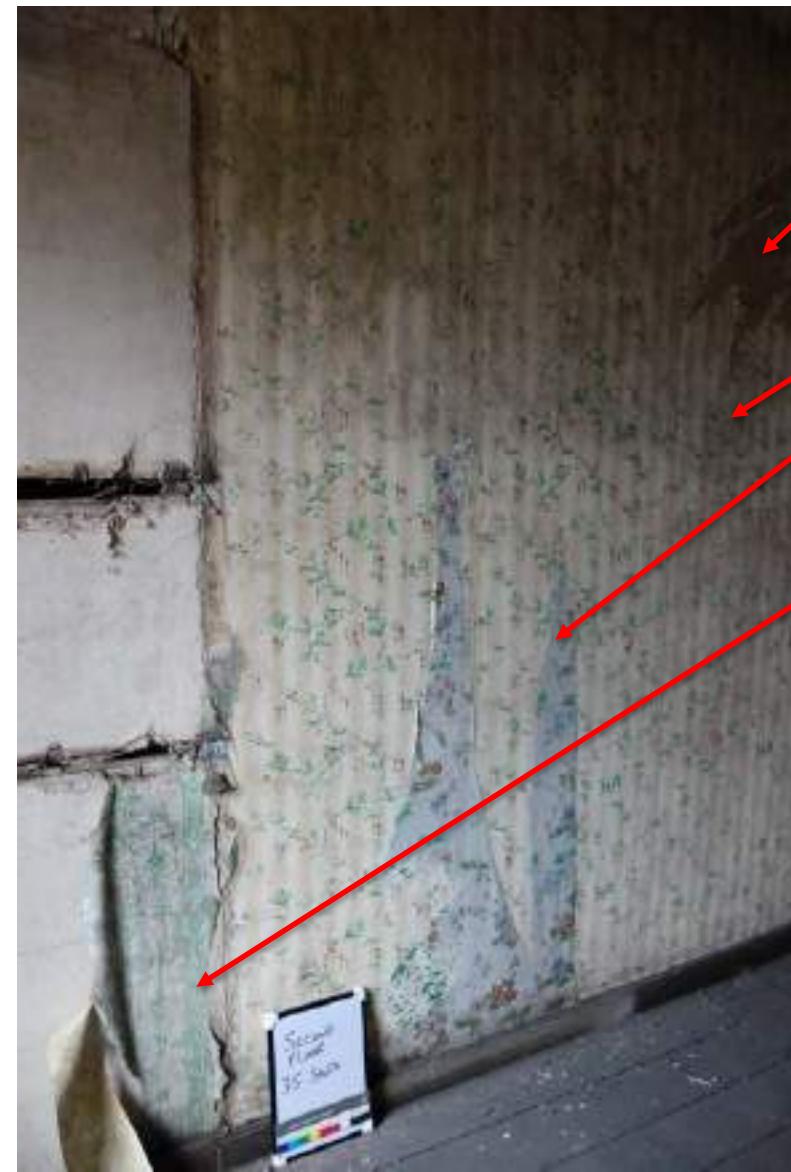
South wall, survival at full height over the majority of the wall face

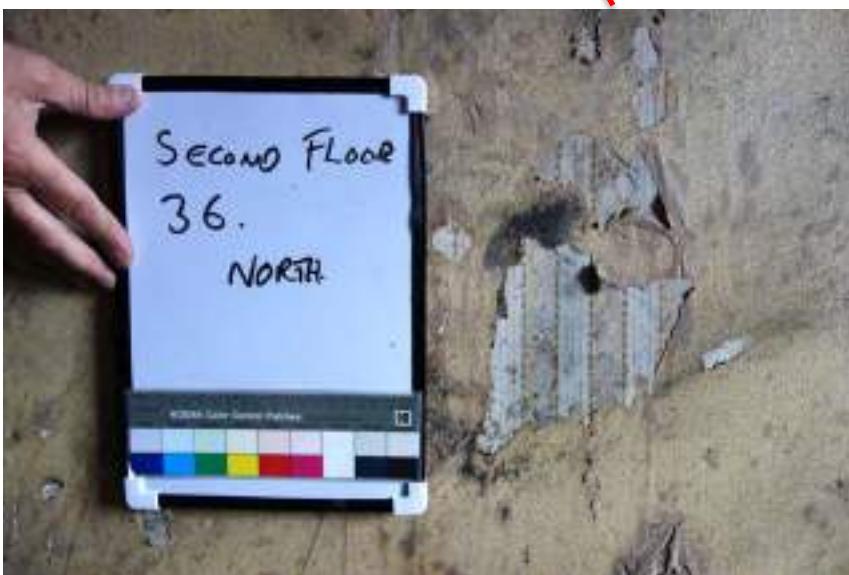
North wall detail of c.1900 wall paper

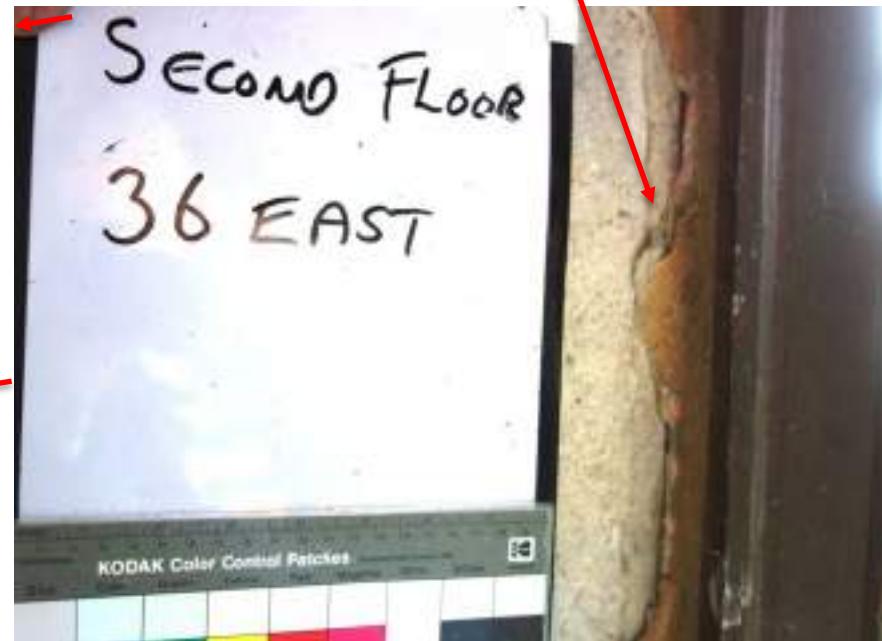
East wall, fragments adjacent to window architrave
