Narrowgate House, Coach-house and Stables

**REPORT ON: HISTORIC WALLPAPER RECORDING AND CONDITION SURVEY
WITH NOTES ON ASSOCIATED HISTORIC FINISHES SURVIVING IN-SITU
AT NARROWGATE HOUSE, ALNWICK**

The Front Façade of Narrowgate House, Alnwick, (Formerly General Lambert's House) 31 & 33 Narrowgate.

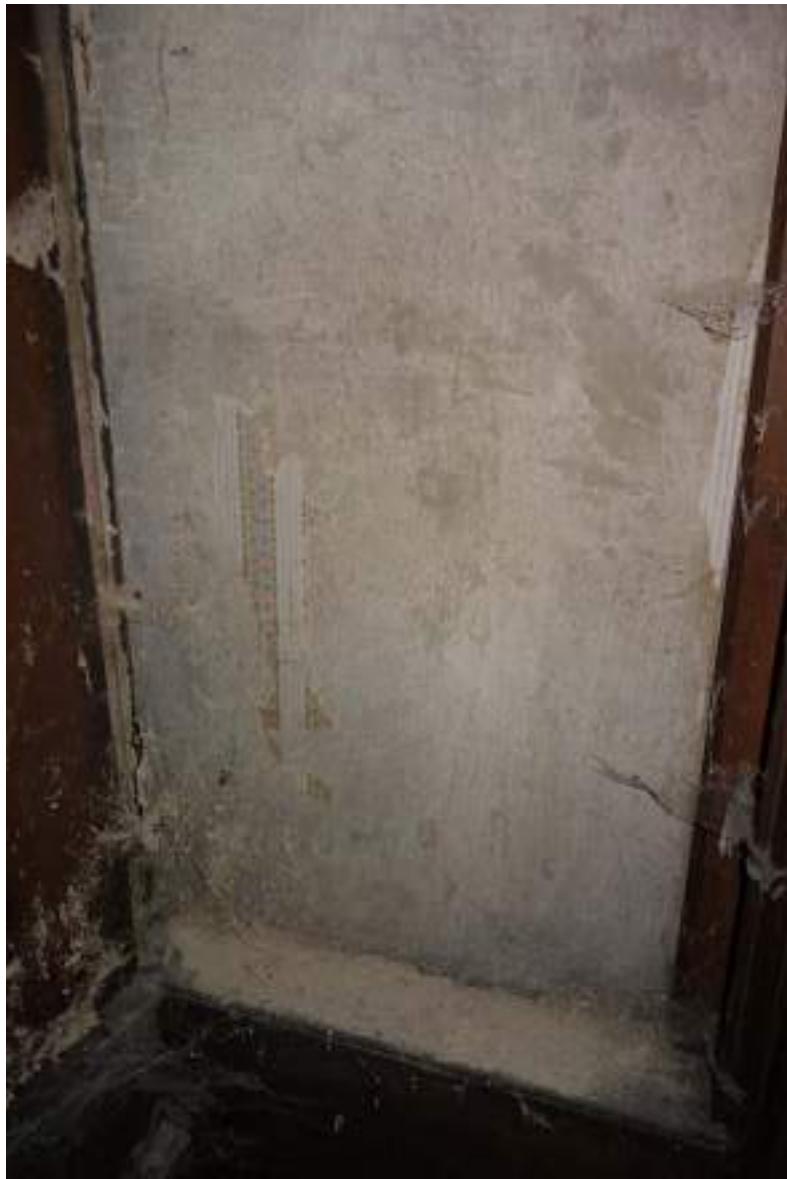
East wall, North end, wall paper fragments

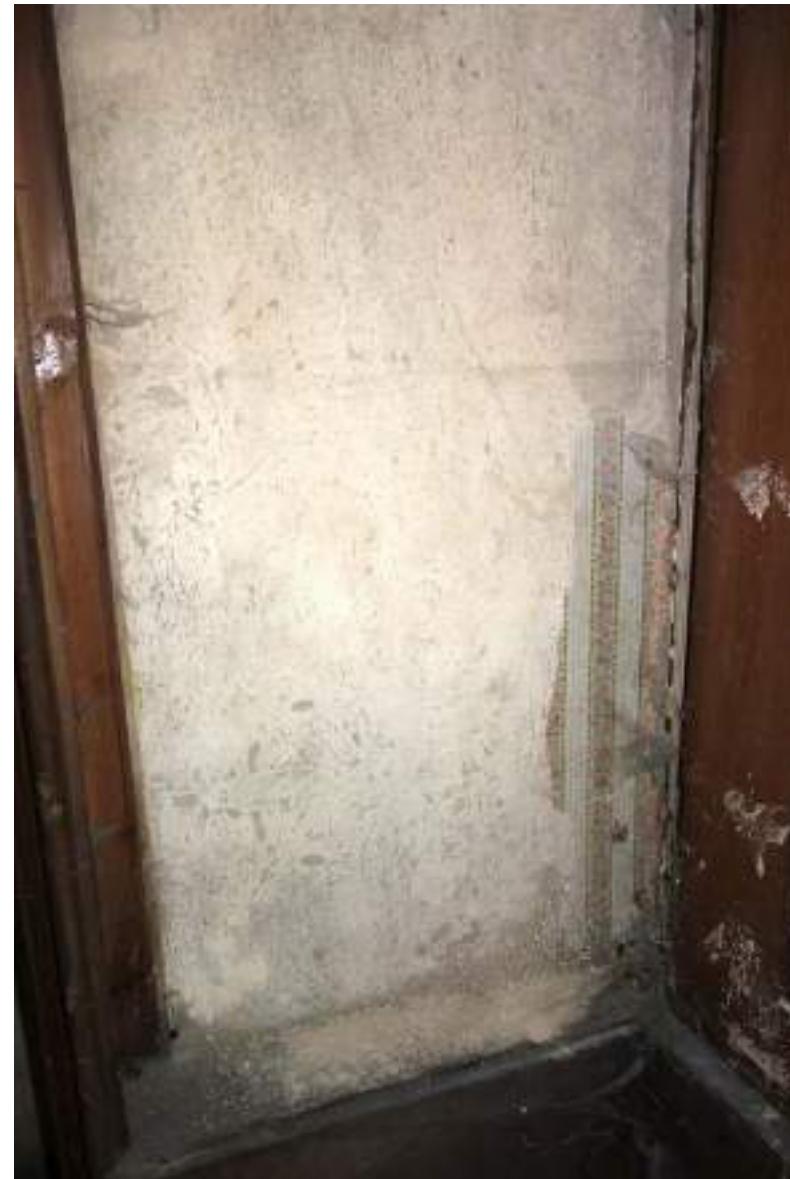
East wall, South end, wall paper fragments

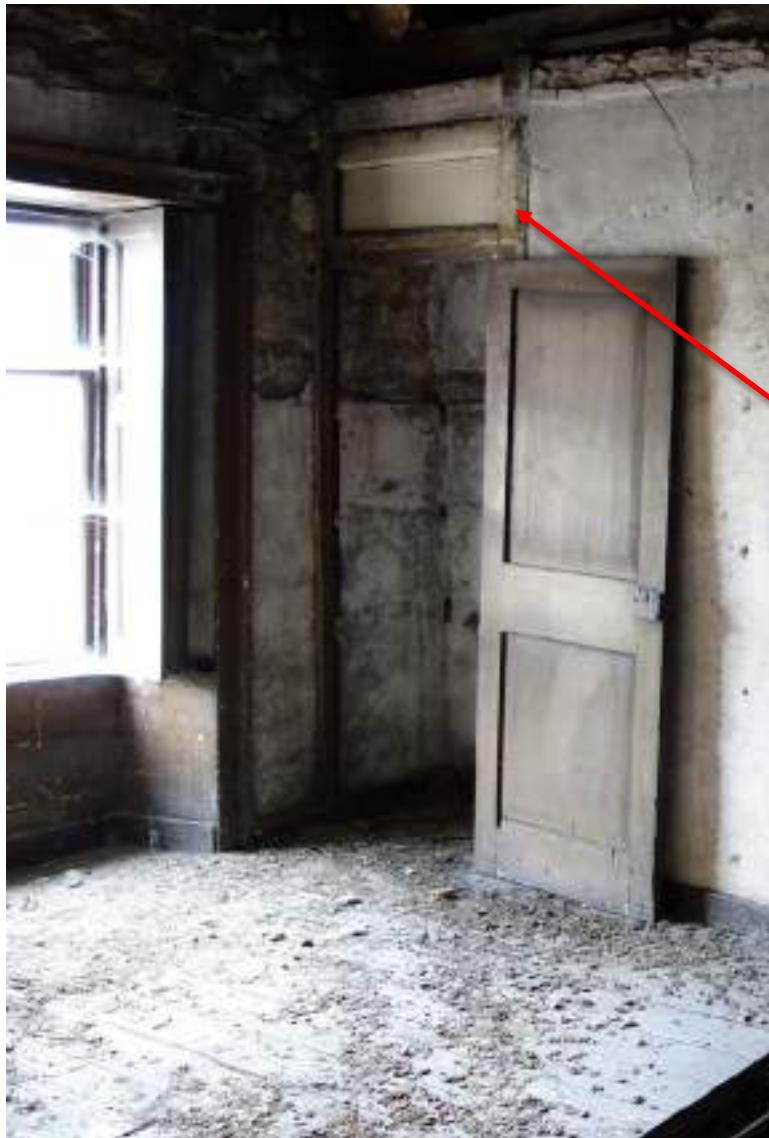
South wall, area of earlier wall face hessian above cupboard

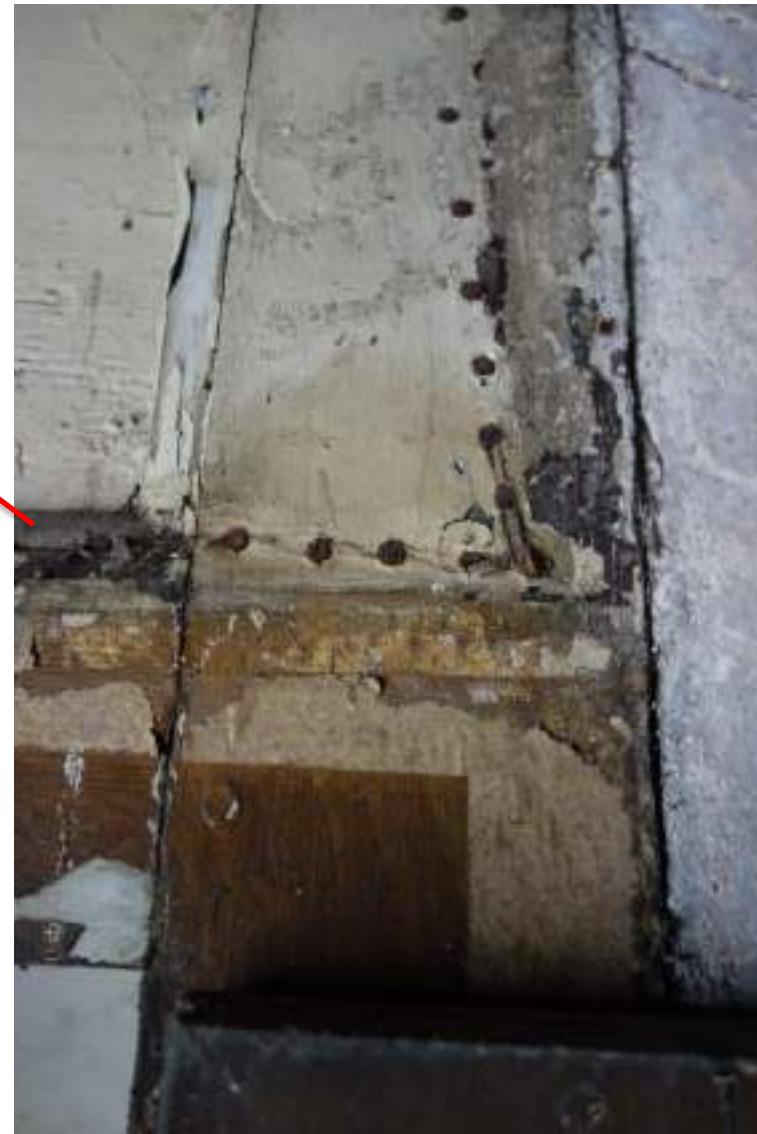
Tacks from the earlier hessian, stretched across battens as a base for wall paper

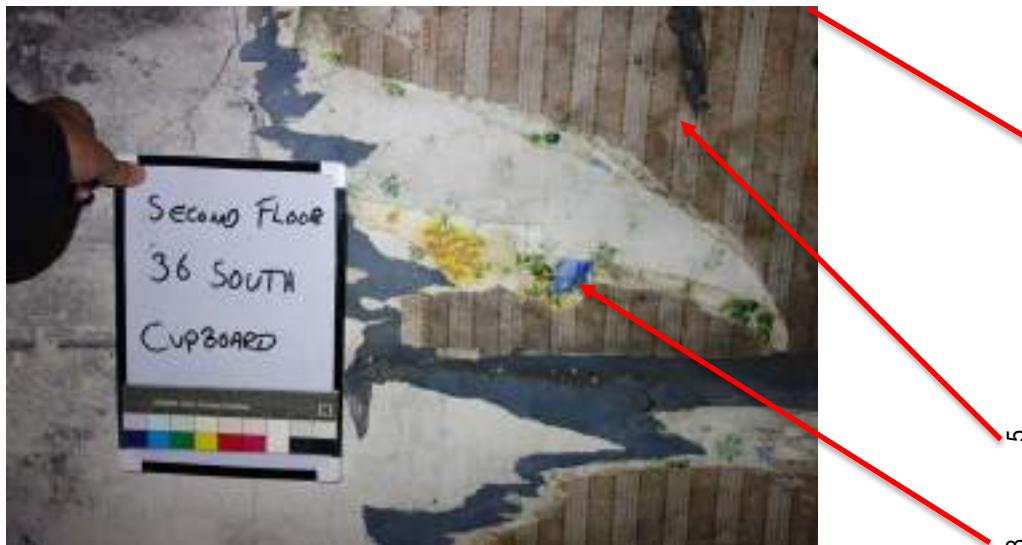
South wall cupboard at third shelf level

The best survival of wallpapers in this room are found in the cupboard to the left of the fireplace. Unfortunately, without separating these papers it was difficult to identify and date them successfully.

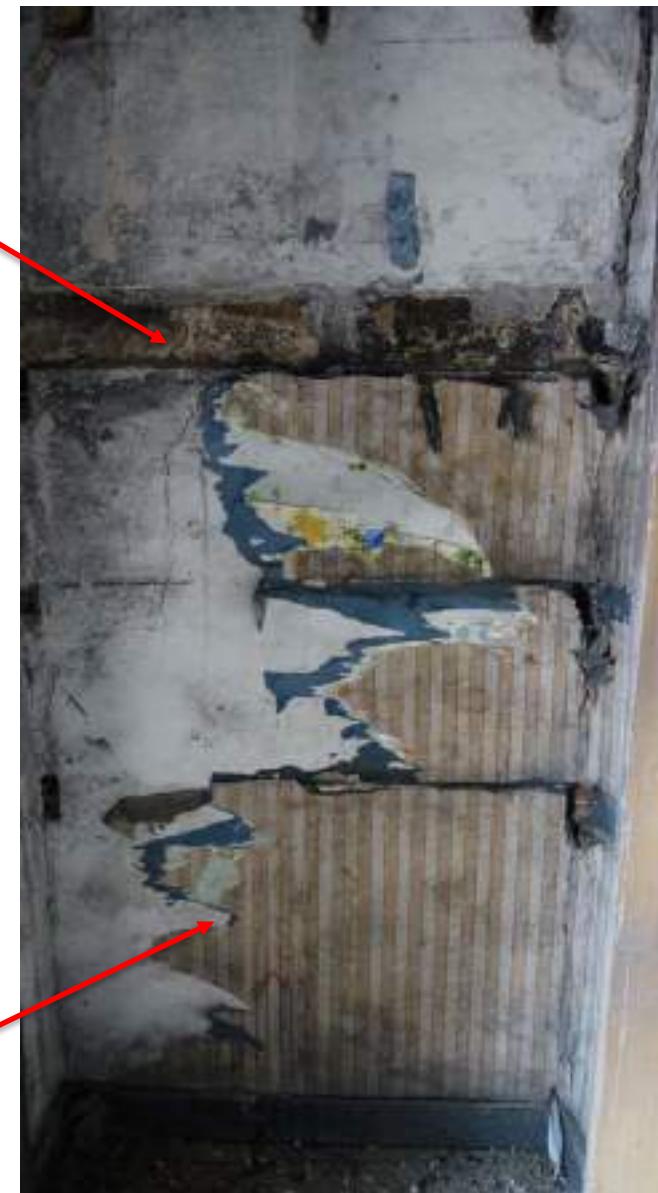
South wall cupboard, with wallpaper survival at lower level

One of the earliest found was located on the lower wallface and is identical to that found in the first-floor room 18, it comprises vertical bands of short horizontal stripes alternating with vertical bands of floral motifs and dates from the 1850s.

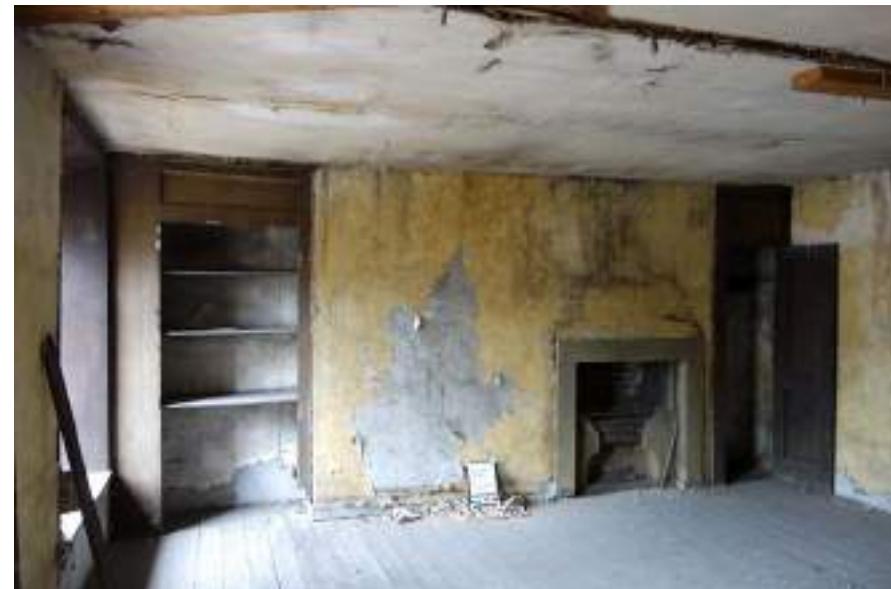
Room 38 South wall

Surface print - Friable and powdery,
Substrate - lime plaster appears sound
Paper tears easily
Staining - some sooty deposits and mild damp ingress
Infestation/damp - dry, damp, dusty and gritty
Risk H&S - surface dust throughout
Testing - none required
Friability - embrittled and buckled paper substrates.

The paper found in this room is a delicate floral trellis pattern similar to that found in room 19 on the first floor and dates from the 1840's.
