STRUCTURAL INSPECTION

THE DIRTY BOTTLES
28 NARROWGATE
ALNWICK
NORTHUMBERLAND
NE66 1JG

S4510-R02

GREENE KING BREWING & RETAILING LTD

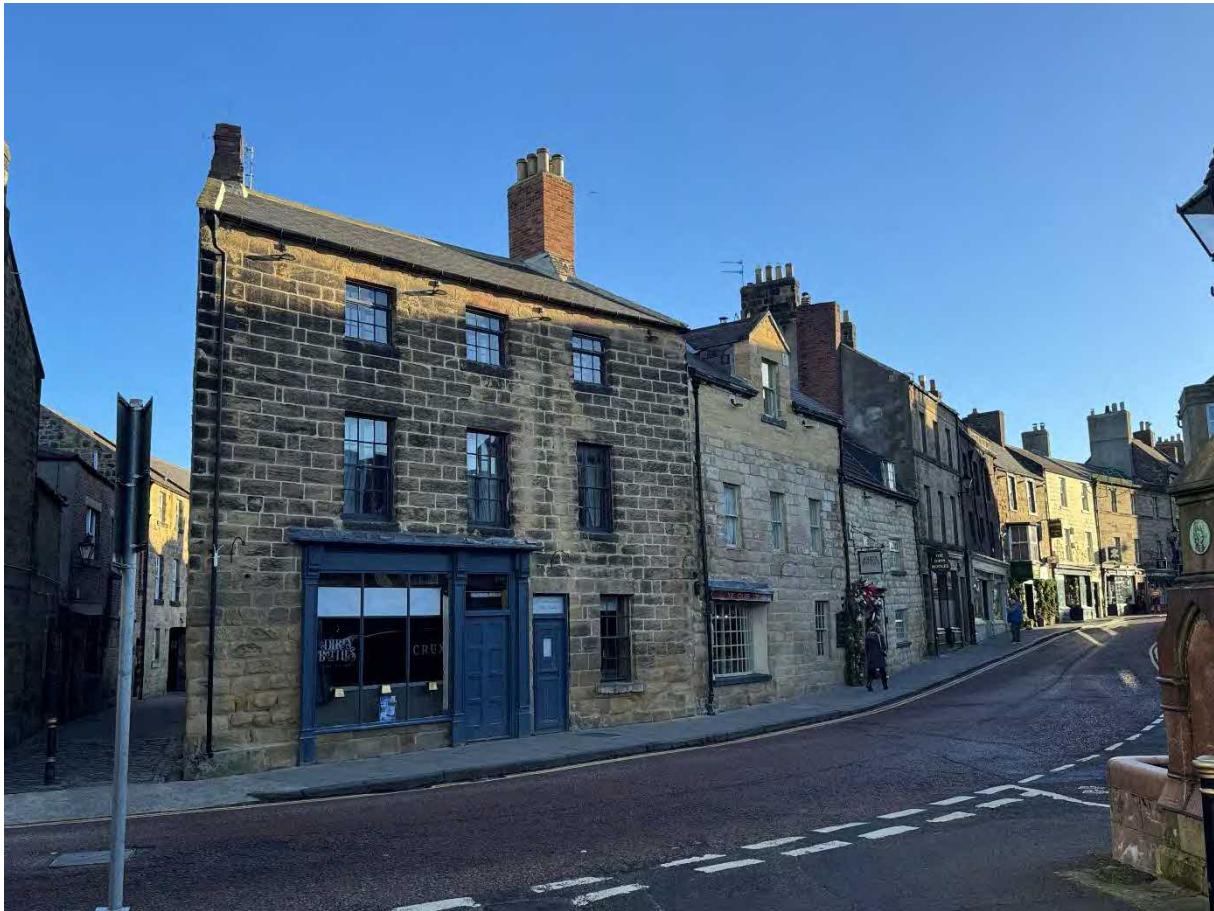
P1 – The Dirty Bottles – No. 34 Narrowgate – Alnwick

Front, southwest elevation.

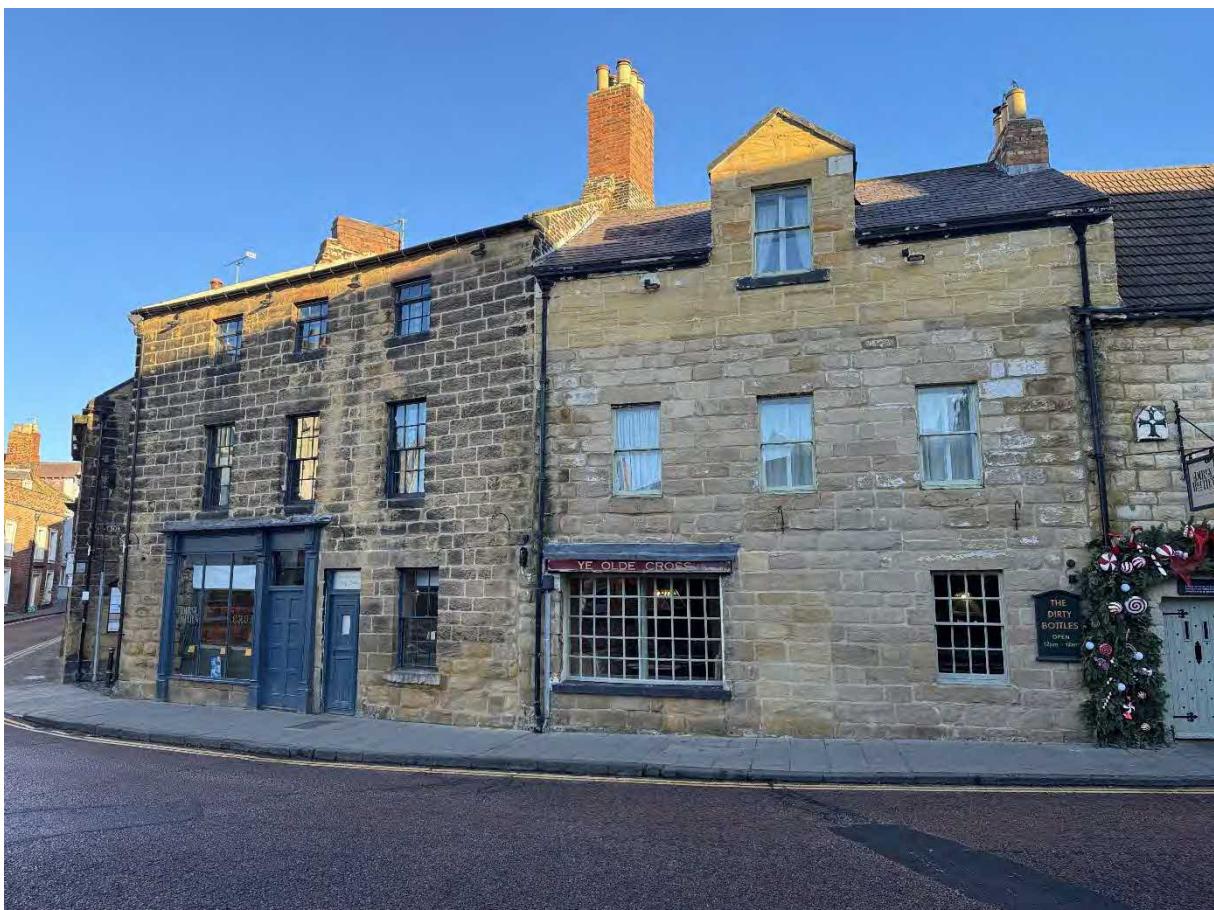
P2 – The Dirty Bottles – No. 32 - 34 Narrowgate - Alnwick

Front, southwest elevation.

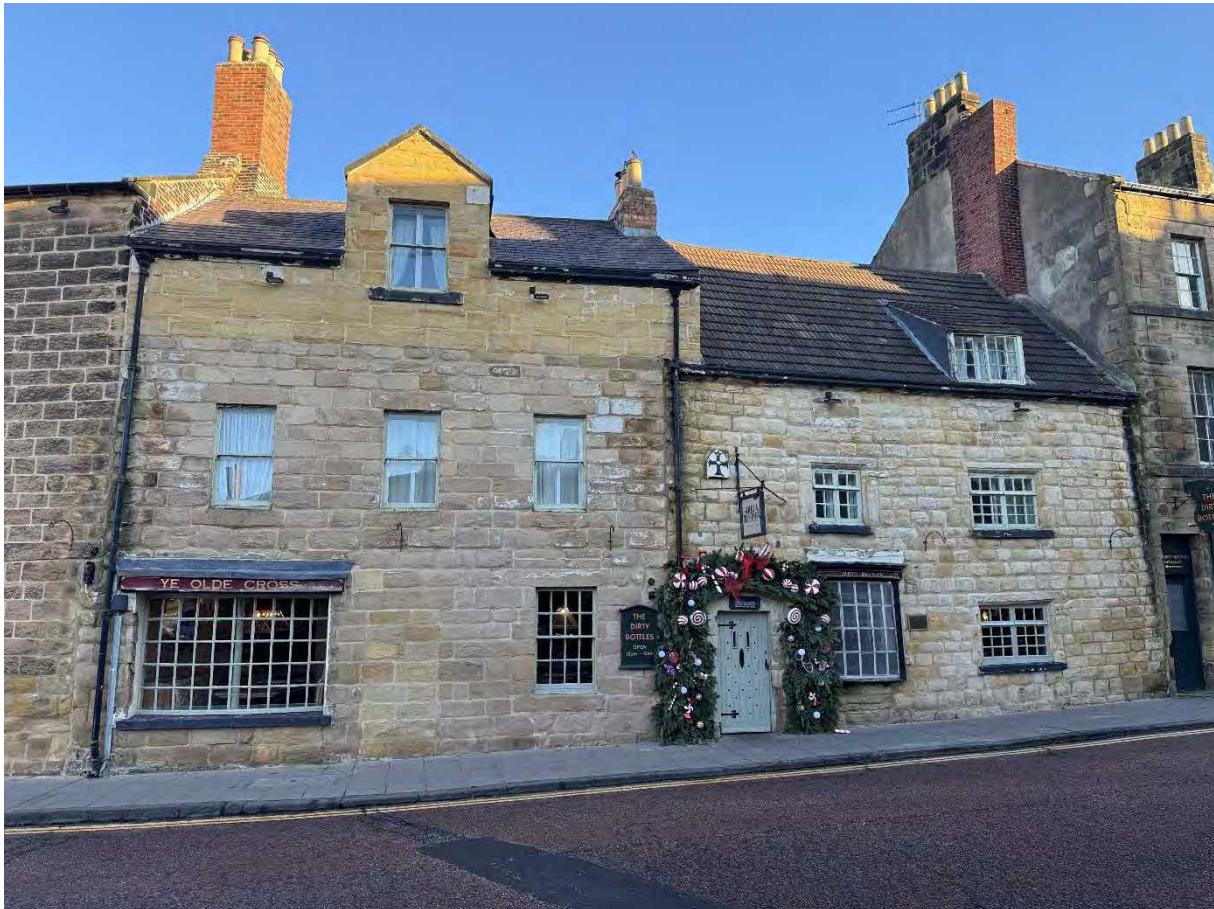
P3 – The Dirty Bottles – No. 30 - 32 Narrowgate - Alnwick
Front, southwest elevation.

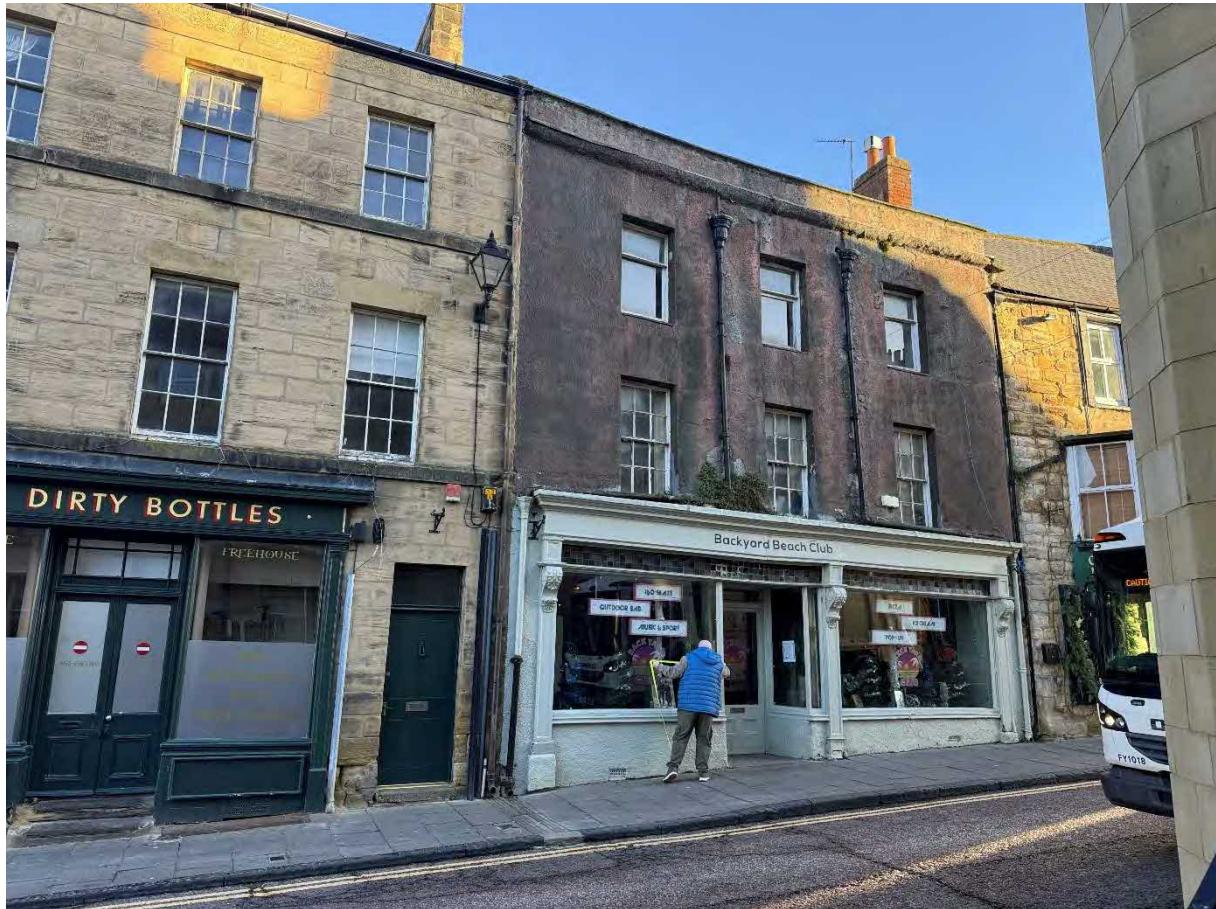
P5 – No. 28 Narrowgate - Alnwick - Front, southwest elevation.

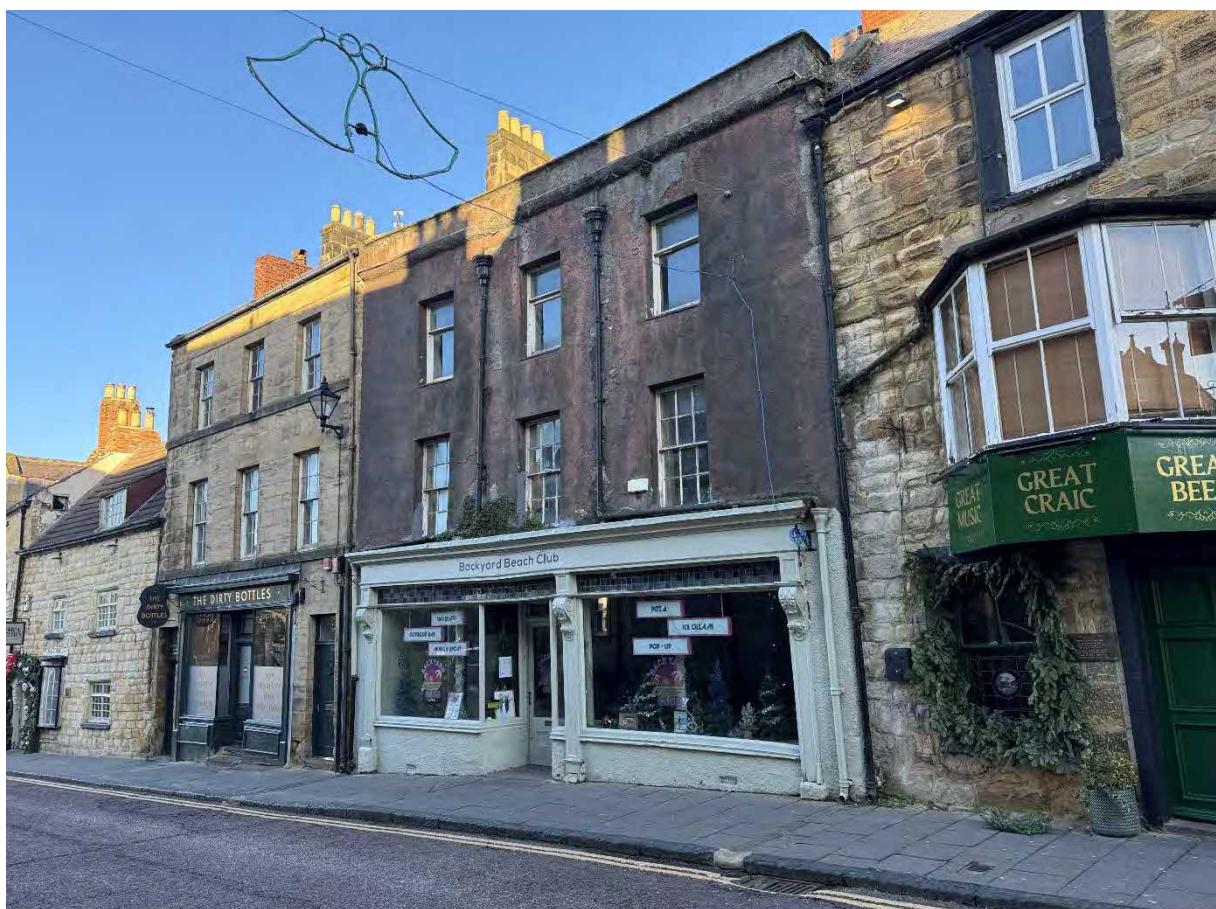
Viewed externally, the wall was noted to have poor vertical alignment at first and second floor levels, the head of the wall leaning (and bowing) inwards towards the north. Refer photograph P7, Appendix A.

The external roof rainwater drainage appears to be defective and water damage and vegetation growth were evident within the wall and above the shopfront fascia. Refer photographs P7 to P9, Appendix A.

P6 – No. 28 Narrowgate – Alnwick - Front, southwest elevation.

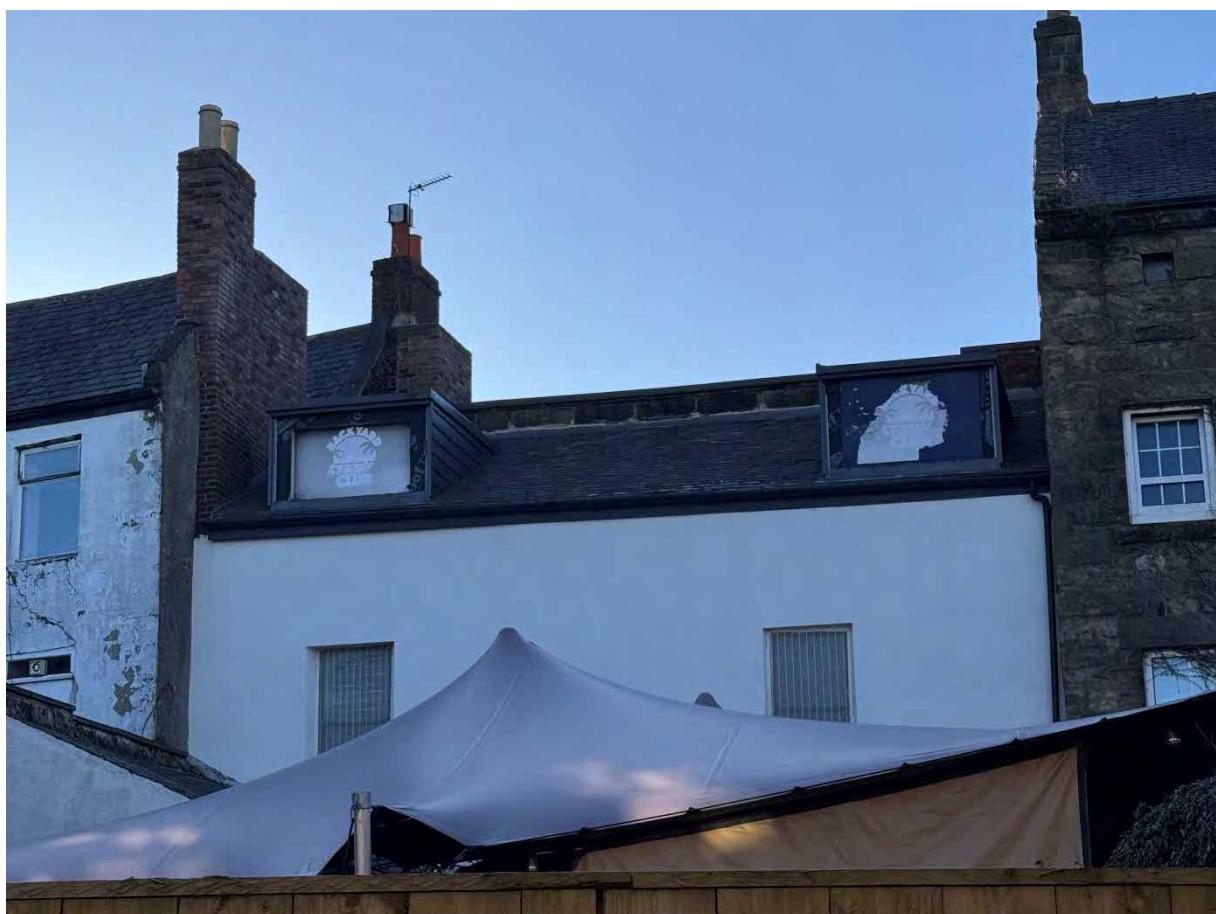
P14 – No. 28 Narrowgate – Alnwick - Rear, northeast elevation (viewed from boundary).

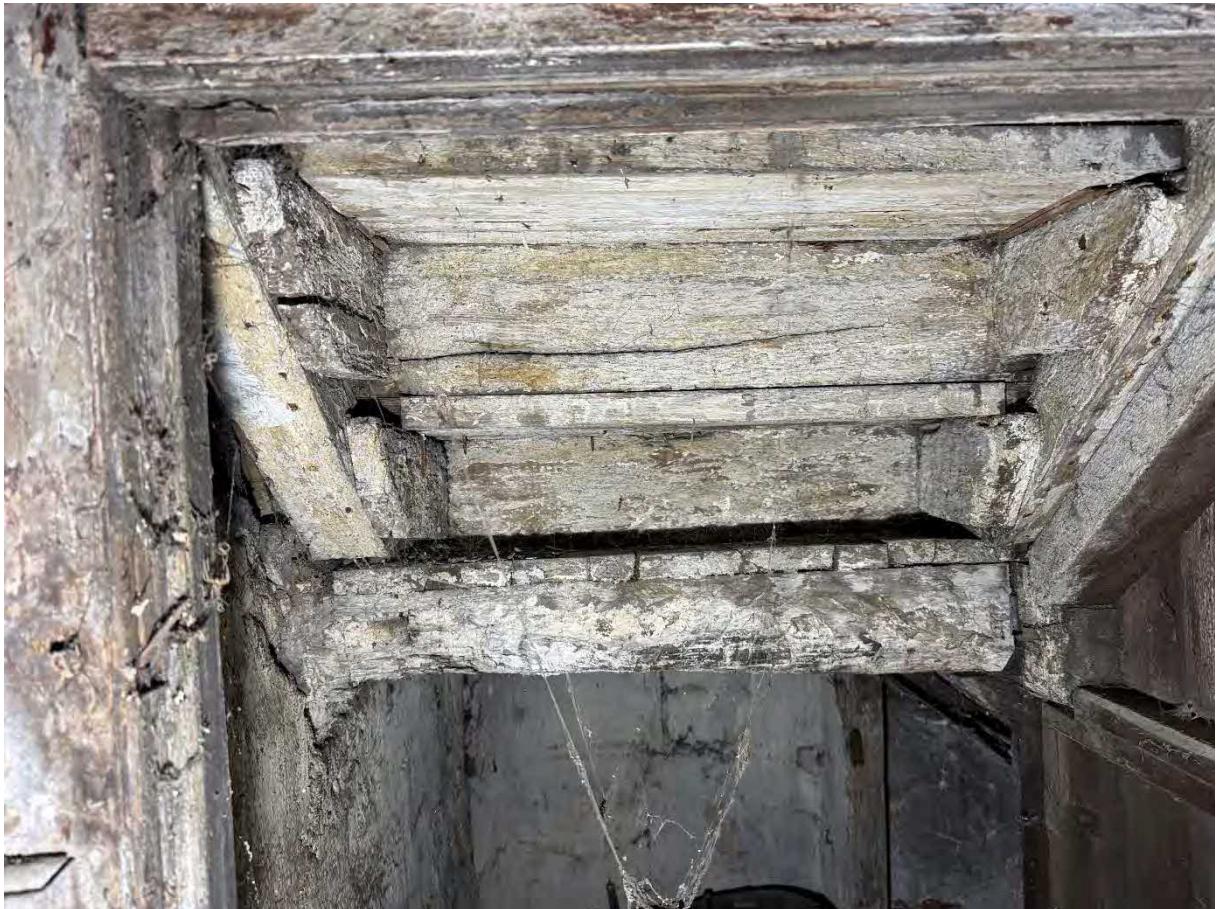
P15 – Entrance to partial basement to rear of property.
View of underside of timber staircase at ground floor level.

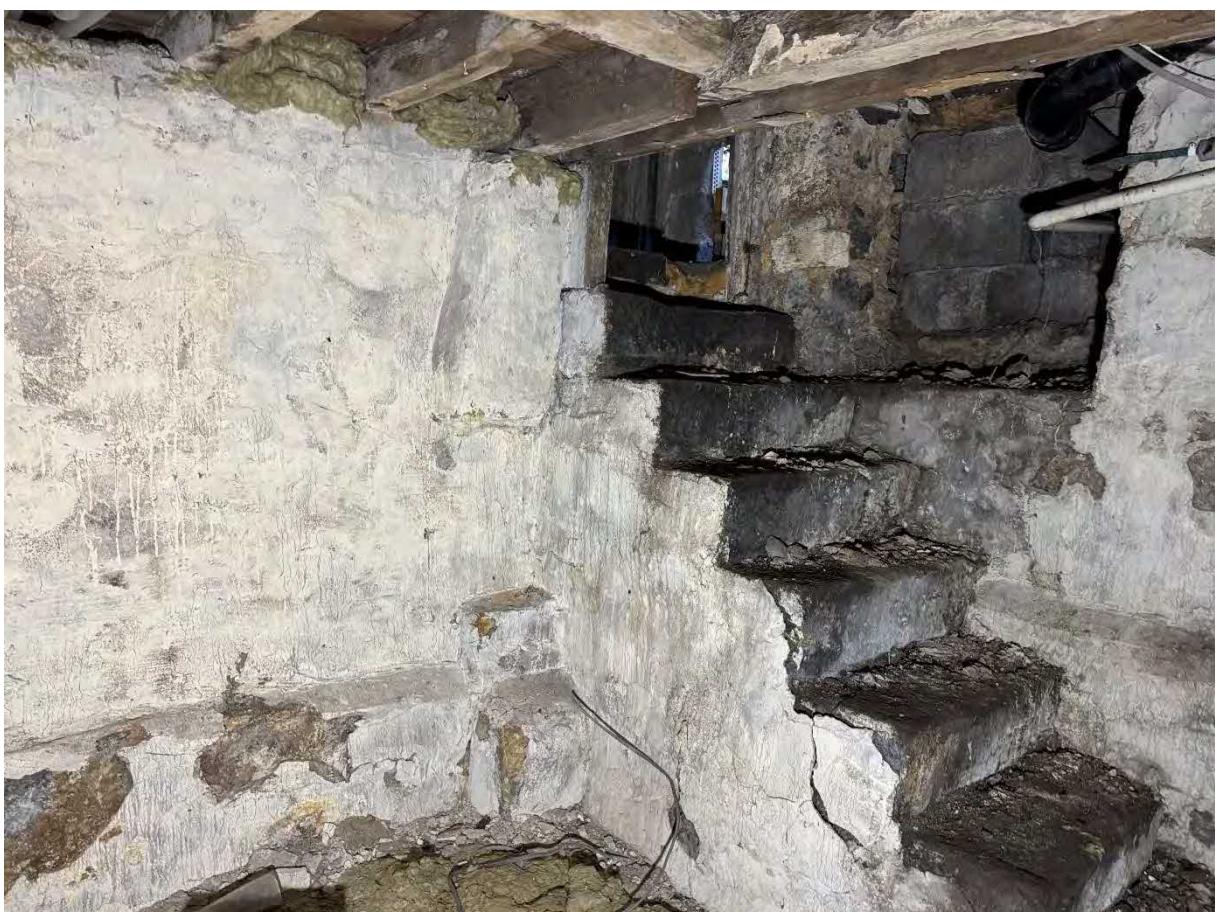
P16 – Entrance to partial basement to rear of property.
Stone steps into basement – timber ground floor over.

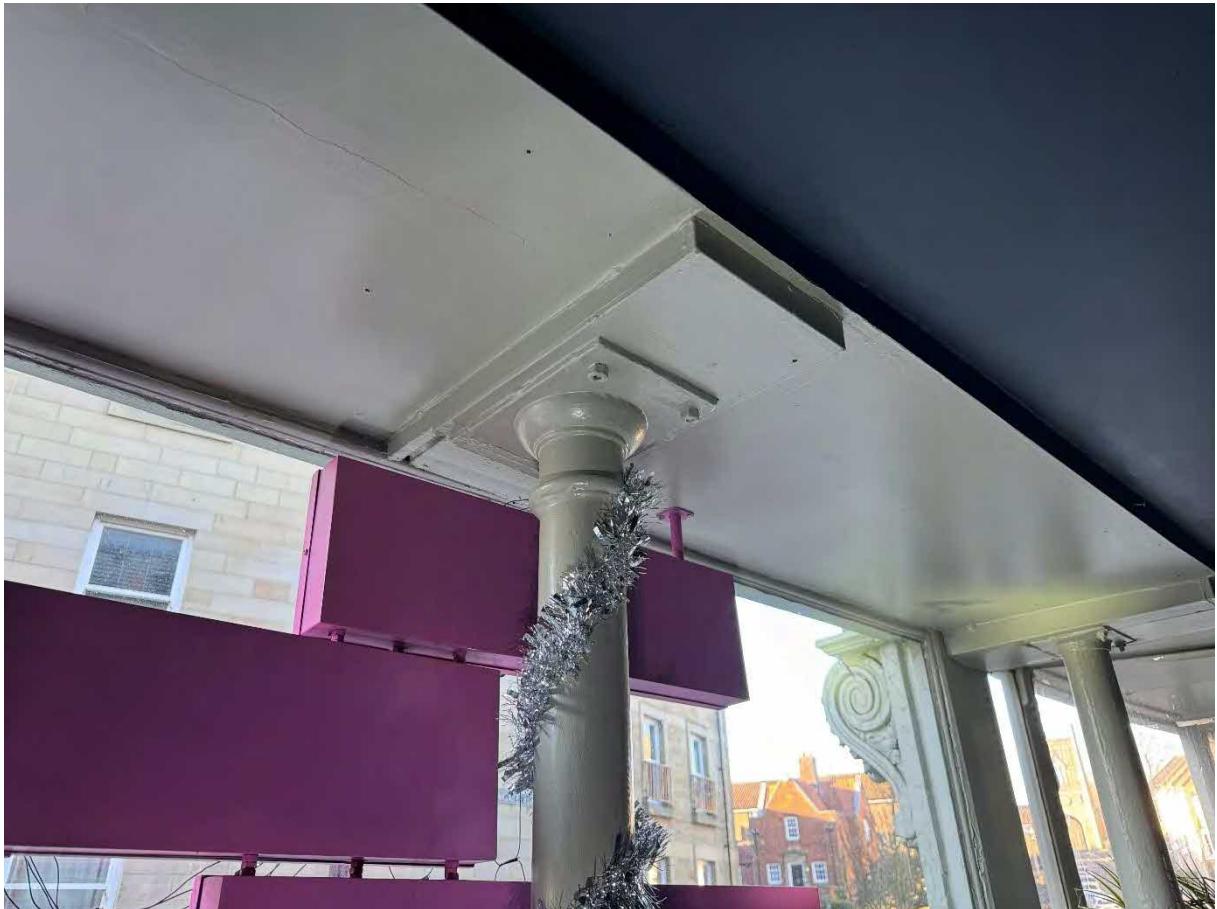
The two outer cast iron columns, supporting the shopfront beams at ground floor level, were noted to lean outwards approx. 20mm over 1.0m level length, towards the road (south). Refer photographs P20 + P21, Appendix A.

P19 – Cast iron columns supporting shopfront beams.

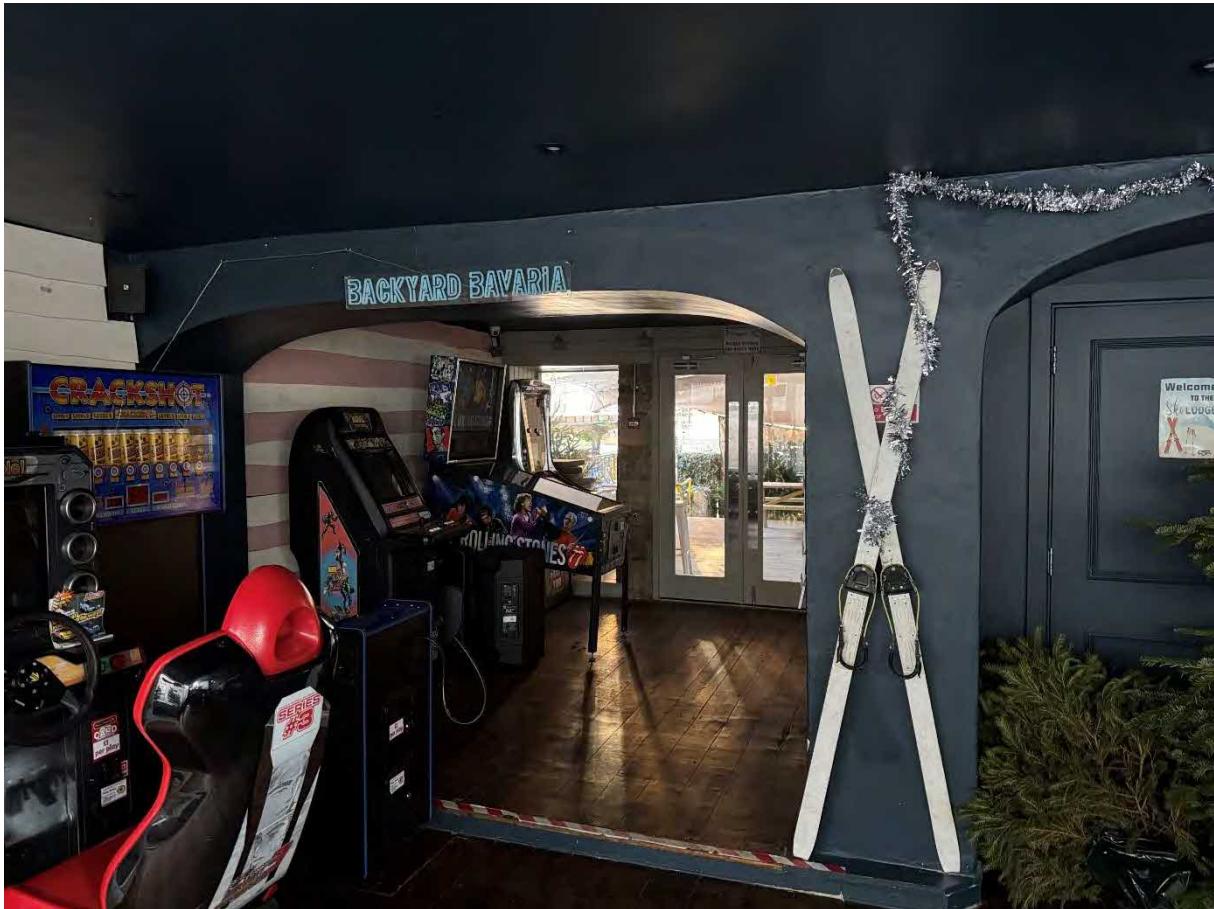
P23 – Ground floor – view from front to rear room.

Loadbearing masonry spine wall to nearside – with large openings at ground floor level.

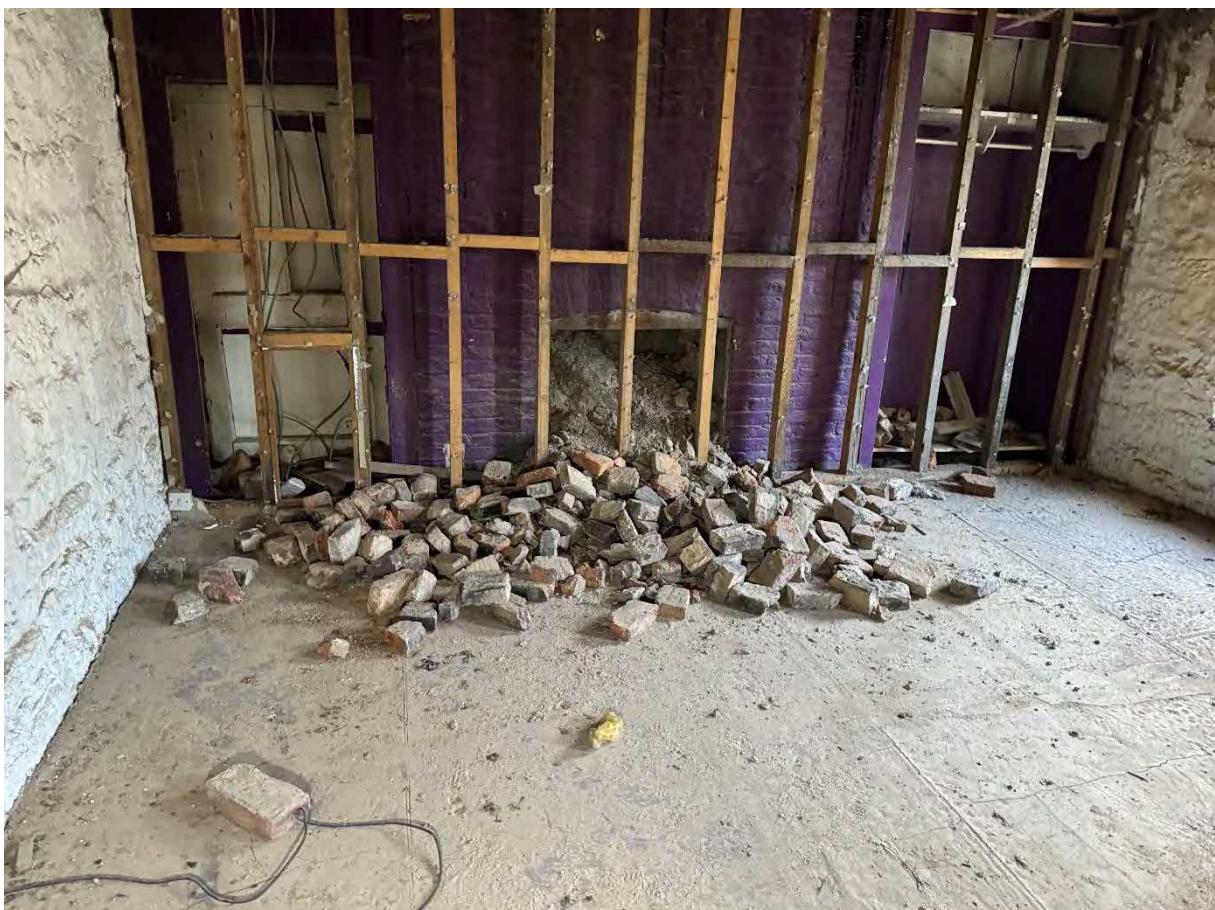
P36 – Brick rubble debris at second floor level – room (6).

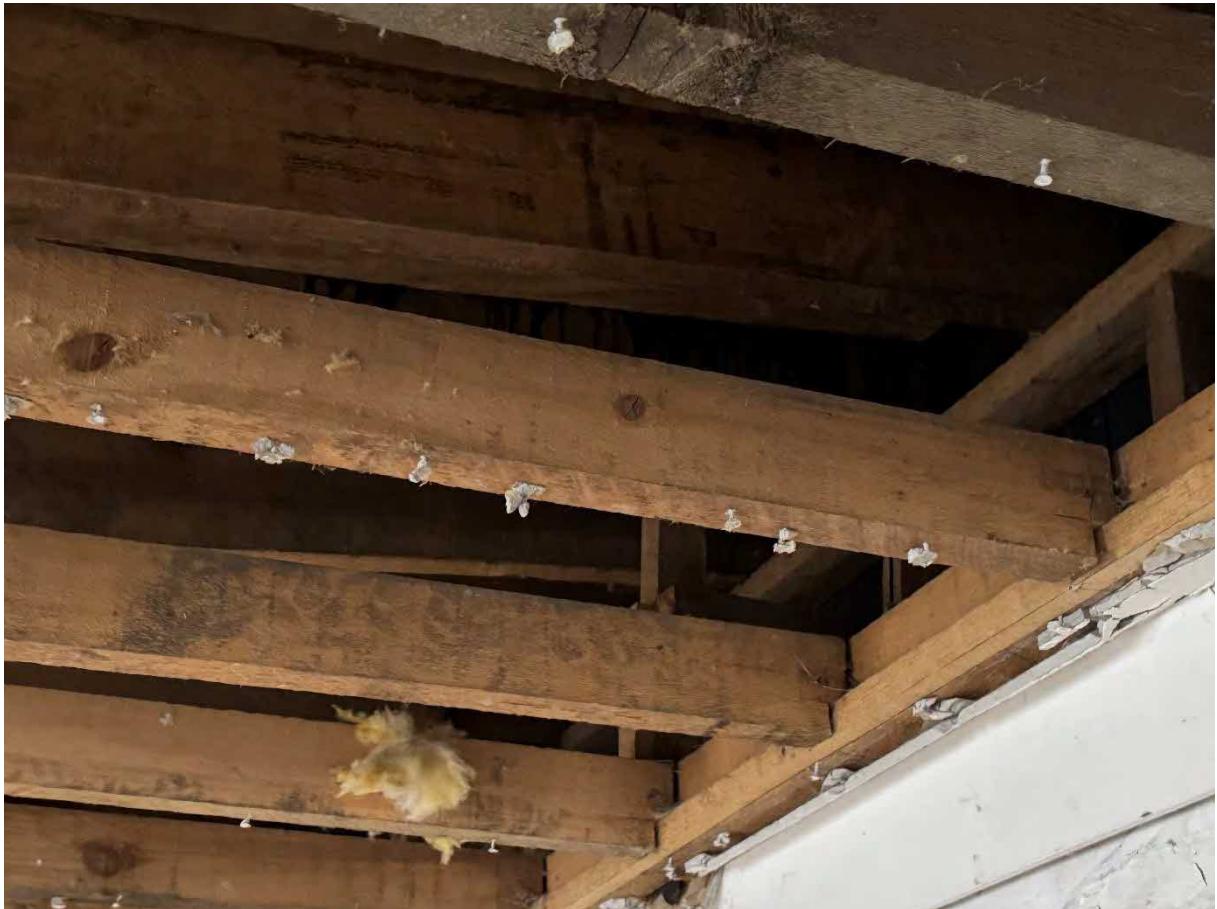
P41 – Underside of low-pitched timber roof to front of building.

Viewed from within room (6).

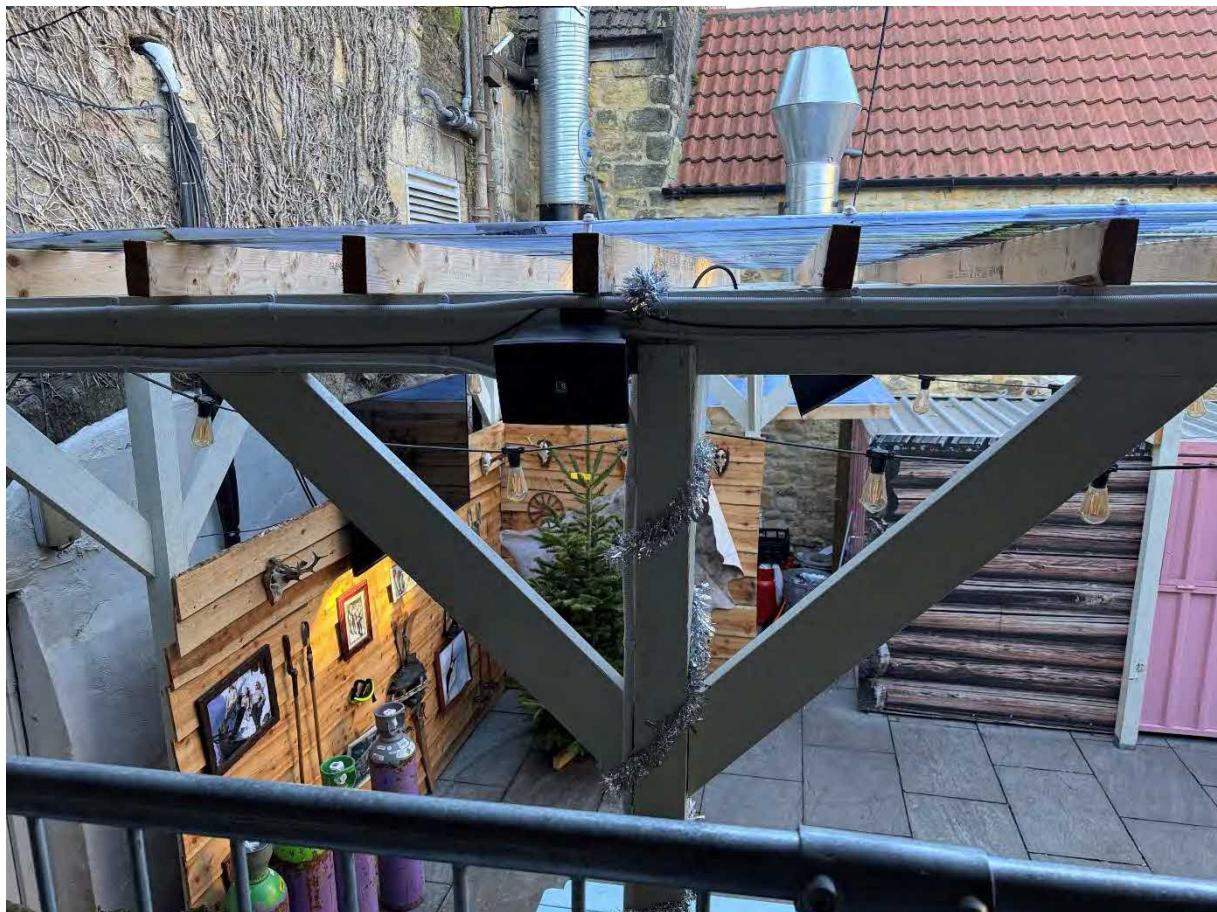
P61 – Timber framed pergola to rear beer garden.

95x45mm timber purlins supported on 145x45mm timber beams, supported on 100x100mm softwood timber posts.

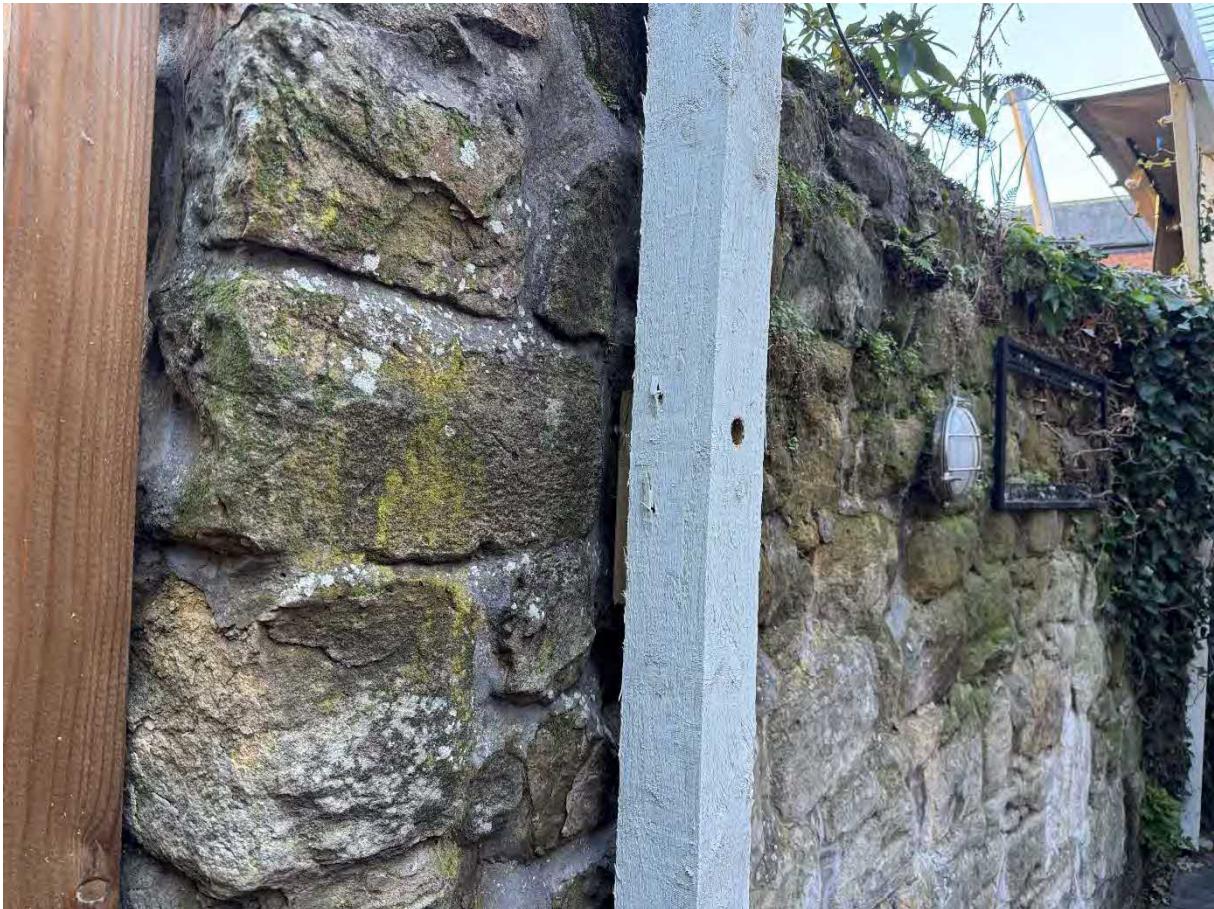
P63 – Timber framed pergola to rear beer garden.
Rear posts bolted to rear stone boundary wall.
